TECHNICAL REPORT REMR-CO-3

**CASE HISTORIES OF CORPS BREAKWATER
AND JETTY STRUCTURES**

Report 2

SOUTH ATLANTIC DIVISION

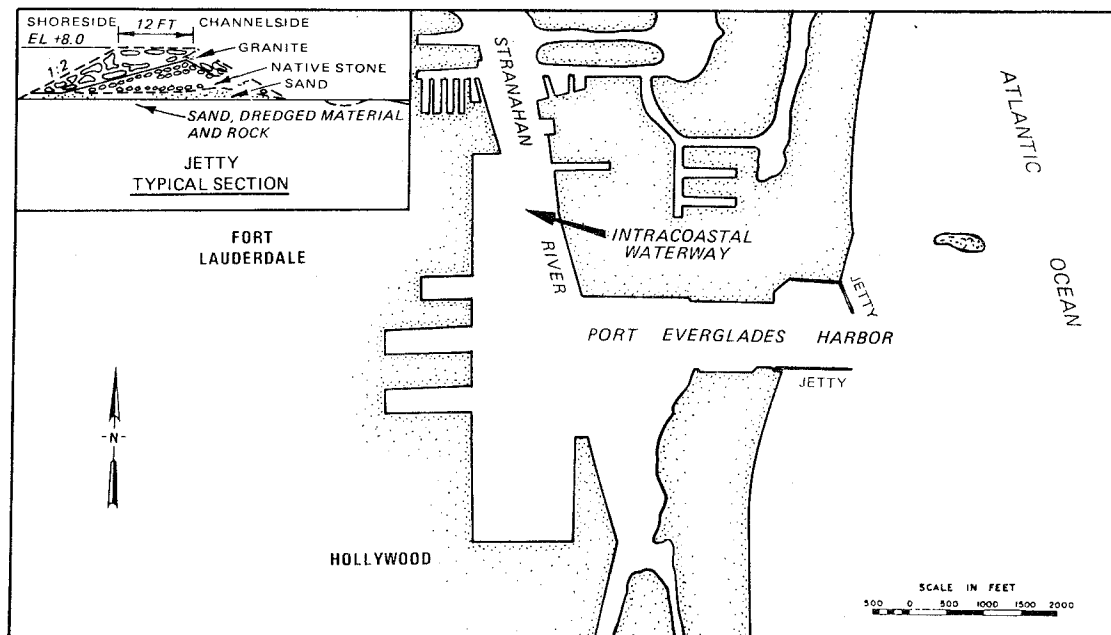
Figure 35. Port Everglades Harbor, Hollywood, Florida

Date(s)	Construction and Rehabilitation History
1928	Jetties were constructed (Figure 35) by local interests using native Florida limestone which ranged in weight from 300 lb to 8 tons (average of 2 tons). The design elevation, width, and side slopes were +6 ft mlw, 12 ft, and 1V:1.5H, respectively.
1931	The structure came under Corps jurisdiction in 1930. A survey of the existing structure showed elevations of from +10 to 0 ft mlw at the shoreward and seaward ends, respectively. Storm and wave action was believed to be major cause of subsidence at the seaward end. Seaward ends of jetties were in approximately 12 ft of water, and a 35-ft-deep channel passed between the jetties. The jetties were approximately 1,200 ft apart at their shoreward ends and converged at their seaward ends to a distance of 550 ft. The north and south jetties were approximately 1,250 and 1,025 ft long, respectively. Natural rock strata underlying the jetty and inlet areas exists at -10 to -15 ft mlw.

1932	Repairs made to the jetties consisted of placement of 2- to 10-ton granite stone to a height of +6 ft mlw, a crest width of 12 ft, and side slopes of 1V:2H. In addition, some old stone (about 400 pieces each weighing 1,000 lb or more) was rehandled in the construction phase. Total estimated quantities of stone were 4,900 and 5,230 tons for the north and south jetties, respectively. Total cost of the repair was \$49,400.
1935	A field survey showed approximate lengths of 1,250 and 1,000 ft for the north and south jetties, respectively. Centerline elevations on the north jetty range from +10 to +5 ft mlw over the shoreward (old) 500 ft and from +4 to +8 ft mlw over the seaward (repaired) 750 ft. Centerline elevations on the south jetty range from +9 to +7.5 ft mlw over the shoreward (old) 300 ft and from +9 to +4 over the seaward 700 ft. The outer 100 ft of each jetty appeared to have subsided 1 to 2 ft from the design elevation of +6 ft mlw.

1939	The jetty survey showed no major changes in centerline elevations. The north jetty elevations were +12 to +8 ft mlw from 0 (shoreward end) to 300 ft, +8 to +4 ft mlw from 300 to 1,200 ft, and +6 to +3 ft mlw from 1,200 to 1,250 ft (seaward end). On the south jetty the elevations were +9 to +6 ft mlw from 0 (shoreward end) to 220 ft, +10 to +7 ft mlw from 220 to 830 ft, and +7 to +3 ft mlw from 830 to 1,000 ft (seaward end).
1940	Repairs to jetties consisted of raising the seaward portions, straightening the seaward end of the south jetty, and placement of a special head section. The repaired lengths were 1,280 and 980 for

Date(s)	Construction and Rehabilitation History
1940 (Cont)	the north and south jetties, respectively. The outer 990 ft and 450 ft of the north and south jetties were brought up to +8 ft mlw with a 12-ft crest and 1V:2H side slopes (Figure 35, inset). The head section of each jetty had a +15-ft mlw crest elevation, a 24-ft-diam crest, and 1V:2H side slopes radiating away from the crown. A total of 18,900 tons of 4- to 12-ton granite stone was placed. (Other work consisted of placing 750 tons of 25- to 150-lb chinking stone and handling of 1,200 pieces of old stone.) Total cost of the repairs was \$142,700.
1978- 1979	As part of harbor deepening improvements, the seaward 200 ft of the north jetty was realigned parallel to the entrance channel (Figure 35). The realignment allowed the channel width between the jetties to be increased from 300 to 450 ft. The estimated realignment cost was \$75,000.

1984- 1985	The inner ends of the jetties were repaired by rebuilding the armor stone layer with new and existing stone. To allow the jetties to be used as fishing piers, void spaces were chinked with smaller stone, and a layer of asphalt was piled on the crown. Prior to the repairs, the inner ends were in very poor condition with numerous void spaces while the remaining parts of the jetties were considered to be in satisfactory condition.

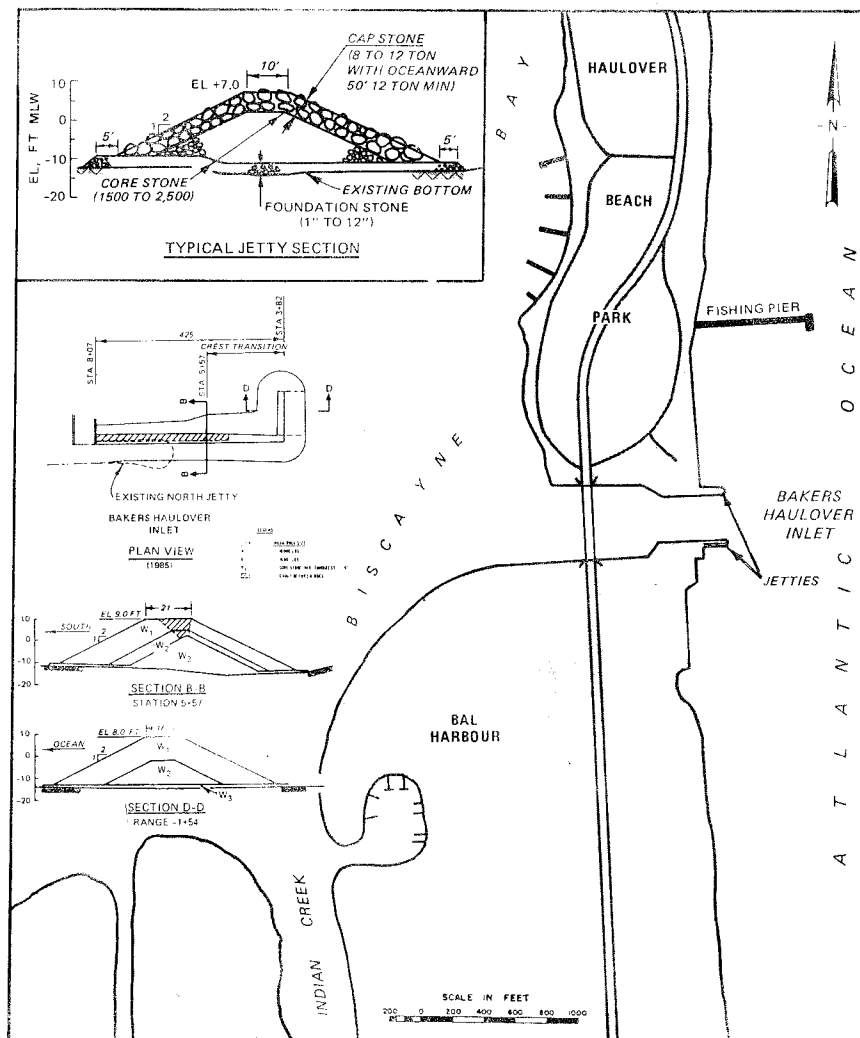
Figure 36. Bakers Haulover Inlet, Florida, 1964

Date(s)	Construction and Rehabilitation History
1925	A man-made inlet was constructed by local interests.
1963- 1964	Existing steel sheet-pile jetties (private construction, date unknown) had rusted through, and wave action had partially removed sand fill behind them. Loss of this fill caused the collapse of portions of an 8-in. concrete cap on both jetties. The sheet-pile jetties were removed and 150-ft-long rubble-mound jetties were constructed in their place (Figure 36). The jetty section consisted of 1,500- to 2,500-lb and 8- to 12-ton stone for the core and cap, respectively. 12-ton minimum cap stone was placed on the outer 50 ft of the jetties. The side slopes were 1V:2H with a crown width and elevation of 10 ft and +7 ft mlw, respectively. The design was based on a wave height of 14 ft and Hudson's slope stability formula. The centerline distance between the jetties was about 415 ft, the south jetty being placed about 100 ft south of the sheet-pile jetty. The channel was dredged to -11 ft mlw. Total cost of the jetties and connecting revetments was \$417,000.

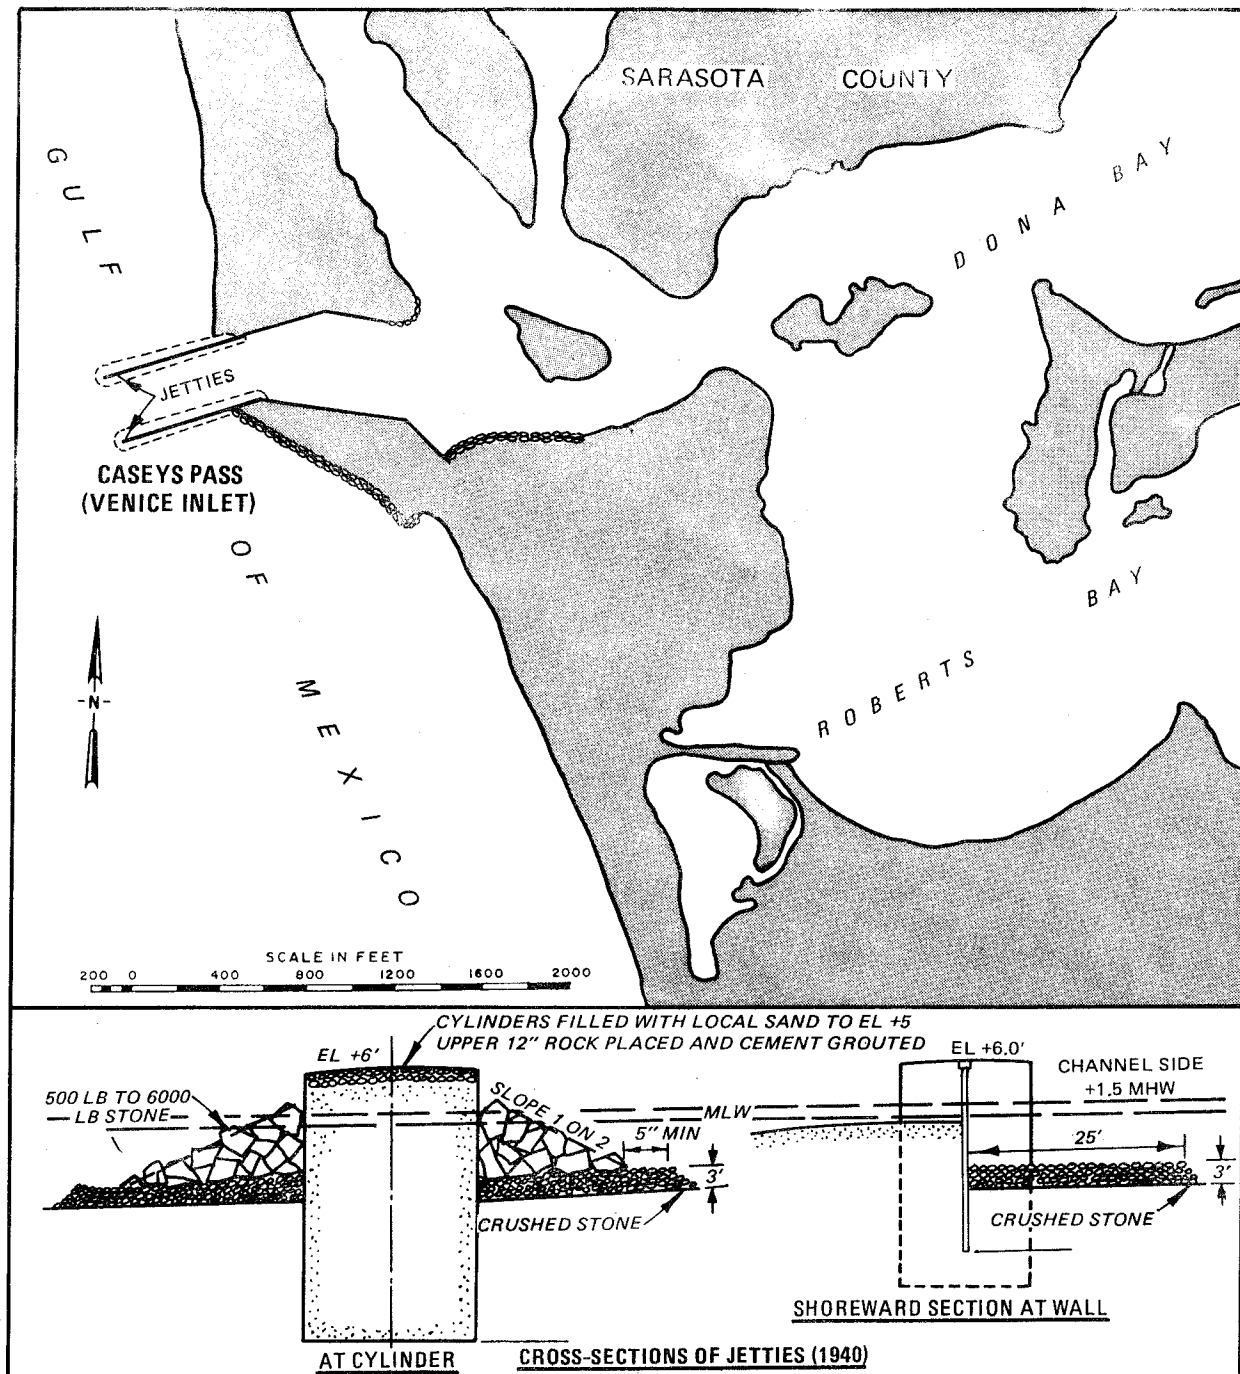
Figure 39. Casey's Pass, Florida

Date(s)	Construction and Rehabilitation History
1937	Two parallel, 660-ft-long steel sheet-pile jetties, spaced 300 ft apart, were constructed at this man-made inlet. Each jetty was composed of 19 cylinders (caissons), 15 to 20 ft in diameter and interconnected by linear sections of sheet pile (Figure 39). Each cylinder was backfilled with sand, and a stone and grout cap was placed in the upper foot. The crest elevation of the jetties was +6 ft mlw. A channel 100 ft wide and 8 ft deep was dredged through the inlet. The jetties were connected to the shore via creosoted wooden sheet-pile bulkheads. The total cost for the jetties and bulkheads was \$137,000.
1938- 1940	Limestone enrockments were placed along all exposed sections of the jetties (Figure 39). The section consisted of (total weights in parentheses) a crushed stone bedding layer (4,000 tons), followed by a layer of 50- to 200-lb (8,000-ton) stone, and covered with 500- to 6,000-lb (10,800-ton) stone placed on 1V:2H side slopes at an elevation of +2 ft mlw. The total cost of the improvements was \$122,000.

1950- 1951	Jetty surveys showed that the heads and seaward sides of the jetties needed repairs. The channel side of the north jetty needed repair because of the proximity of the channel causing scouring at the toe.
1955	Repairs were made to the seaward end of the south jetty which was in a "severely damaged" condition. A total of 650 tons of 3- to 6-ton cover stone was placed on a 2-ft-thick foundation blanket of 2- to 6-in. stone at a total cost of \$6,500. Repairs were also made to the collapsed concrete caps on the 1st and 8th caisson from its seaward end. Nearly 3/4 of the first caisson was severely damaged, and 3- to 6-ton cover stone was placed to +6 ft mlw with a 10-ft crown width. The upper 4 ft of the 8th caisson was filled with stone, and the upper foot of this was capped with concrete grout.
1963	Repairs to the concrete cylinder caps and jetty stone/rock revetments were made at a cost of \$30,000. At this time, the channel was dredged to a depth of -9 ft mlw. Along the exposed seaward sections, 3- to 6-ton capstone totaling 615 and 770 tons was placed on the north and south jetties, respectively, and approximately 20 capstones were reset. Several of the seaward cylinders were repaired. Their caps and sand were removed to -1 ft mlw, replaced with the broken pieces of the cap and 20- to 200-lb stone, and grouted with concrete throughout the upper 18 in. of stone.

Date(s)	Construction and Rehabilitation History
1968- 1969	<p>Visual examinations and detailed surveys showed the sheet-pile cylinders and walls to be in need of immediate repairs. Voids between the original concrete caps and the underlying sand existed in virtually all cylinders not repaired in 1963. Corrosion was the main cause of deterioration, with subsequent removal of sand from the cylinders because of wave and current action. Rehabilitation of the jetties was carried out in 1969 (Figure 40). The sheet-pile walls and cylinders (except the outer two on the north and outer one on the south) were removed down to +2 ft mlw, and the sand within the cylinders were removed to mlw. The existing concrete cap (broken into pieces less than 12 in. long) and 1- to 12-in. bedding stone were placed in the cylinders to +2 ft mlw. This was overlaid with 4- to 10-ton capstone (70 percent > 8 tons), with similar capstone placed along the connecting walls, to bring the structure to the original design elevation of +6 ft mlw with a crown width of 10 ft. Additional 4- to 10-ton capstone was placed, as needed, to bring the side slopes up to 1V:2H. On the outer 50 ft of the jetties, the side slopes were 1V:3H. Finally, asphaltic concrete was placed (Figure 40) on the jetties. This material was placed over the entire crown width down to mlw, and had 1V:1H side slopes. The design of the jetties used Hudson's formula with wave heights of 12 to 16 ft and wave periods of 7 to 9 sec.</p>

1978	<p>Repair to jetties consisted of resetting stone and adding 6- to 12-ton stone (75 percent > 10 ton) on the outer 200 ft of the jetties and 2- to 6-ton stone on the next 450 ft of the jetties as needed to solidify the structure.</p>
1985	<p>The jetties are in good condition except for their head sections which are in need of some repair.</p>

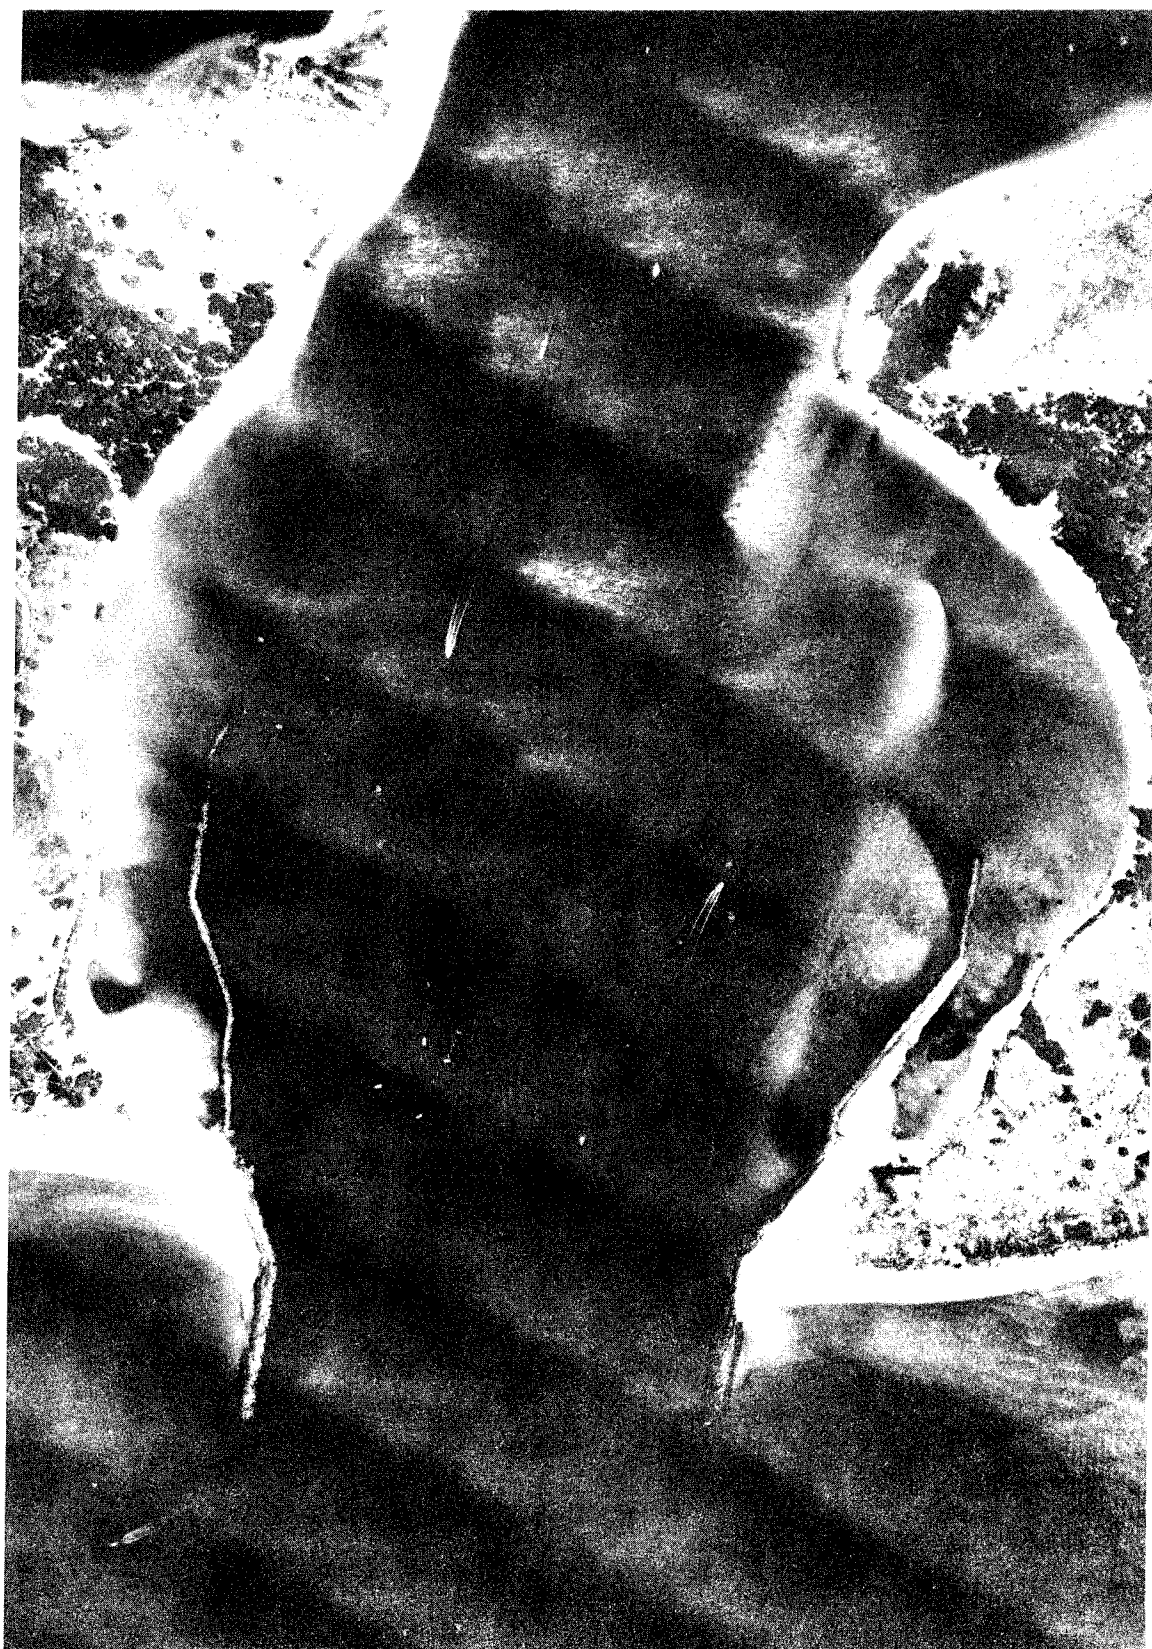
Figure 52. Panama City jetties, February 1984

Date(s)	Construction and Rehabilitation History
1983- 1984 (Cont)	<p>The outer 200 ft of the existing west jetty was in fair condition with an average elevation of +4.5 ft mlw, and the average water depth, seaward of the jetty, was -20 ft mlw. A scour valley extended along the toe of the west jetty head and was approximately 50 ft wide and 10 to 12 ft deep seaward of the jetty axis. The east jetty wing extension was in fair condition with an average elevation of +4.5 ft. The west jetty wing extension was in poor condition with average elevations of +3.5, +0.5, and -7.5 ft mlw along successive landward sections of 700, 450, and 400 ft (landward end). Side slopes were typically 1V:2H or less (i.e. 1V:3H). Rehabilitation of 1,060- and 1,240-ft-long seaward sections of the east and west jetties, respectively, employed 3 design cross sections (Figure 51). The inner trunk section had a +6 ft mlw crown elevation and 5- to 9-ton cover stone. The outer trunk section had a +7.5-ft mlw crown elevation and 9- to 12-ton cover stone. Both sections had 15-ft minimum crown widths. The head section had a +9 ft mlw crown elevation, 20-ft minimum crown width, and 12- to 20-ton cover stone. All sections had 1-V:2-H side slopes except the head semicircles, which were warped from 1V:2H (normal to the jetty axis) to 1V:3H (along the jetty axis). Transition sections (both in geometry and stone size) between the design sections were 100 ft long, except for the east jetty inner to outer trunk transition, which was 79 ft long. The lengths of the head, inner trunk, and outer trunk sections on the east jetty were 100, 301, and 420 ft long, respectively, and on the west jetty were 100, 300, and 500 ft long, respectively. The estimated quantity of cover stone was 21,600 tons. The rehabilitation also required removing approximately 150 ft of collapsed steel sheet-pile wall on the west jetty (beginning 1,000 ft from the seaward end) and breaking up the asphalt layer which covered sections of both jetties (from the 1938 repairs), into segments no larger than 20 sq ft. The entrance channel is presently maintained at a depth of 42 ft and a width of 450 ft. Figure 52 is an aerial view of the jetties taken prior to their rehabilitation.</p>
