DoD Corrosion Prevention and Control Program

Demonstration and Validation of Materials for Corrosion-Resistant Fencing and Guard Railings in Aggressive Climates

Final Report on Project F09-AR02

October 2015

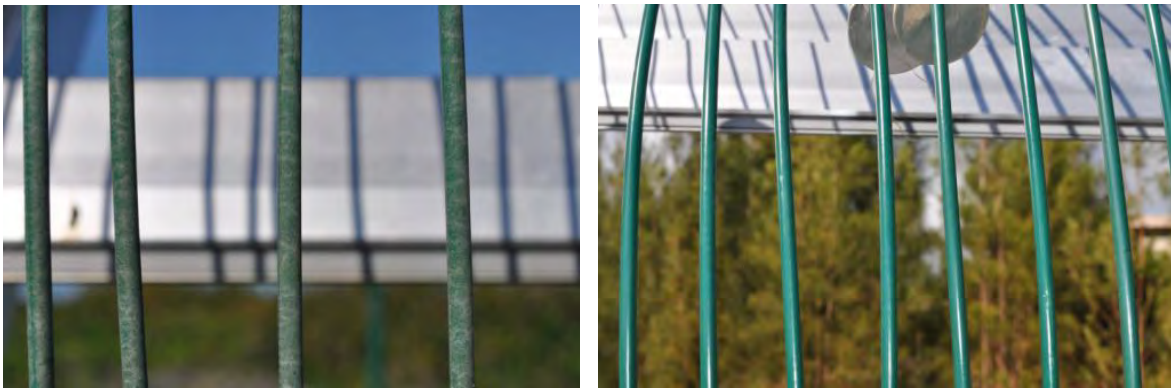
Figure 18. Standard PVC coated galvanized wire coupon at FRF (left) and KTA (right) after 6 months of exposure.

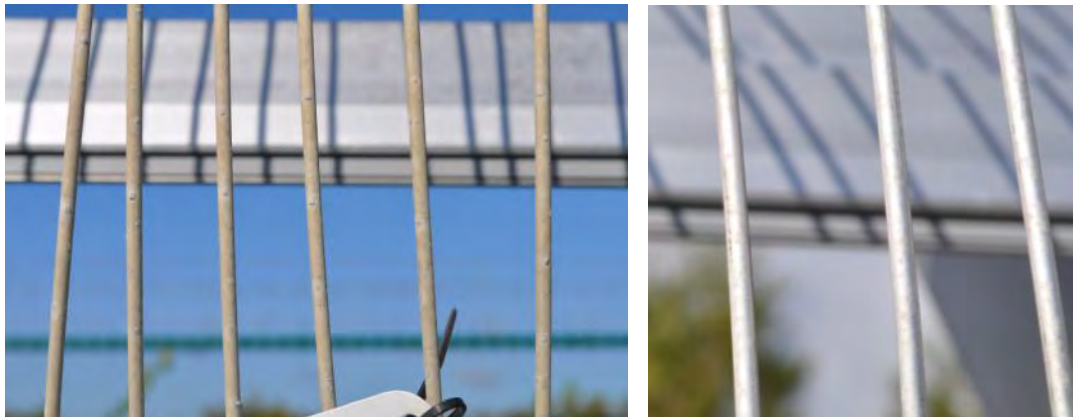
Figure 19. Aluminum wire coupon at FRF (left) and KTA (right) after 6 months of exposure.

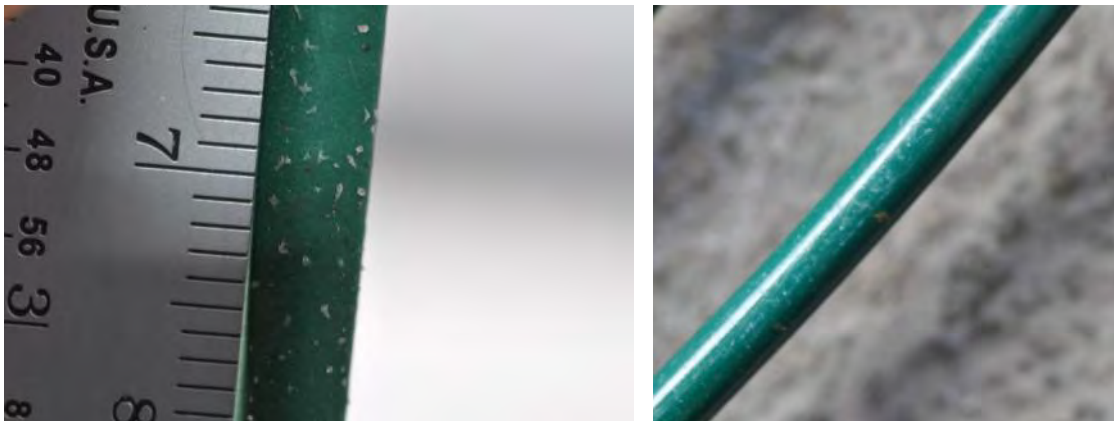
Figure 22. Standard PVC coated galvanized steel wire coupon at FRF (left) and KTA (right) after 12 months of exposure.

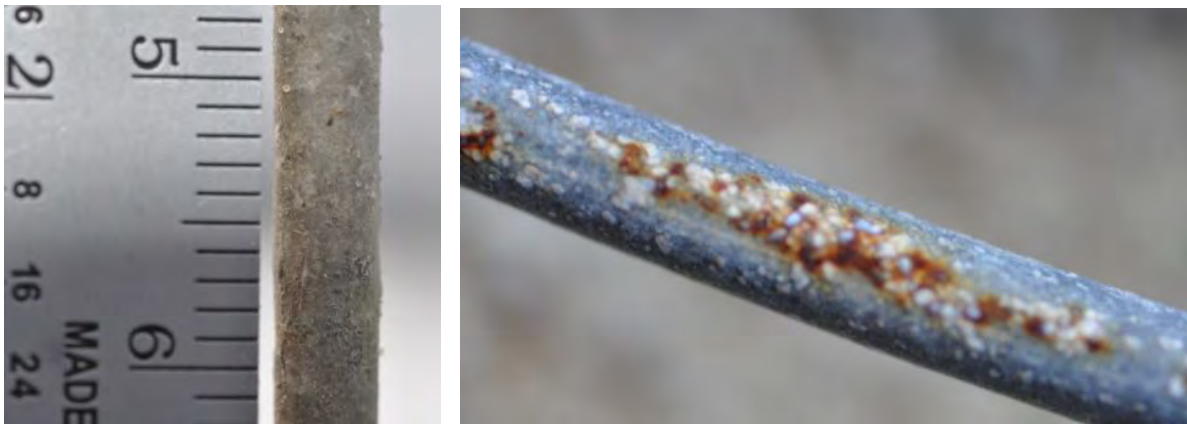
Figure 23. Standard galvanized steel wire coupon at FRF (left) and KTA (right) after 12 months of exposure.

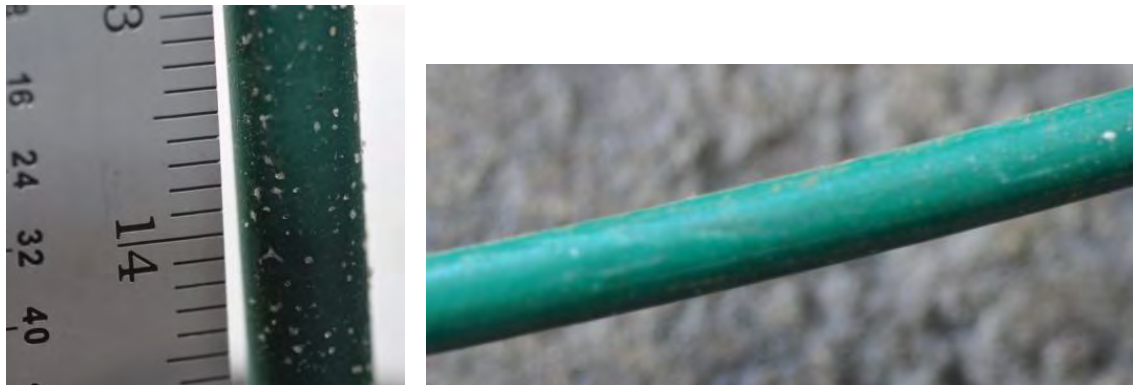
Figure 25. Fuse bonded PVC coated wire coupon at FRF (left) and KTA (right) after 12 months of exposure.

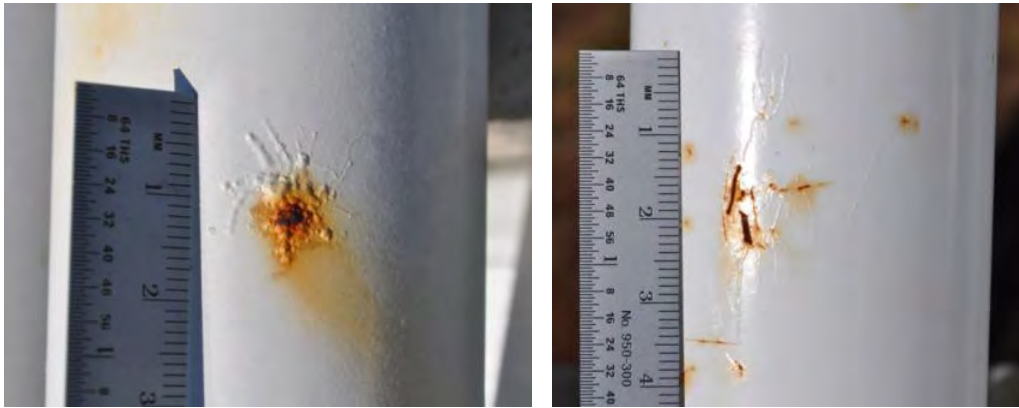
Figure 30. Coated steel railing coupon at FRF (left) and KTA (right) after 6 months of exposure.

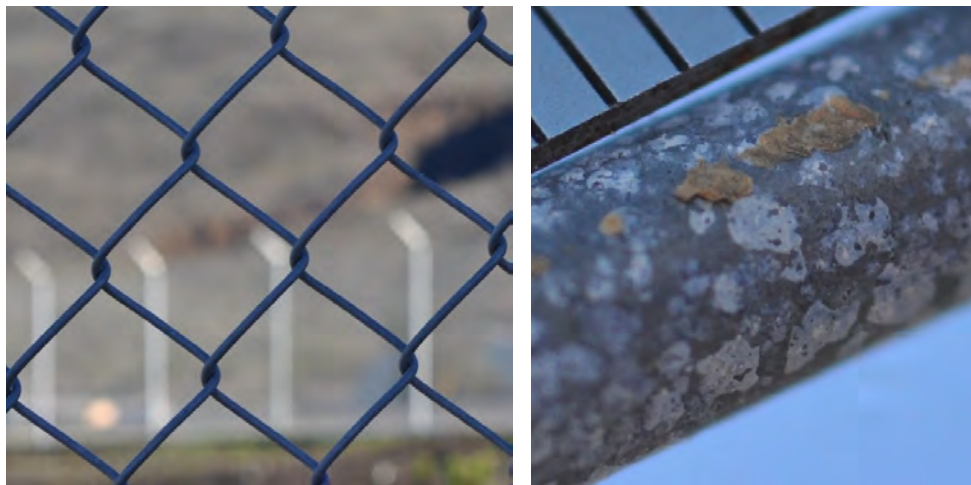
Figure A16. Galvan showing localized corrosion on 10% of its total surface after 12 months exposure.

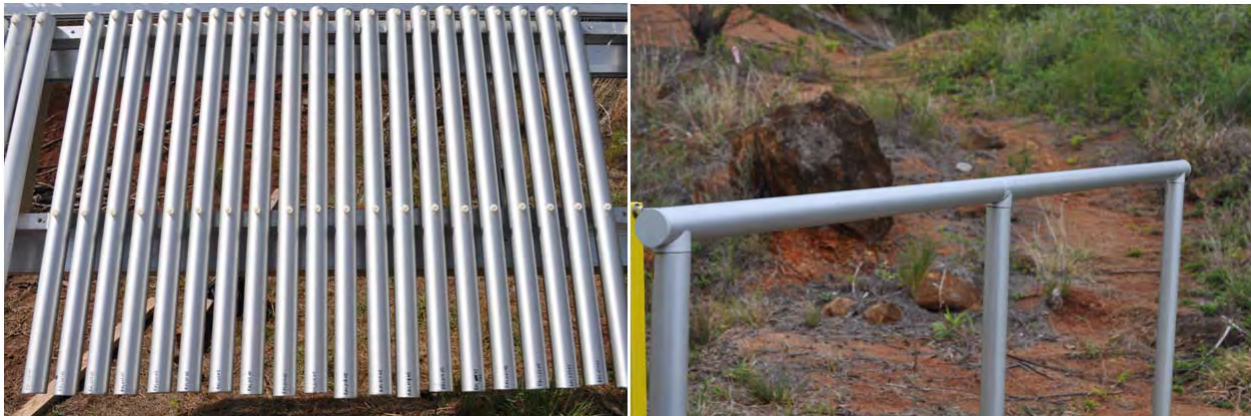
Railing Coupons				
	Stainless Steel	50%	Oxidation	Surface oxidation has discolored the material
	Aluminum	<5%	Pitting	Pitting has begun in areas where the anodize may have been damaged
	Coated Steel	10%	Rust	Rust has begun to form where the coating has failed. Discoloring of the coating due to the rust.
	FRP	0%	N/A	No visible corrosion
Fabricated Railing				
	Stainless Steel	80%	Oxidation	Surface oxidation has discolored the material. T-fittings show 90% surface corrosion likely due to lack of passivation.
	Aluminum	<5%	Pitting	Pitting has begun in areas where the anodize may have been damaged
	Coated Steel	10%	Rust	Rust has begun to form where the coating has failed. Discoloring of the coating due to the rust.
	FRP	0%	N/A	No visible corrosion

Figure B69. (Left) Aluminum railing coupons. (Right) Aluminum railing test section.

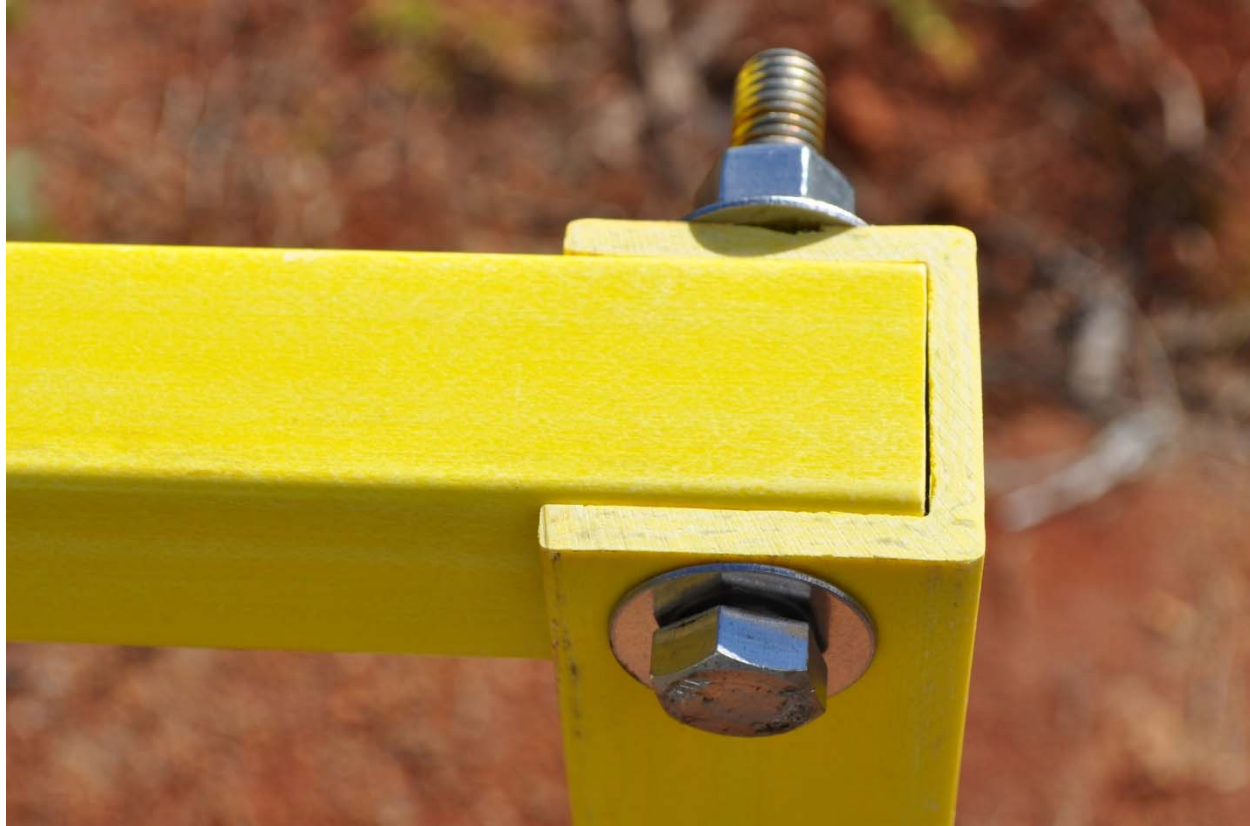
Figure B78. Fabricated FRP Railing

FRP	25%	UV	Discoloring due to UV exposure on the face of the railing that faces the sun
