**AN
ENVIRONMENTAL REVIEW
OF THE
PROPOSED RETURN
OF
U.S. AIR FORCE LEASED PROPERTY,
ASCENSION AUXILIARY AIRFIELD
TO
THE BRITISH GOVERNMENT**

Tim deGavre
Computer Sciences Raytheon

March 26, 2004

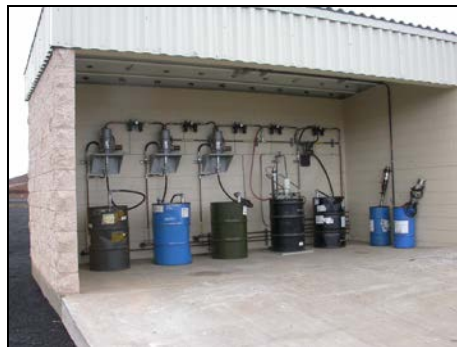
In addition to JP-8 fuel stored in tanks at the facilities to supply the stand-by generators, petroleum products are kept in the Airfield AGE (LOX) storage building. The following products, each contained in a 55-gallon drum, are stored at this site.

- Grease
- Transmission Fluid
- Gear Lube
- JP-8 (Note that diesel fuel is not used in the diesel generators or diesel engines on Ascension AAF. JP-8, to which motor oil is added, is used instead).

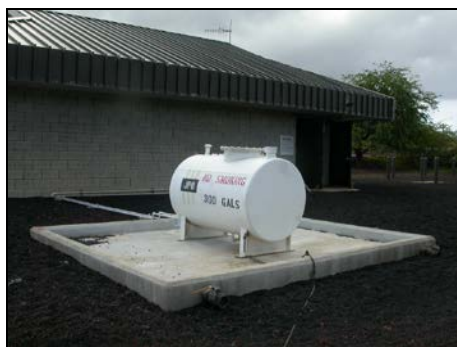
The following buildings in this Survey have back-up generators and, consequently, above ground storage tanks for the JP-8 fuel to run them -

- Command Control Building, Cross Hill
- Homing Beacon Equipment Building
- Back-up Power Generator (for the Airfield Lighting Control Building)
- Back-up Power Generator (for the Fire Station/Airfield AGE (LOX) Storage Building)

The outside of these tanks were inspected and noted as being sound, free from any leaks. The containment areas were clean and the outflow gates locked.

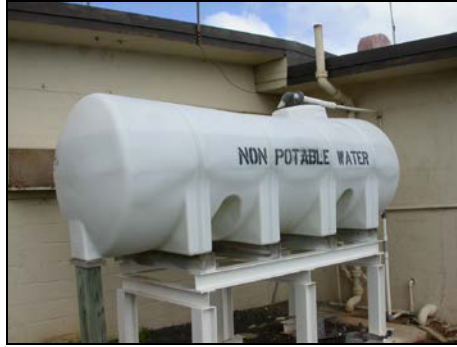
The following building has an above ground portable water storage tank –

- Command Control Building, Cross Hill

This tank was inspected and noted as being sound, free from any leaks.

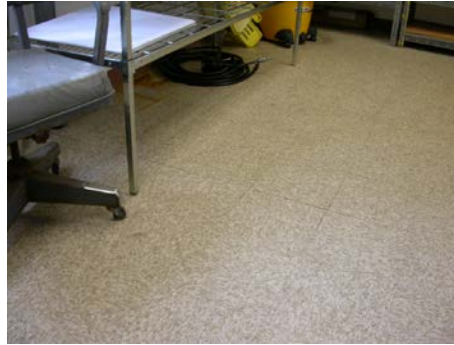
A review of the Ascension Asbestos Record indicates that the following facilities in the areas of this survey contain asbestos -

<u>Facility</u>	<u>Location</u>	<u>Asbestos</u>	<u>Remarks</u>
Rawinsonde Bldg	Sub-ceiling	35%	
Homing Beacon	Roofing Material	20% Chrysotile	New Structure
Command Control	Vinyl Floor Tile, black	20% Chrysotile	
Command Control	Wall panels, grey	40% Chrysotile	
Command Control	Ceiling Tile, grey	1% Chrysotile	No hazard
Command Control	Ceiling Tile, grey	5% Chrysotile	
Command Control	Thermal Insulation	85% Chrysotile	
Control Tower	Vinyl Floor, 9x9	Assume Asbestos	
Control Tower	Roofing green	Assume Asbestos

2. Asbestos and Lead-based Paint. It is recommended that the asbestos and lead-based paint in the facilities noted be left unabated and that the British Government be advised of the location and condition of these substances should the facilities be turned over to them.

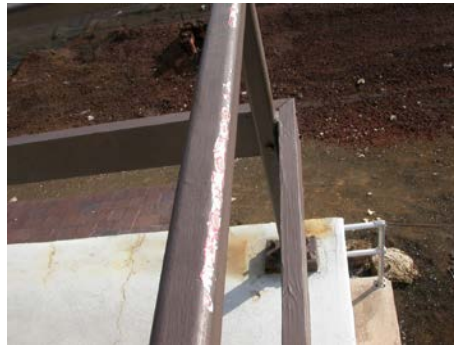
Section 3.18

A review of the Ascension Lead-based Paint Report indicates that the following facilities in the areas surveyed contain lead-based paint -

<u>Facility</u>	<u>Lead Content</u>	<u>Color</u>	<u>Int/Ext</u>	<u>Location</u>
Airfield Runway	1.7mg/cm	Yellow	Exterior	Striping
Paved Overrun	1.1mg/cm	Yellow	Exterior	Striping
Taxiway	1.1mg/cm	Yellow	Exterior	Striping
Apron	2.5mg/cm	Orange	Exterior	Striping
Rawinsonde Bldg	9.2mg/cm	Brown	Exterior	Support poles
Command Ctrl Bldg	1.5mg/cm	Tan	Exterior	Walls
Command Ctrl Bldg	2.0mg/cm	Green	Interior	Walls
Command Ctrl Bldg	1.0mg/cm	Tan	Both	Door
Control Tower	2.9mg/cm	Red	Exterior	Walls

The paint is not peeling in these facilities; consequently, it is not hazardous if left

That the asbestos and lead-based paint be left unabated and that the British Government be advised as to the location and condition of these substances should the facilities be turned over to them.

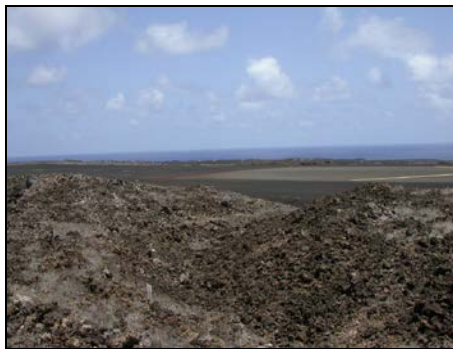
The area to the south of the runway and outside an imaginary line running 1000' parallel to it, is undeveloped, unused land covered with volcanic rock. About mid-point along the runway, before Round Hill, there's an ash mining pit belonging to the British Government.

The area directly at the end of the runway and extending and flaring to the ocean, (the departure overfly area) is undeveloped, unused land covered with volcanic rock and bordering on the Sooty tern fairs, or nesting areas.

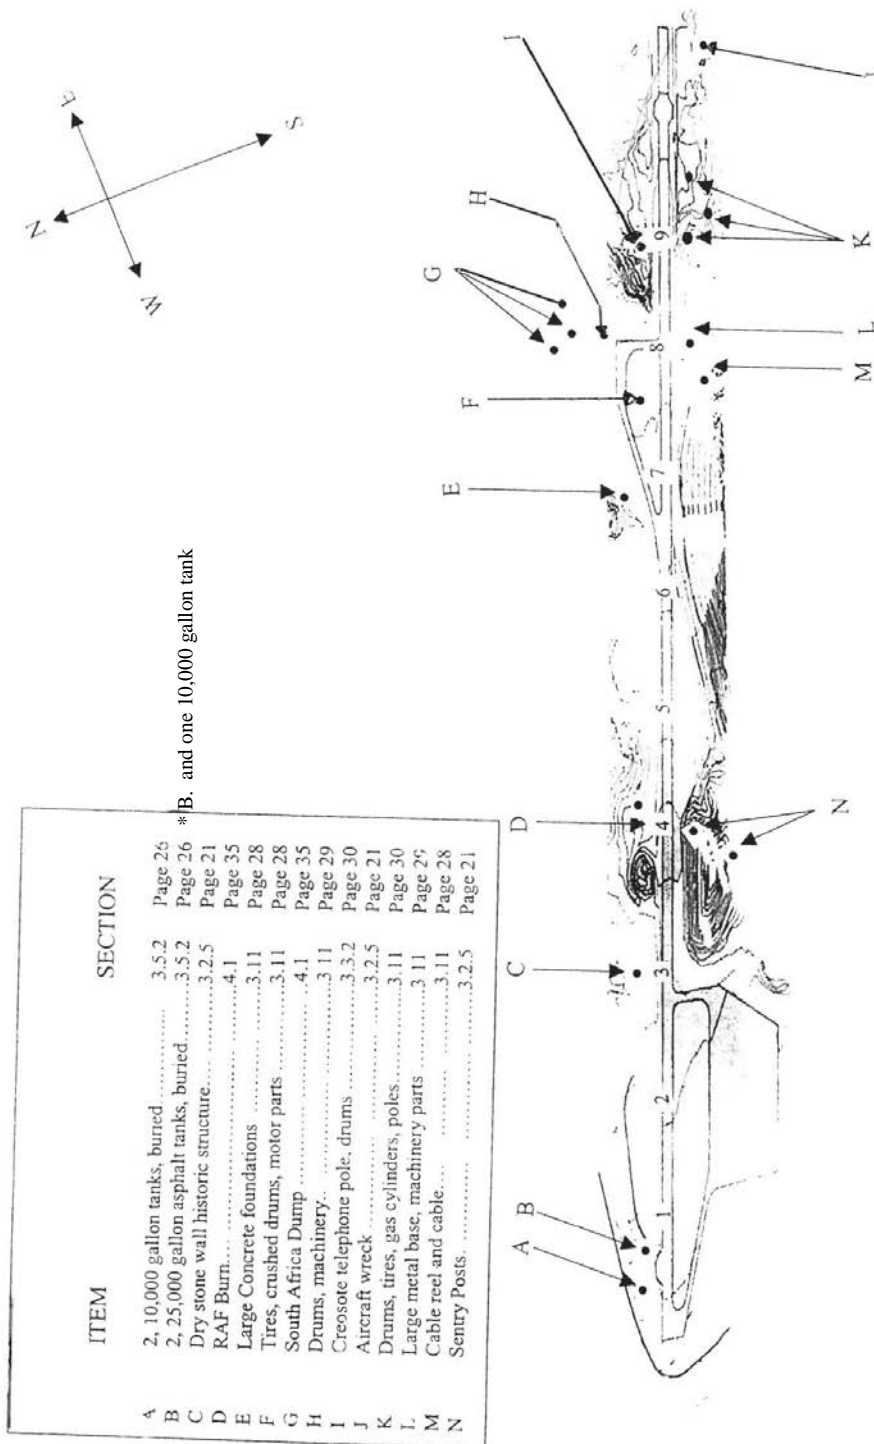
MAP OF ASCENSION AIRFIELD

Depicting the location of the dump sites, aircraft wreck, historical sites, etc.
discussed in the Environmental Baseline Survey.

That the debris (rusted drums, tires, machinery, etc.) remain where it is and that the British Government be advised as to its location and condition. The USAF may consider, simply for aesthetic reasons, removing the tires from the center of the High Speed Turn-around.

That the poles and wreck remain in situ. However the aircraft wreck, being classified as an historical site, which may prompt the curious to examine it, should be appropriately marked as containing asbestos material to warn the visitors of this hazard.
