**GUN DIVISION
REPORT NO. WGD -11**

THE MACRO ETCH TEST AS A MEANS OF JUDGING THE ACCEPTABILITY OF MATERIAL FOR THE MANUFACTURE OF CENTRIFUGALLY CAST "COLD WORKED" GUN TUBES

PROGRESS REPORT #1

THE COLD WORKING OF TEST CYLINDERS OF SELECTED MACRO STRUCTURES

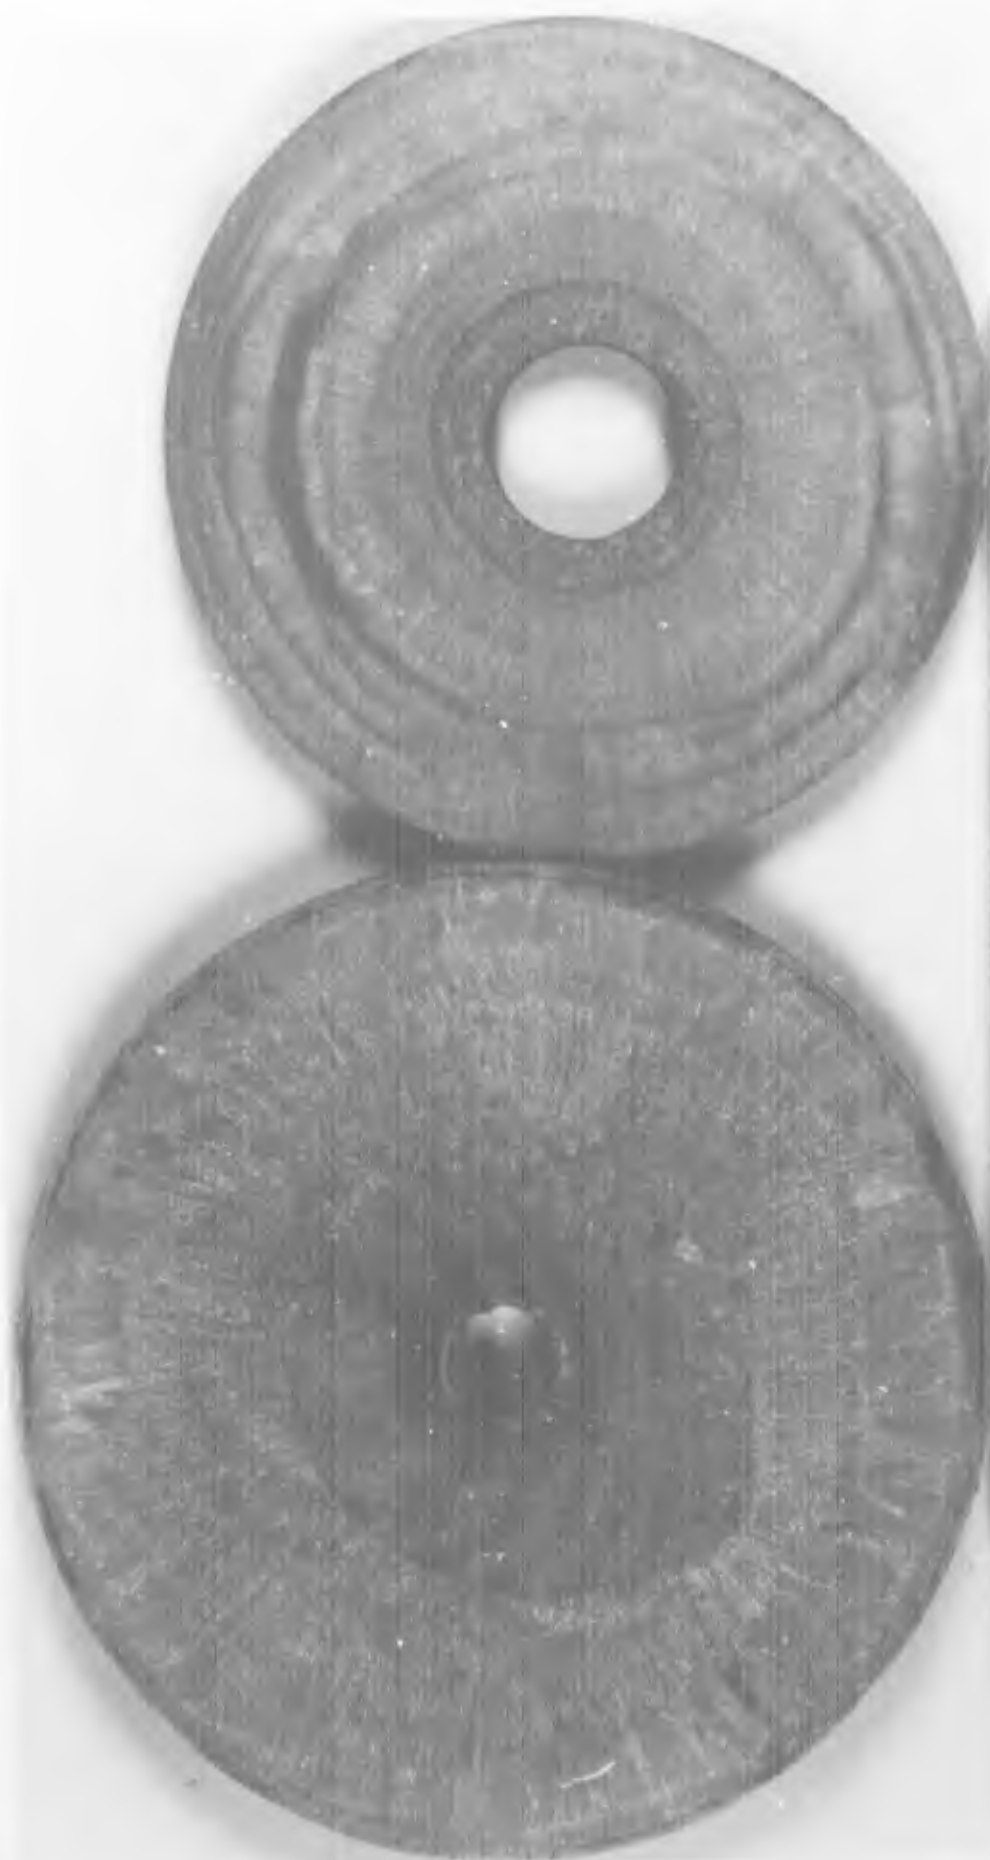
AS CAST MACROETCHED BREECH AND MUZZLE DISCS FROM 3" LINER
CASTING 3F1347. 27 NOVEMBER 1943 WTN.223-4043

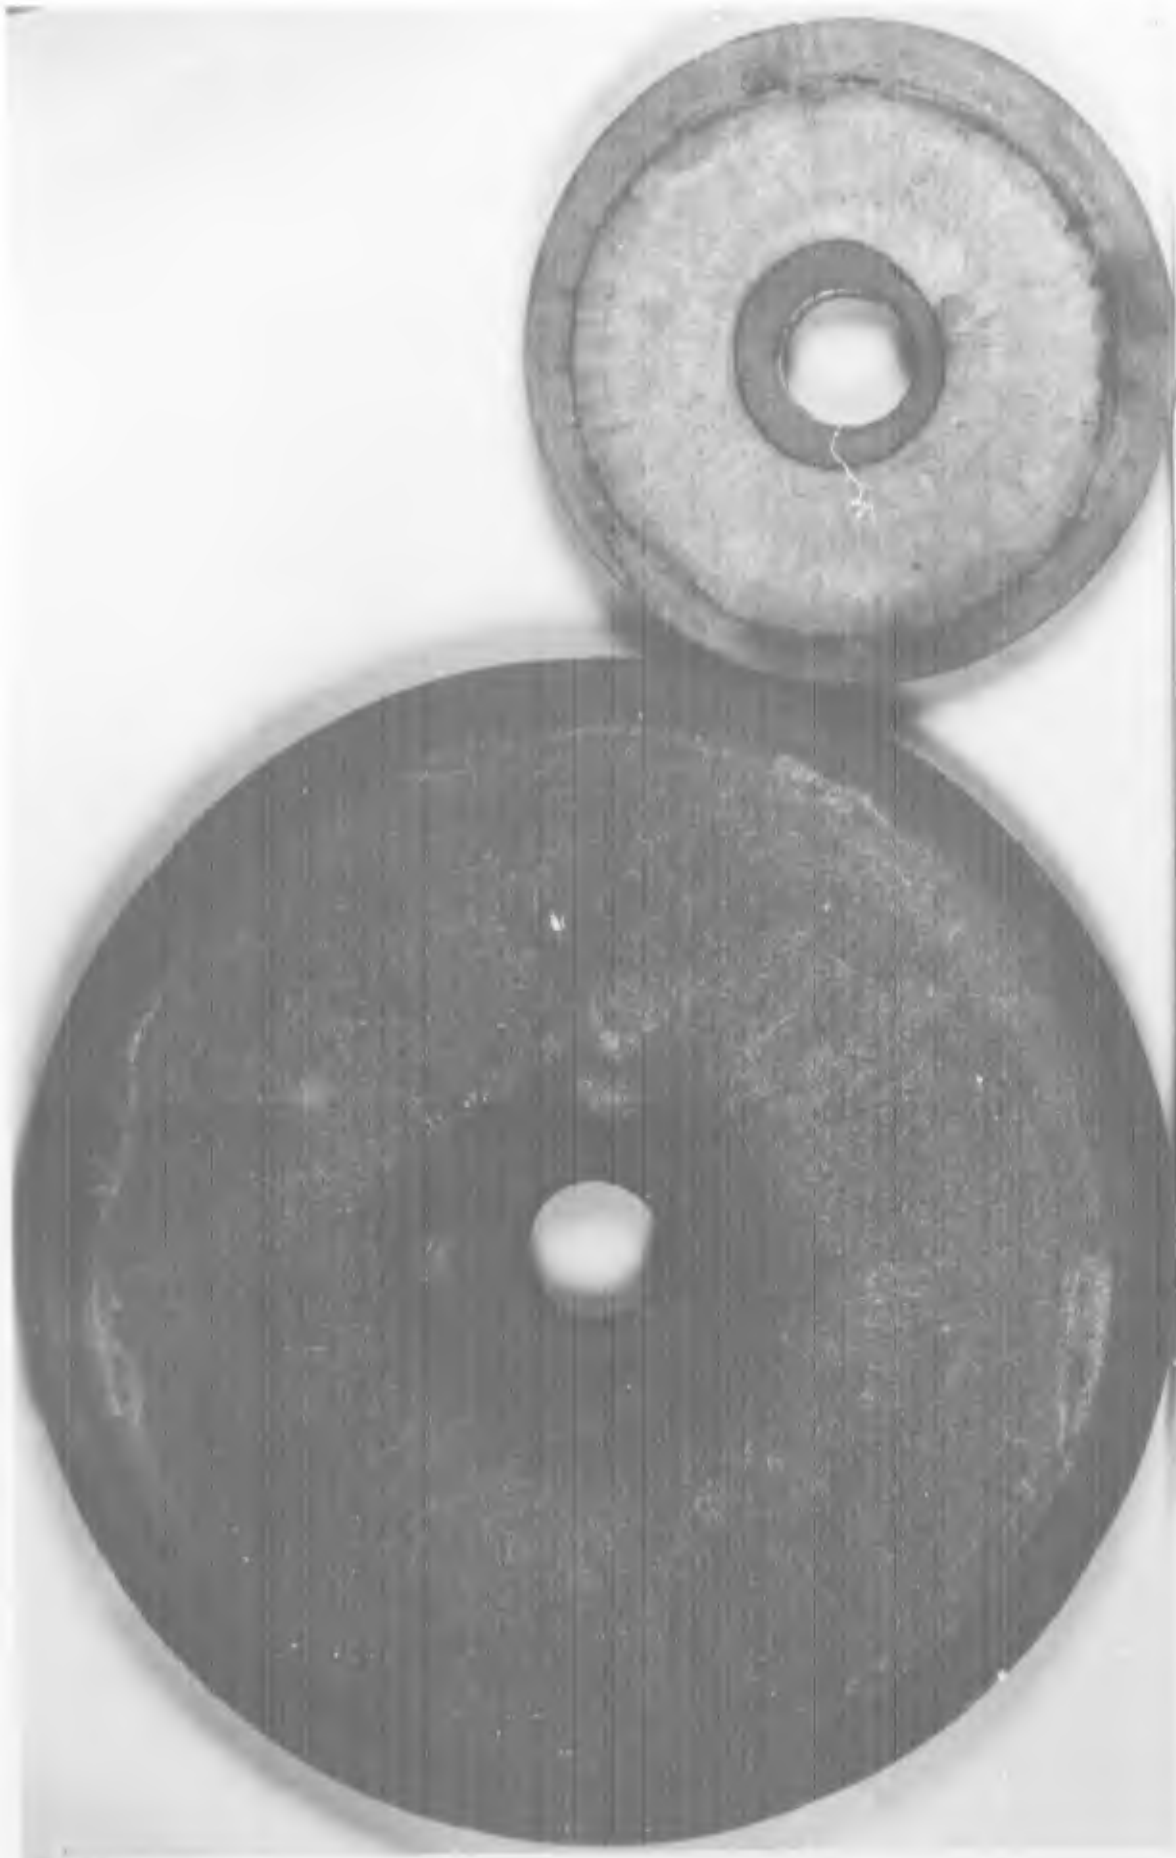
FIG. 5

AS CAST MACROETCHED BREECH AND MUZZLE DISCS FROM 90MM
GUN CASTING 362775. 27 NOVEMBER 1943 MTN. 223-4042

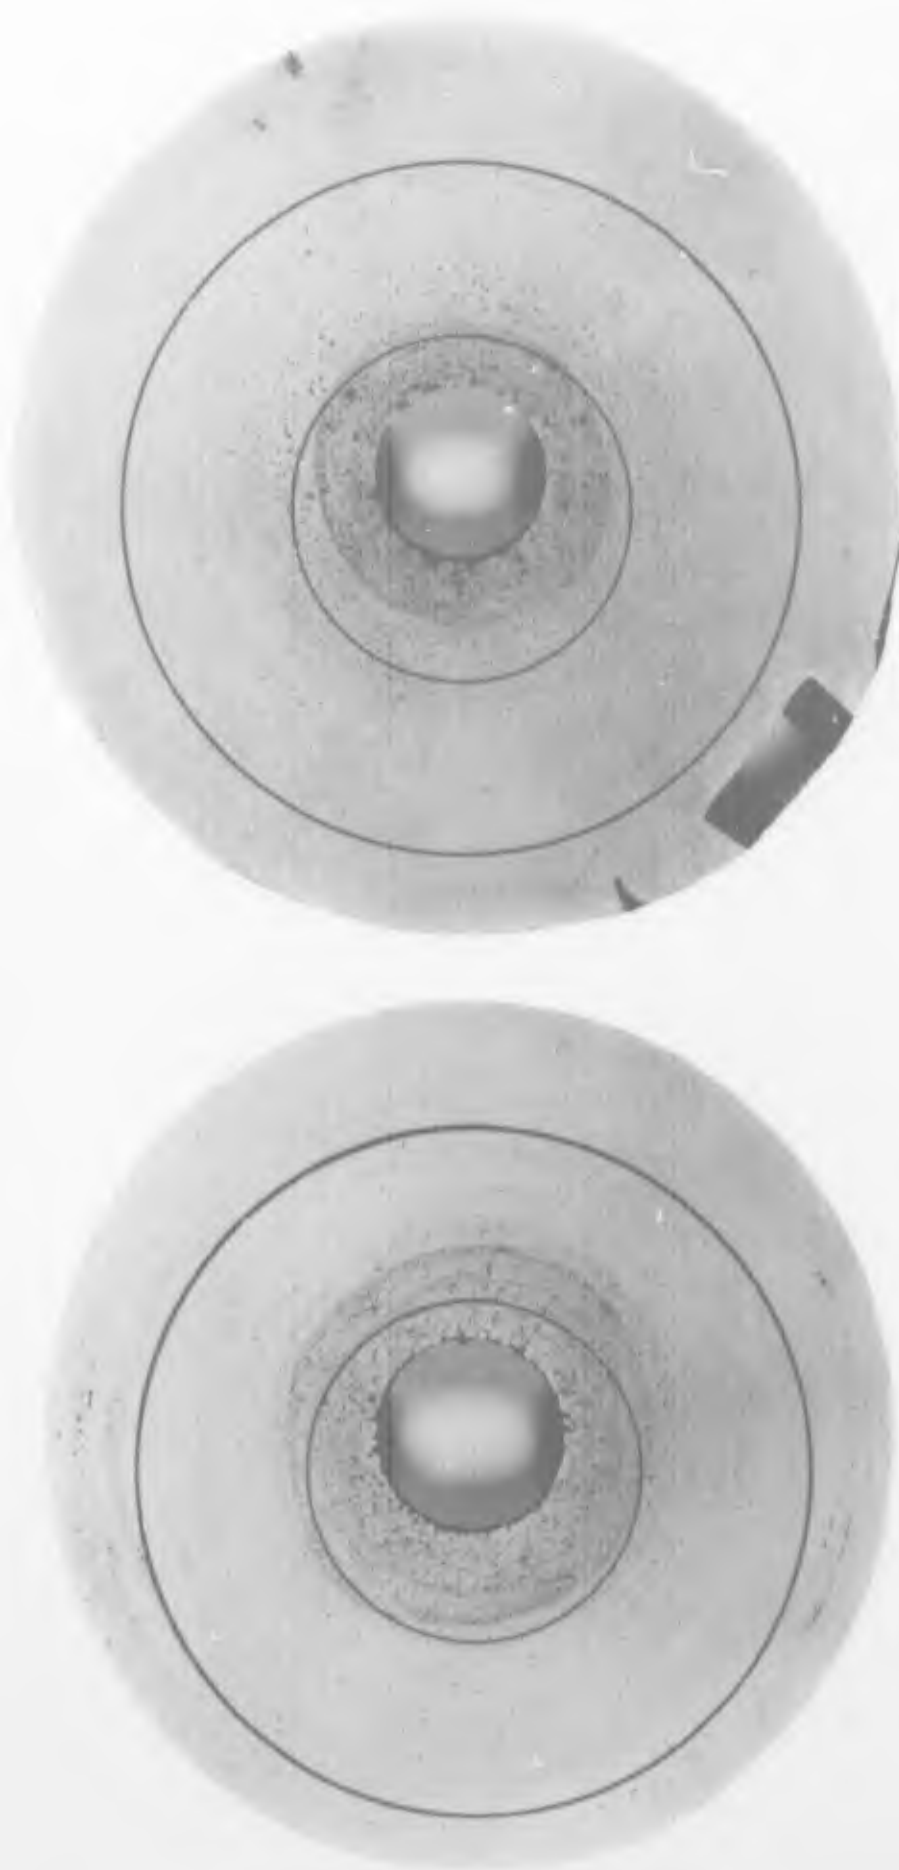
BRECH AND MUZZLE DISCS FROM CYLINDER #2 OF 3" LINER CASTING 3F 1347. BLACK CIRCLES INDICATE FINISHED MACHINED DIMENSIONS OF CYLINDER. THIS PICTURE SHOWS HOW OFF-CENTER BORING PRESENTS TWO MACRO CONDITIONS IN THE BORE OF THE TEST CYLINDER.
20 APRIL 1944
WTN. 639-6312

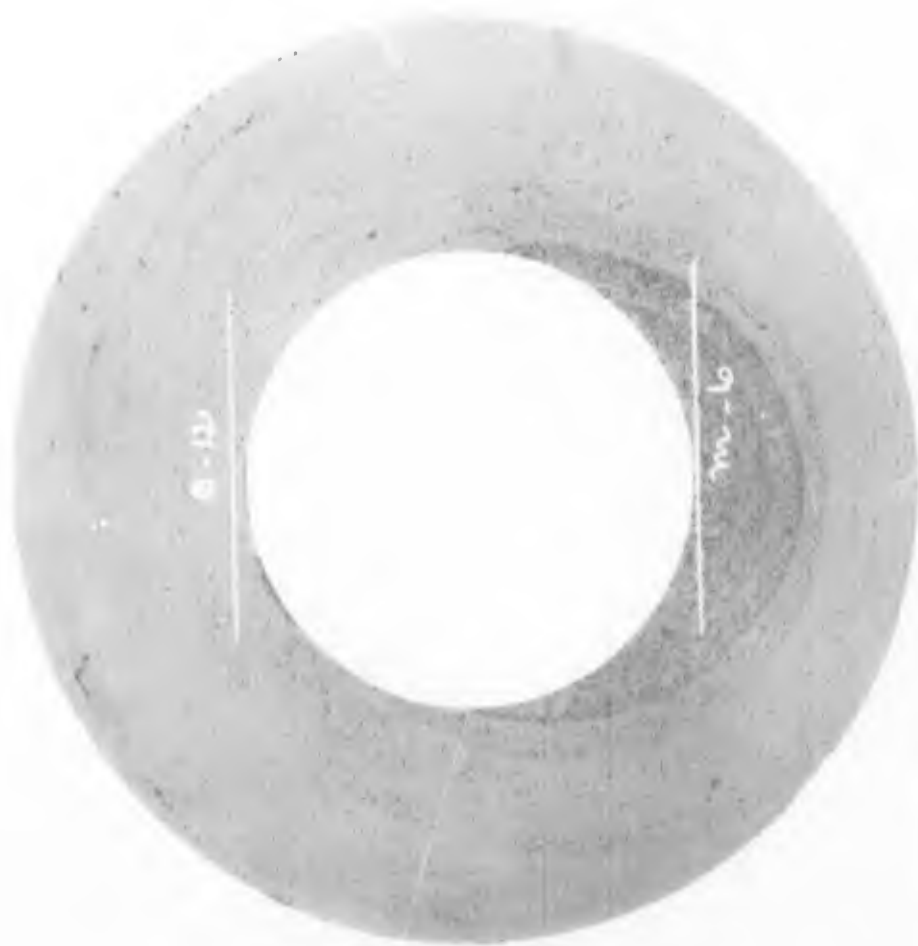
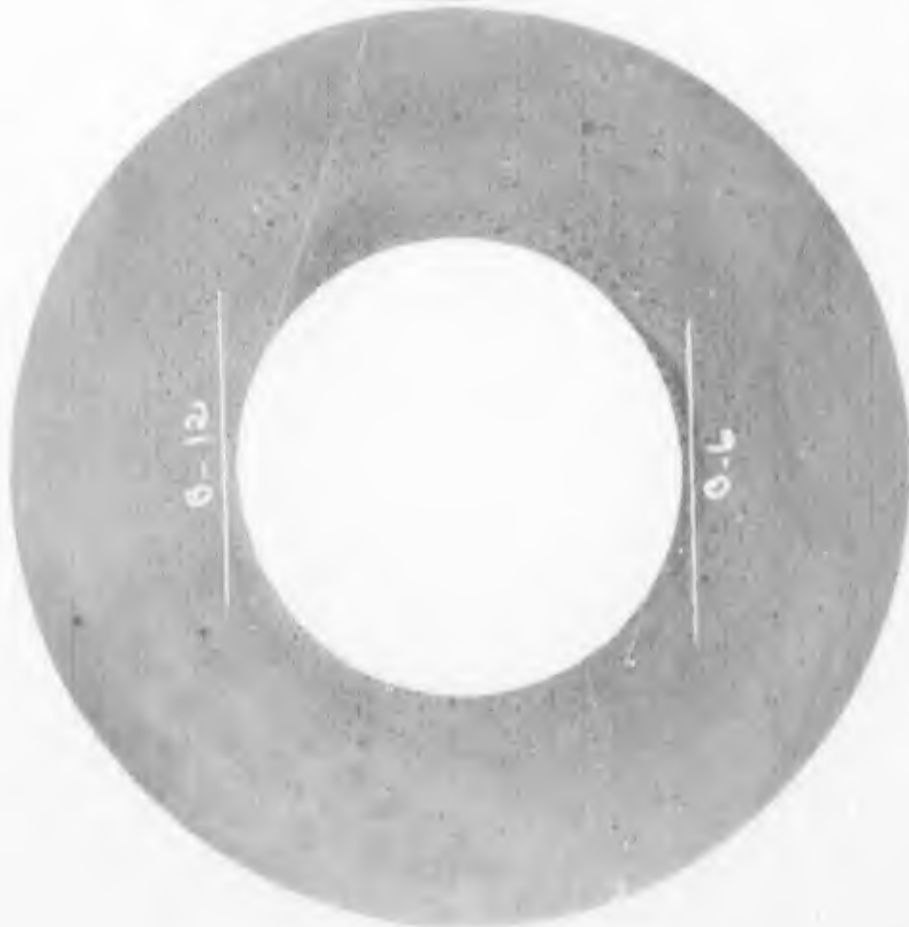
FIG. 8

MACROETCHED BREECH AND MUZZLE DISCS AND PHYSICAL PROPERTIES FROM CYLINDER #2 OF 3M
LINER CASTING 3F1347 BORED 1/4" OFF CENTER. 3 JAN 1944 MTN. 223-4135

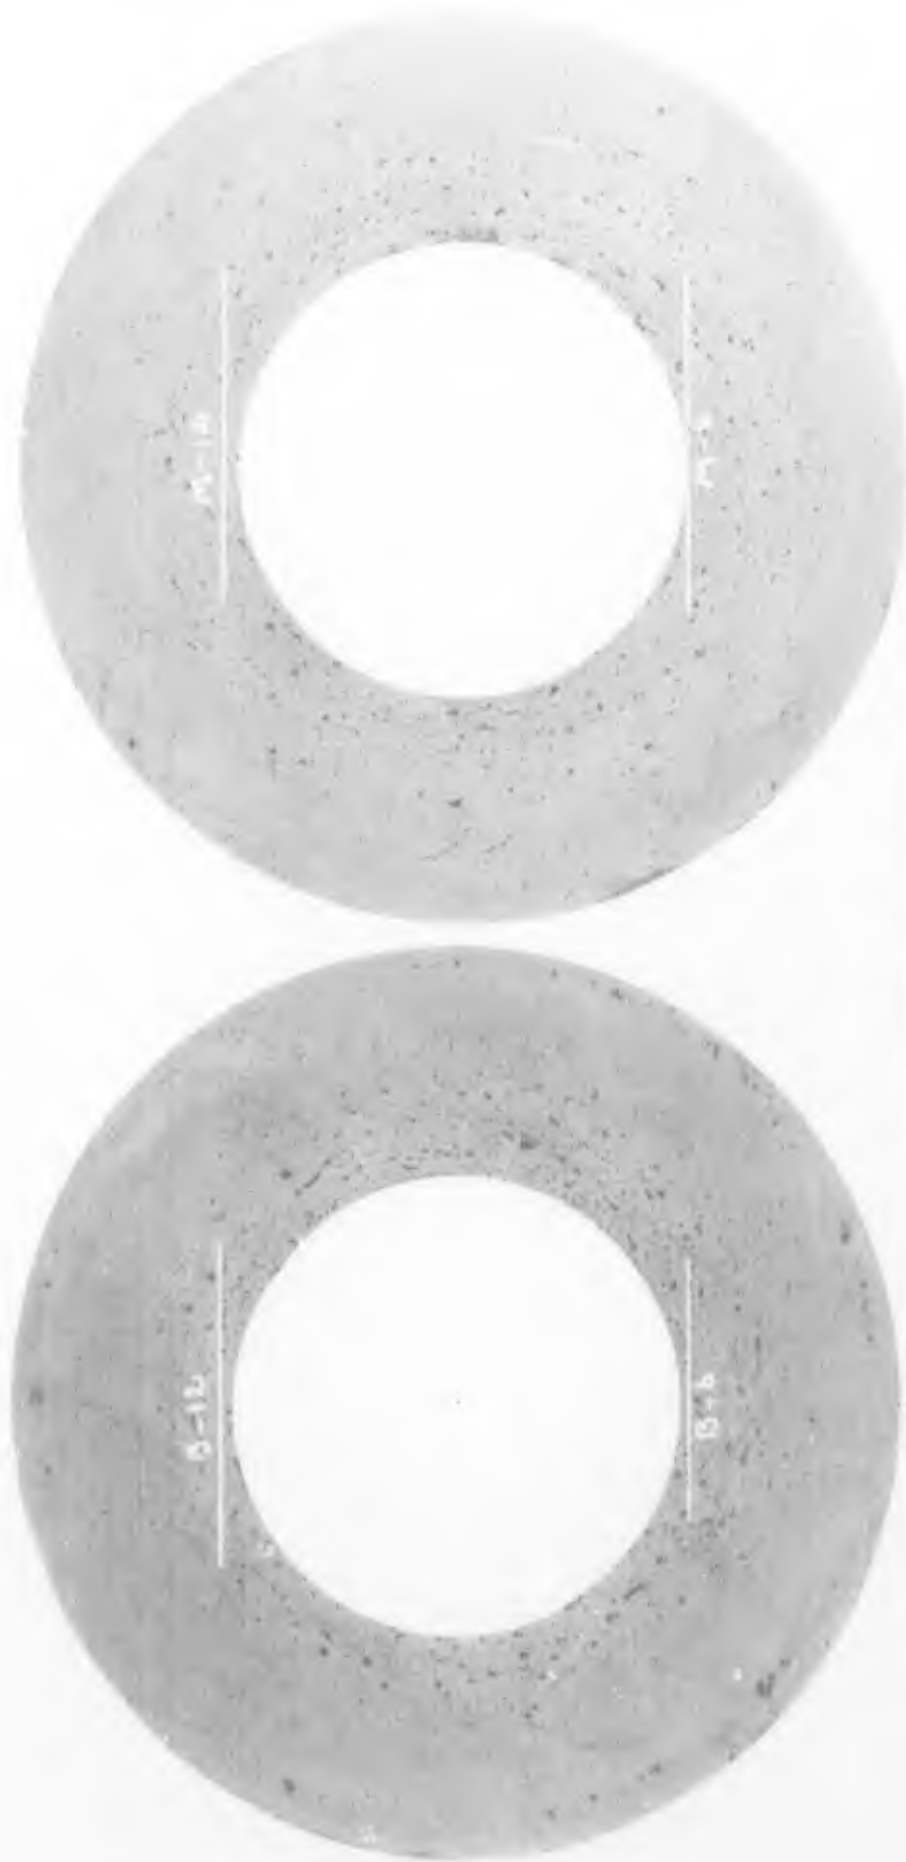
MACROETCHED BREECH AND MUZZLE DISCS AND PHYSICAL PROPERTIES OF CYLINDER #1 FROM 90MM
 CASTING 3G2775 BORED ON CENTER. 3 JAN 1944 WTN.223-4137

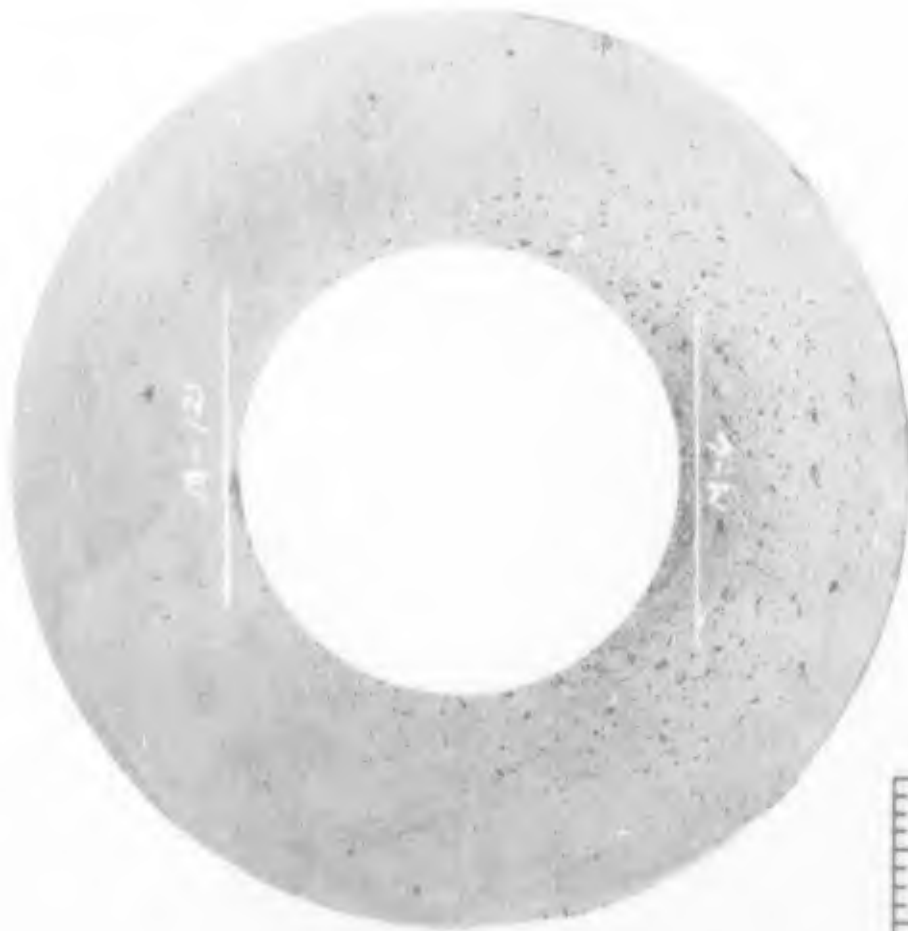
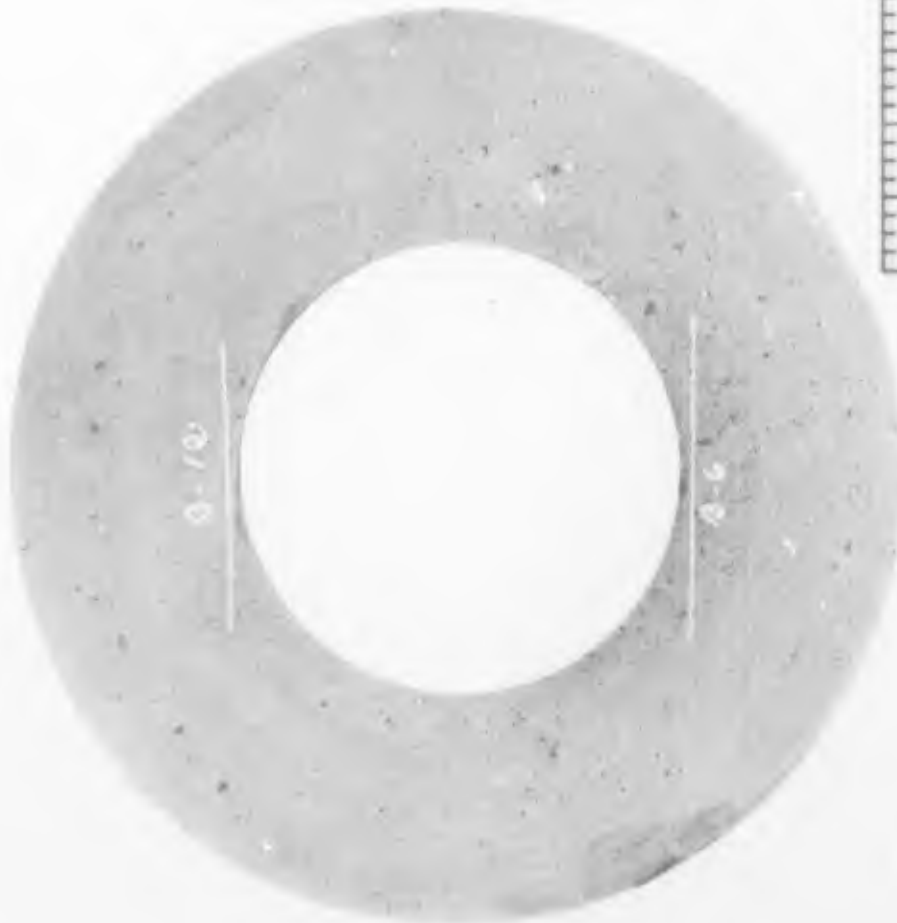
MACROETCHED BREECH AND MUZZLE DISCS AND PHYSICAL PROPERTIES OF CYLINDER #2 FROM 9.4MM
 CASTING 30275 BORED 1/2" OFF CENTER. 3 JAN 1944 WTN.223-4138

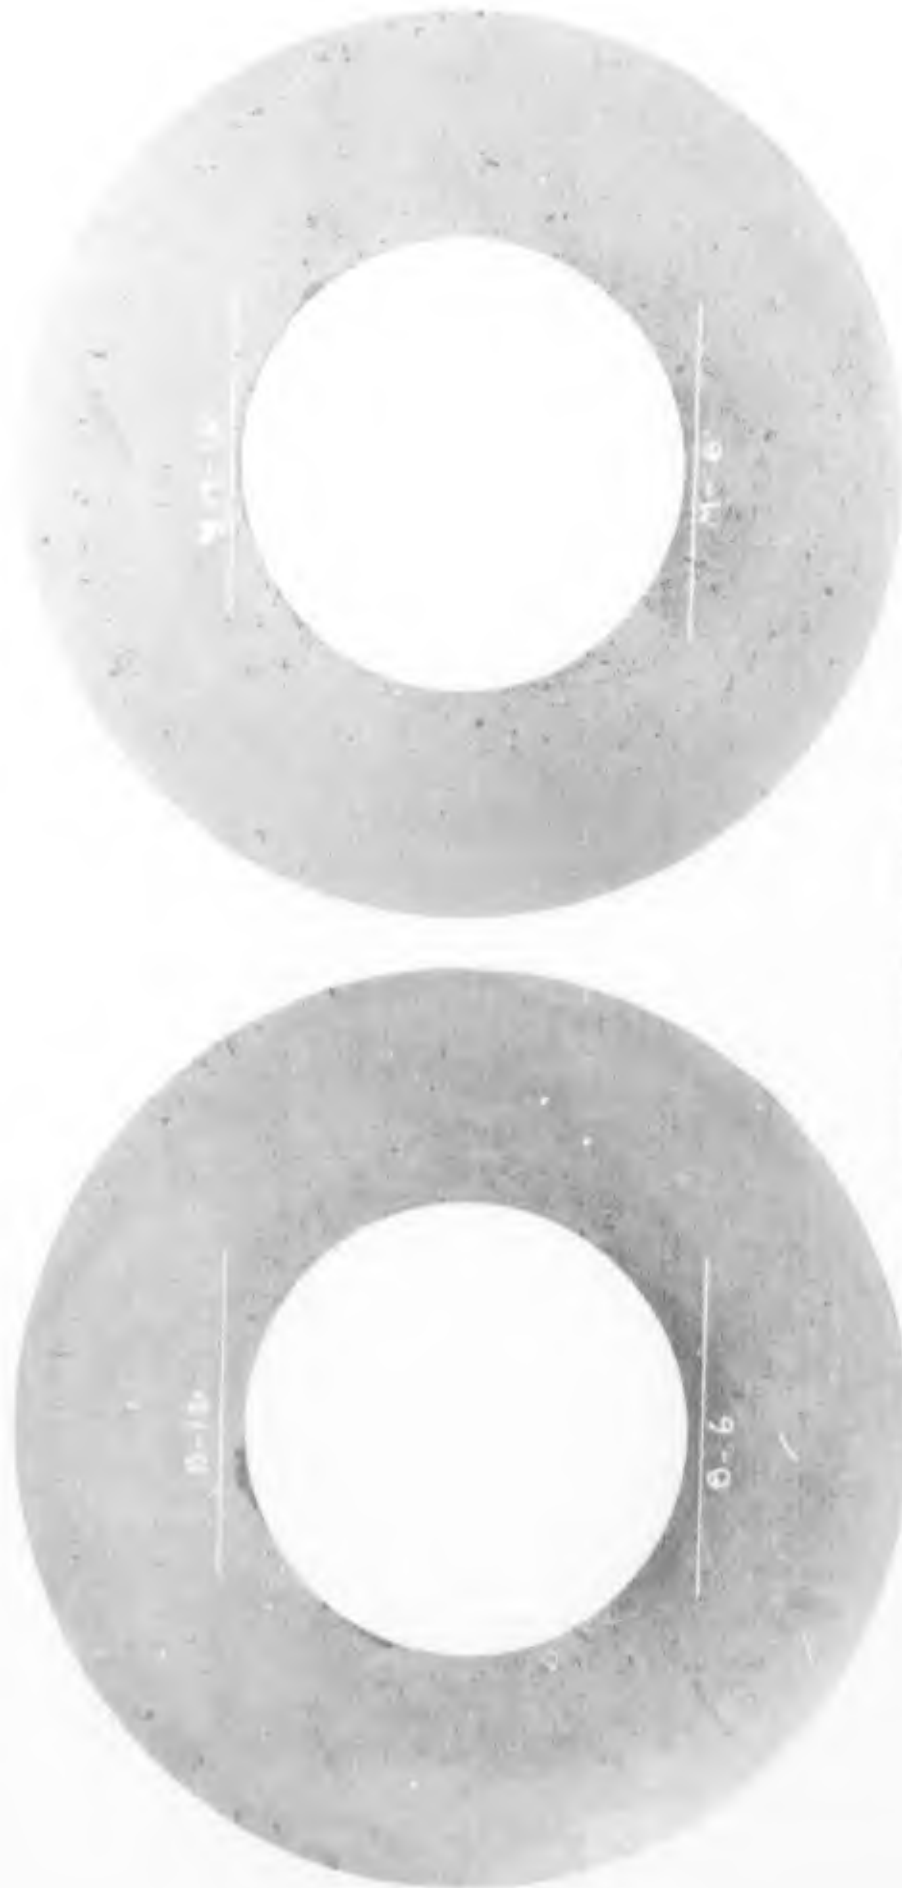
FIG. 12

MACROETCHED BREECH AND MUZZLE DISCS AND PHYSICAL PROPERTIES FROM CYLINDER #3 OF DOWN
CASTING 302775 BORED 1/2" OFF CENTER. 3 JAN 1944 MTN.223-4139
