REPORT NO. 710/14

TEST OF COMPOSITE PLATES FOR  
ARMOR PLATE

Report No. 710/14  
Watertown Arsenal

Test of Composite Plates for Armor Plate

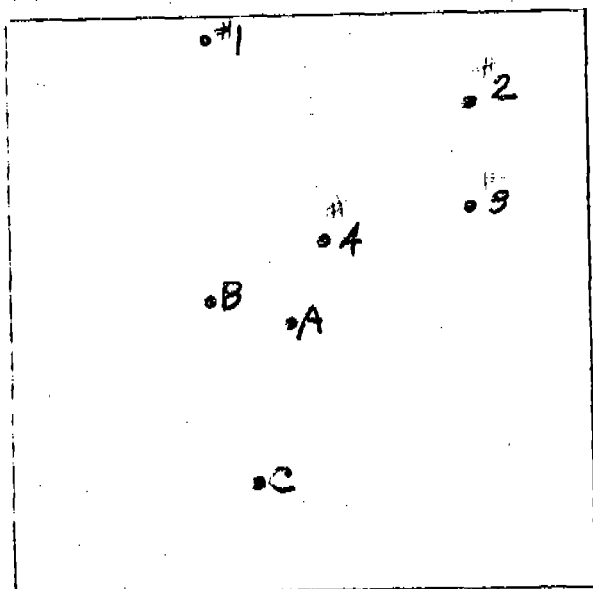
PLATE NO. Combination "B"

Combination "A" plate was put together as one plate without any spacing between the plate; this combination failed completely. The combination of plates was fired both at the front and back. The back of the plate when fired at, gave better results than the front; when fired at the front the cores made complete penetrations, but firing at the back, the cores stayed in the plate, the points just coming through the opposite side.

ROUND NO.	STRIKING VELOCITY	REMARKS
1	2460	
2	"	Comp. penetratio
3	"	"
4	"	"
A	2460	"
B	"	Comp. penetratio
C	"	points of core just through and core stayed in plate.

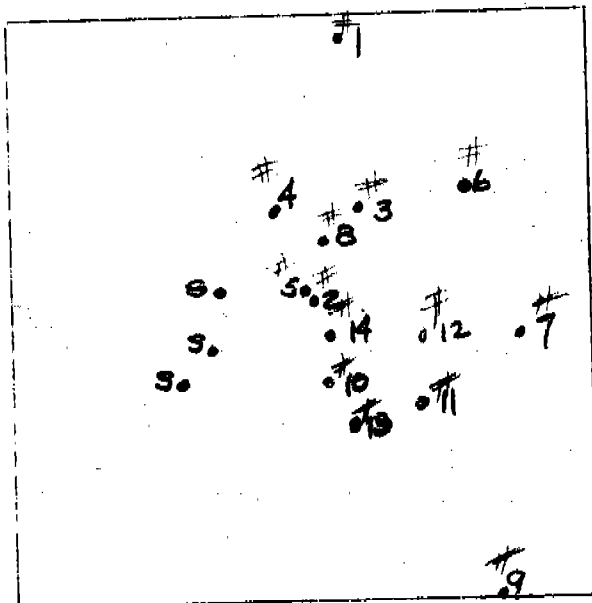
Combination "B" plate was made up as shown on sketch, with a space between the last and next to the last plate. Three rounds of service velocity (2460 f.s.) were fired at the plate here at Watertown Arsenal, and it was found that the cores stayed in the plate without damage to the back plate.

This plate was found very good using 2460 f.s. velocity ammunition and Springfield rifle, and plate was sent to Frankford Arsenal for further firing test, the results of which are included within the pages of this report.

ROUND NO.	STRIKING VELOCITY	REMARKS
S, S, & S.	2460	Bulged dural to face of back plate-no damage on back plate.

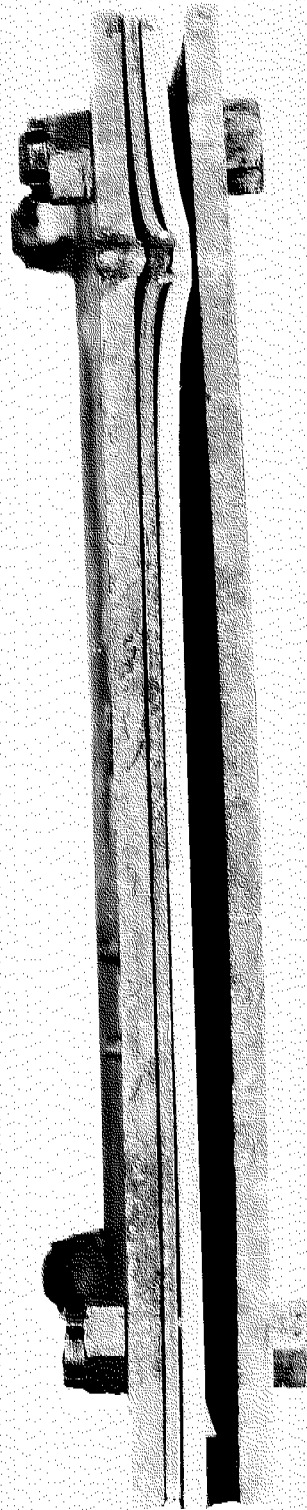
710-25

The photographs at the back of this report should be studied and special attention should be paid to the condition of the low carbon steel 1/8" plate and the dural sheet which gave with the core and flattered against the back plate.

<u>ROUND NO.</u>	<u>TYPE</u>	<u>STRIKING VELOCITY</u>	<u>REMARKS</u>
SSS (3)	30AP192E	2460 f.s.	Bulged Dural to face of back plate-no damage on back plate.
1	30-24 Gerlich	4000 f.s.	
2	"	"	
3	"	"	Bulged Dural, but not as much as SSS.
4	"	4100 f.s.	In same hold no damage, none of these
5	"	"	bothered back plate.
6	30APHVTI	2300 f.s.	No damage to back plate-these rounds
7	"	"	were not best Ammunition-some old bullets-
8	"	"	can't count so much.
9	"	"	
10	"	"	Partial-star crack-point of core shows
11	"	"	1/16" bulge.
12	"	"	Complete-went through drilled holes in
13	"	"	back plate.
14	"	"	CIP-would have been complete except
			back-stop held core.
			Same as 12.
			Same as 10
