Watertown Arsenal Laboratory  
Report Number WAL 710/414  
Problem No. B-52

6 October 1943

Metallurgical Examination of Cast Turret No. 757 for M4  
Tank, Manufactured by Union Steel Castings Co., Ballistically  
Tested at Subzero Temperatures at Camp Shilo, Canada.

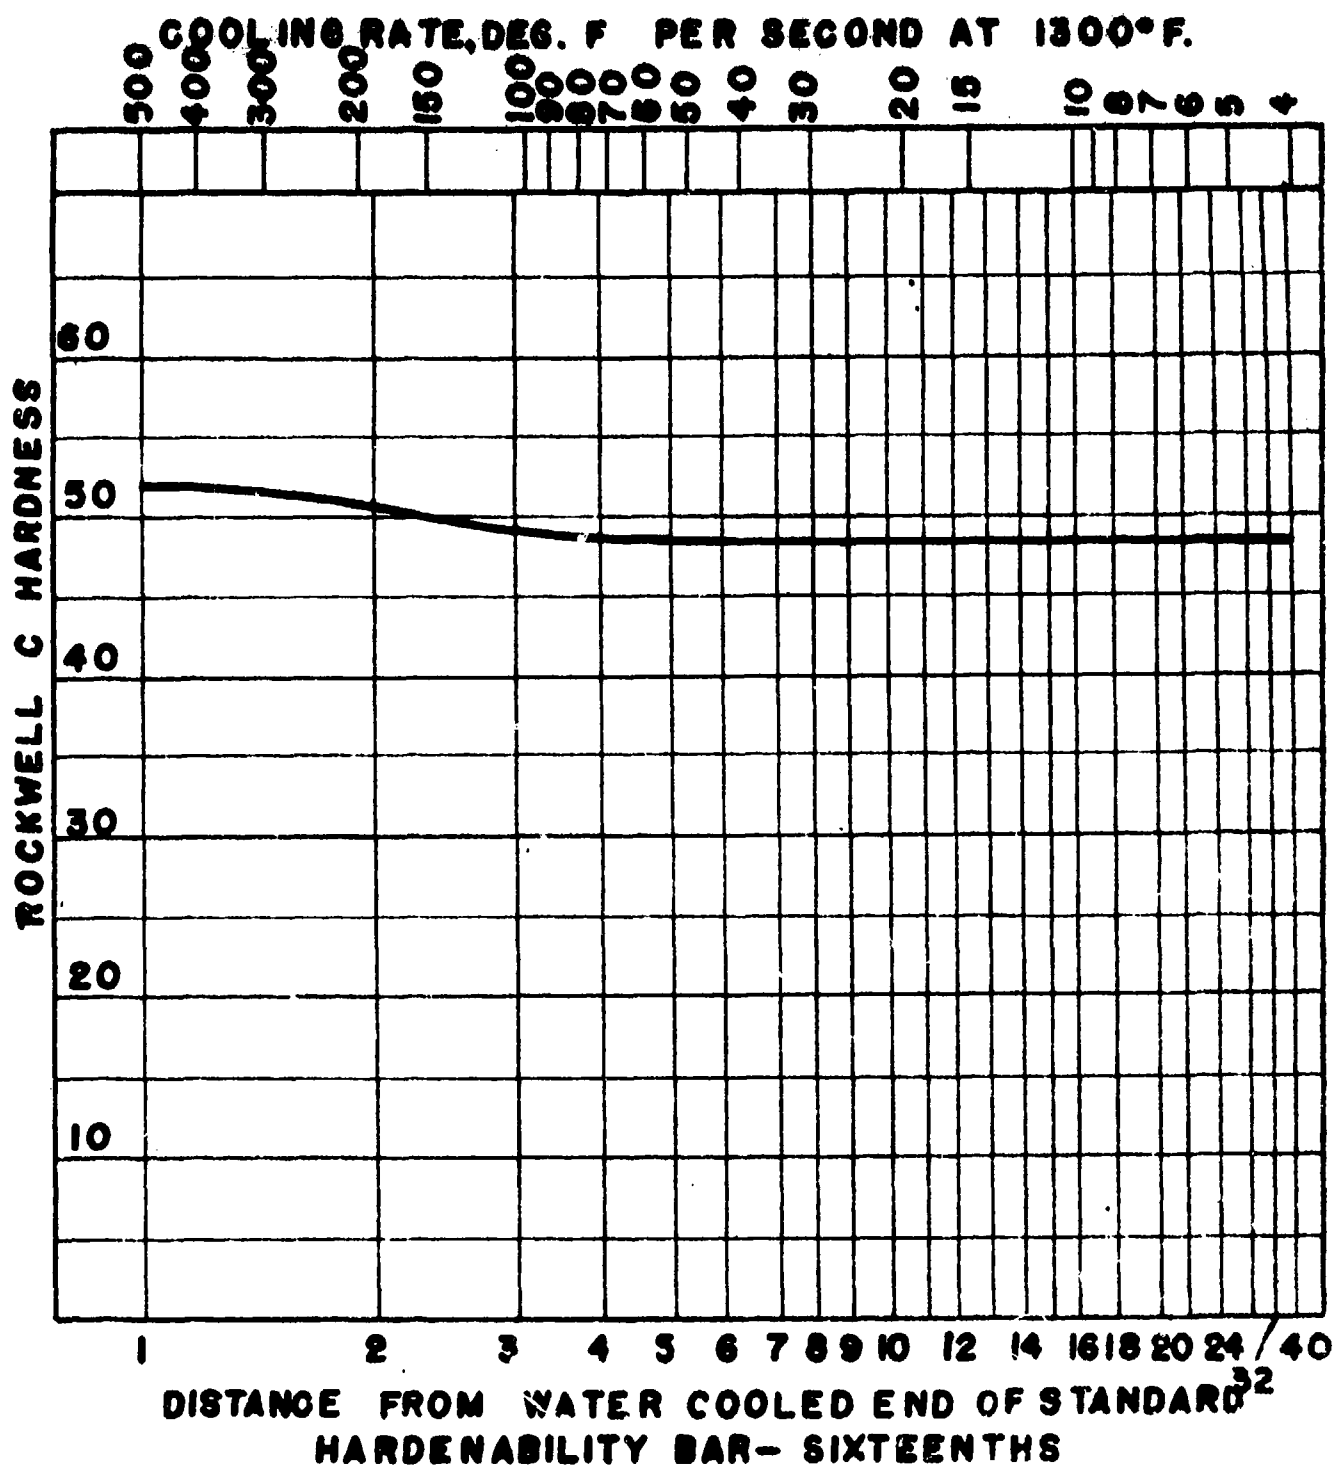
**FIGURE 5-**

The hardenability was determined by end-quenching a standard Jominy bar according to the standard procedure after austenitizing for 2 hours at 1600°F. The hardenability curve shown in Figure 5 indicates that the steel possesses more than adequate hardenability to completely harden through upon quenching, since the maximum thickness of the casting is approximately 3" and the average thickness approximately 2".

PLATE NO.	HEAT NO.	C	MN	SI	S	P	NI	CR	MO	CU	AL	QUENCH TEMP °F	TIME HRS.	G.S.
M3		.28	.94	.25	.028	.031	2.50	.97	.45	.05	.011	1600	2	
UNION STEEL CASTINGS Co. TURRET No. 757.														
JOMINY HARDENABILITY CURVE.														
													A.H. 9/17/43
