Rpt. No. WT-809

# Operation UPSHOT-KNOTHOLE

ADDITIONAL DATA ON THE VULNERABILITY  
OF PARKED AIRCRAFT TO ATOMIC BOMBS

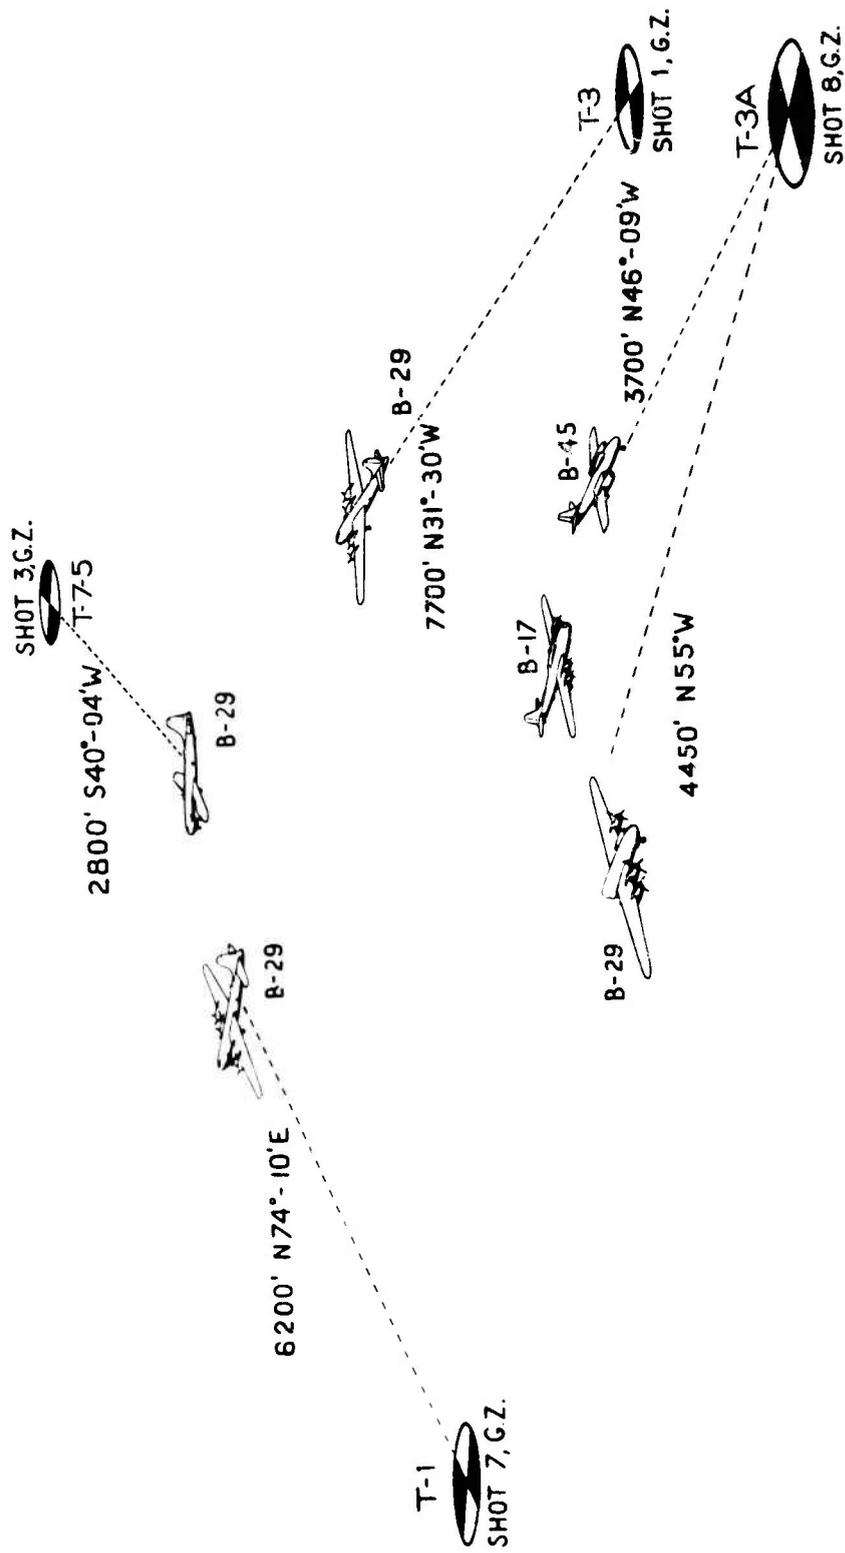
Fig. 2.1 Schematic View, Showing Range and Orientation of All Bomber Aircraft That Were Present in Shots 1, 3, 7, and 8.

A schematic drawing showing range and orientation of all bomber aircraft taking part in Shots 1, 3, 7, and 8, is given in Fig. 2.1. Relative location of ground zeros is not to scale; range and bearing of aircraft from ground zero are given as measured. Aircraft B-29 (066) was exposed in Shots 1, 3, 7, and 8, as shown. It was originally intended to include this aircraft in only three tests; however, because of the lower than anticipated yield of Shot 3, the side-in exposure was repeated in Shot 7. The B-17 and B-45 aircraft were tested in Shot 8 only. Aircraft were moored according to standard field tie-down procedures except for having extra strong cables on the nose tie-downs of the B-45 and B-29 during Shot 8. To reduce the possibility of fires, organic material was removed from the interior of the aircraft, and aluminum foil was placed inside all translucent media. The range, orientation, and anticipated overpressure are listed below.

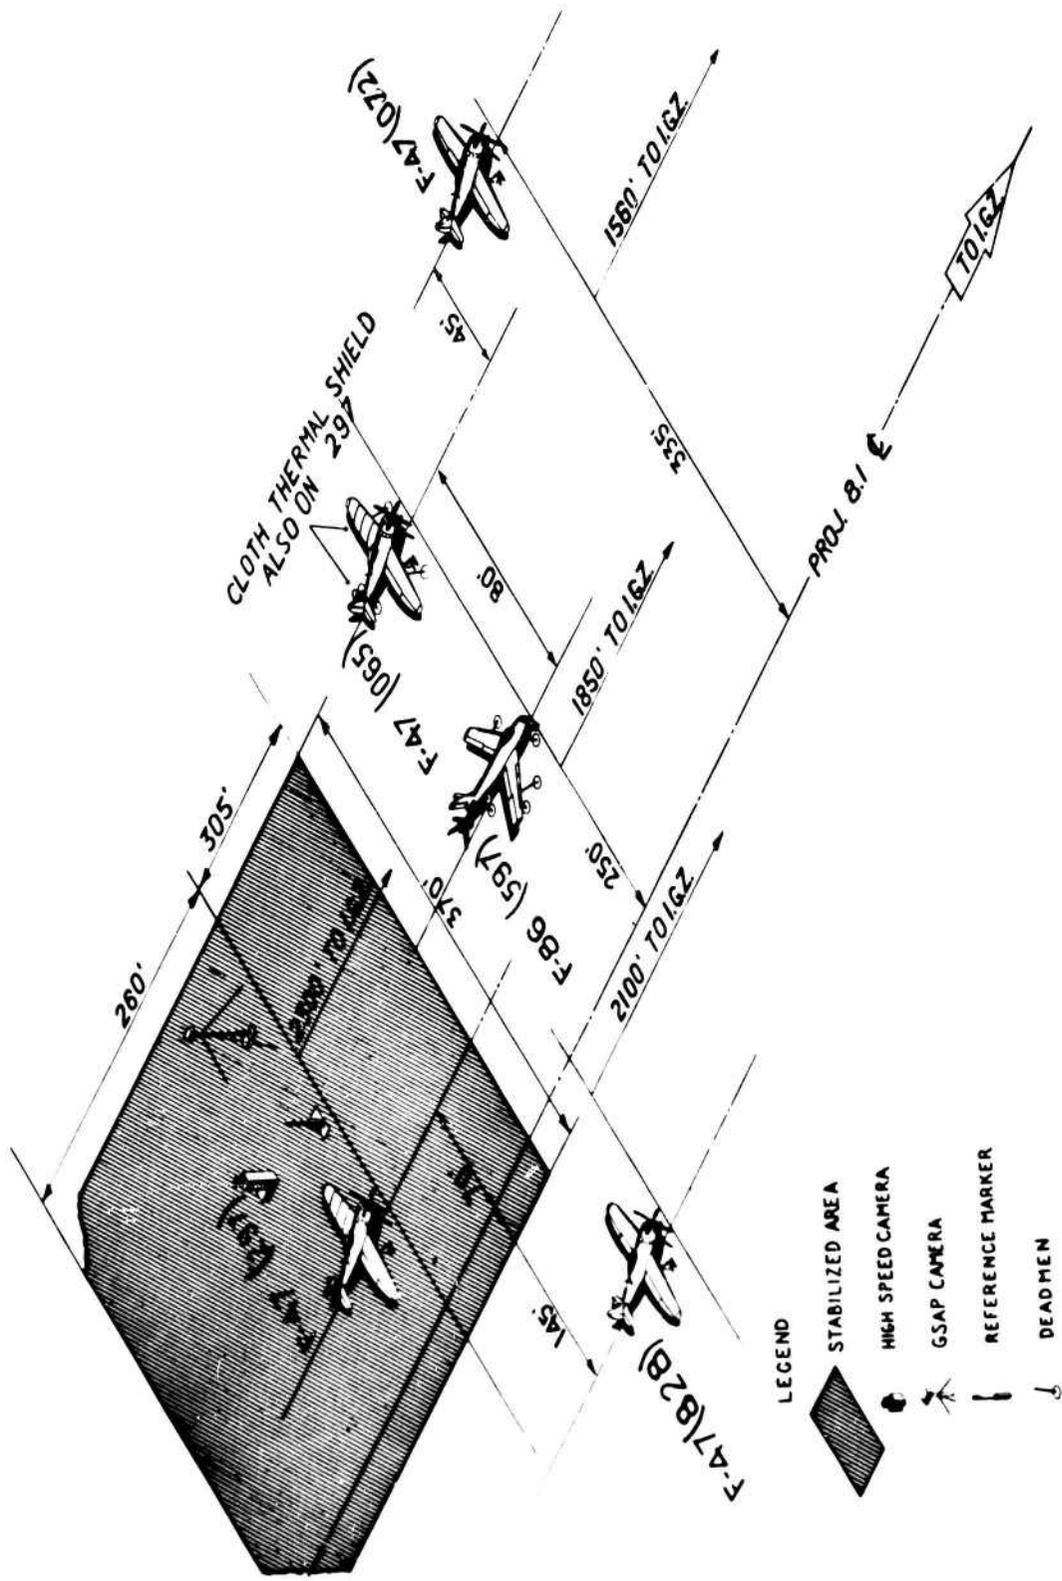
Fig. 2.4 Schematic View Showing Deployment of Fighter Aircraft for Shot 10

Positioning of the fighter aircraft for Shot 10 is shown in Fig. 2.4. This arrangement was designed to investigate further the damage produced in the higher overpressure regions and to provide additional data on the effect of thermal shielding at higher inputs. All aircraft were oriented nose-in at ground ranges of from 1560 ft to 2300 ft. Aircraft F-47 (297), equipped with a thermal shield during Shot 9, was moved to the 2300 ft range and the left wing and left horizontal stabilizer refitted with a thermal radiation shield. The F-86
