OPERATION BUSTER

PROJECT 3.8

EFFECTS OF AN ATOMIC DETONATION ON
AIRCRAFT STRUCTURES ON THE GROUND

January 1952

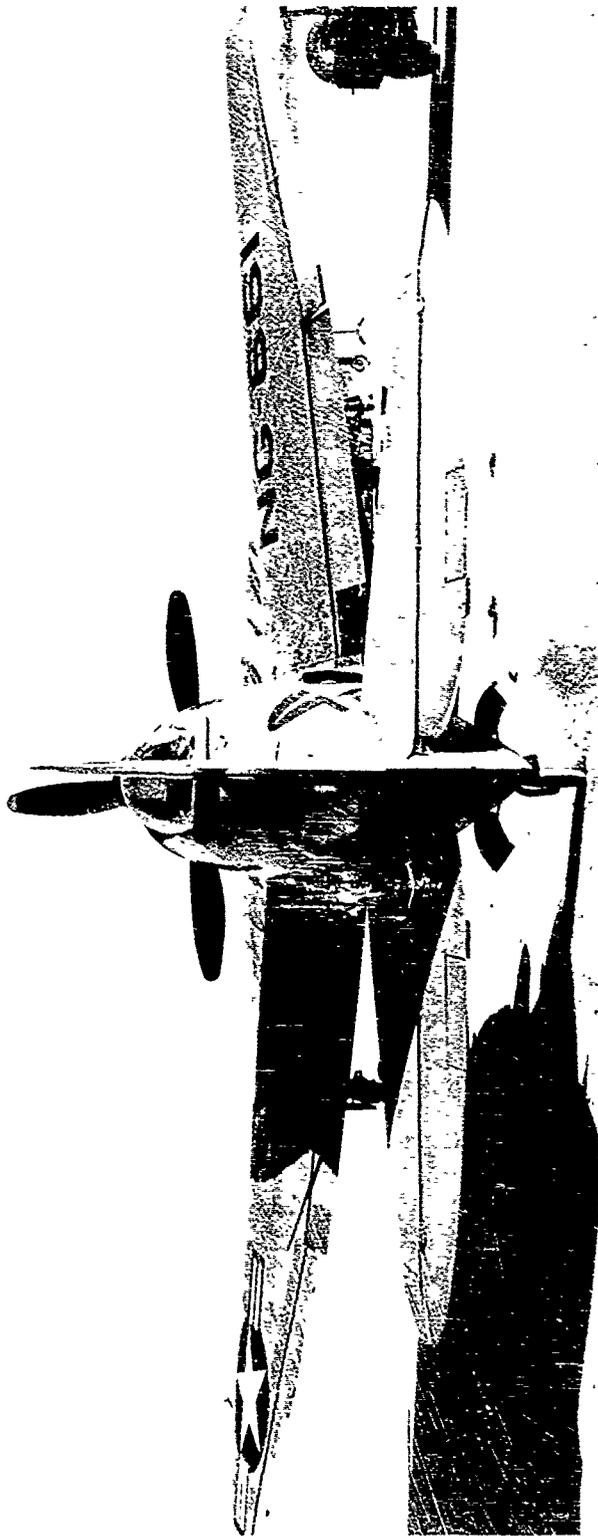
The F-47 was placed at a ground range of 4,250 feet from the target ground zero on a true bearing of North $85^{\circ} 58'$ East with the tail of the aircraft toward the blast. The condition of the F-47 as received is shown in Fig. 2.3.

Fig. 2.3 Condition of F-47 Prior to Exposure to Dog Shot

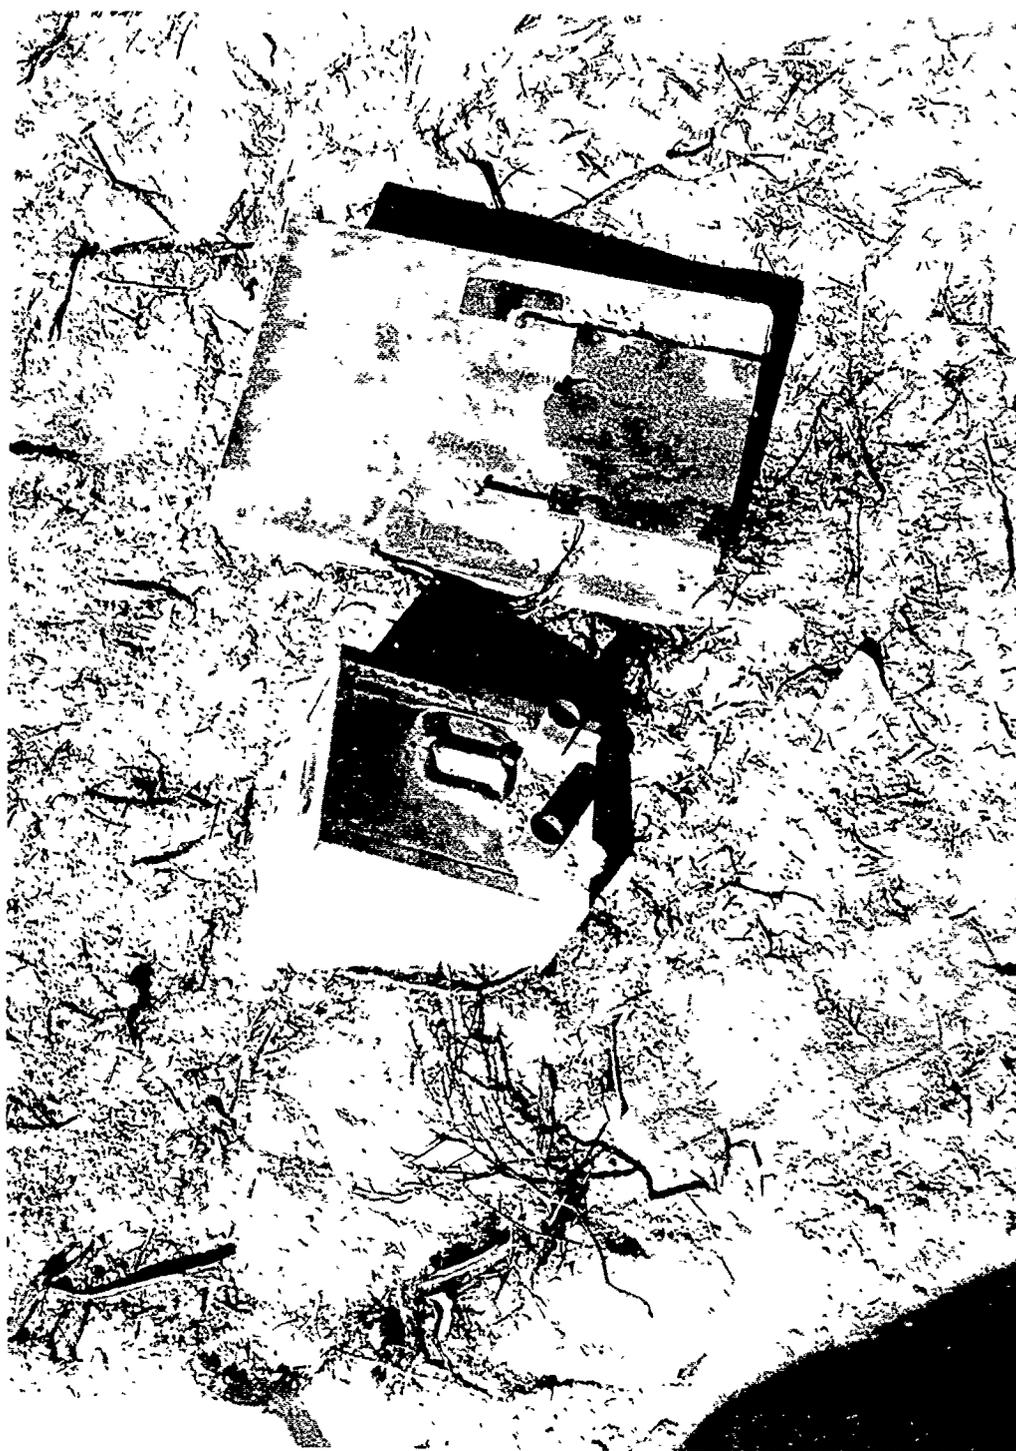
Fig. A.3 Condition of Ground Mounted Instrument Chest (Large Box) with Thin Skin Thermal Sensing Plate on Top. Small chest contains photo cell triggering mechanism for starting recording systems.
