Report No. FAA-SS-73-10

# SST Technology Follow-On Program-Phase II

## DEVELOPMENT AND EVALUATION OF FUEL TANK SEALANTS

**FINAL REPORT**  
Task II

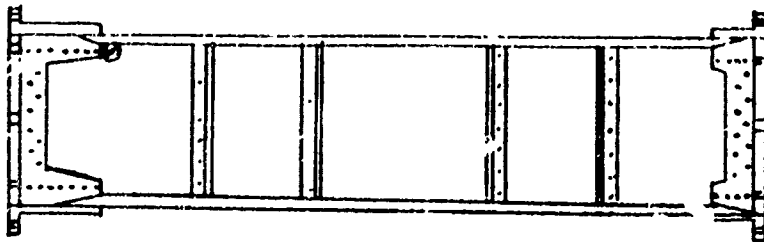
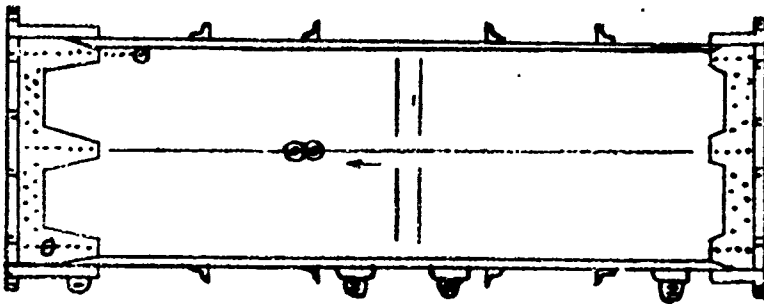
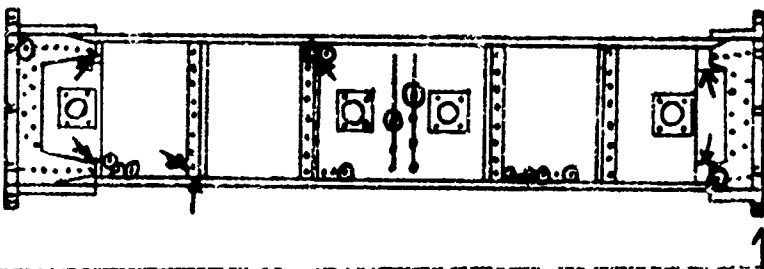
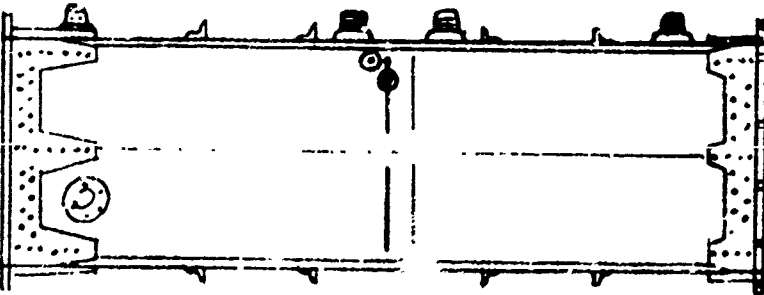
TANK NO. 2 - LEAKAGE AFTER 524 HOURS ENV. CONDITIONING  
 AT 415-441 OF.

LEAKS MARKED WITH CIRCLES (FASTENER LEAKS) OR ARROWS (SEAM LEAKS)  
 LEAK TESTED 3-17-70

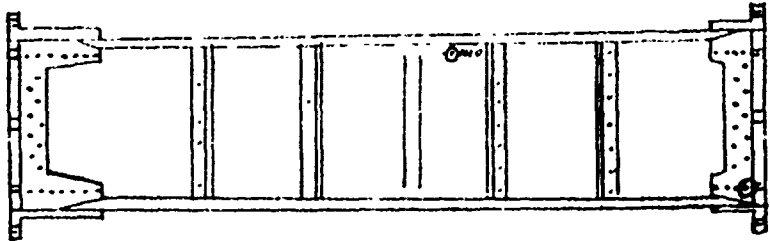
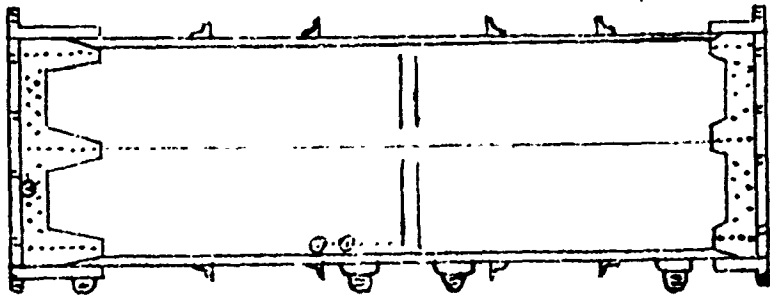
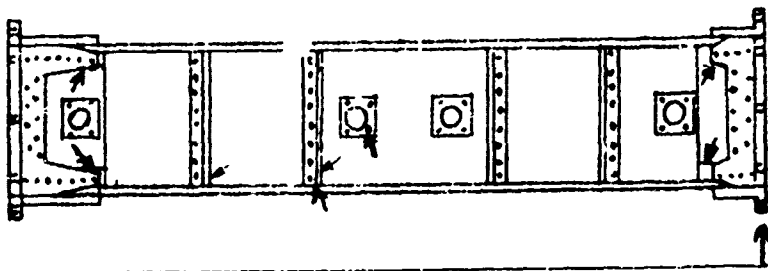
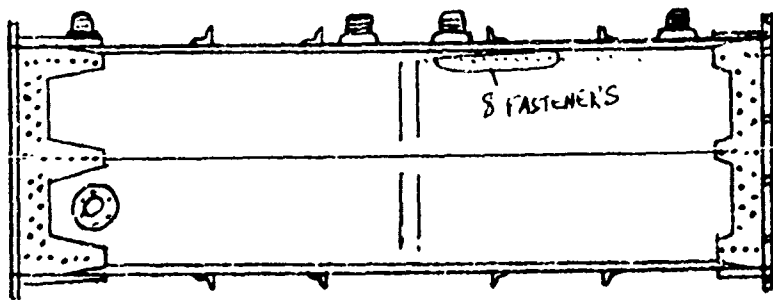
TANK NO. 1 - LEAKAGE AFTER 127 HOURS ENV. CONDITIONING  
 AT 415 44°F. (LEAKAGE TEST NO. 1)

LEAKS MARKED WITH CIRCLES (FASTENER LEAKS) OR ARROWS (CA  
 LEAK TESTED 3-17-70

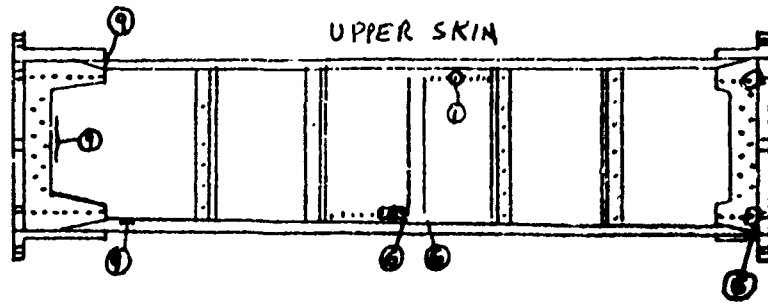
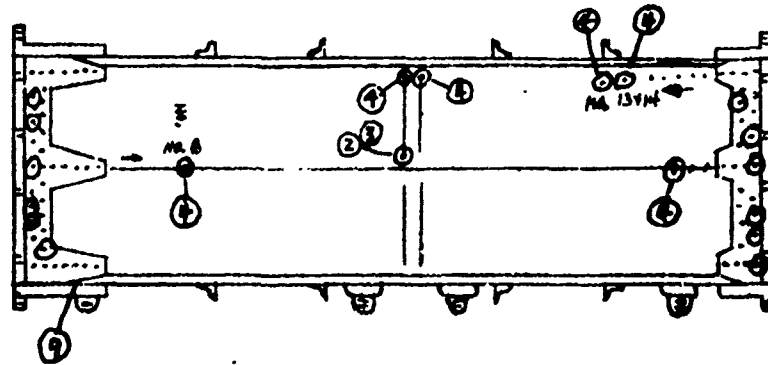
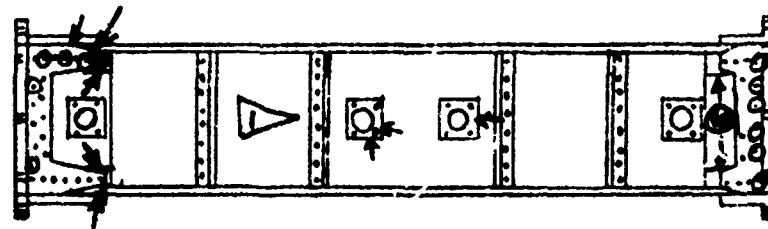
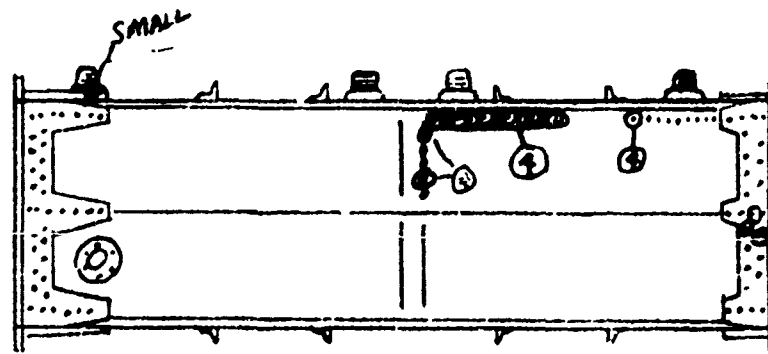
TANK NO. 1 - LEAKAGE AFTER 524 HRS ENV COND. PLUS 5% LOAD CYCLES AT 426-441°F. (LEAKAGE TEST NO. 2) PAGE A-5

LEAKS MARKED WITH CIRCLES (FASTENER LEAKS) OR ARROWS (SEAM LEAKS)  
LEAK TESTED 3-31-70

ON DOOR - ALL FASTENERS (EXCEPT ON STIFFENERS LEAKING BADLY!) FAY SEAL AROUND DOOR LEAKING BADLY!

SMALL LEAKS

VERY SMALL LEAKS

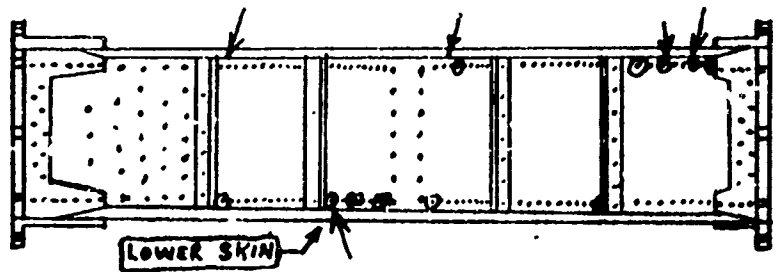
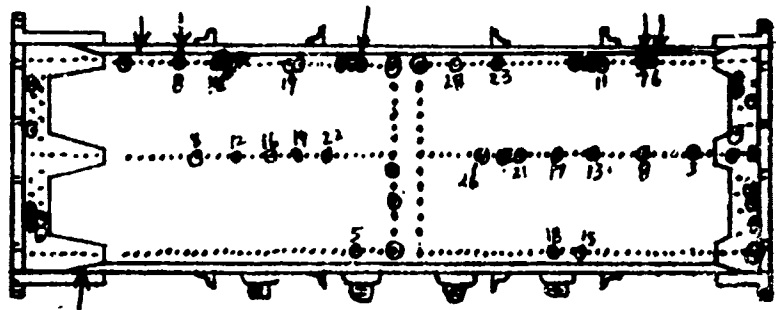
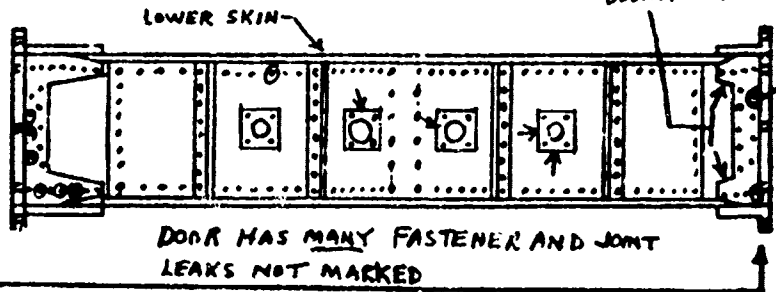
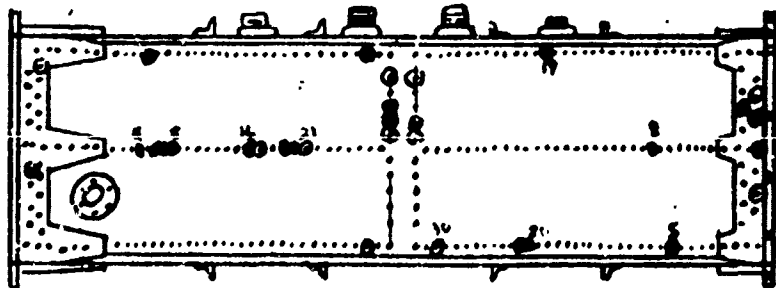
TANK NO. 1 - LEAKAGE TEST NO. 5 (50 LOAD CYCLES HOT, AFTER REPAIRS)

TWO REPAIR FILLETS BLOWN OUT AND LEAKING

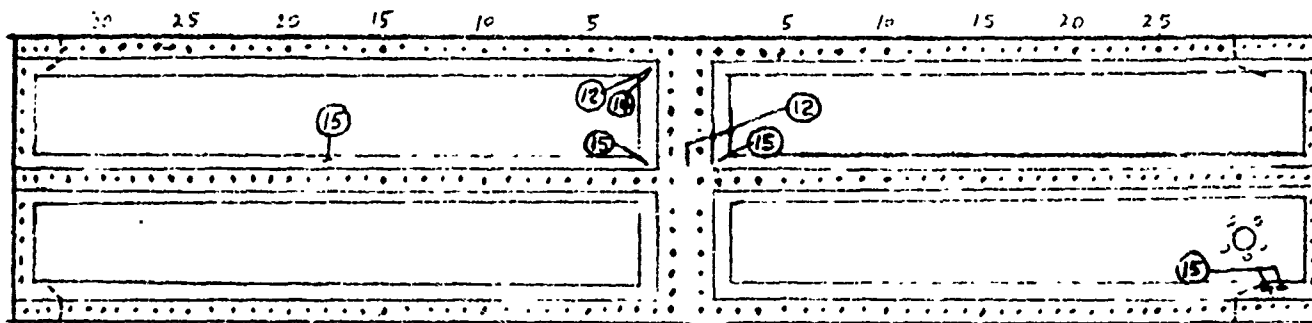
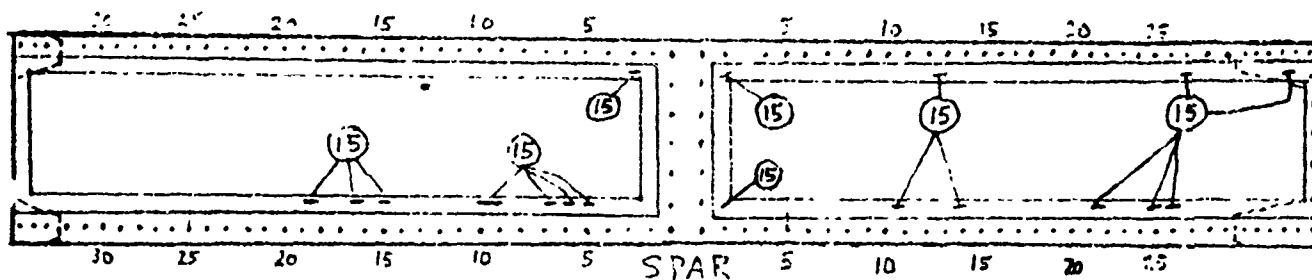
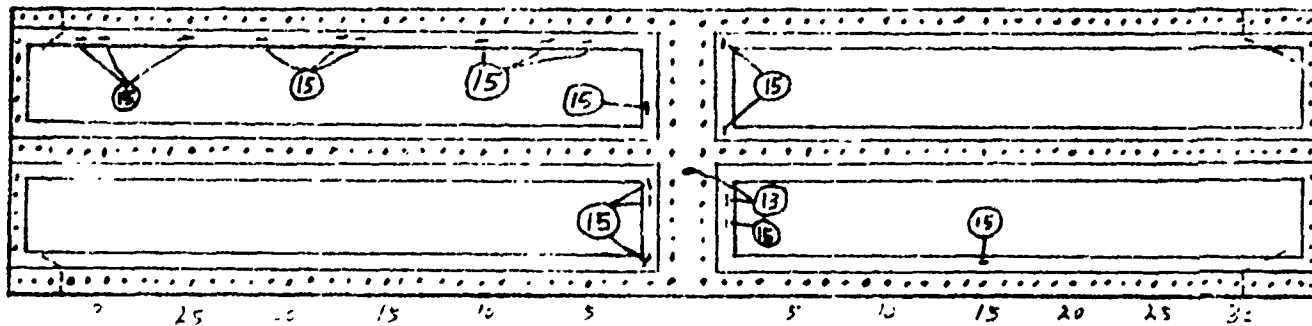
FILLET DEFECTS OBSERVED AFTER LEAKAGE TEST  
NO. 7 (PRIOR TO INTERNAL LEAKAGE ANALYSIS)

A "C" POINTING TO ABOVE AREA INDICATES A SMALL LEAK WITH CONTINUOUS BUBBLING.  
 AN "L" INDICATES A LARGE LEAK WITH VIGOROUS BUBBLING.

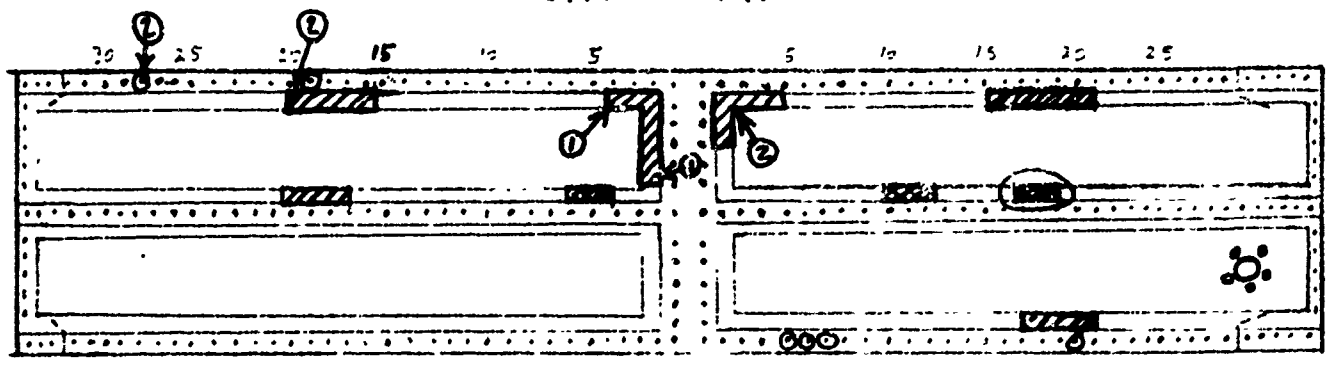
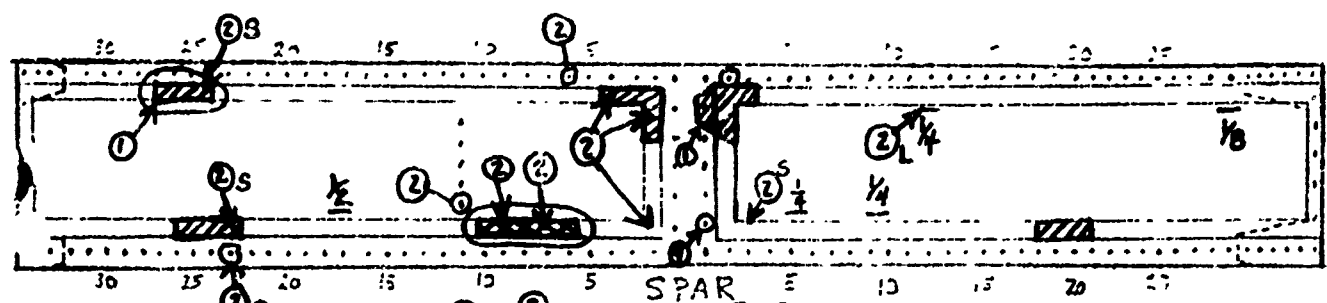
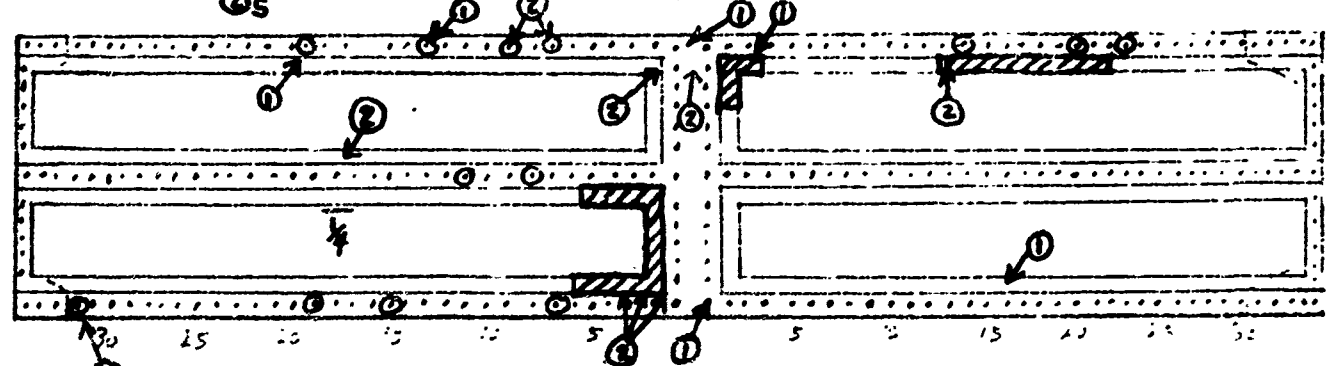
TANK NO. 1 INTERIOR LEAKAGE ANALYSIS CONDUCTED AFTER 12 ENVIRONMENTAL CONDITIONING CYCLES. ANALYSIS CONDUCTED USING 5 PSIG NEGATIVE (VACUUM) PRESSURE IN TANK WITH WATER LAYER ON INTERIOR TO VISUALLY INDICATE LEAKAGE BY BUBBLING.

① EXISTING LEAKING FASTENERS AFTER 12 ENV. COND. CYCLES (NOT REPAIRED)

- FILLET REPAIRED AFTER 12 ENV. COND. CYCLES (AUG 70)
- LEAK AFTER 20 ENV. COND. CYCLES (NOV 70)
- FILLET REPAIRED AFTER 20 ENV. COND. CYCLES (NOV 70)
- LEAK AFTER 31 ENV. COND. CYCLES (AUG 71)
- FILLET REPAIRED, ADHESION CHECKED, THEN RE-REPAIRED
- EXISTING FILLET CRACK AFTER 20 ENV. COND. CYCLES  $\frac{1}{4} = \sim$  LENGTH

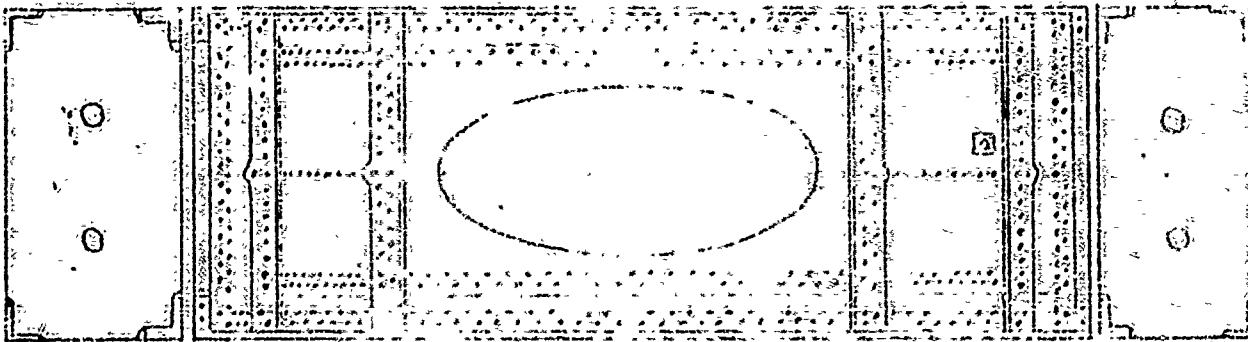
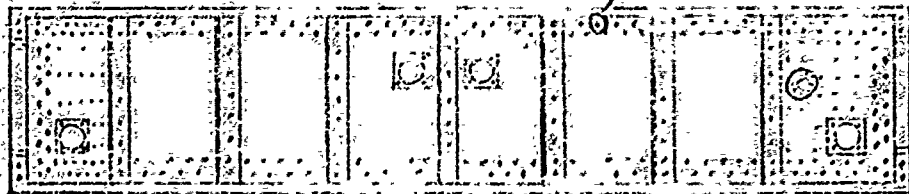
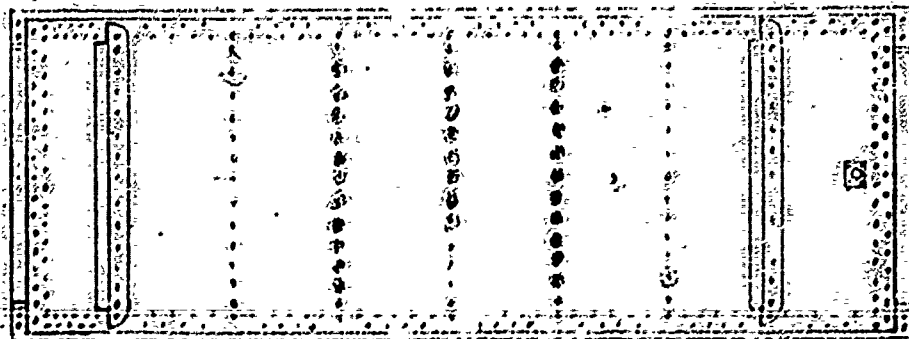
CALC		REVISED	DATE	TANK NO. 3 LEAKAGE TEST NO. 1	
CHECK				ORIGINAL LEAK TEST - PRIOR TO ANY	
APP				TESTING AT YAGITA	
APP				<b>BOLLINE</b>	
CONTRACT NO.				DATA SHEET NO. 3-1	PAGE B-1

SMALL FASTENER LEAK

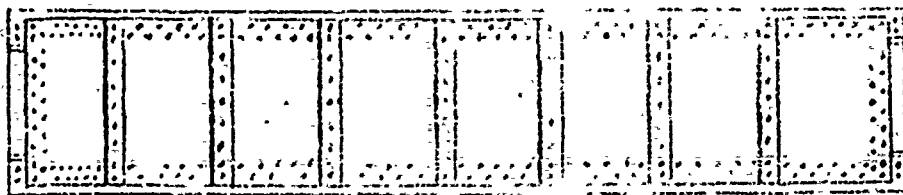
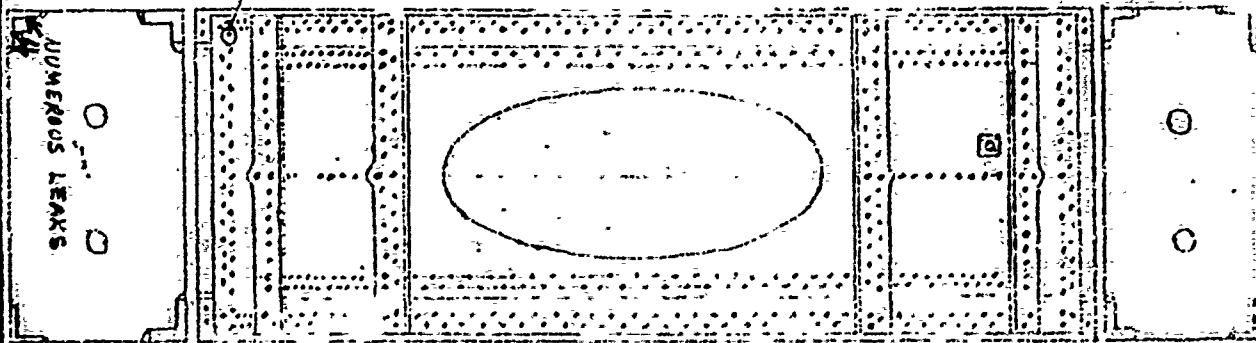
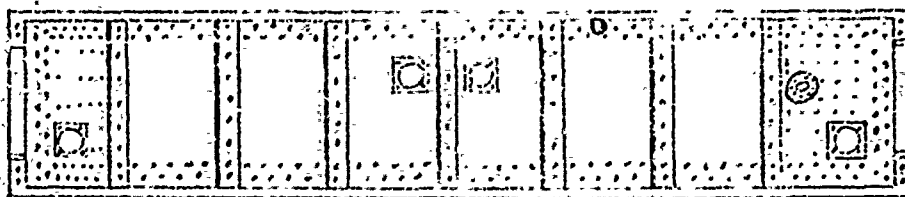
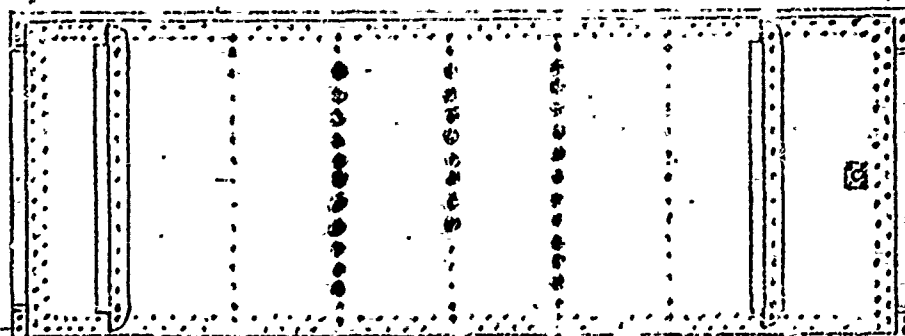
CALC		REVISED	DATE	TANK NO. 3 LEAKAGE TEST NO. 2. LEAK TESTED AFTER INITIAL LOAD CYCLING AT ALL 3 TEMPERATURES	
CHECK					
APR					
APR					
CONTRACT NO.				DATA SHEET NO. 3-2	FILE B-2

HOLE LEAKS WHERE FASTENER WAS MISSING (BROKE OFF DURING CYCLIC LOADING)

TWO SMALL JOINT  
LEAKS

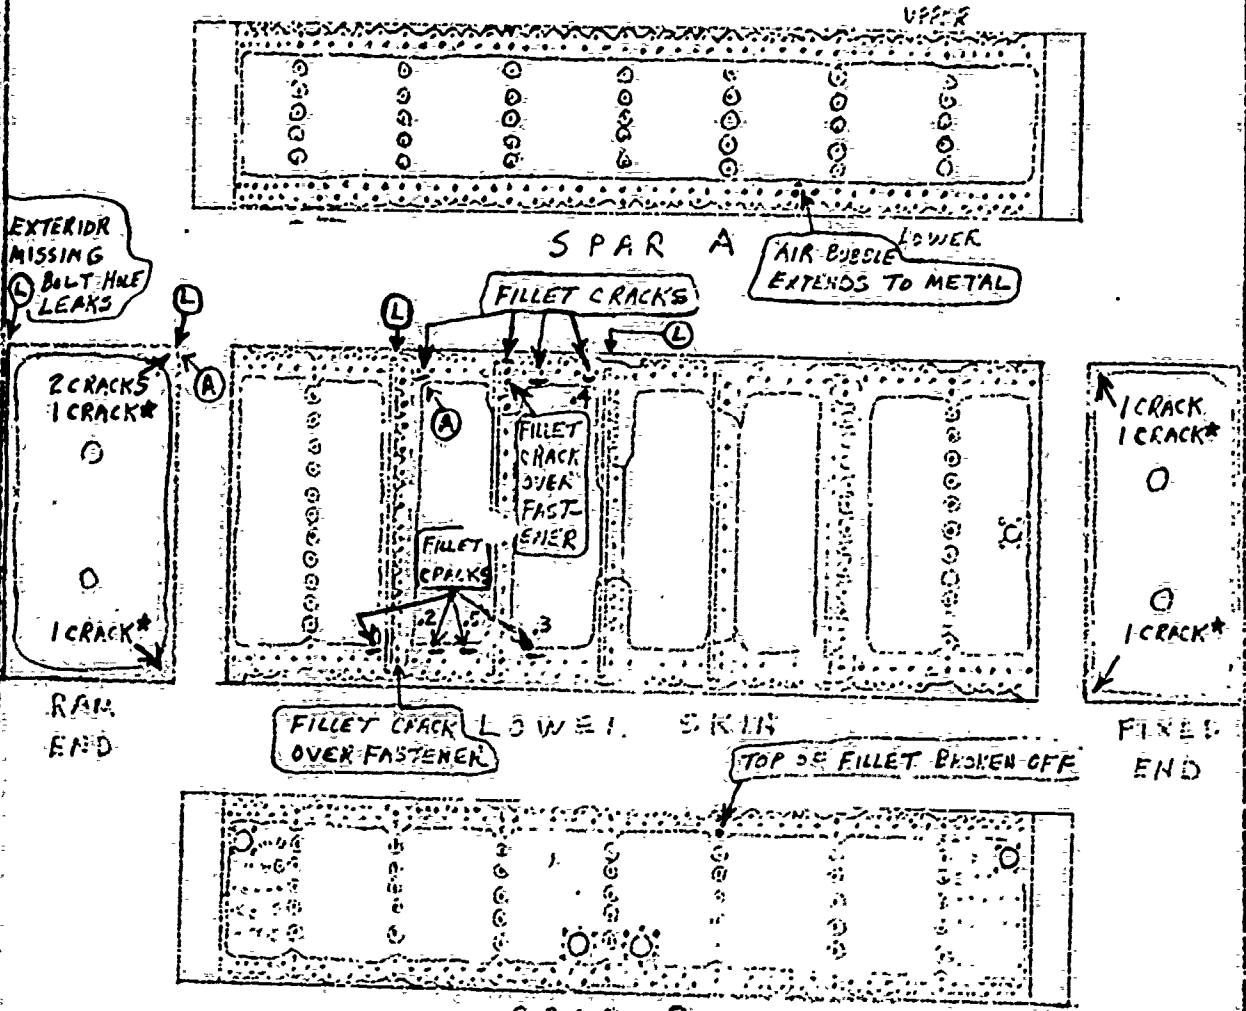
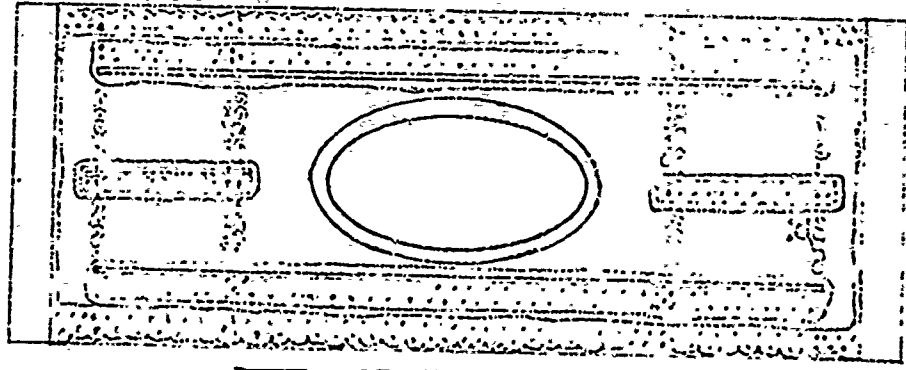
CALC		REVISED	DATE	THIRD AND INTERIOR VIEW AFTER INITIAL LOAD CYCLING AT 3 TON LOADS	03-8297
CHECK					
APR					
APR

SPAR B  
 (A) 3 PSIG VACUUM LEAK TEST SHOWED INTERIOR LEAK HERE (BOBBING THRU WATER)

NUMBERS INDICATE CRACK LENGTH UPPER SKIN  
 (L) = EXTERIOR JOINT LEAK  
 \* = MAY BE INCOMPATIBILITY OF REPAIR OVER CURVED SEAMANT

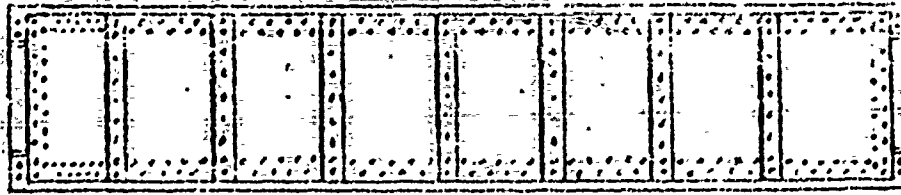
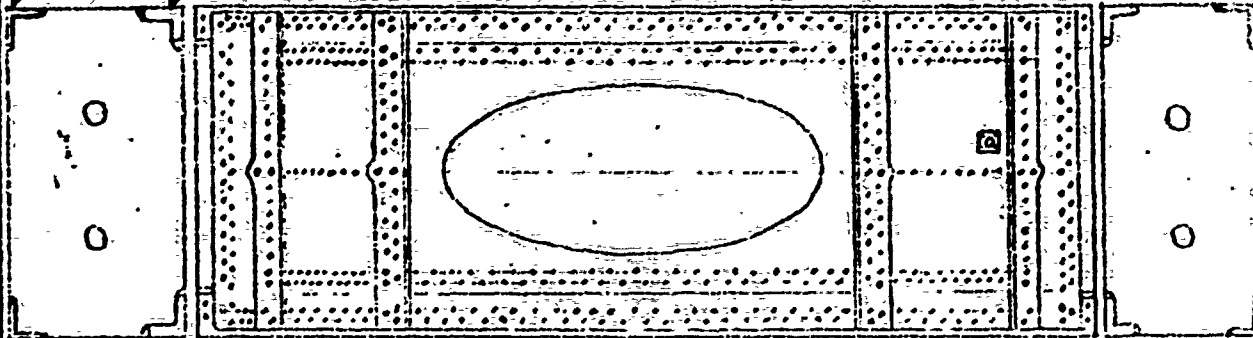
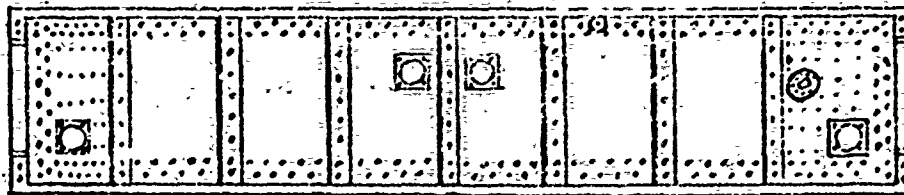
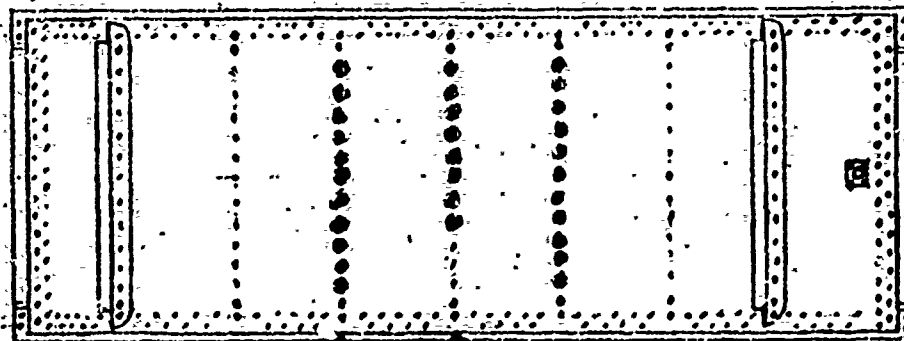
CALC		REVISED	DATE	TANK NO. 3 LEAKAGE TEST NO. 3.	
CHECK				LEAK TESTED AFTER 1500 LOAD CYCLES	
APP				AT R.T. PLUS 500 HOT CYCLES.	
APP				THE ENGINEERING COMPANY SUNBELT AVENUE, NEW ORLEANS, LA.	PAGE
CONTRACT NO.				DATA SHEET NO. 3-4	B-4

*Previous leak (had not been repaired) / Previously repaired but still leaking*

LOWER SKIN  
NEW LEAK

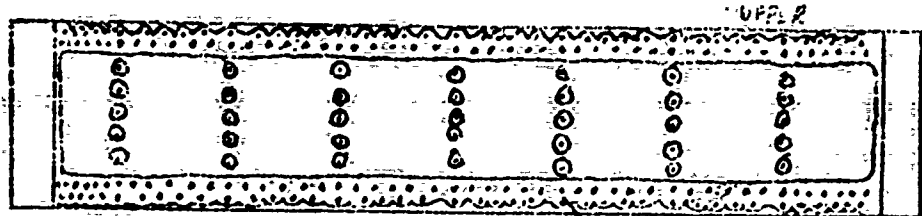
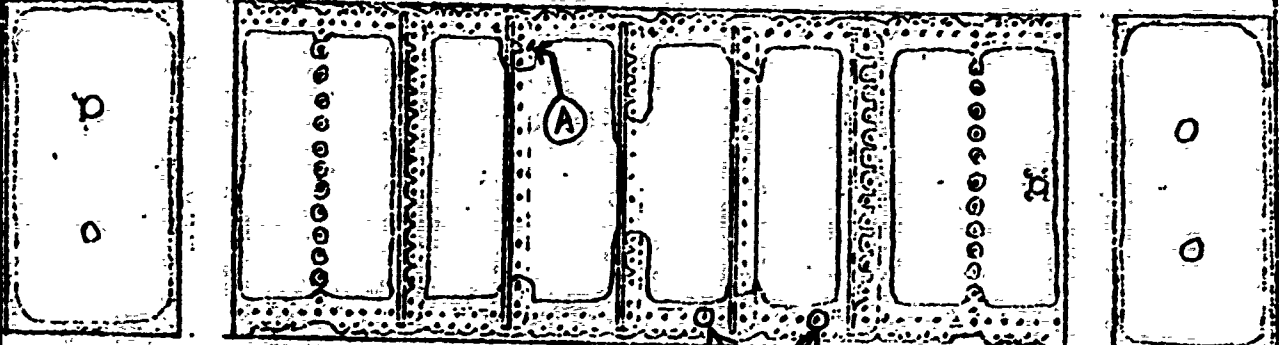
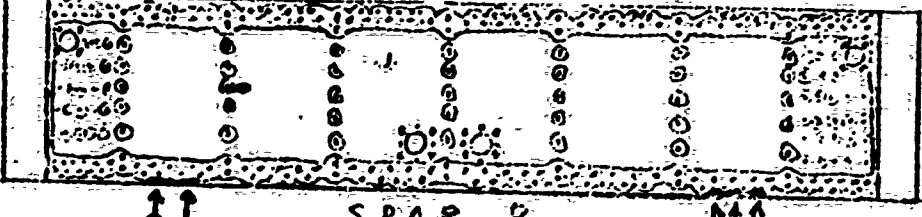
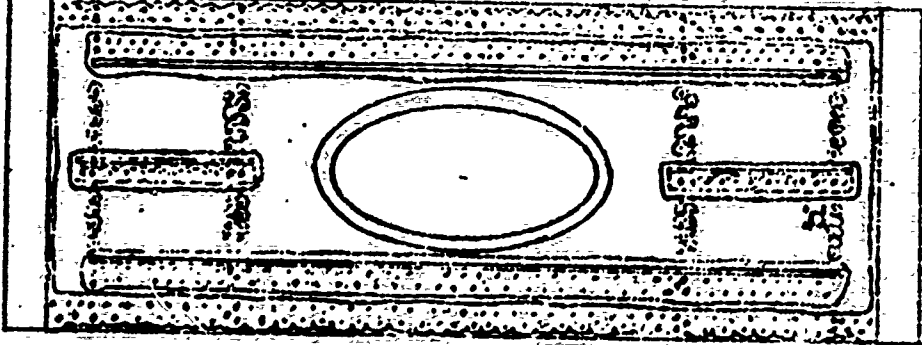
<table><tr> <td>CALC</td> <td></td> <td></td> <td>DESIGNED</td> <td>DATE</td> <td rowspan="4">           TANK NO. 3 INTERIOR VIEW            SHOWING ADDITIONAL *CRACKS AFTER            1500 P.T. CYCLES + 500 HOT CYCLES         </td> </tr></table>

*cracks in fillets?*

CRACKS OVER FASTENER

(A) VERY SMALL FILLET CRACKS

\*CRACKS IN ADDITION TO THOSE SHOWN IN DATA SHEET NO. 3-3

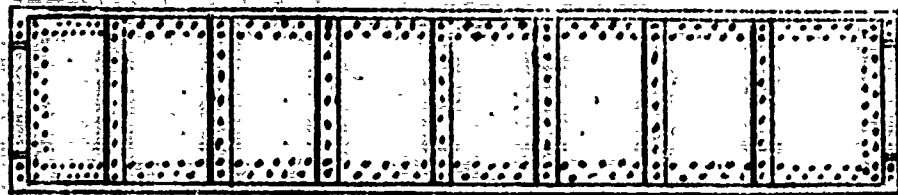
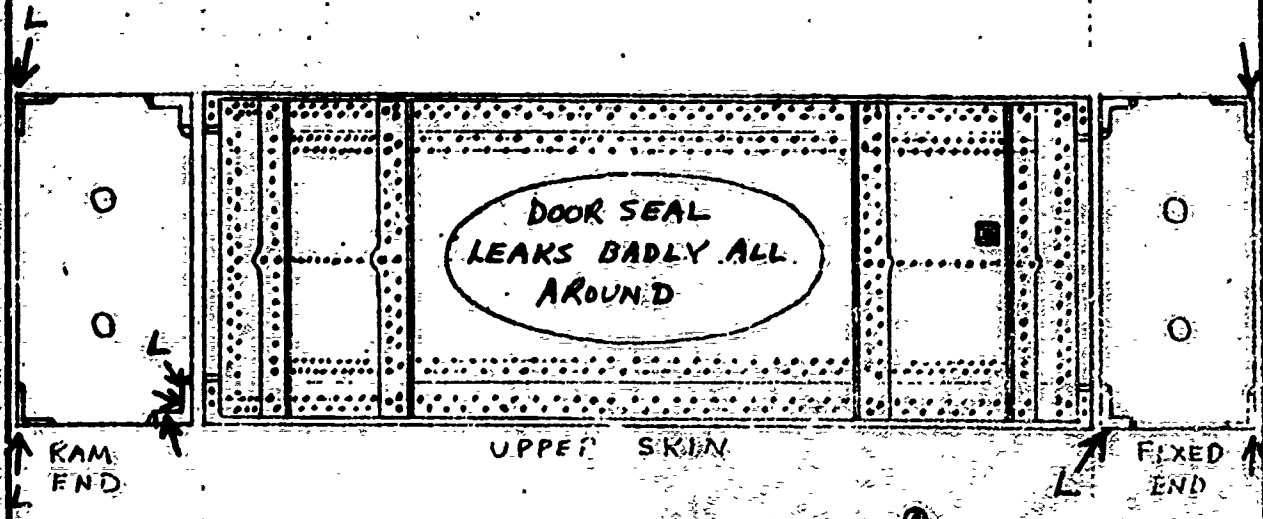
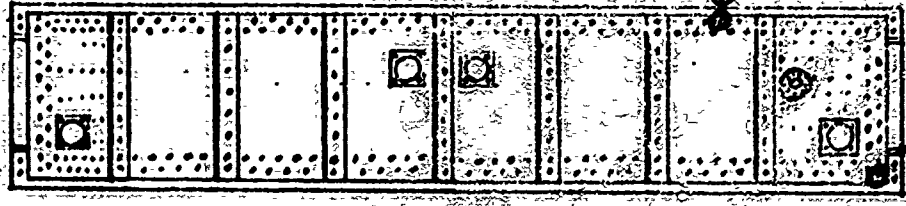
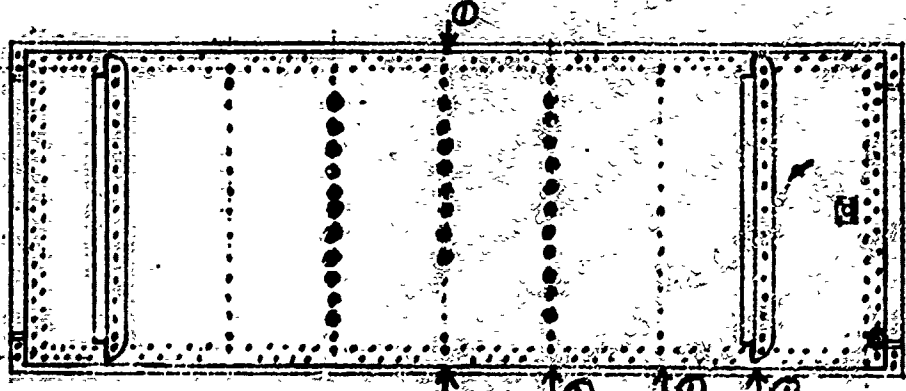
ENG	LM	8-6-71	REVISED	DATE	TANK NO. 3 LEAKAGE TEST NO. 4
					AFTER 8 ENVIRONMENTAL
					CONDITIONING CYCLES
					8-7

ARROWS INDICATE LEAKS  
 L = LARGE LEAK (RAPID PURGING)  
 S = SMALL LEAK (SLOW PURGING)  
 TEST CONDUCTED: 3-31-71

⊙ ADDITIONAL LEAKS DURING SECOND LEAK TEST 8-3-71 (ORIGINAL LEAK TEST WAS 3-31-71)

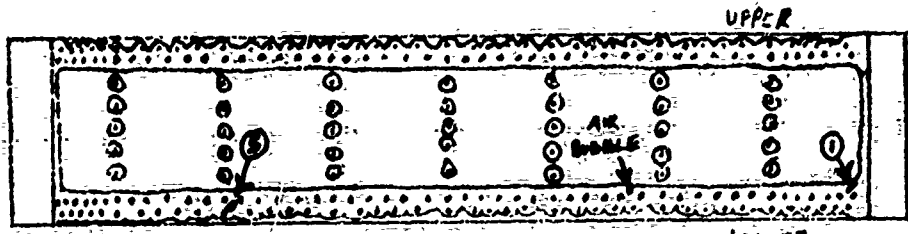
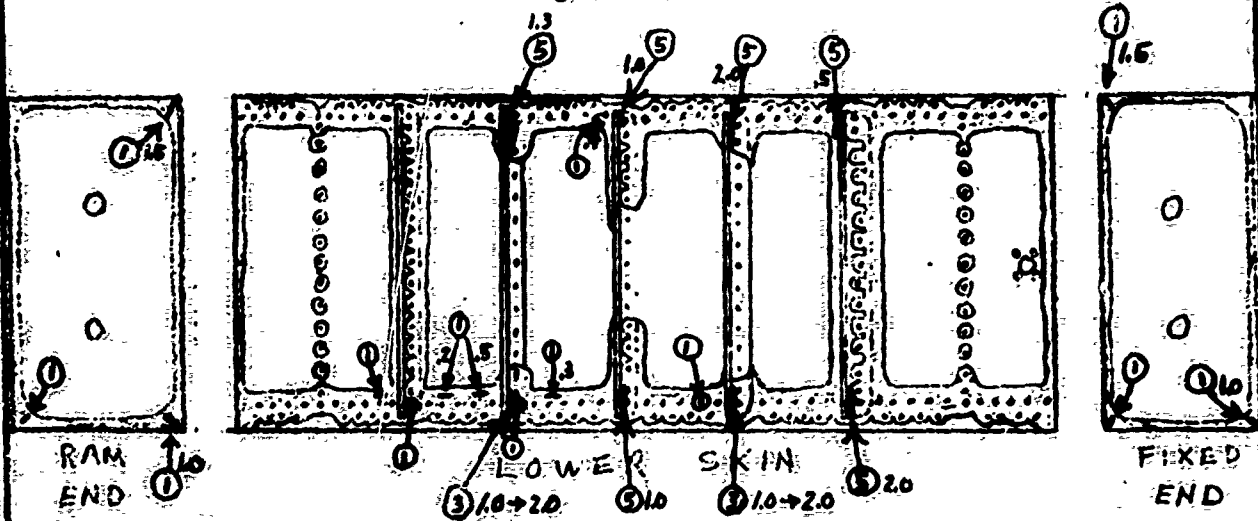
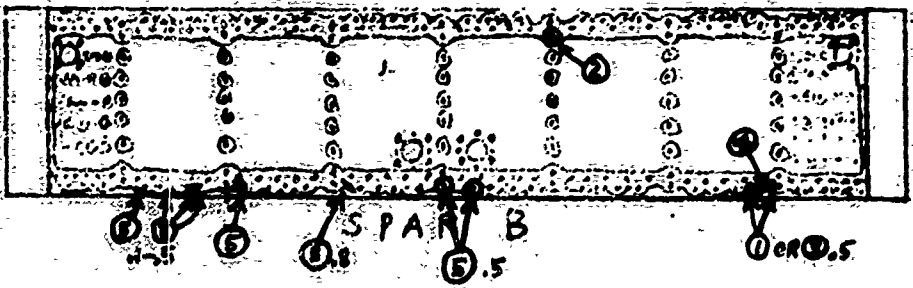
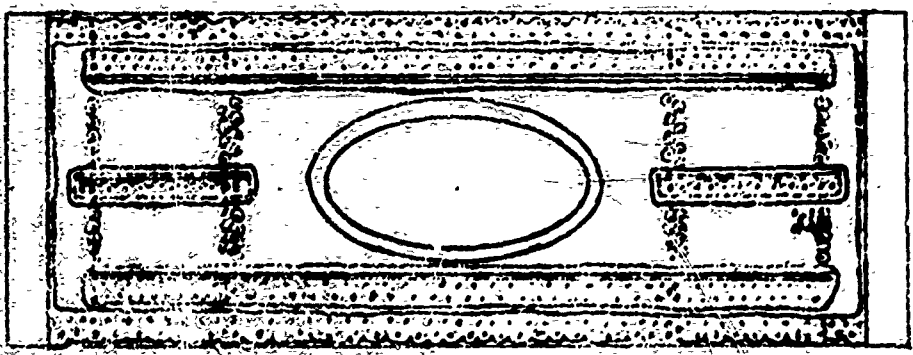
TANK NO. 3 INTERIOR VIEW  
AFTER 8 ENVIRONMENTAL  
CONDITIONING CYCLES

- ① → INDICATES FILLET CRACK (LENGTH AS NOTED IN INCHES)
- ② → FILLET OVER FASTENER PARTIALLY TORN OFF
- ③ → FILLET: CRACKS THAT LENGTHENED WHEN TANK WAS DRIED OUT (16 HRS @ 310°F) ON AUG 5 TO PREPARE FOR REPAIRS.
- ④ → LOSS OF ADHESION
- ⑤ → NEW FILLET CRACKS WHICH DEVELOPED DURING AMBIENT STORAGE (BETWEEN 6 APRIL AND 6 AUGUST 1971) OR WHEN TANK WAS DRIED OUT (16 HRS @ 310°F) ON AUG 5, 1971 TO PREPARE FOR REPAIRS.

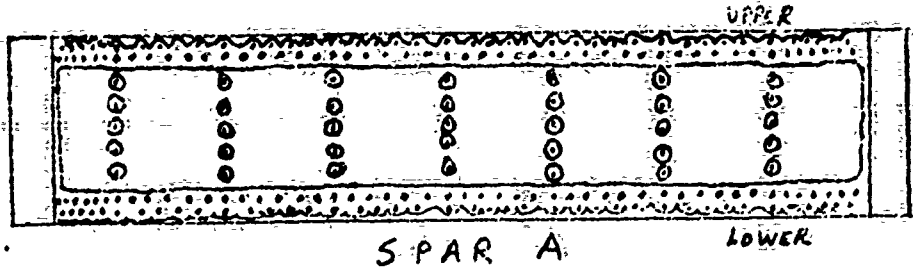
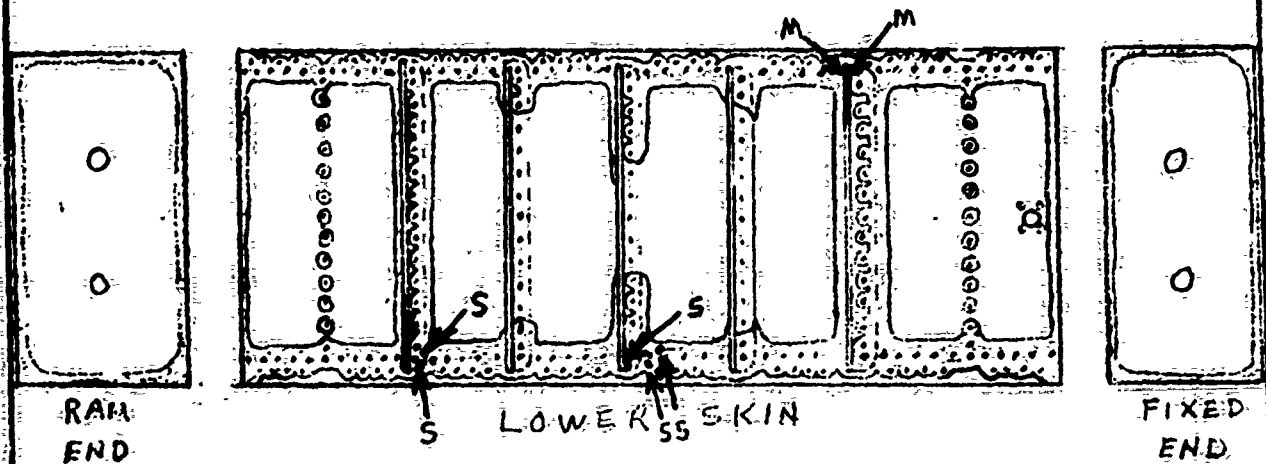
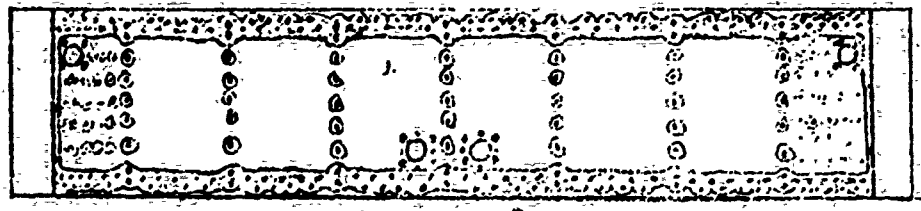
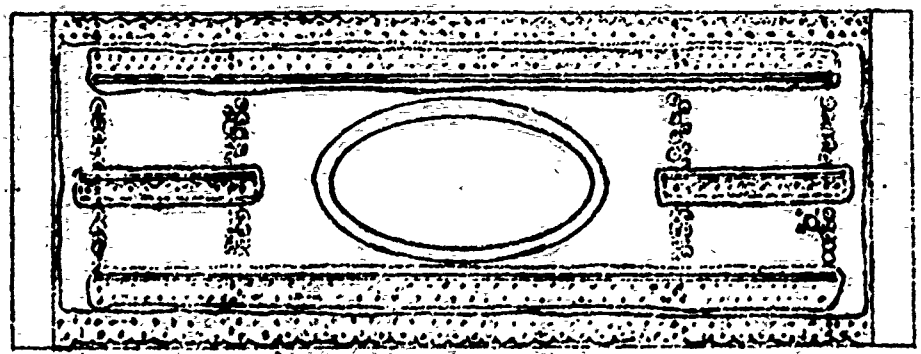
TANK NO. 3 INTERIOR VIEW  
 LEAKAGE AFTER 16 HRS DRY OUT  
 AT 310°F.

L-LARGE LEAK (RAPID BUBBLING) UPPER SKIN  
 M-MEDIUM LEAK (~1 BUBBLE PER 15 SEC.)  
 S-SMALL LEAK (<1 BUBBLE PER MIN)

INTERIOR LEAKAGE WITH 3 PSI VACUUM

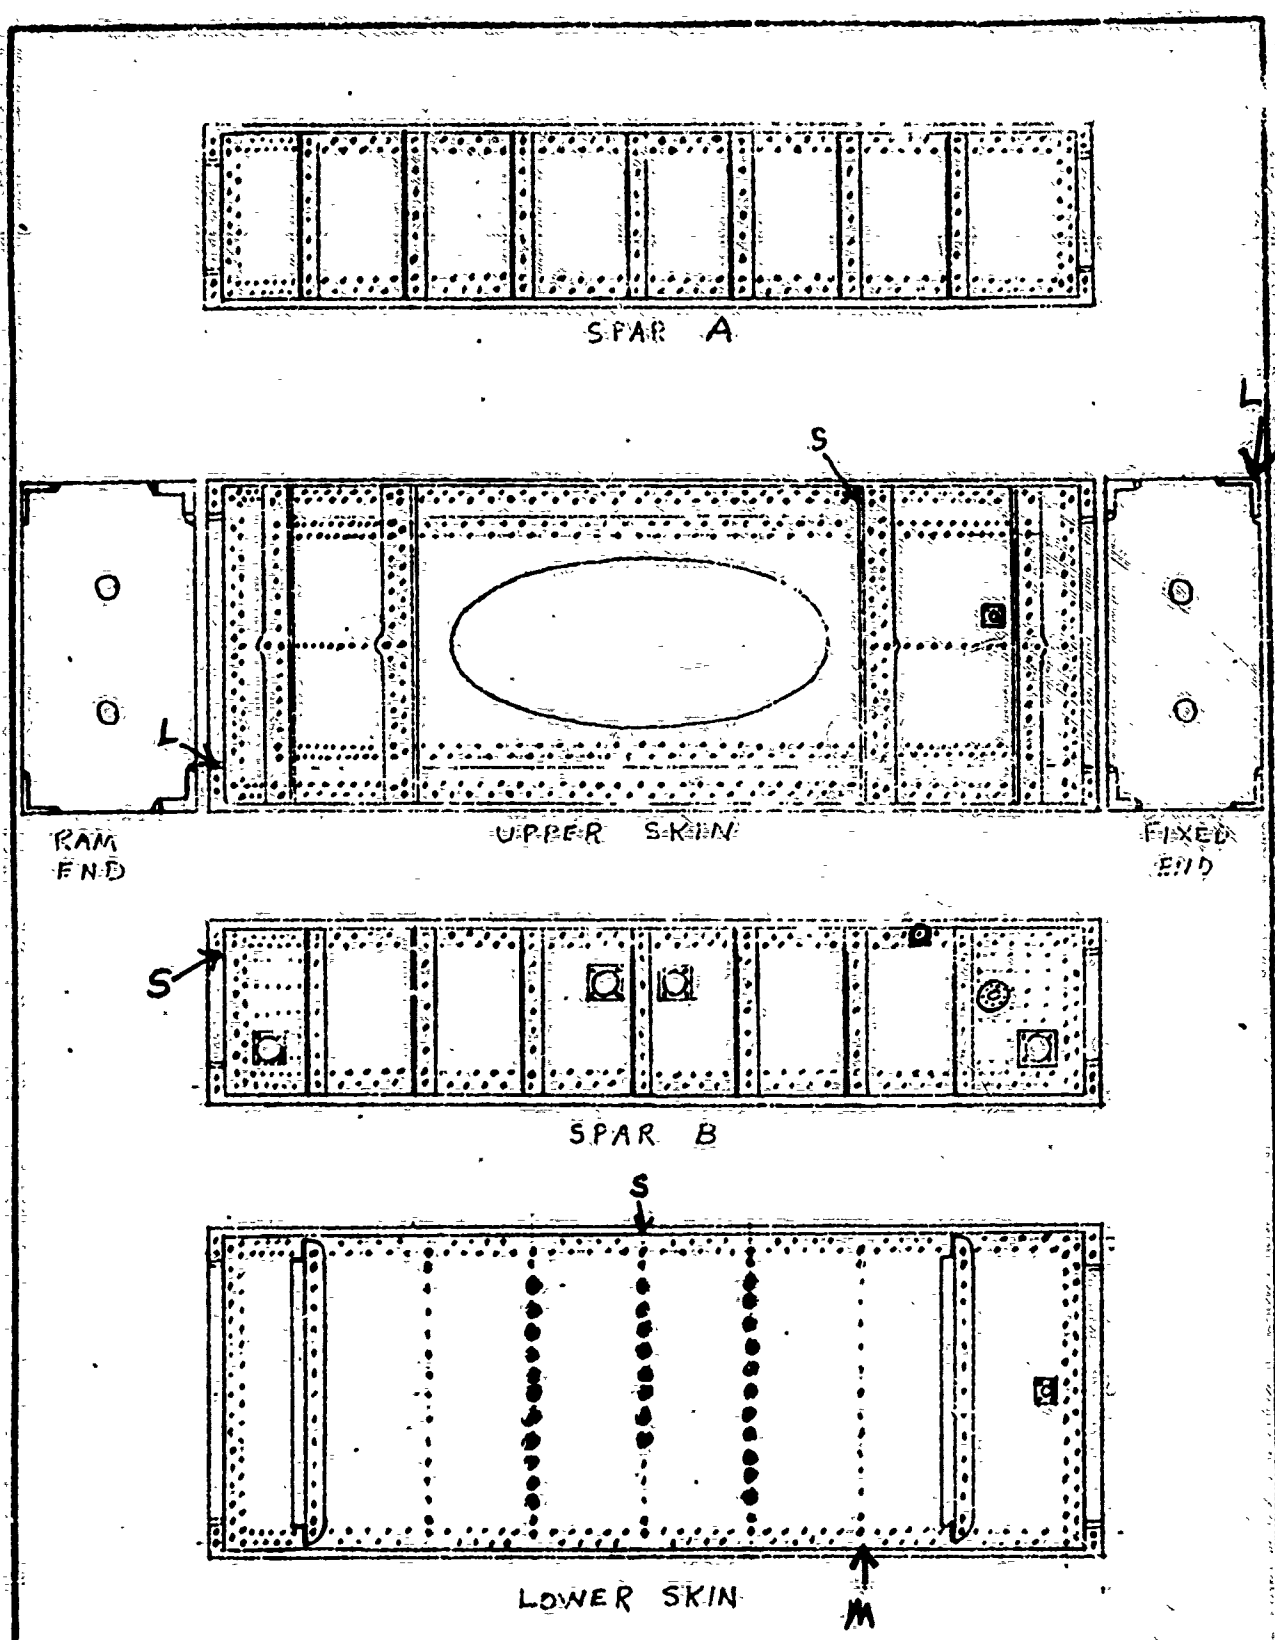
SEE PAGE B-9 FOR CODE

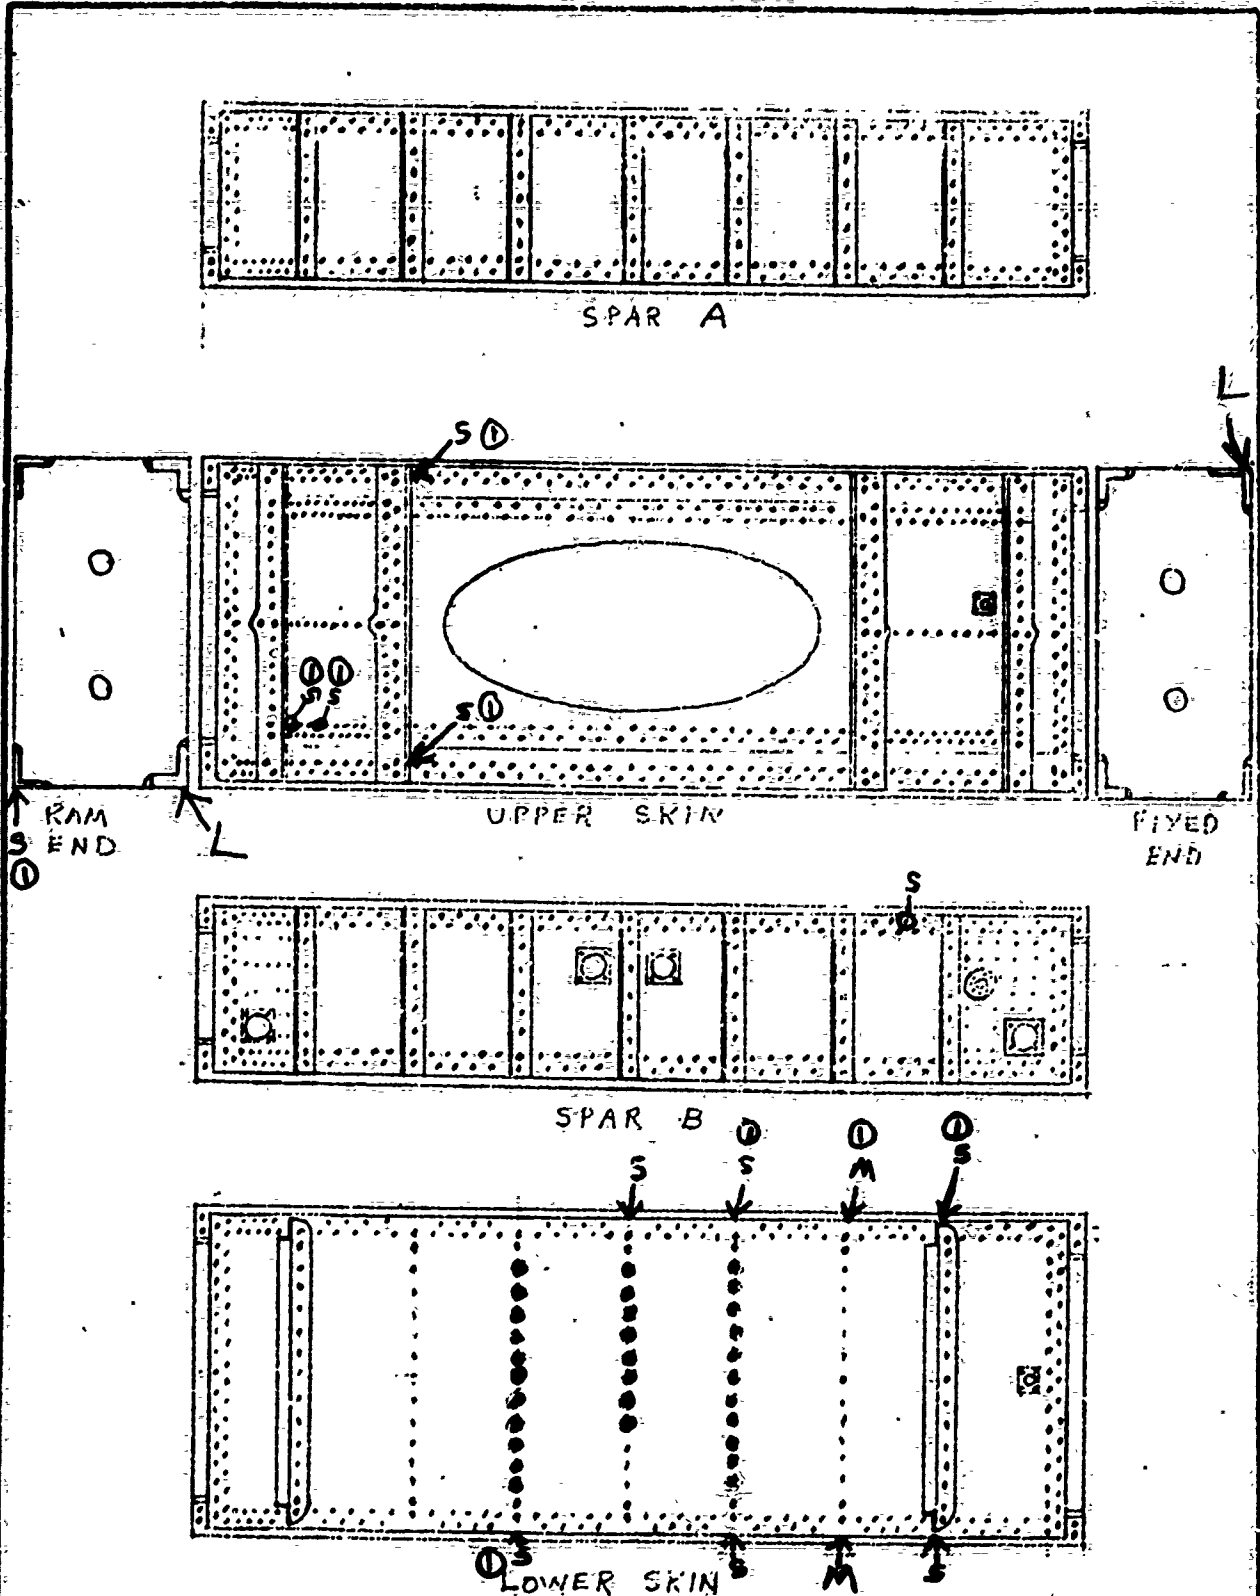
CALC	JAM	REVISED	DATE	TANK NO. 3 LEAKAGE TEST NO. 6
CHECK				AFTER LOAD CYCLING AT THREE
APP				TEMPERATURES (FOLLOWING 8 CYCLES
APP

① - NEW LEAKS THIS TEST

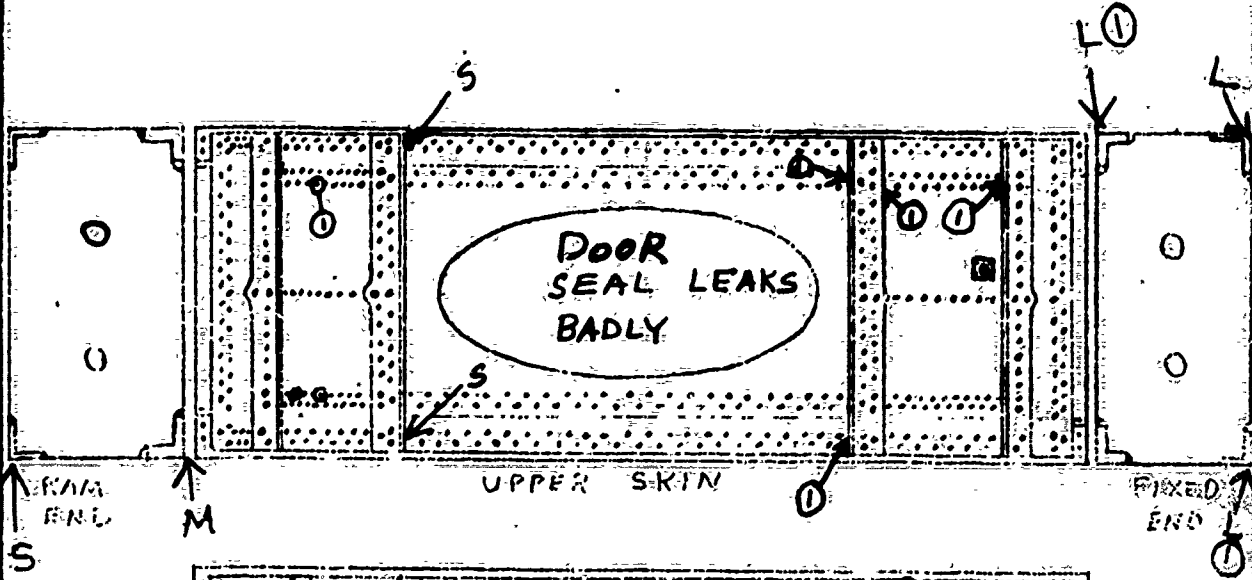
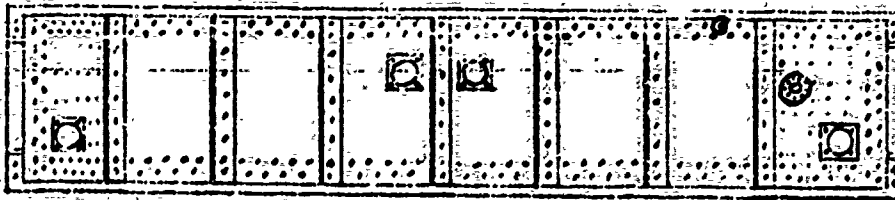
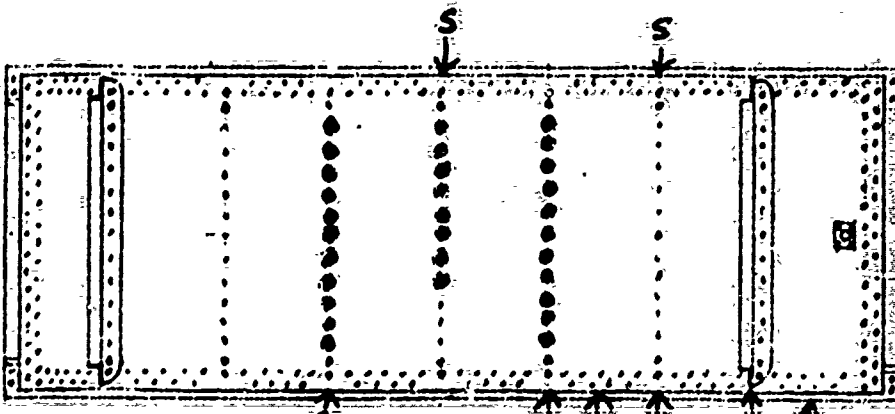
CALC	<i>Lu</i>	1-4-72	REVISED	RATE	TANK NO. 3 LEAKAGE TEST NO. 7
CHECK					AFTER 22 ENVIRONMENTAL
APP					CONDITIONING CYCLES
APP					THE BEIND COMPANY AUSTIN 130-11111 TEXAS 78701
CONTACT NO.					PAGE B-12

SUMMARY:  
9 NEW  
LEAKS

① NEW LEAKS  
THIS TEST

S - SMALL LEAK  
M - MEDIUM LEAK  
L - LARGE LEAK
