Report No. FAA-SS-73-10

# SST Technology Follow-On Program-Phase II

## DEVELOPMENT AND EVALUATION OF FUEL TANK SEALANTS

**FINAL REPORT**  
Task II

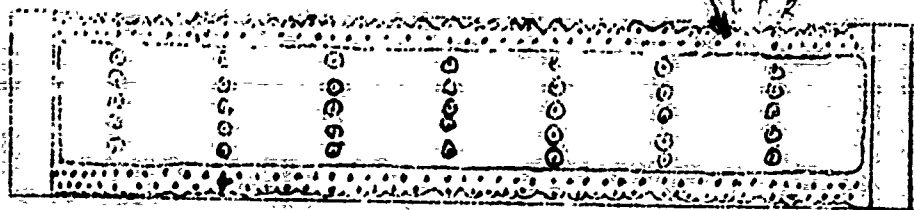
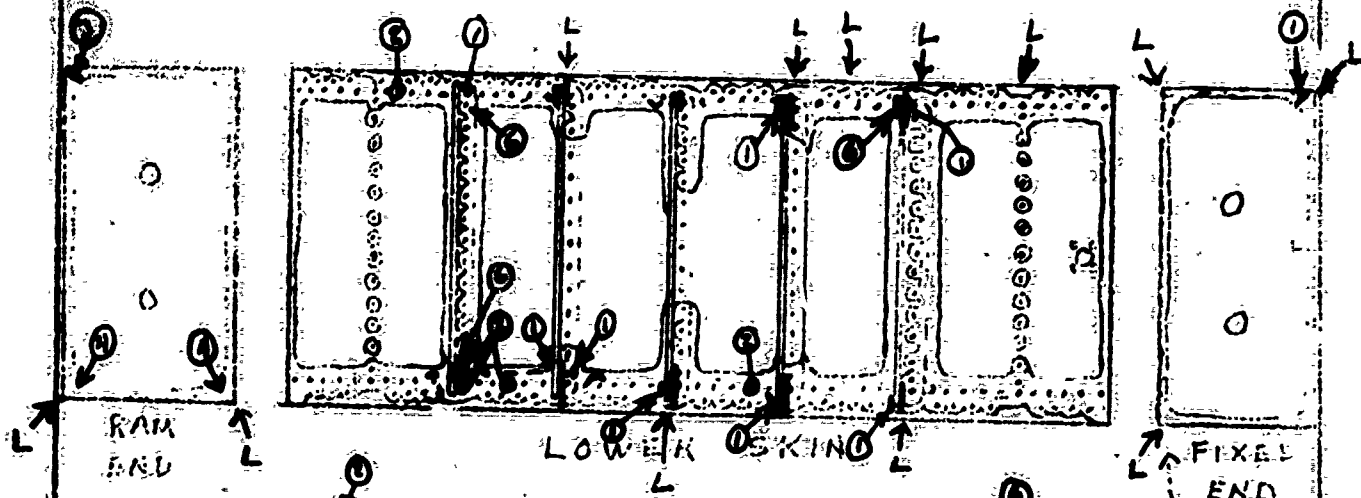
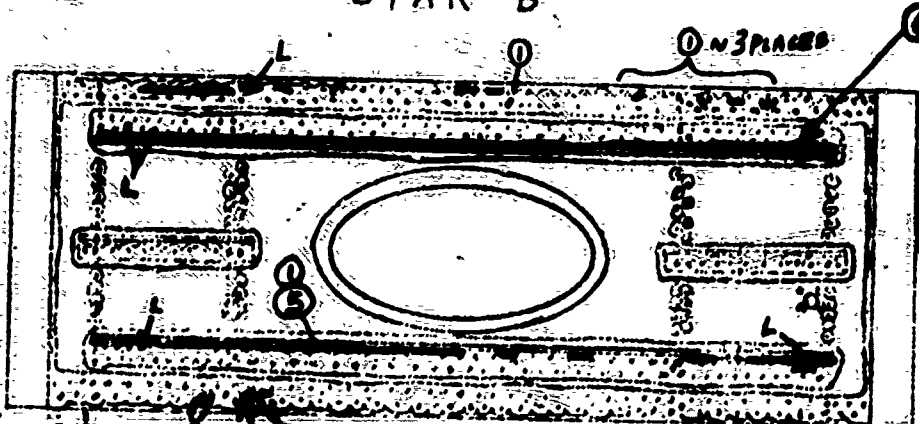
TANK NO. 3 INTERIOR VIEW  
 AFTER 22 ENVIRONMENTAL  
 CONDITIONING CYCLES (JAN 72)

**SUMMARY:**  
 28 NEW DEFECTS  
 17 PLACES  
 9 PLACES

- ① NEW CRACK THIS TEST
- ② SEALANT OVER FASTENER TORN
- ③ NEW CRACK IN ORIGINAL SEALANT
- ④ SOME EVIDENCE OF LOSS OF ADHESION OF REPAIR SEALANT TO ORIGINAL SEALANT
- ⑤ FILLET CRACK ALONG STIFFENER
- ⑥ UPPER SKIN
- L = EXTERIOR LEAK (SEE PAGE B-12)

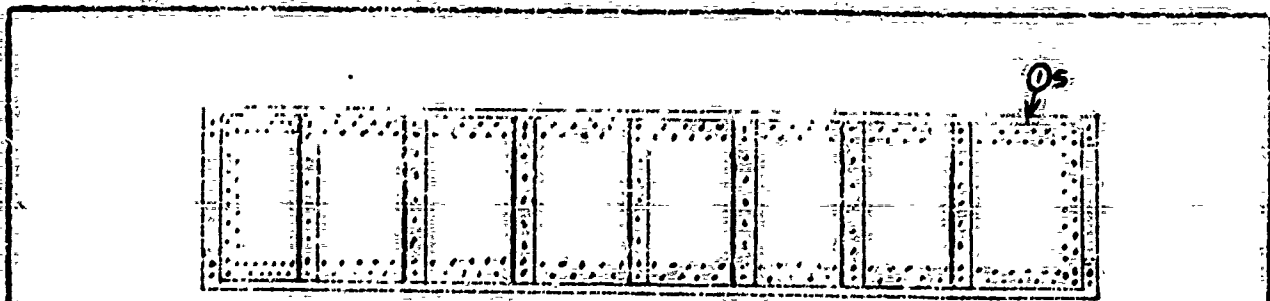
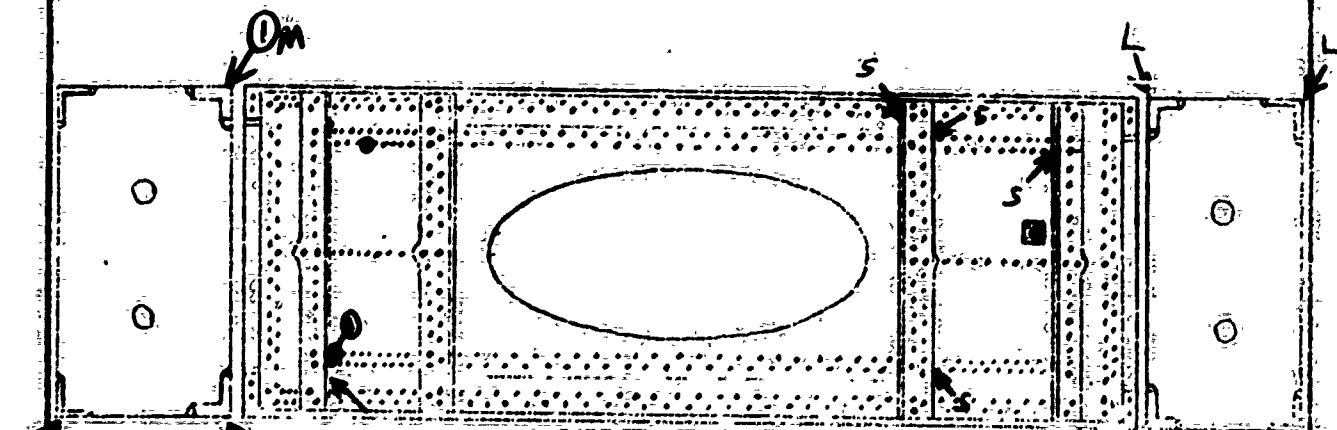
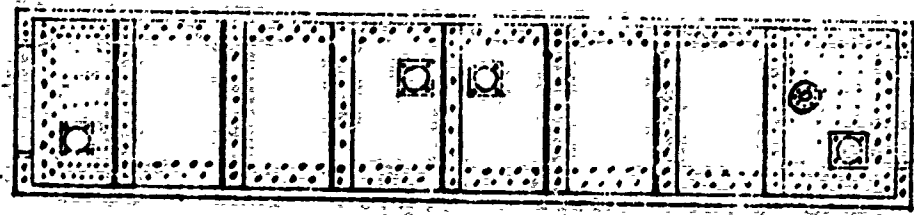
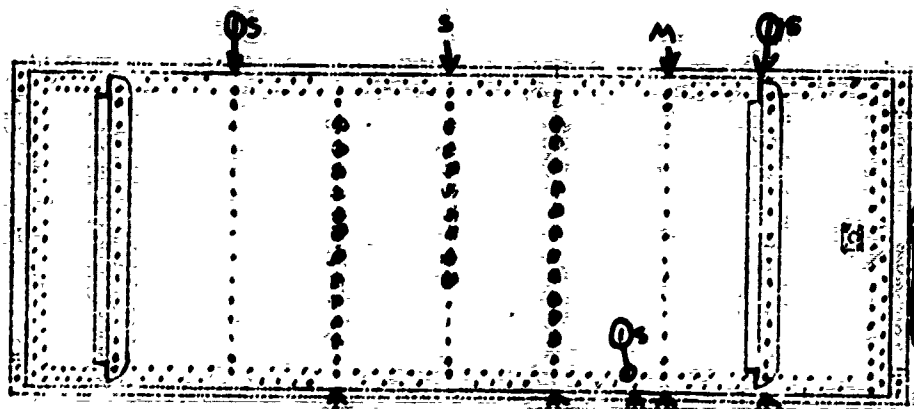
CALC	CHECK	APR	APR	NOTED	DATE	TANK NO. 3 LEAKAGE TEST NO. 6
						AFTER LOAD CYCLING AT 3 TEMPS. (FOLLOWING 22 CYCLES OF ENV. COND)
						THE BOEING CO. PAVY BOEING COMPANY, WASHINGTON, D.C.

SUMMARY:  
6 NEW  
LEAKS

① NEW LEAKS THIS TEST  
S = SMALL LEAK  
M = MEDIUM LEAK L = LARGE LEAK

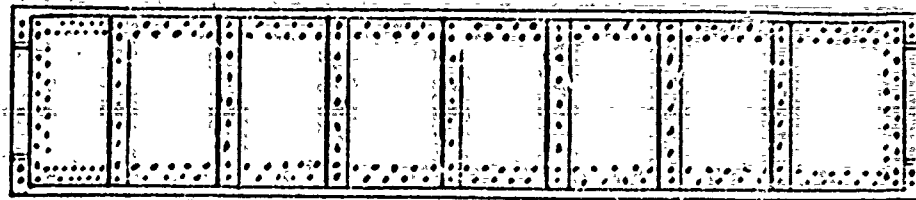
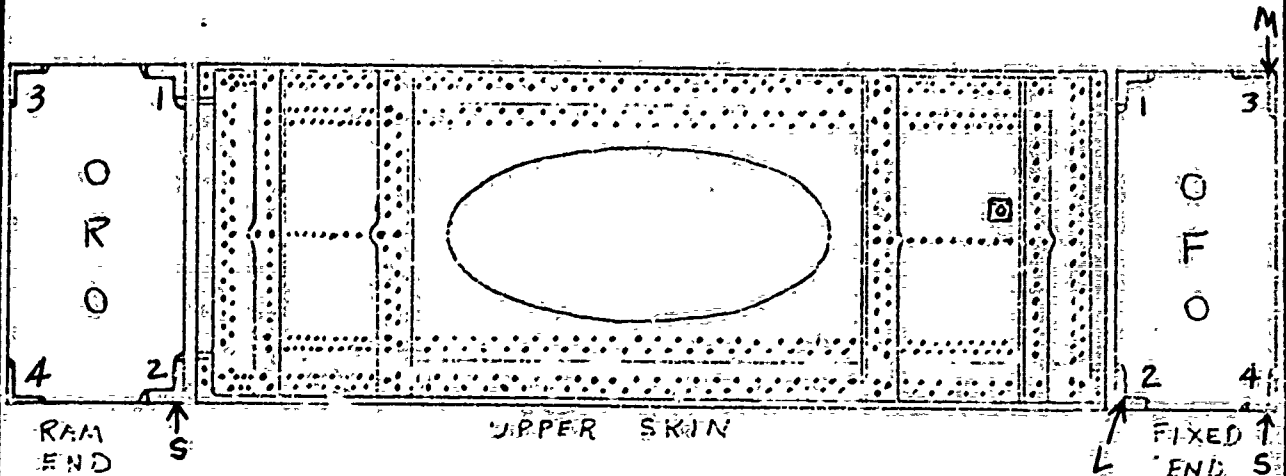
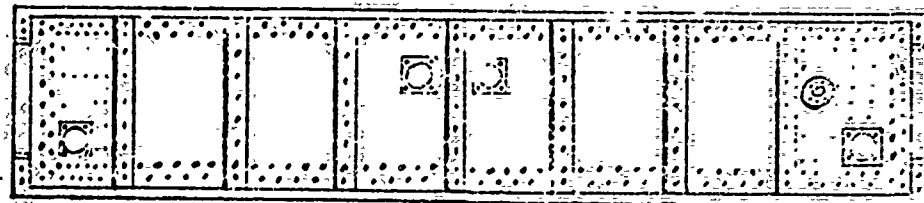
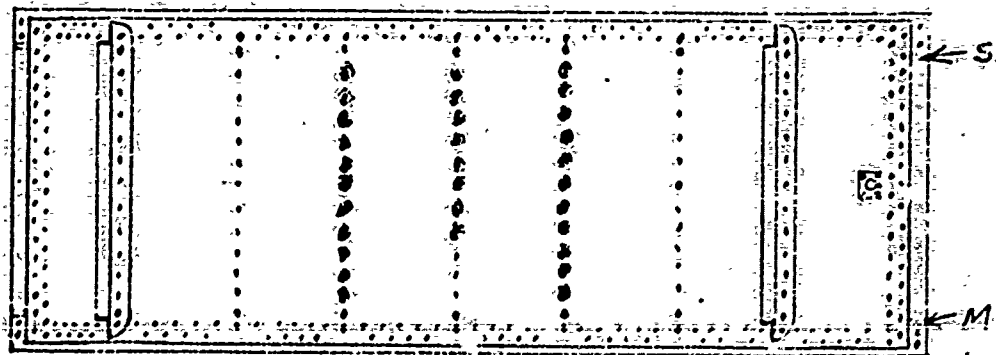
CALC			REVISED	DATE	TANK NO. 3 LEAKAGE TEST NO. 1 AFTER REPAIRS OF SIX LEAKING CORNERS (SEE PAGE B-14)	03-8297
CHECK						
APR						
APR

S = SMALL LEAK  
 M = MEDIUM LEAK  
 L = LARGE LEAK

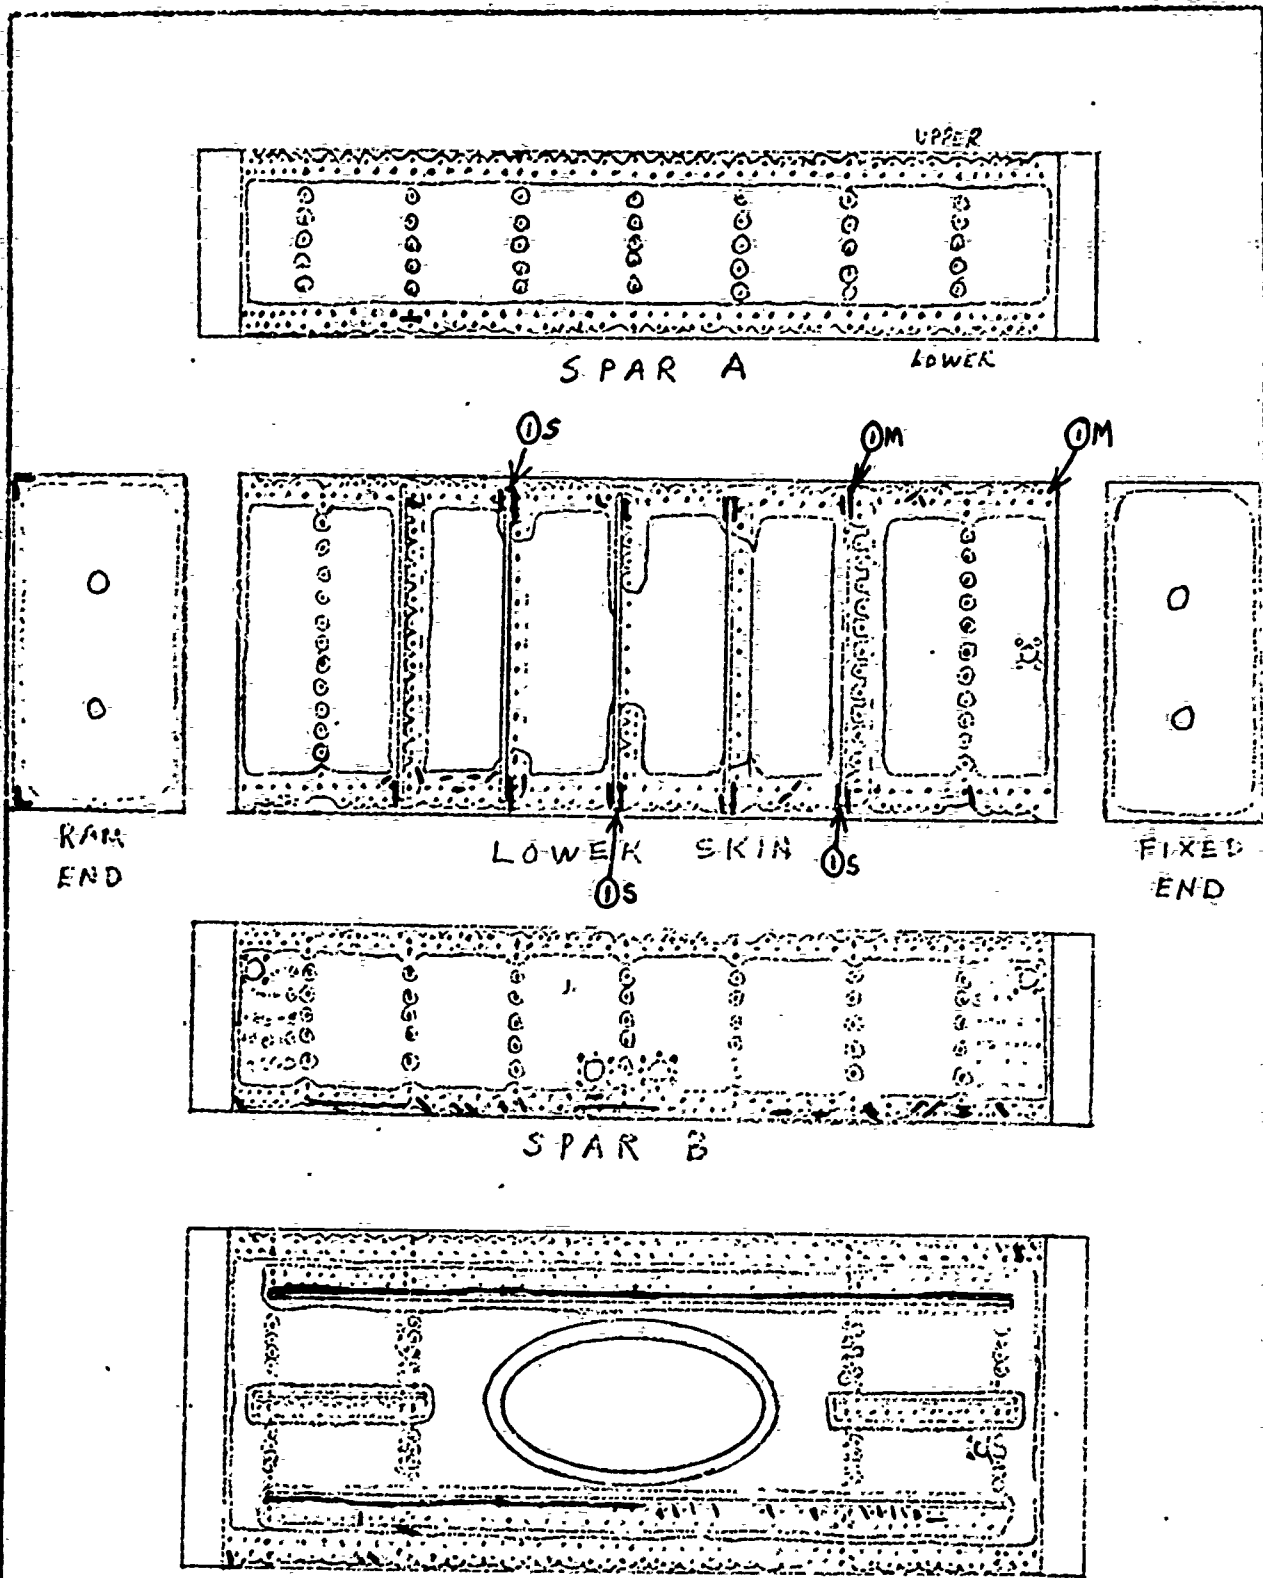
CALC			REVISED	DATE	TANK NO. 2 INTERIOR SKIN AFTER 39 CYCLES OF ENVIRONMENTAL CONDITIONING, PLUS 16 HOURS DRYOUT AT 400°F.	D3-8297 FACE B-17 104.12
CHECK						
APX						
APR

S = SMALL LEAK  
 M = MEDIUM LEAK  
 L = LARGE LEAK  
 ⊙ → INTERIOR LEAK - WATER BUBBLING THRU 3 PSI VACUUM

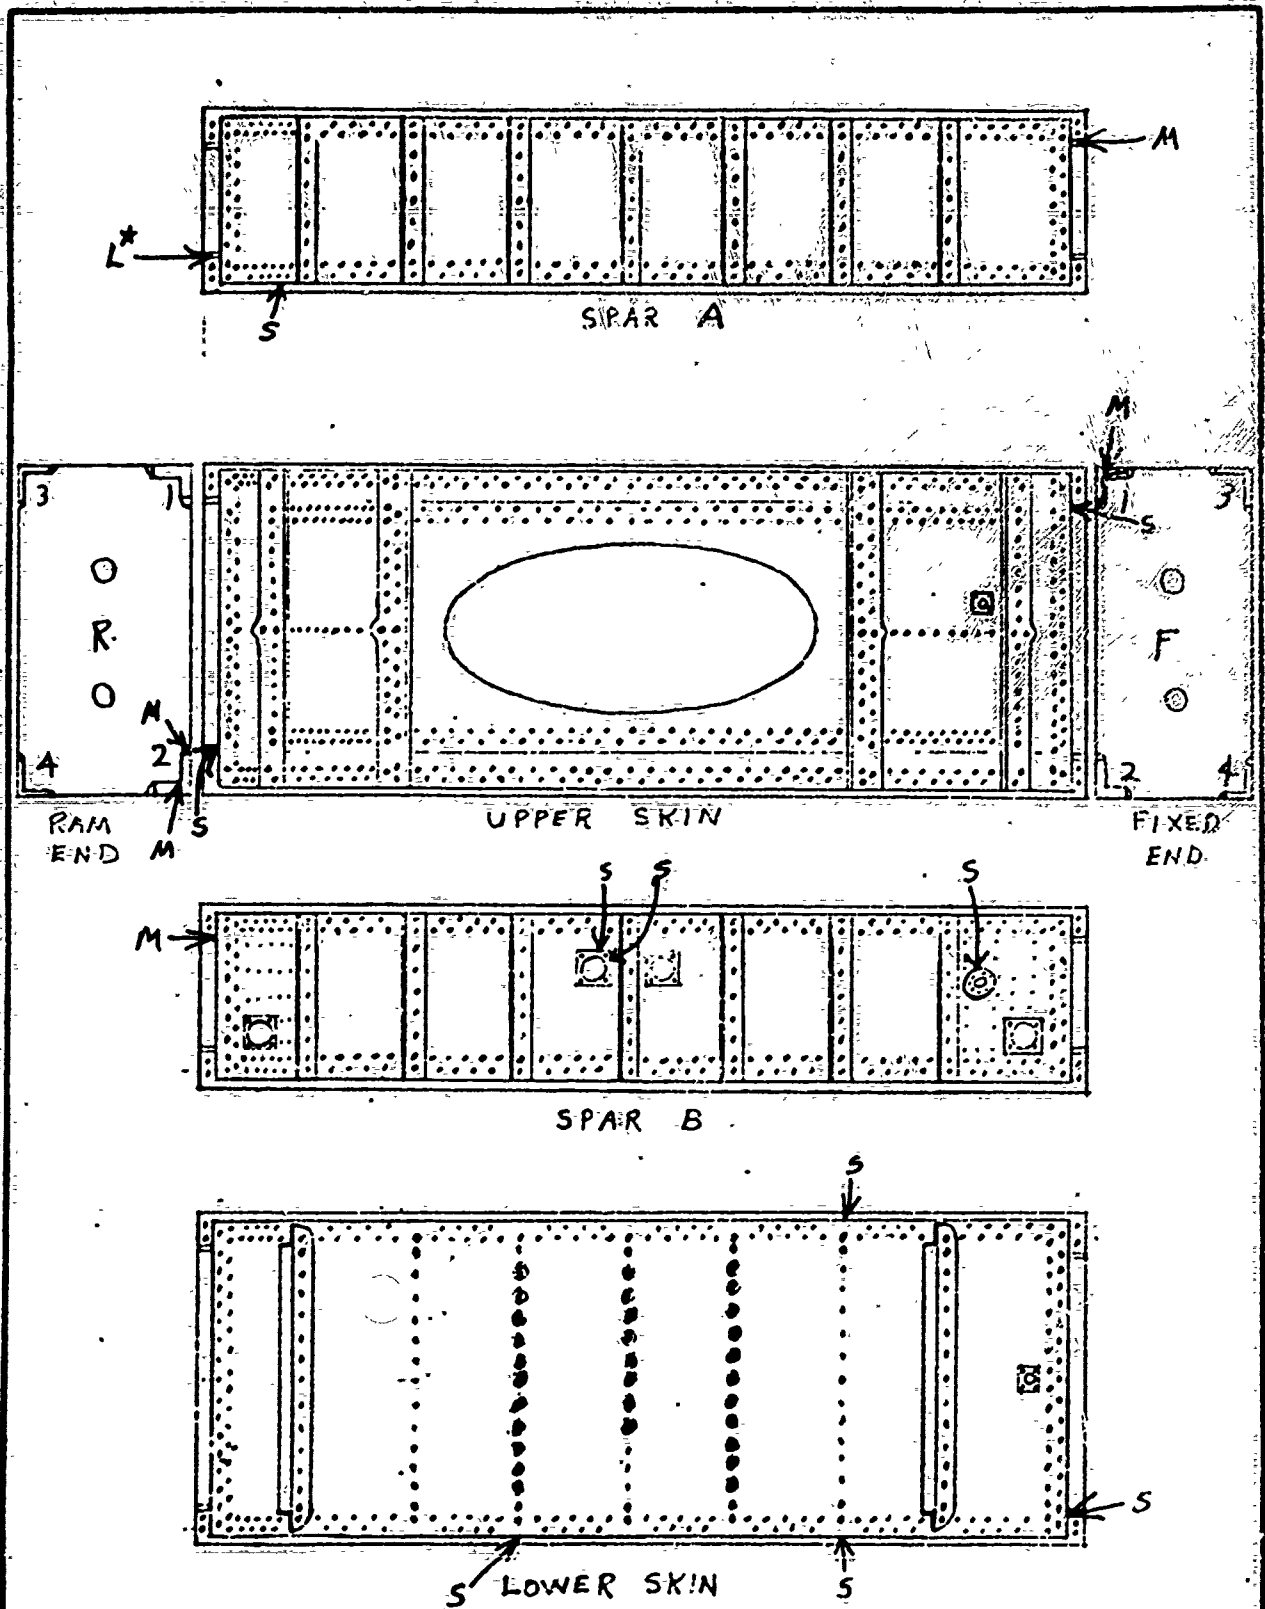
CALC		REVISED	DATE	TANK NO. 3 LEAKAGE TEST NO. 11 AFTER 39 ENVIRONMENTAL CONDITIONING CYCLES, PLUS LEAD CYCLING AT ALL 3 TEMPERATURES	
CHECK					
APR					
APR					
CONTRACT NO.				THE <b>BOEING</b> COMPANY <small>AIRCRAFT DIVISION - WILMOTA BRANCH</small>	
				03-8297 PAGE B-18 104.13

\* LEAKED STEADY STREAM WHEN FILLED WITH JP-4 ON TEST JIG | TESTED 8-16-72

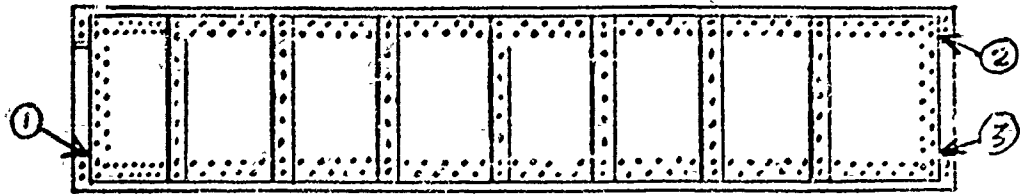
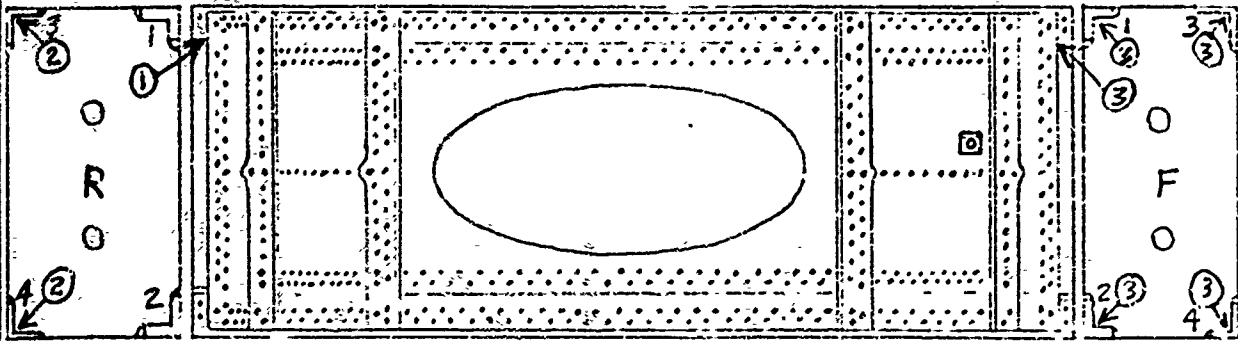
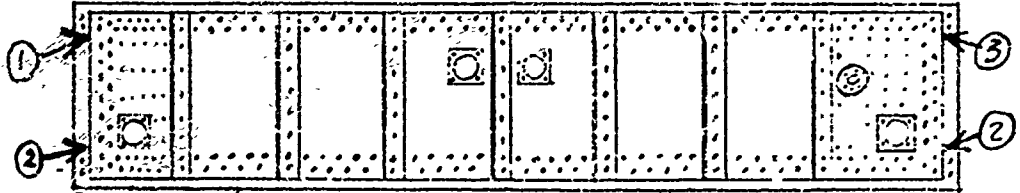
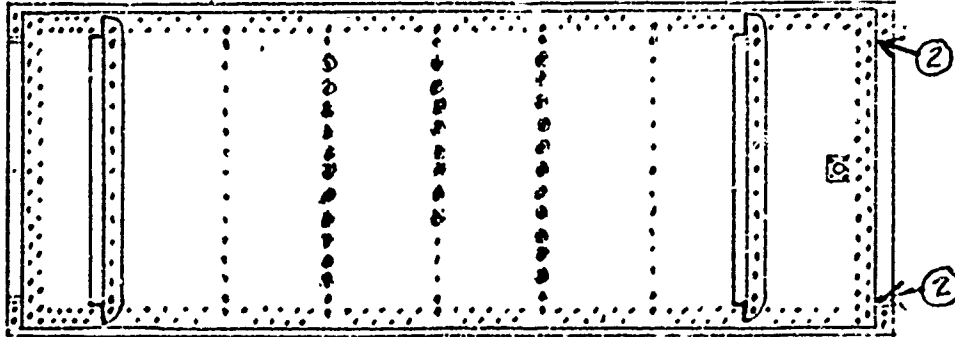
CALC			REVISED	DATE	TANK NO. 3 LEAKAGE TEST NO. 12	
CHECK					AFTER 46 ENVIRONMENTAL CONDITIONING CYCLES	
APR						D3-8297
APR						
THE <b>SPRING</b> COMPANY AIRPLANE DIVISION - OHIO BRANCH						PAGE 1
CONTRACT NO.						104.14

- ① LARGE LEAK
- ② SMALL LEAK
- ③ VERY SMALL LEAK

ENDS ONLY LEAK TESTED BY  
WATER IMMERSION - SPECIAL PROCEDURE ON 8-11-77

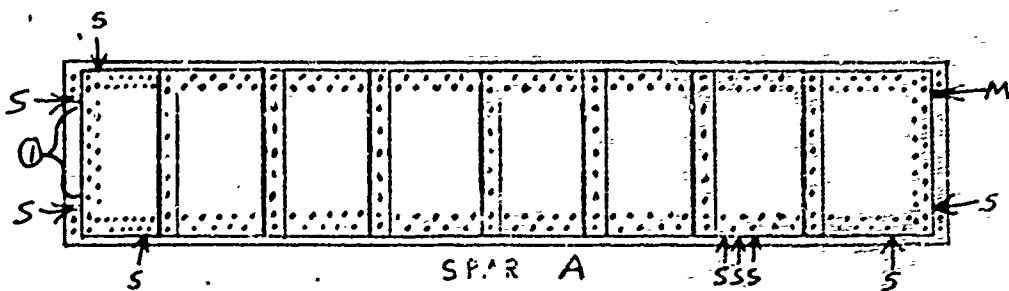
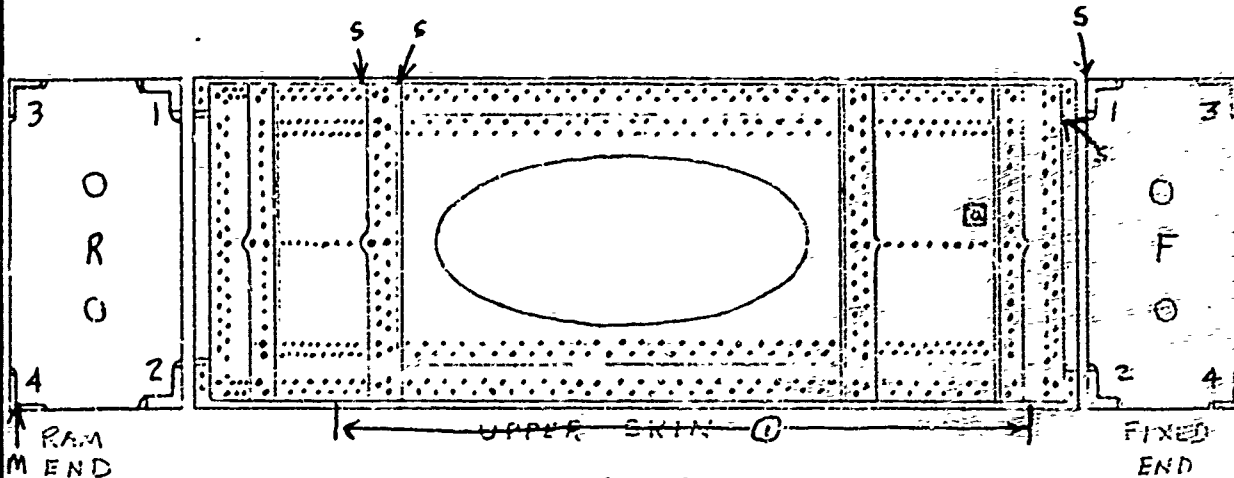
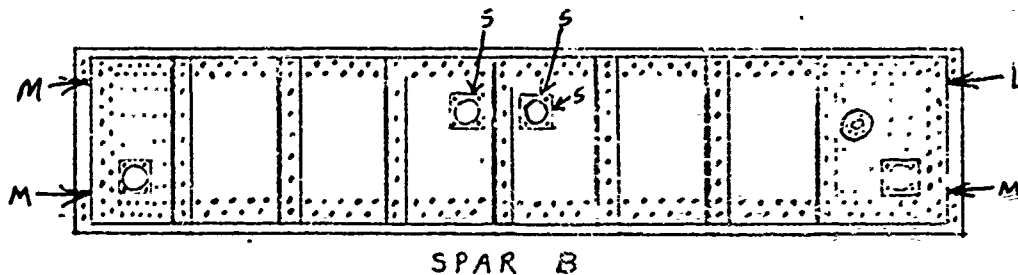
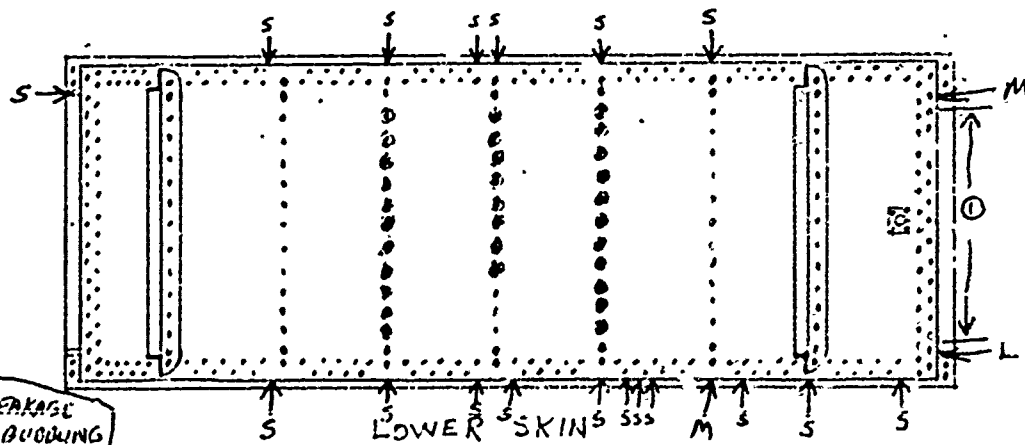
CALC	<i>Lur</i>	REVISED	DATE	TANK NO. 3 LEAKAGE TEST A.2. 12	D3-8297
CHECK				AFTER 54 ENVIRONMENTAL CONDITIONING CYCLES	
APR				PLUS LOADING AT ALL 3 TEMPERATURES	
APR					
CONTRACT NO.				THE <b>ADDERN</b> COMPANY <small>AIRPLANE DIVISION - 20100 DALLAS</small>	PAGE B-20 104.15

RELATIVE LEAKAGE  
 S=SMALL BUBBLING  
 M= MEDIUM "  
 L= LARGE "

① VERY SLIGHT BUBBLING, RANDOM  
 OVER LENGTH INDICATED

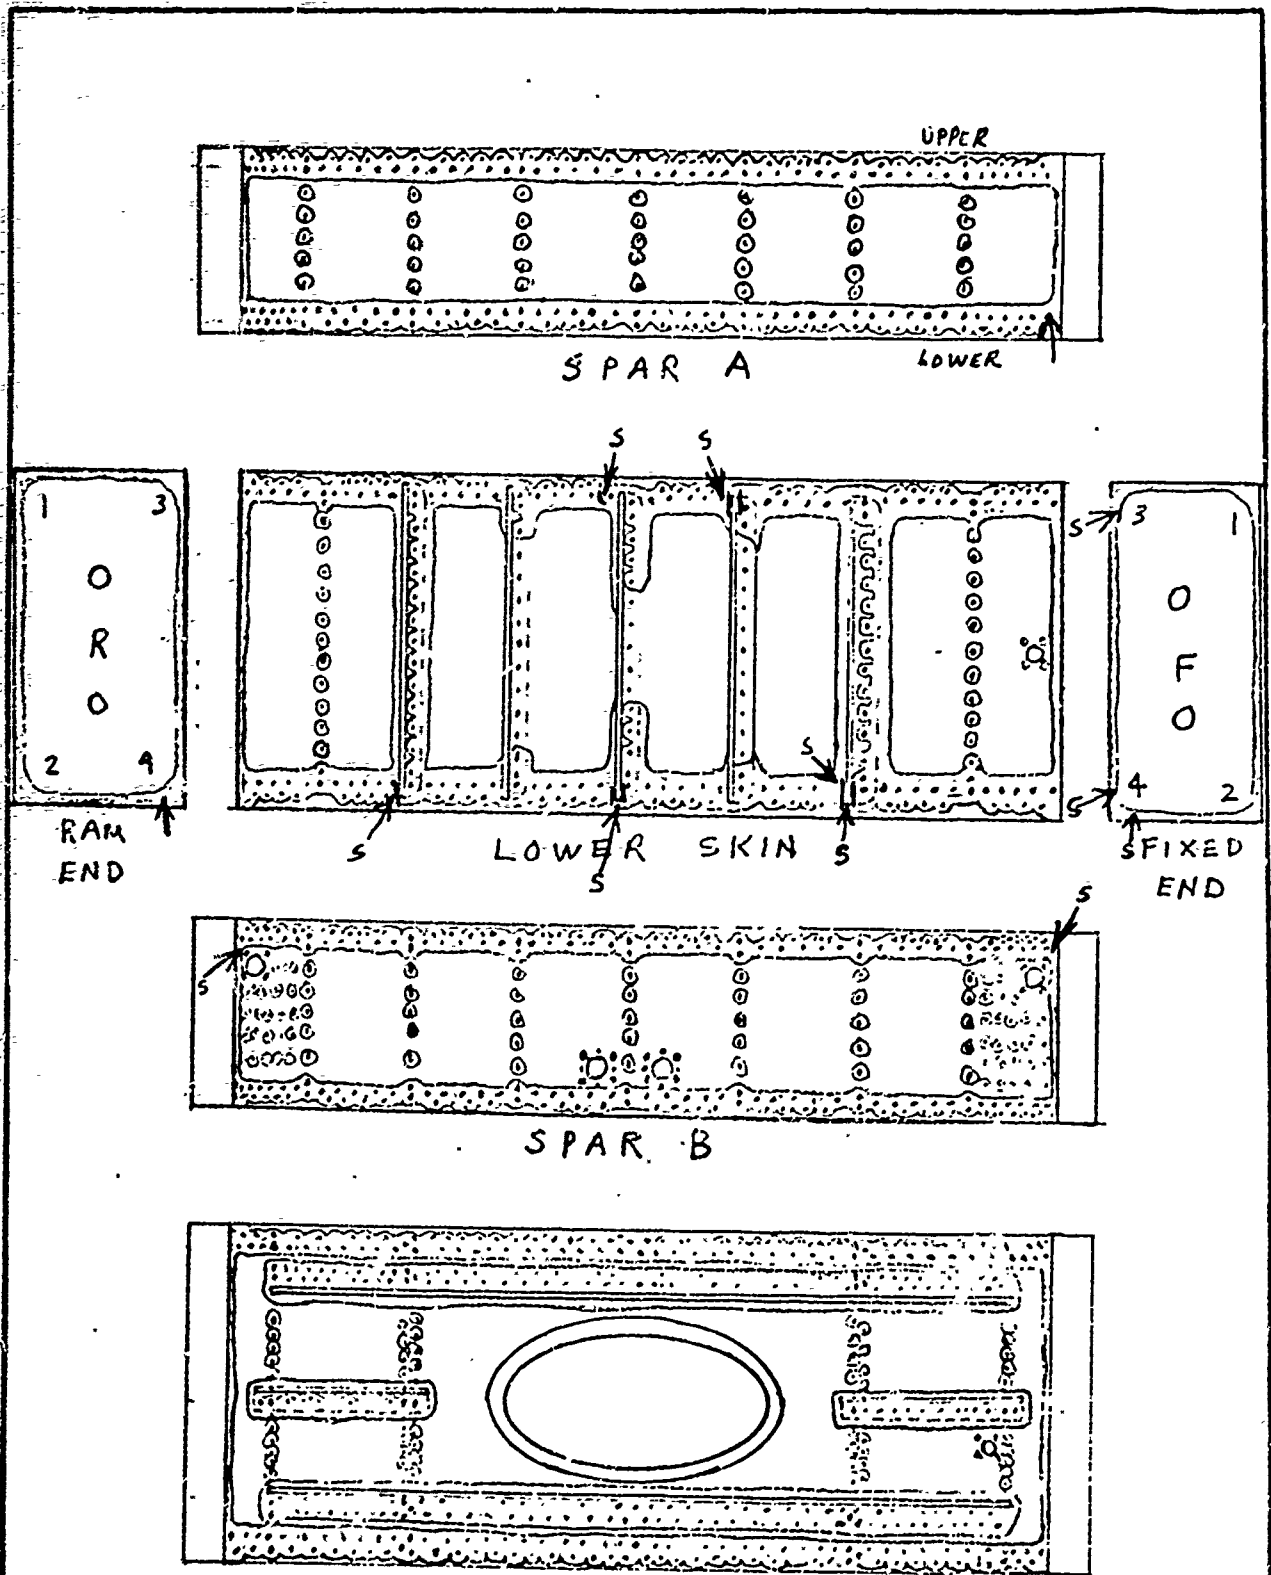
CALC	CHECK	APR	APR	REVISED	DATE	TANK NO. 3 INTERIOR LEAKAGE AFTER 54 ENVIRONMENTAL CONDITIONING CYCLES PLUS LOADING AT ALL 3 TEMPERATURES	03-8297
						THE <b>INTERNATIONAL</b> COMPANY AIRPLANE DIVISION WICHITA BRANCH	PAGE 5-21 104.16
CONTRACT NO. REV. D

S=SMALL BUBBLING  
 M=MED. "  
 L=LARGE "

→ INTERIOR LEAKAGE-WATER BUBBLING  
 THROUGH 3PSI VACUUM

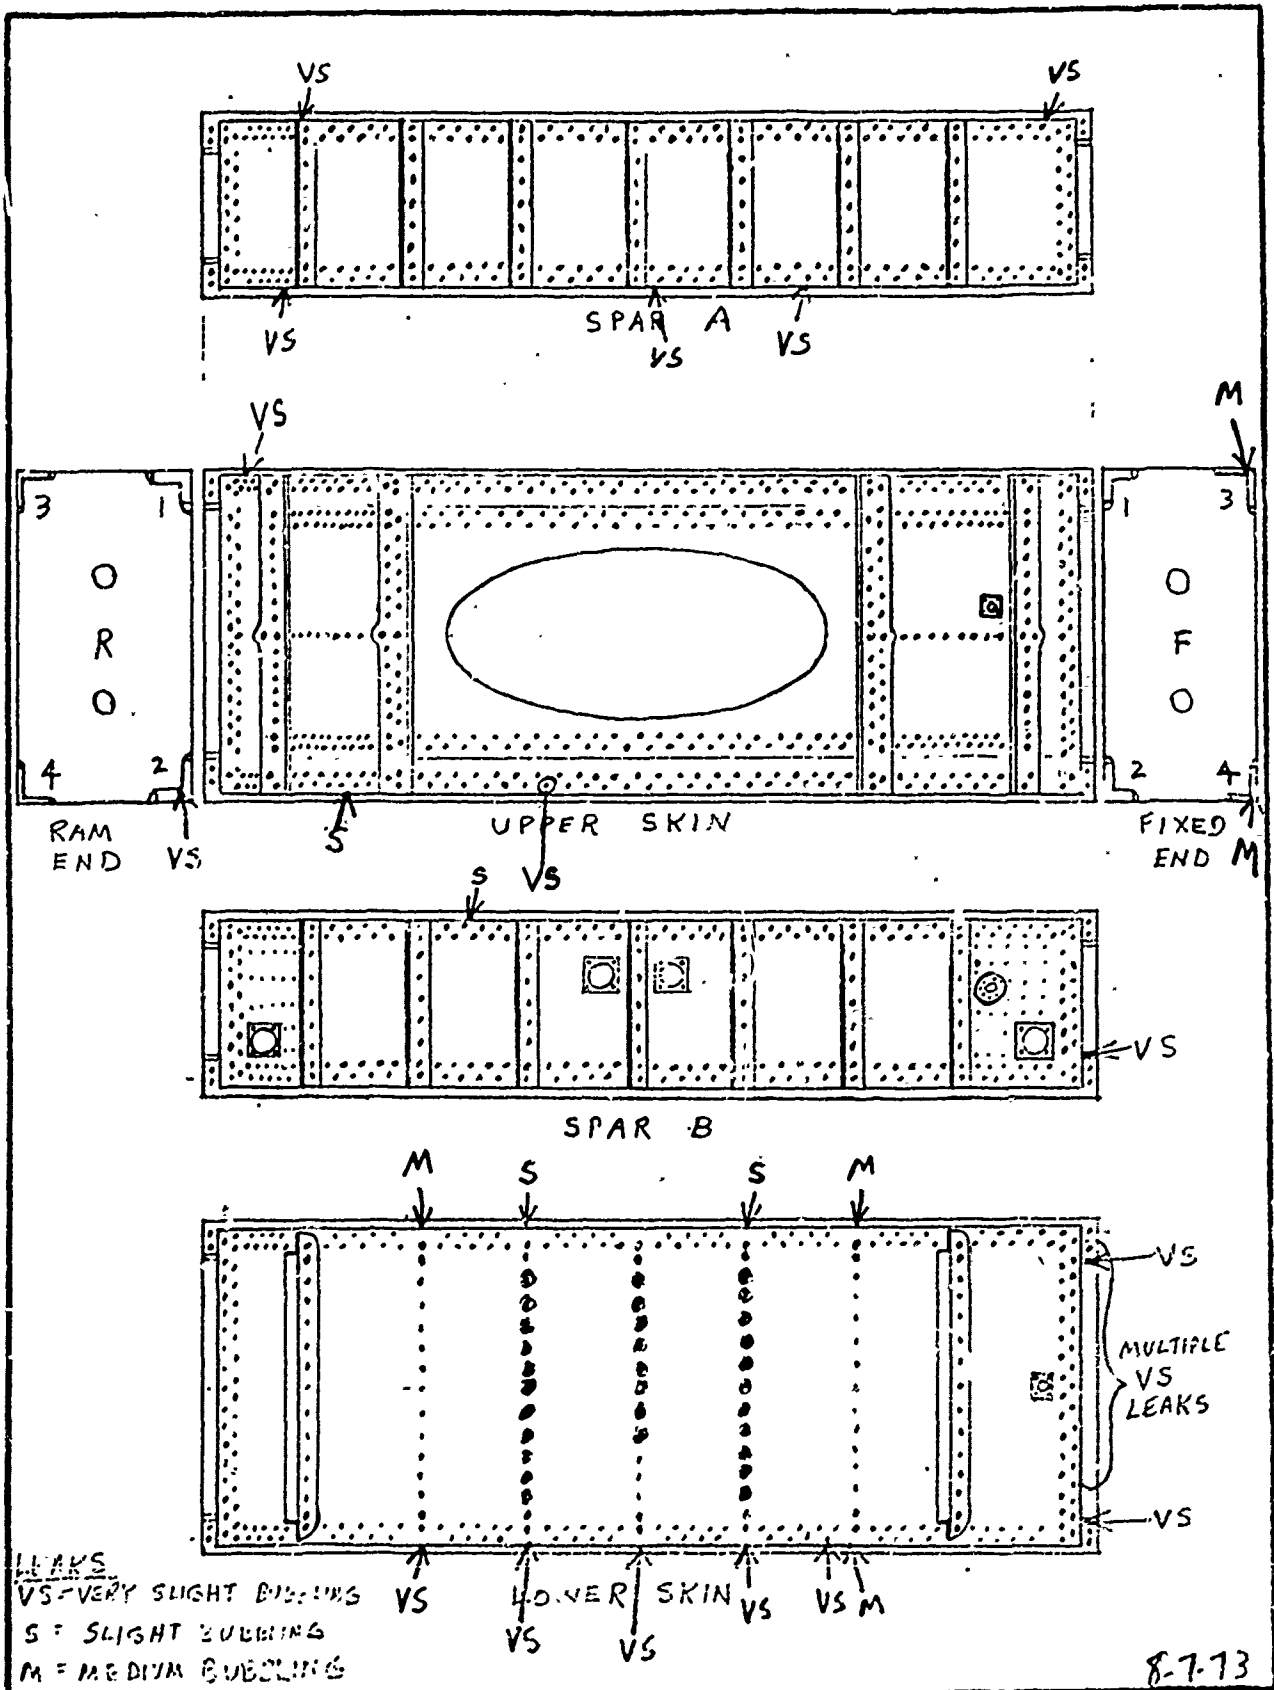
CALC		REVISED	DATE	TANK NO. 5 LEAKAGE TEST NO. 1	
CHECK				A. I. D. 14 EXPERIMENTAL CONDUC-	
APR				THE BROWN COMPANY	03-8297
APR				THE BROWN COMPANY	PAGE
CONTRACT NO.					2-22

LEAKS  
 VS = VERY SLIGHT BUBBLING  
 S = SLIGHT BUBBLING  
 M = MEDIUM BUBBLING

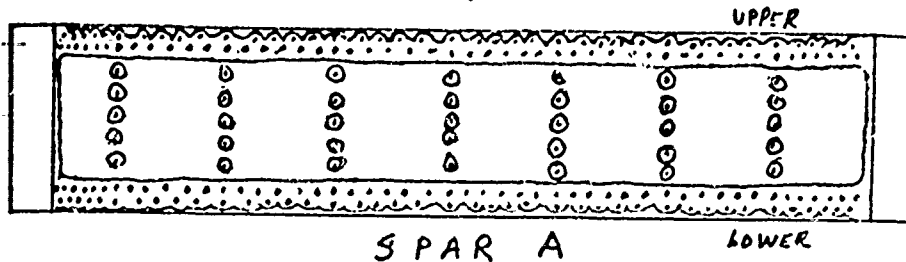
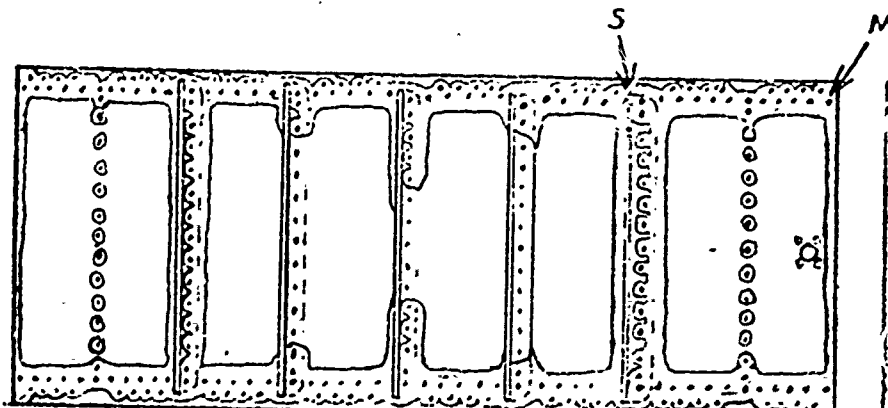
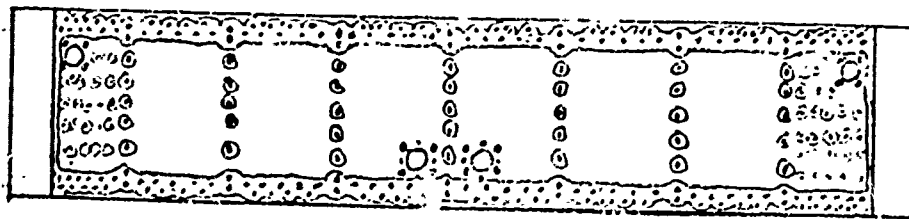
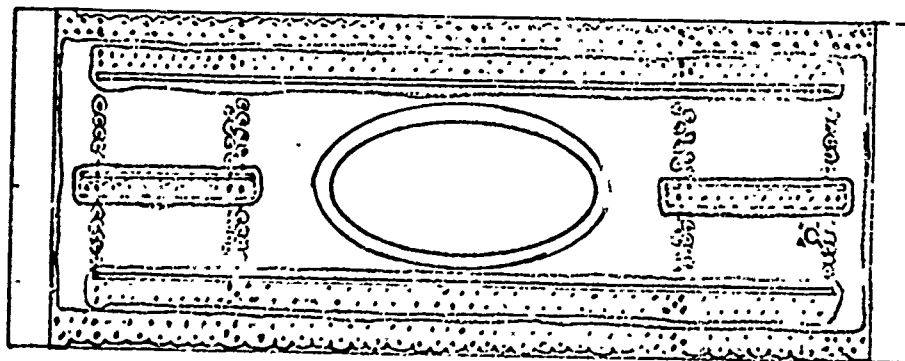
CALC	CHECK	APR	APR	REVISED	DATE	TANK NO. 3 INTERIOR VIEW 1 DAY AFTER 7 ENVIRONMENTAL CONDITIONING CYCLES BY LIAISON FT 3	03-8297
						THE <b>BOEING</b> COMPANY APPLIANCE DIVISION - WILMOTA BRANCH	PAGE B-23
CONTRACT NO. REV. B							104.18

LEAKS

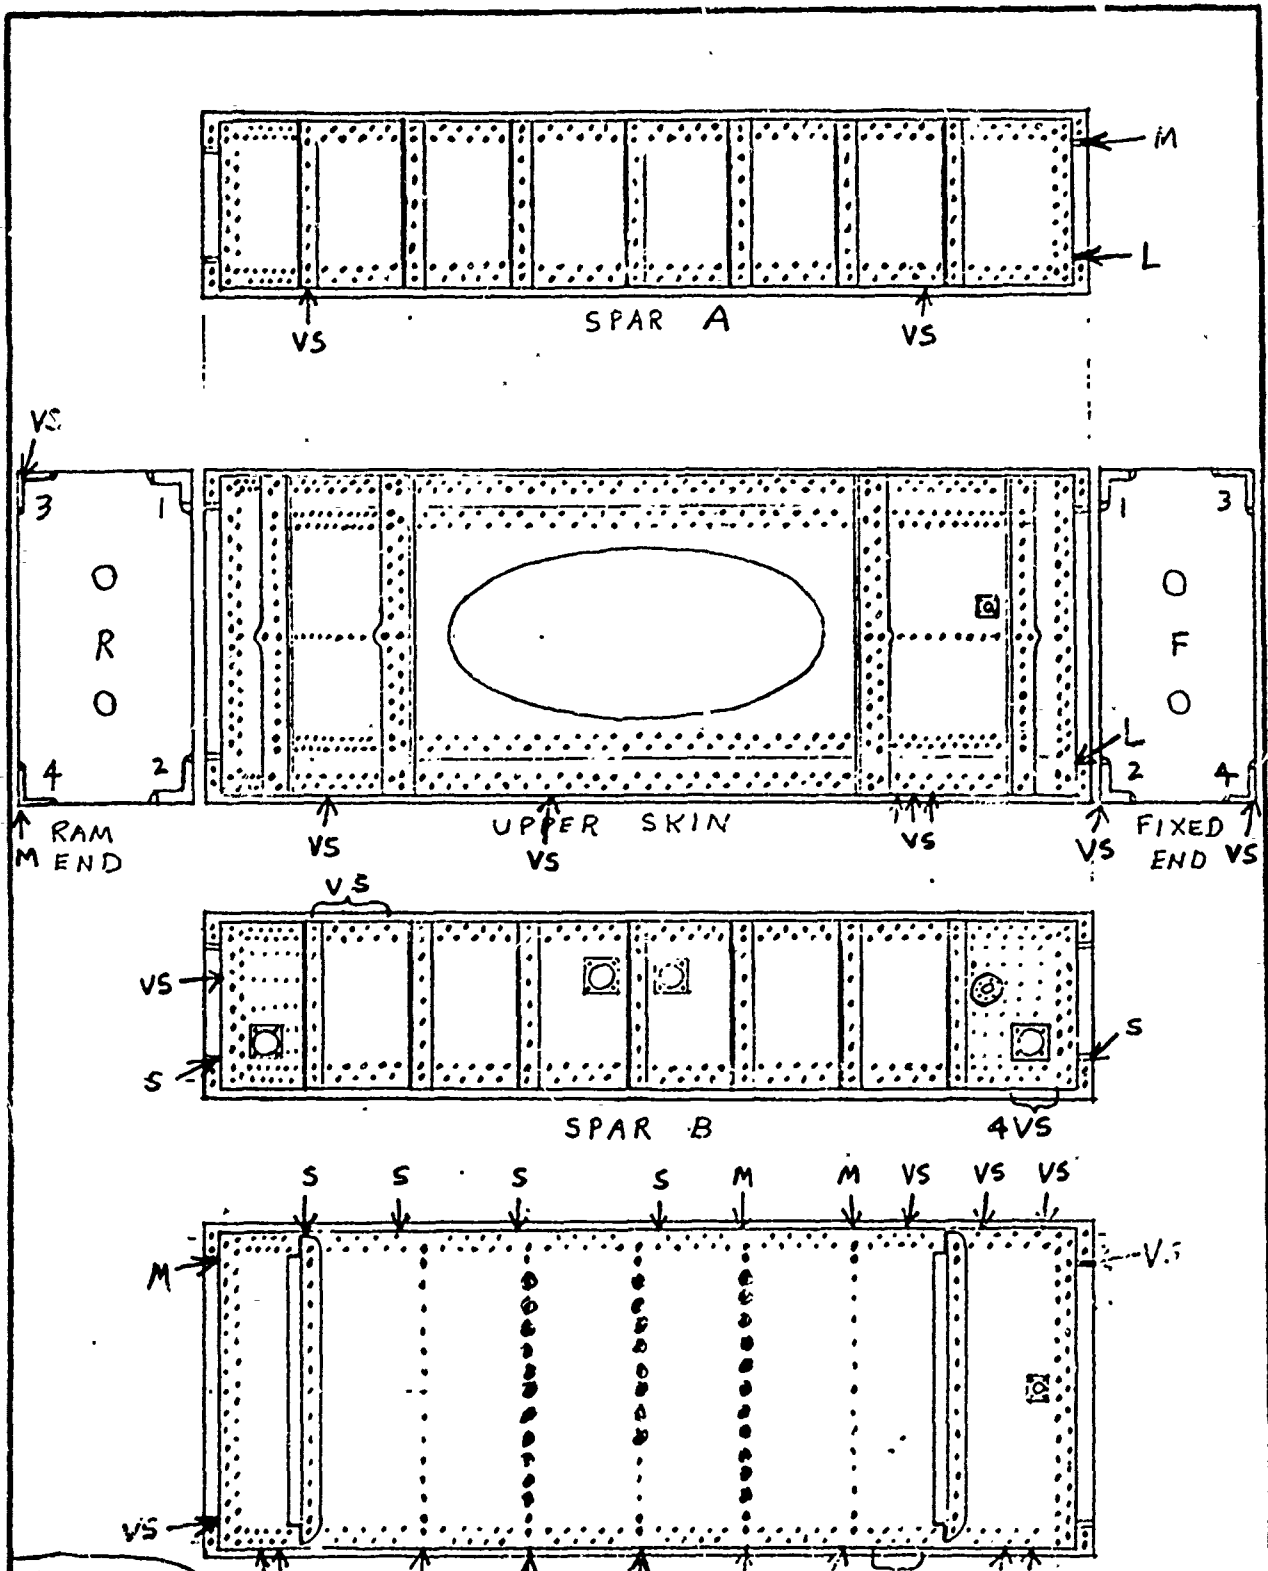
CALC		REVISED	DATE	TANK NO. 3 LEAKAGE TEST NO. 14	
CHECK				AFTER 92 ENVIRONMENTAL CONDITIONING	
APR				CYCLES	
APR					D3-8297
THE <b>BOEING</b> COMPANY AIRPLANE DIVISION - RICHMOND BRANCH					PAGE
CONTRACT NO.					B-24

LEAKS

VS - VERY SLIGHT BUBBLING  
 S - SLIGHT BUBBLING  
 M - MEDIUM BUBBLING  
 L - LARGE BUBBLING

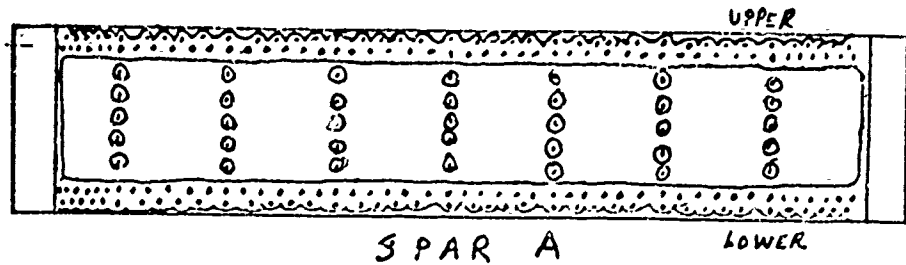
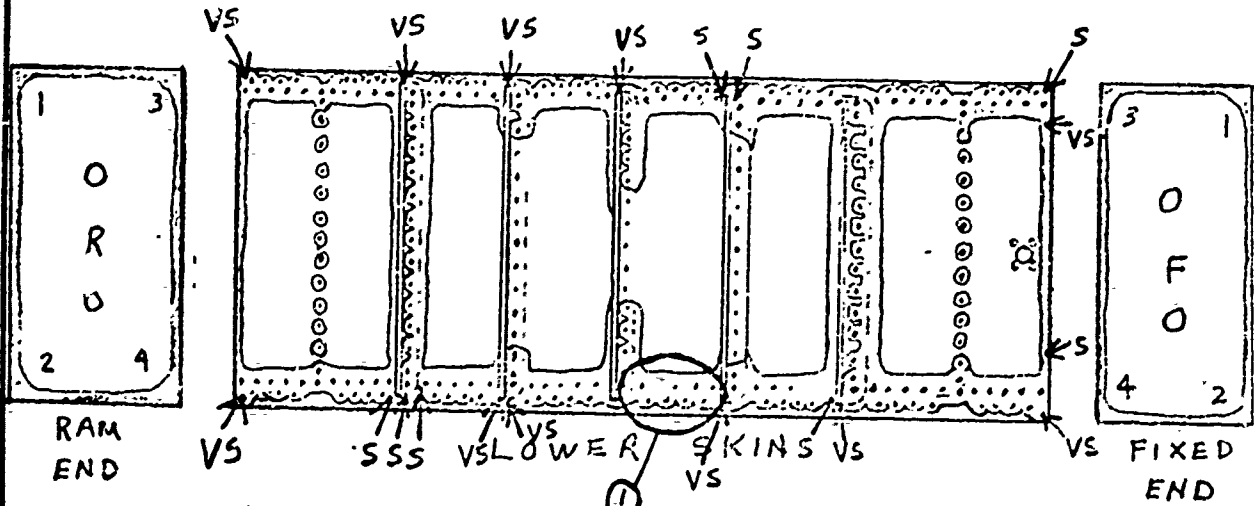
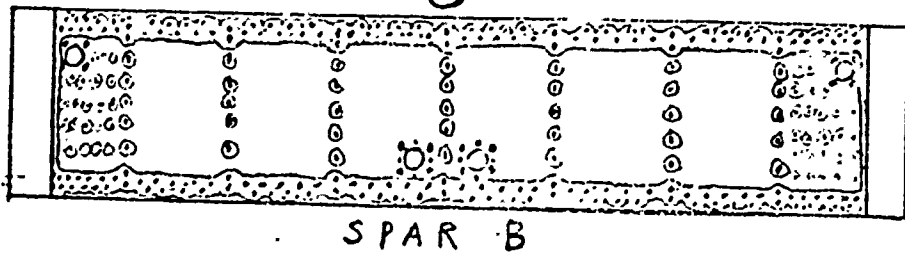
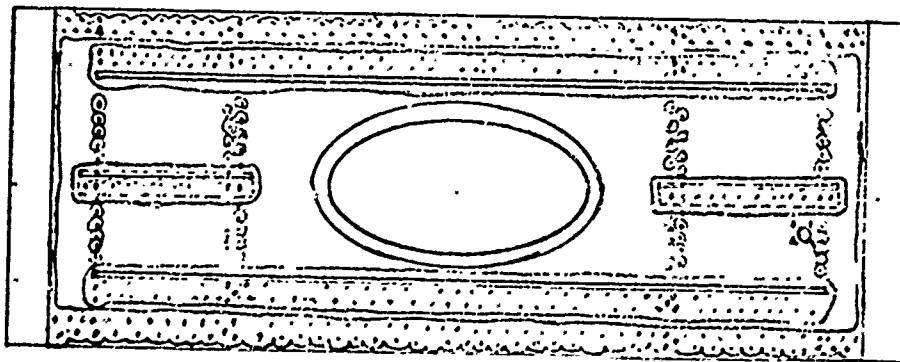
CALC			REVISED	DATE	TANK A, B INTERIOR VIEW LEAKAGE AFTER 92 ENVIRONMENTAL CONDITIONING CYCLES	
CHECK						
APR						
APR						
CONTRACT NO. REV. 3					<p>THE <b>GENSLER</b> COMPANY AERIAL TUBING - WHITE BRANCH</p>	03-8297
						PAGE B-25

LEAKS

VS- VERY SMALL BUBBLING  
S- SMALL BUBBLING
