NWC TP 5921

# Reduction of Fuel Fire Cook-Off Hazard of Rocket Motors

by  
Ronald F. Vetter  
*Propulsion Development Department*

JUNE 1977

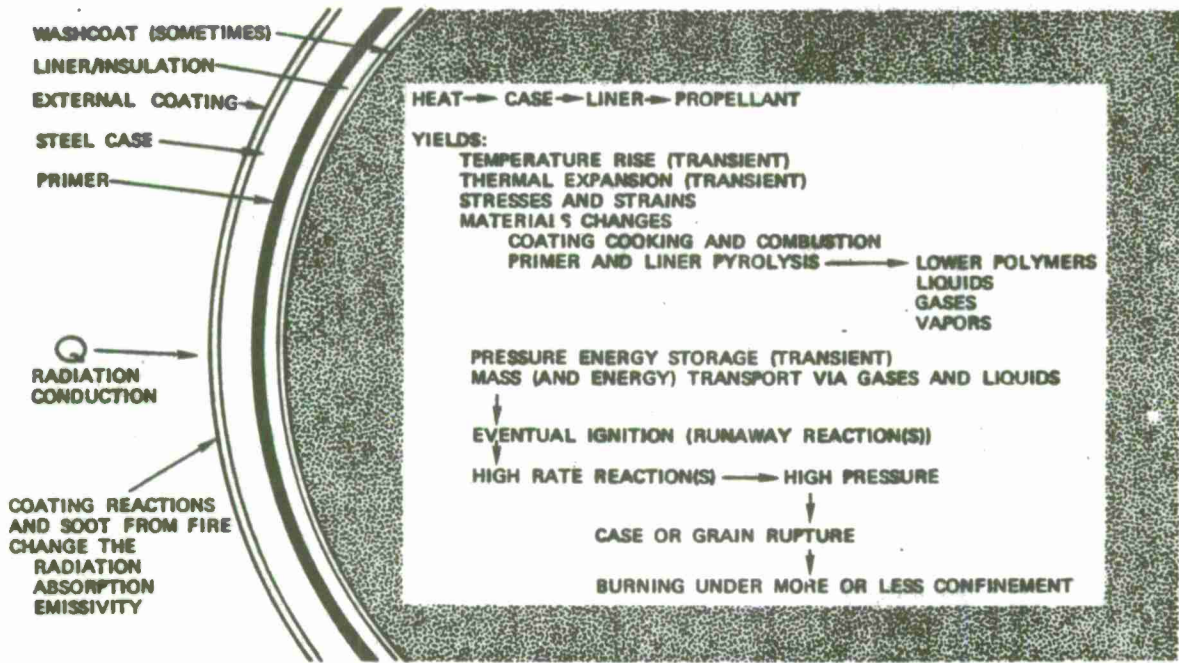
Figure 1 was prepared in an attempt to provide a concise expression of the complex cook-off situation. Briefly, the primary process is energy transport from the heat of the fire into the rocket motor until various simultaneous transport processes create mechanical failure. The propellant's high energy is released by combustion which occurs wherever the temperature and pressure exceed a threshold. Some energy is released (exothermic) without ignition and some energy is absorbed (endothermic) in addition to raising the temperature of the materials. The following detailed sequence assumed a relatively clean (not foaming or charring) separation of liner from the motor case wall. (Such a separation is believed beneficial and will be discussed in detail later.)

FIGURE 1. Sequence of Cookoff Process.

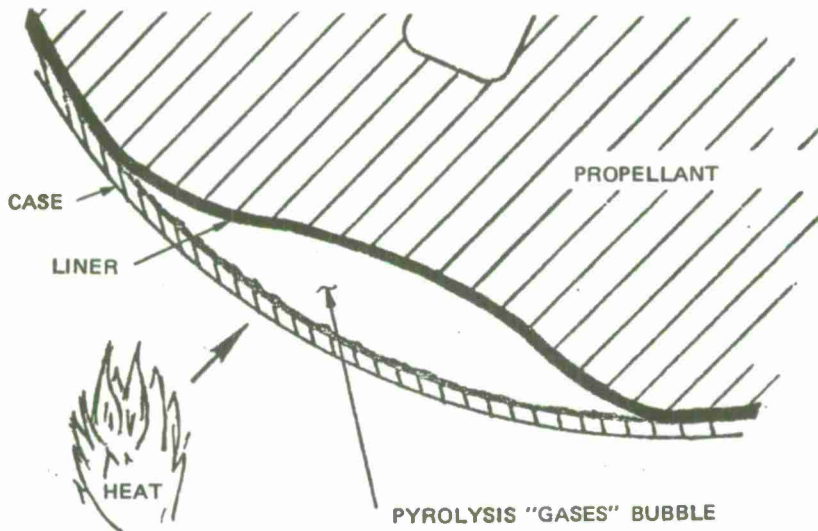
FIGURE 2. Cross Section of Case After Pyrolysis Gases Have Been Generated From the Case Primer and a Part of the Liner. Note that the pyrolysis gases bubble forms on the bottom part of the case in a fire and that clean separation is typical of liner which does not form an adhesive char. The hotter surface of the liner will be liquidus (melting) and a boiling heat transfer exists for a time on the inner wall of the case into the bubble.

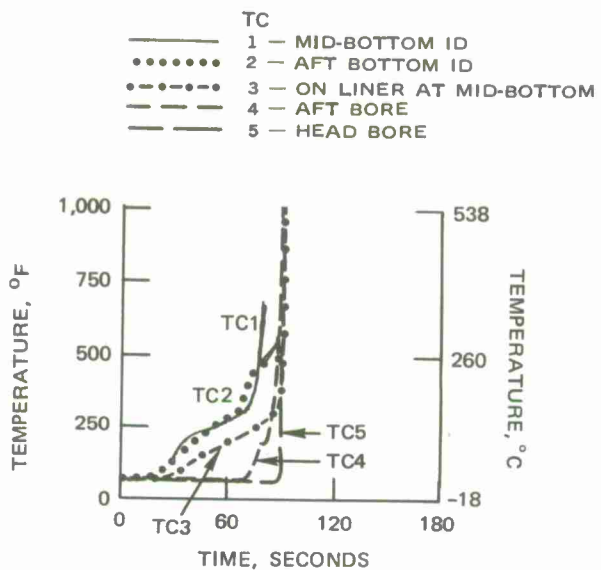
The fire was good; all flame thermocouples reached 538°C (1000°F) at 17 to 21 seconds. Thermocouples located on the fiberglass tube ID (midsection and about one-fourth toward the aft end) started rising at 10-12 seconds. They showed a faster temperature rise rate at about 65 seconds and 149°C (300°F). This temperature may correspond to the unbonding of liner and increasing decomposition of the case polymer. Figure 7 shows the temperatures. It appears that the liner/propellant temperature, 155°C (312°F), at 88 seconds (about the time a loud burning noise was first heard) was much below the ignition temperature.

FIGURE 7. Cook-Off of 23.5 cm Diameter Fiberglass Simulated Motor.

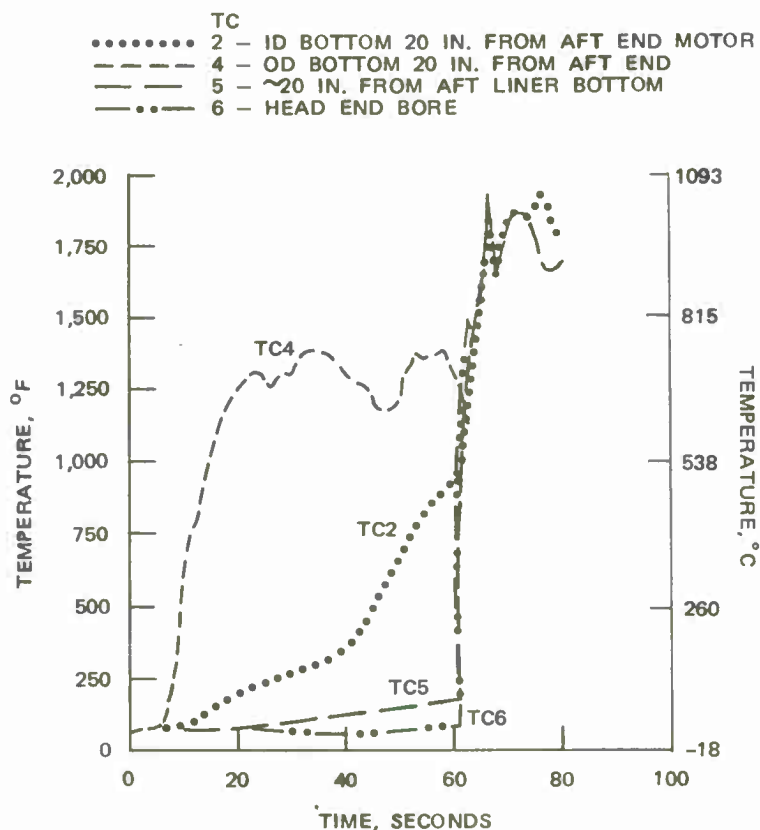
The three thermocouples on the case wall bottom ID showed similar temperatures. All temperatures began to rise at about 9 seconds, reached 400°C (750°F) at about 50 seconds, were near 480°C (900°F) at 60 seconds, and then rose sharply (see Figure 9). All the test-item-connected thermocouples indicated fast rate changes at 62 seconds. Ignition (per sound, television and movies) apparently occurred at 56 seconds; there was a noise (pop) and burning sound at about 58 or 59 seconds with the sound level increasing soon thereafter. Thus, the probability is that the thermocouples were torn loose at approximately 61 seconds. The motor case remains were directly below the original location (Figure 10).

FIGURE 9. Mk 52 (LR-13 Liner/RV-13 Propellant) Temperatures During Cook-Off.

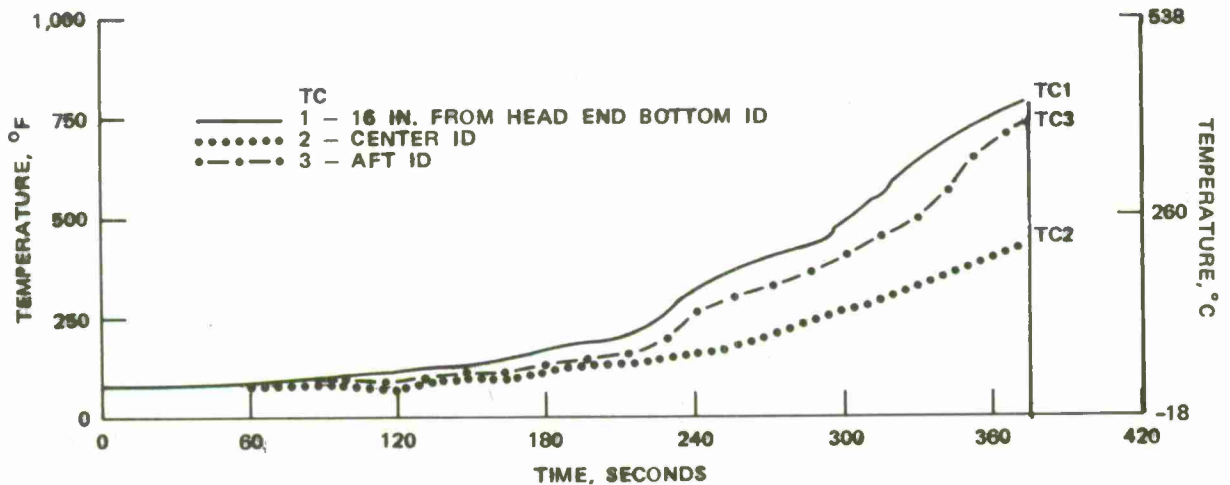
FIGURE 11. Case Inside Diameter Bottom Temperatures During Cook-Off.

Deflagration (pressure rupture) occurred at 375 seconds. The fire never reached the MIL-STD-1648 requirement since the highest peak of flame temperature was only 650°C (1200°F) per the thermocouples near the item. The case tears were full metal thickness (not stretched skin) and yielded fifteen pieces with little remaining of the head or aft domes (see Figure 12). One large chunk of propellant left the pit itself and burned near the cage wall. Propellant burned from approximately 380-400 seconds, which indicates relatively large chunks. The single liner/propellant interface thermocouple showed 133°C (272°F) at 375 seconds (Figure 13), but the center bottom was less heated than the fore and aft regions. As is often the case, the aft bore temperature rose fairly rapidly, leading to ignition. This is assumed to be hot pyrolysis product gases leaking around the aft grain end and is believed to be the proximate cause of ignition.

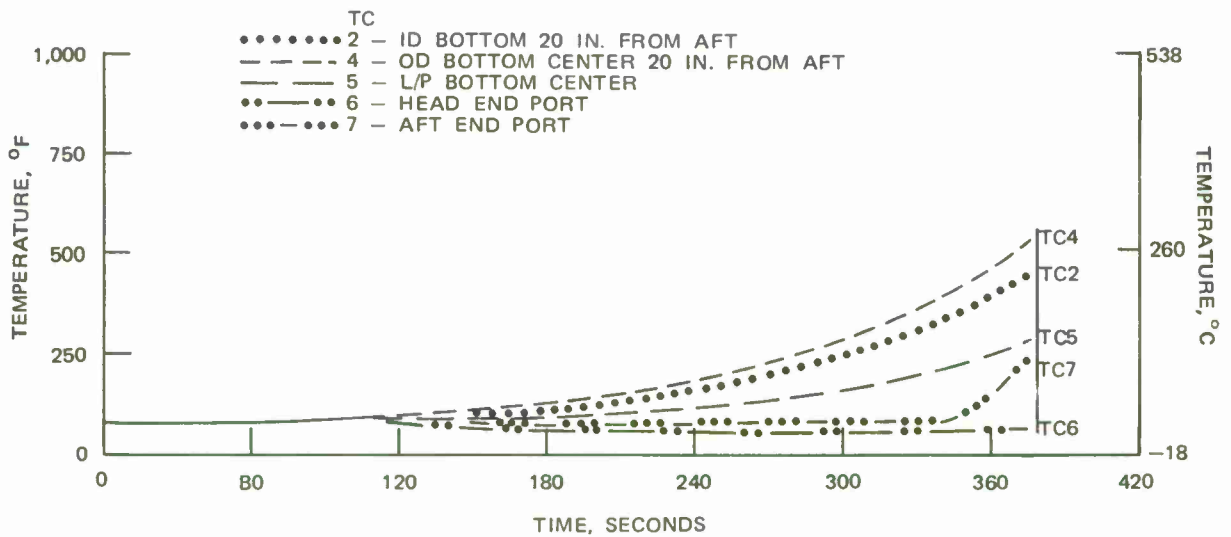
FIGURE 13. Temperature During Cook-Off of Mk 52 Case With CTPB Liner.

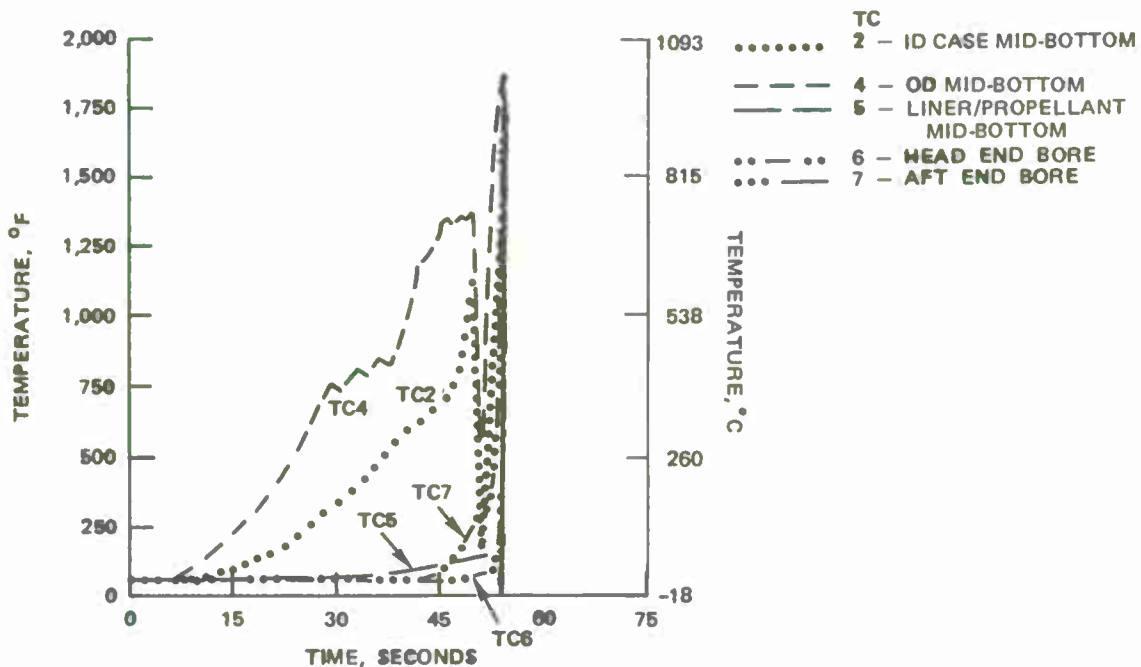
The case ID thermocouples at the head end and middle indicated above 427°C (800°F) (with fast increasing temperature preceding) at 49 seconds and a jump at 50 seconds. The more aft thermocouple rose rapidly from 478°C (892°F) at 49 seconds to 688°C (1270°F) at 51 seconds, 967°C (1773°F) at 52 seconds, 1226°C (2238°F) at 53 seconds, and then dropped very low. This might have been due to flame in the aft case area burning off the thermocouple wires. The case OD thermocouple at mid-bottom seemed reasonably true until 50 seconds, but was no good at 51 seconds; which might mean case motion at that time. The liner/propellant temperature at mid-bottom jumped after 54 seconds when it reached only 69°C (156°F). The head and aft ends of the bore show temperature jumps between 53 and 54 seconds, leading us to believe that the rupture of the case into three pieces occurred at about 54 seconds. However, a bulge and leak and/or ejection of the nozzle plug (silicone potting around wires and tubing) occurred at 49+ seconds when the chamber pressure peaked (545 kPa (79 psi) per oscillograph) and dropped rapidly to zero, then built up to 110 kPa (16 psi) at 54+ seconds before dropping again to zero. It is therefore conceivable that the nozzle seal broke loose (leaked) at 545 kPa due to pyrolysis gases from the liner (?) entering the aft end of the grain (see Figure 14 which shows the aft bore temperature rising from 40 seconds). The aft bore temperature hovered at about 135°C (275°F) for several seconds starting at 50 seconds (when the chamber pressure dropped) at which time we can see first activity in the forward bore temperature. Grain bore ignition occurred at 54 seconds with head end trailing aft end, corresponding to the television-visible fire spreading all around at 54 seconds.

FIGURE 14. Temperatures During Cook-Off of Mk 52 With LRV-1 Liner.

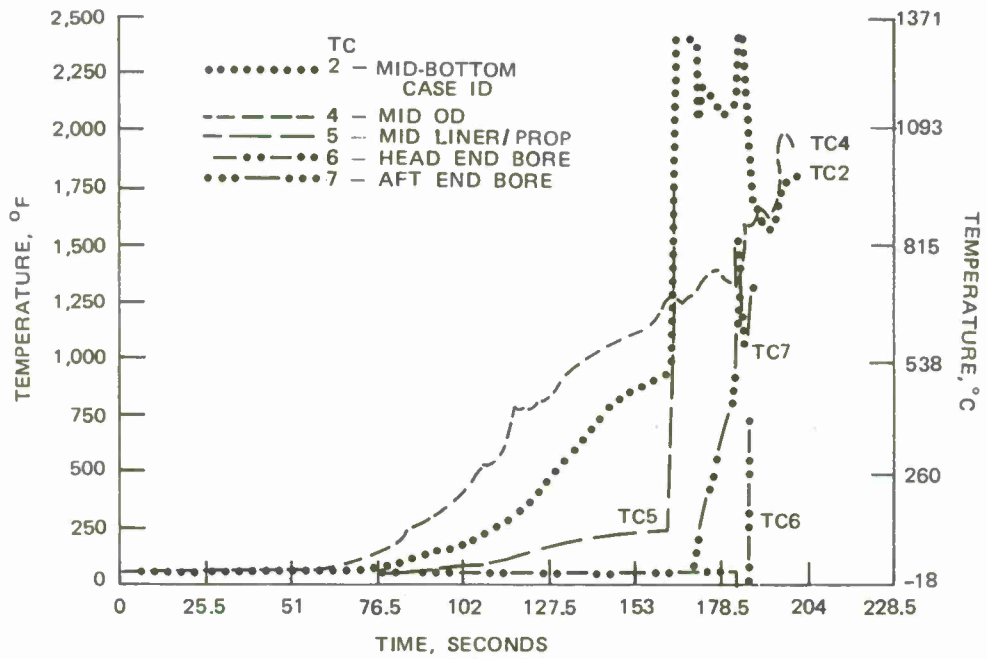
There was a mild breeze when this unit was tested. The unit was exposed to 600 gallons of burning JP-5, but the breeze had only a mild effect. However, a delay (after adding the regular gasoline (starter) to the rags with their squibs) for the purpose of recalibrating the computer led to a slow ignition. A temperature of 538°C (1000°F) was reached at 101-129 seconds and initial ordnance reaction occurred at about 160 seconds when flame temperatures were below 815°C (1500°F). The initial reaction was a low level sound increasing over several seconds to the usual low pressure propellant burning noise at 170 seconds. A visible eruption and increased burning were noted at 184 seconds with burning noise until about 200 seconds. Post-test inspection revealed that the aft end of the motor had burned through (Figure 16), then the nozzle and grain ejected. The ejection pressure was sufficient for the nozzle to make a small dent in the 3 mm witness plate, but the motor tube was propelled much more forcibly by the propellant and the dummy warhead pierced a witness plate, bent its support frame and lifted the plate around (pivoted approximately 90 degrees when hit on one end). Thermocouple data indicate the case ID was near 538°C (1000°F) at first reaction with flame exposure at 164 seconds. The liner/propellant bondline thermocouple also showed a similar response at the same time. This may mean that the initial propellant burning was in the vicinity of these thermocouple leads (considered likely) and not all along the tube ID bottom. The aft bore temperature started rising at 170 seconds (when burning noise was established) and jumped at 183 seconds while the head end bore temperature showed an increase of 17°C (30°F) at 138 seconds and went negative at 184 seconds (Figure 17). This means internal bore ignition from aft end gases and nozzle ejection occurred at 184 seconds.

FIGURE 17. Temperatures During Cook-Off of Mk 36/50 With HTPB Liner.

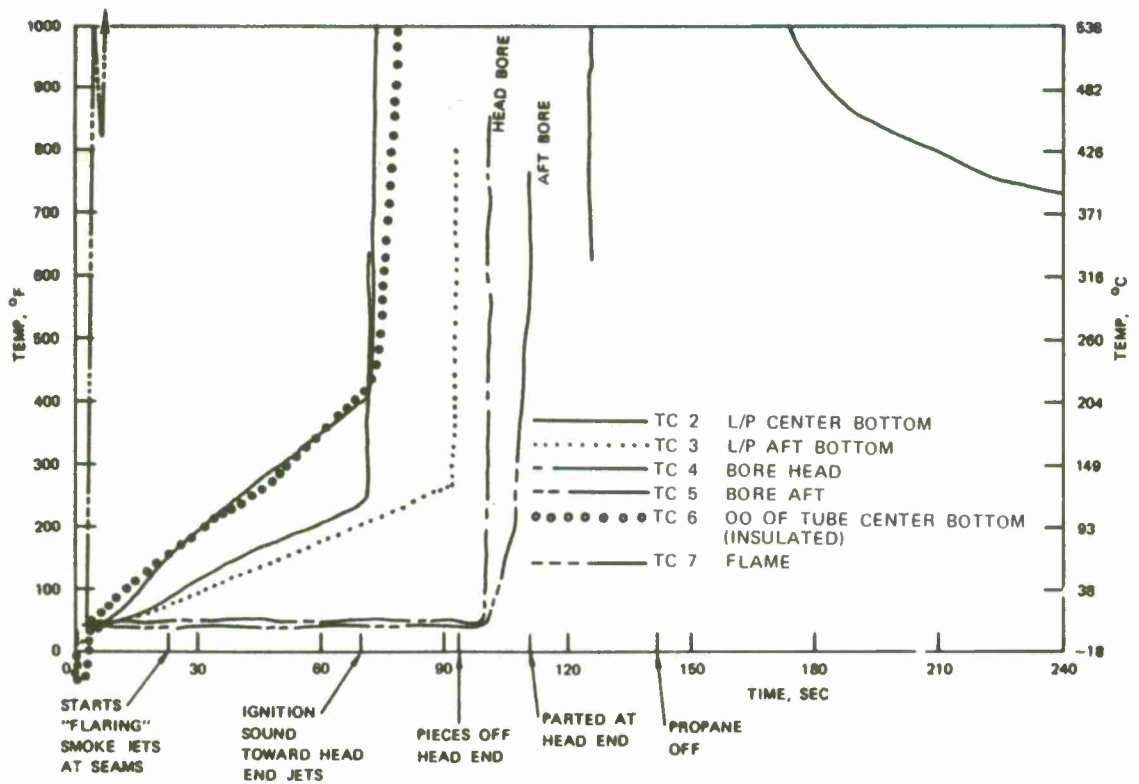
Test of 0.25 mm by 10-cm-wide spiral wrapped bonded steel shim (Rapier type) 13 cm diameter "motor" resulted in mild deflagration, as expected; i.e., the unit burned in place with low pressure and no pressure vessel burst. Thermocouple data are shown in Figure 20. A high speed movie shows the formation of smoke jets from numerous places as the case adhesive decomposed. Eventually, propellant ignition occurred on the grain outside diameter. This resulted in gas that cut the shimstock and enlarged holes, as well as causing unraveling of the shimstock on [ne end. The bore, reached by burning through the web, was then ignited and the case soon separated from one end closure. Two motor end pieces plus a dozen pieces of unwrapped shimstock were all that remained (see Figure 21). This test, using the unique construction in a closed vessel configuration, indicates that this motor case fabrication method can provide ordnance which will "burn" per MIL-STD-1648(AS) in a fuel fire.

FIGURE 20. Temperatures During Cook-Off of HTPB Lined Low Smoke Propellant Loaded Steel Shim Spiral Laminated Rocket Motor.

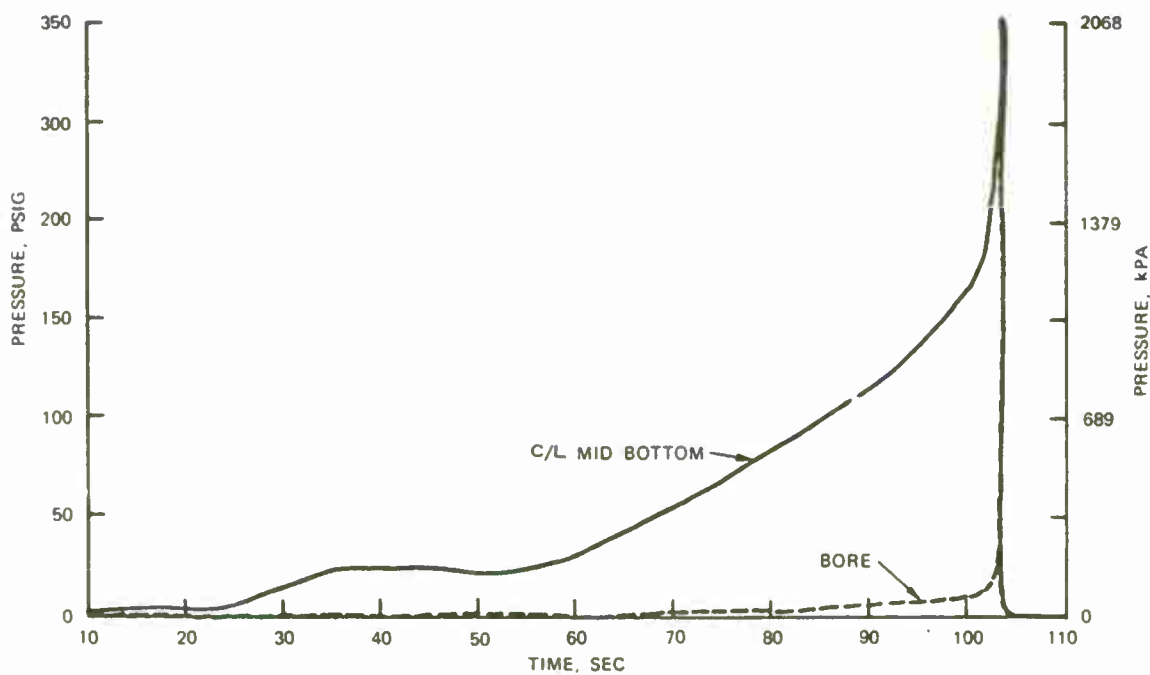
A 10-cm-diameter model motor, lined with HTPB based liner containing oxamide and cast with low smoke HTPB propellant, was tested in the propane/air burner facility. Figure 22 shows the thermocouple data obtained and Figure 23 shows the bore and liner/case midbottom casewall pressures monitored during the cook-off. The vagaries of the thermocouple readings are believed due to eventual thermal flow to junctions in some of the thermocouples. These junctions were necessary due to severing during lining operations. No movie coverage was obtained because the film broke; however, video tape records were obtained. The failure mode was again structural loss of the flat end of the model motor and ejection of the grain. The oxamide/HTPB liner showed gas pressure at 25 seconds with a maximum thermocouple temperature of 232°C on the case ID. The polyether liner gas pressure rose a bit at 38 seconds when 343°C was seen by one case ID thermocouple. There was much more pressure (more gas formed) from the oxamide filled liner. Case rupture (end plate ejection) occurred at 104 seconds for the oxamide filled liner at 2.1 MPa, per the slow response gauges. (The polyether-polyurethane-lined unit had a maximum pressure of 1.4 MPa and failed at 58 seconds.) Neither case showed steel stretching although the oxamide-HTPB-lined case ID maximum thermocouple temperature was 660°C. Figure 24 is the oscillograph pressure traces at rupture.

It is difficult to do more than conjecture that some propellant surface area ignited at about 101 seconds (see Figure 23) and that the movement of the grain (allowed by failure of the closed end) toward the rupturing end allowed gas to enter the bore. Pressure on the grain OD caused it to deform inward and against the aft (open bore) end taper. Failure of the closed end then would vent the forward end pressure, providing the force to hold the grain against the aft closure. This means that the case failed before the gases leaked into the bore, i.e., the bore was not ignited prior to failure.

FIGURE 23. Pressures of Bore and Liner/Case Mid-Bottom During Cook-Off.

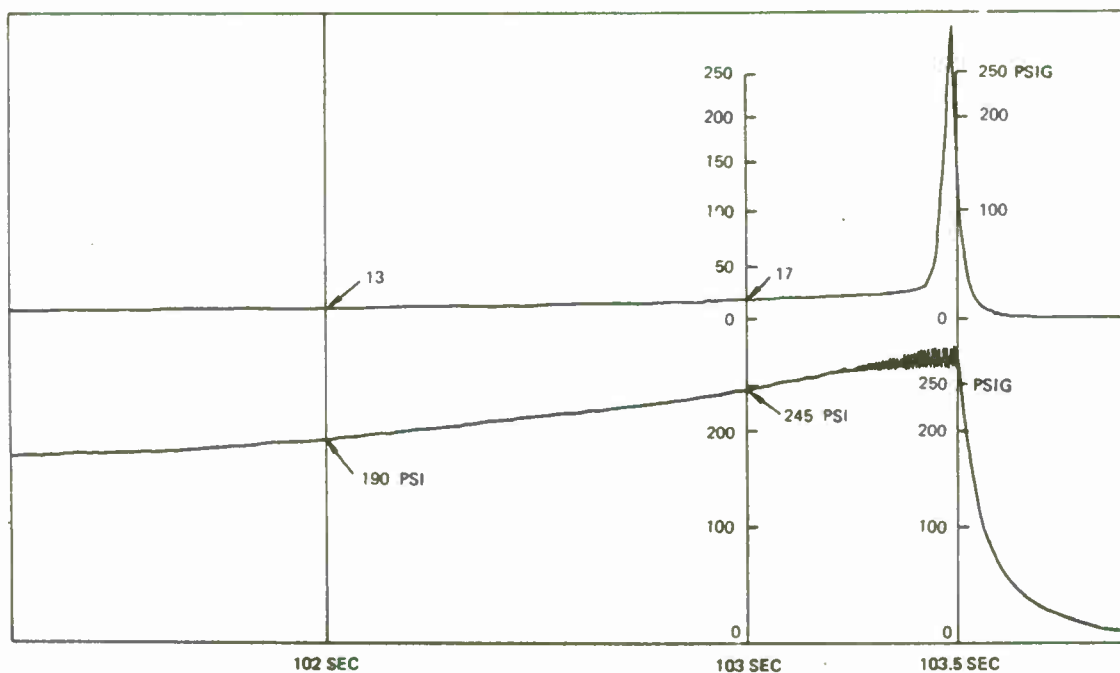
FIGURE 24. Oscillograph Pressure Records at "Reaction Time."

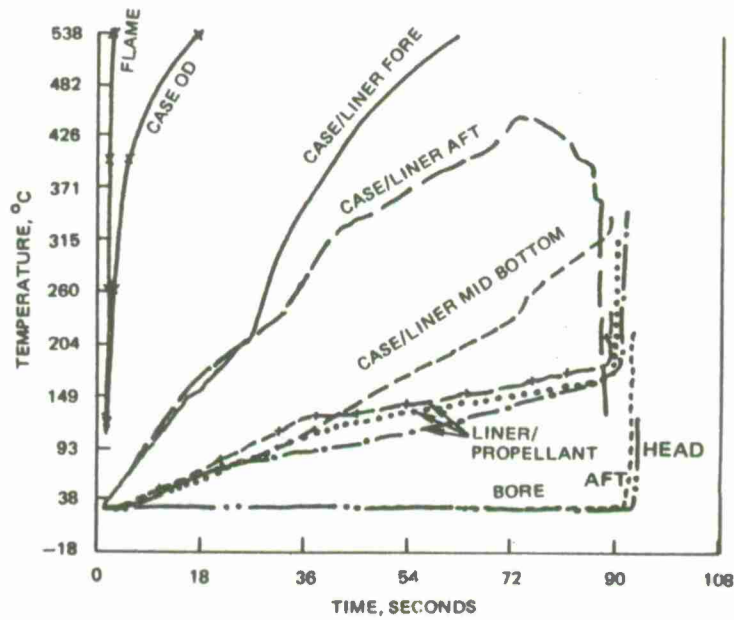
The videotape test records indicated loud noise and case separation at the aft joint, etc., at 89 seconds after propane ignition. Thermocouple data (Figure 27) showed some activity at 88.5 seconds or soon thereafter. The bottom ID (fore, center and aft) thermocouples showed a jump at 89 seconds while the liner/propellant temperatures near those same locations increased at 90.5, 91.5 and 89.5 seconds, respectively. Bore thermocouples showed minor rises at 88.5 and 89 seconds; these may have been due to adiabatic compression or electrical signal cross-over. Aft bore temperature rise occurred after 92 seconds, while forward bore temperature rise occurred at 94 seconds. The unit was burning well on the grain OD and separated into two pieces at that time. Unexplained temperature excursions of the case ID thermocouple data occurred after 70 seconds.

FIGURE 27. Thermocouple Temperatures During Cook-Off With LR-29M Liner and RV-7 Propellant.

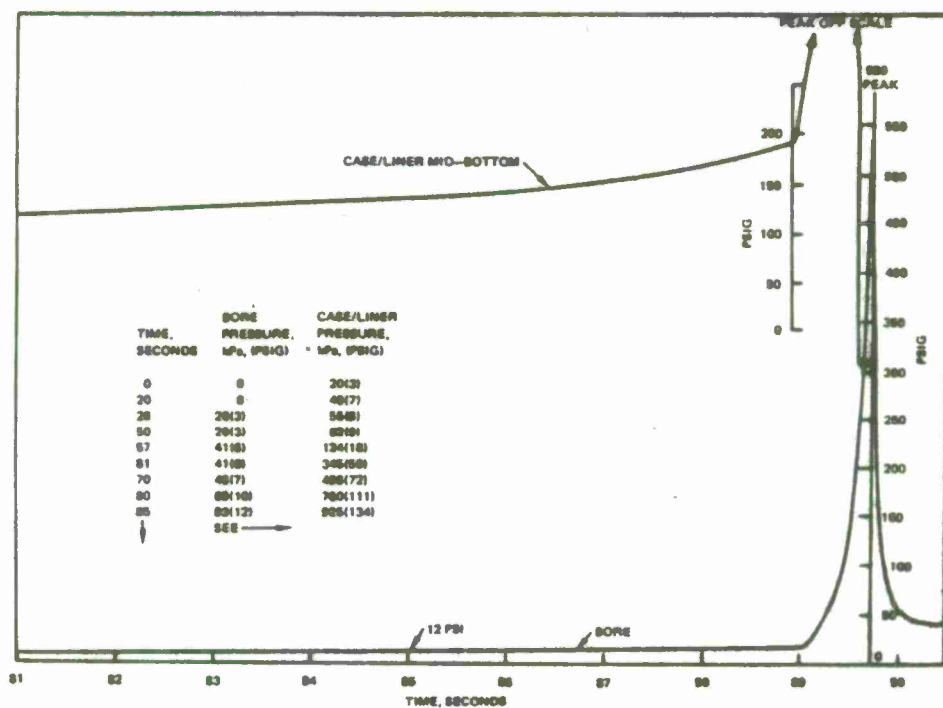
The center bottom case/liner pressure tap and aft end bore pressure measurements provided some interesting data (Figure 28). Case/liner pressure started to rise very quickly, with a little jump from 124 kPa (18 psig) at 57 seconds to 276 kPa (40 psi) at 60 seconds. A knee, where the rate of rise jumps up, occurred at 88.9 seconds with the case/liner pressure at 1324 kPa (192 psig). Bore pressure was first indicated at 28 seconds, then reached 41 kPa (6 psig) at 60 seconds and 138 (20 psig) at 88.9 seconds. Bore pressure then jumped to a peak of 4 MPa (580 psig) at 89.7 seconds after the case/liner pressure peaked off-scale at 89.6 seconds.

FIGURE 28. Pressures During Cook-Off.

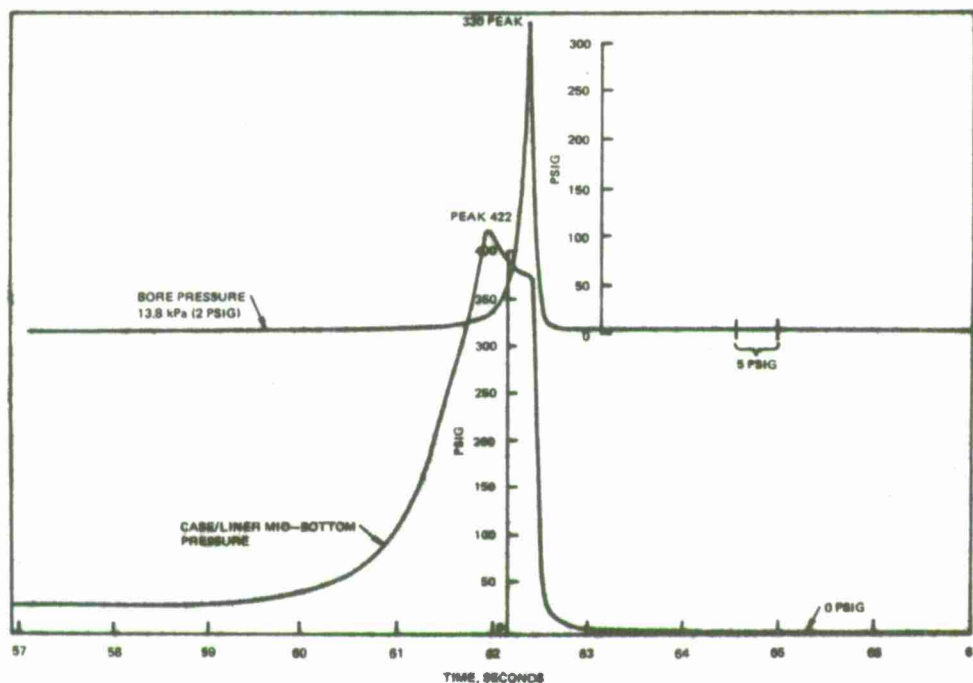
FIGURE 29. Case/Liner Bottom and Bore Pressures at Case Rupture.

At about 62.4 seconds, both pressures very rapidly collapsed to zero and near zero; which must correspond to the case rupture. The pressure was 2.58 MPa (375 psi) at the case/liner measuring location and 2.28 MPa (330 psi) in the bore. The bore pressure went from 34 kPa (5 psig) at 63 seconds (after rupture) to 21 kPa (3 psig) at 80 seconds; which corresponds to the time the jetting-noise-of-burning increase was recorded on the videotape. The pressure then came up to 76 kPa (~ 11 psi) at 80.7 seconds and dropped slowly to 14 kPa (2 psi) at 86 seconds (Figure 30). The case/liner pressure dropped to -34 kPa (-5 psig) at 86.3 seconds. This corresponds in time to the observed dropping off of the grain segment and case head end (cantilevered from the case aft end which was mounted to the test support).

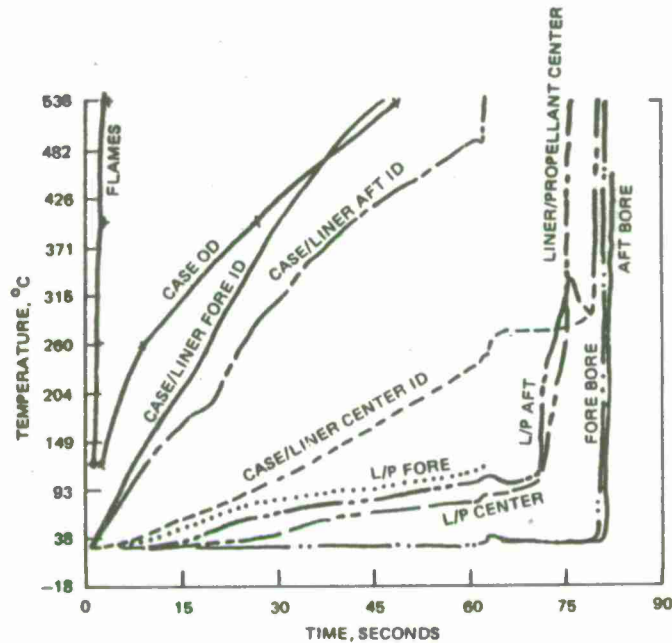
Thermocouple data (Figure 32) show the forward bottom case ID, and bottom case OD just forward of center, were both quite hot, reaching 538°C at 45.5 and 48.5 seconds, respectively. The forward ID reached a peak of 598°C at 57.5 seconds, then dropped a few degrees to 580°C at 60.5 seconds. At this time there was a very rapid rise to propellant flame temperature (thermocouple saturation at 62 seconds) which would indicate ignition of some propellant near the thermocouple. The thermocouple on the liner (about 2.5 cm from the case ID thermocouple) showed a jump from 120°C at 62 seconds to 1304°C (saturation) at 62.5 seconds. Recall that the case/liner pressure showed an increasing rate rise from 60 seconds to a peak at almost 62 seconds with case rupture at about 62.5 seconds. The bore thermocouples both jumped about 11°C at 62.5 seconds, which probably indicates some gas was leaking into the bore. The aft rise was actually 14°C while the fore end rise was 9°C. These are probably more than would be expected from adiabatic air compression when the propellant "balloon" is compressed, but perhaps not. The bore did cool until 79.5

FIGURE 32. Temperatures During Cook-Off of Polyether Polyurethane Lined Model Motor.

seconds, at which time the forward bore thermocouple started to rise. The aft thermocouple started up at 81 seconds and both reached saturation at 82.5 seconds. Bore pressure showed a rise at 80 seconds. The aft bottom liner/propellant thermocouple indicated that flame reached it at 76 seconds while the center bottom liner/propellant thermocouple was saturated at 81 seconds.

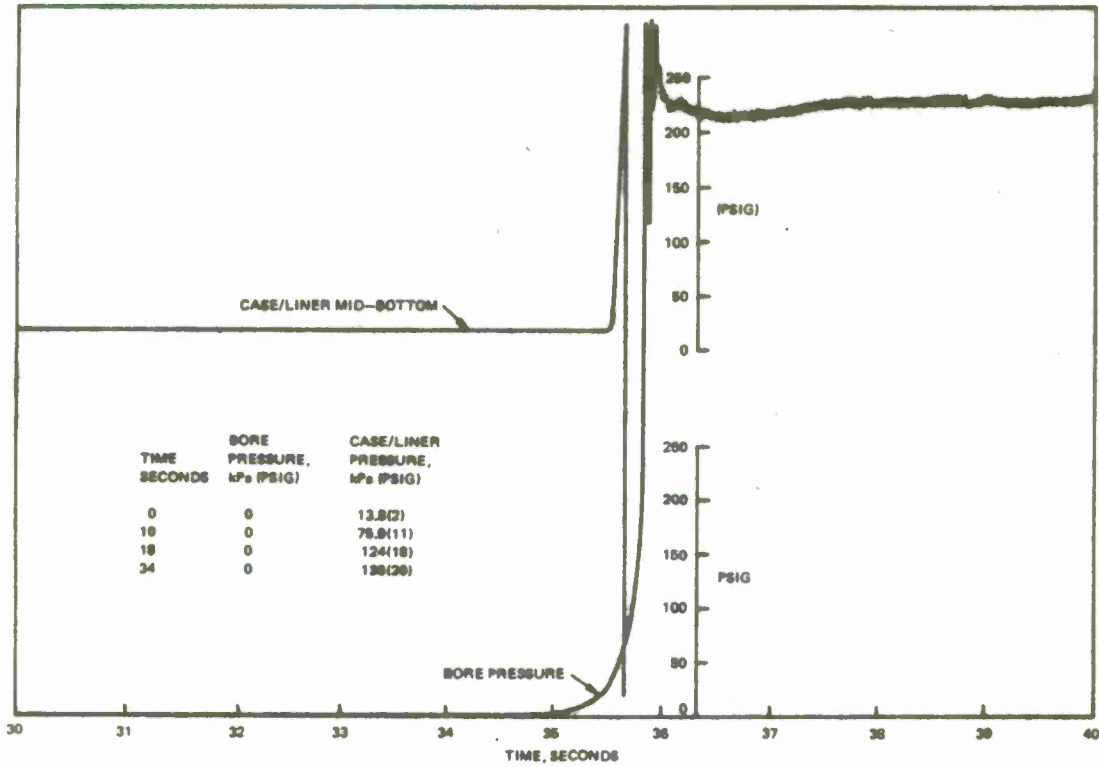
Midbottom case/liner and bore pressure data were taken as before (Figure 33). The case/liner pressure data do not appear to be accurate; pressure rose very quickly but then stayed flat at about 131 kPa (19 psi) from 18 to about 36 seconds when an abrupt rise (off-scale) above 2.1 MPa (300 psi) occurred. The bore pressure showed no pressure rise until 35 seconds, then rose relatively slowly to 138 kPa (20 psi) at a faster rate (from the time case/liner pressure spiked upward) to about 483 kPa (70 psig), then faster yet until saturation and gauge failure 0.1 second or more after the case/liner pressure spiked.

FIGURE 33. Pressures at Case Rupture.

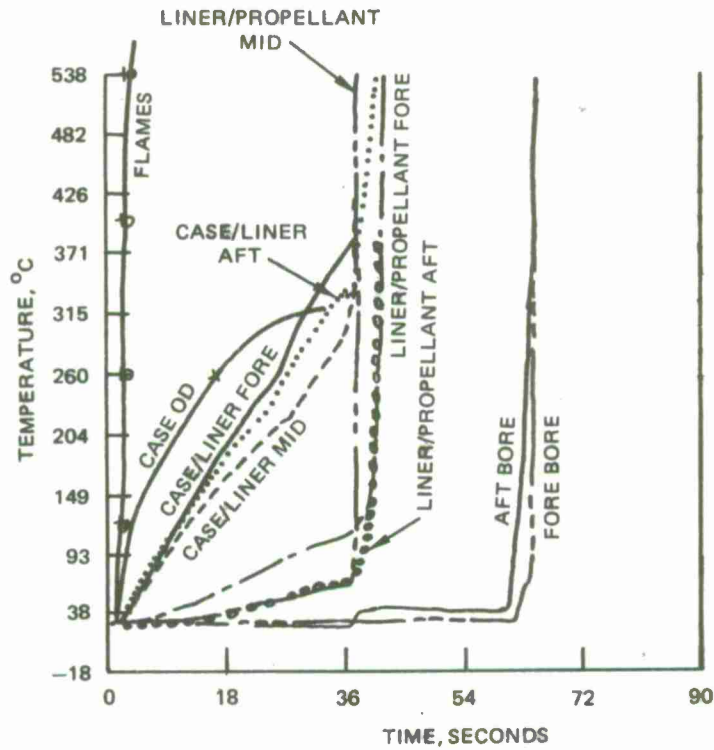
Thermocouple data (Figure 34) show case ID bottom temperatures of 315-370°C at rupture. One thermocouple shows a decrease for 1 second before 37.5 seconds, which apparently was the rupture time. The data at the 38 second time show jumps and discontinuities although two thermocouples jumped at the 37.5 second datum. Thermocouple saturation (equivalent to propellant burning about the thermocouple) was first reached at 40.5 seconds on the two thermocouples that had been attached to the case ID. Of the three propellant/liner thermocouples, one reached saturation at 42.5 seconds and the other two reached saturation at 44.5 seconds. This agrees with the movie observations of no propellant burning for a brief time after case rupture and gradual ignition of the propellant as the liner burned away. The bore thermocouples showed an 11°C jump at 38 seconds for the aft end only and rose at

FIGURE 34. Temperatures During Cook-Off of HMX Propellant Model Motor.

61.5 and 62.5 seconds for the aft and fore ends, respectively. The head end showed flame temperature at 65 seconds, followed by the aft end at 69.5 seconds. These times correspond to the grain bending nearly 90 degrees, as was seen in the movie and video films, and then burning from both ends.

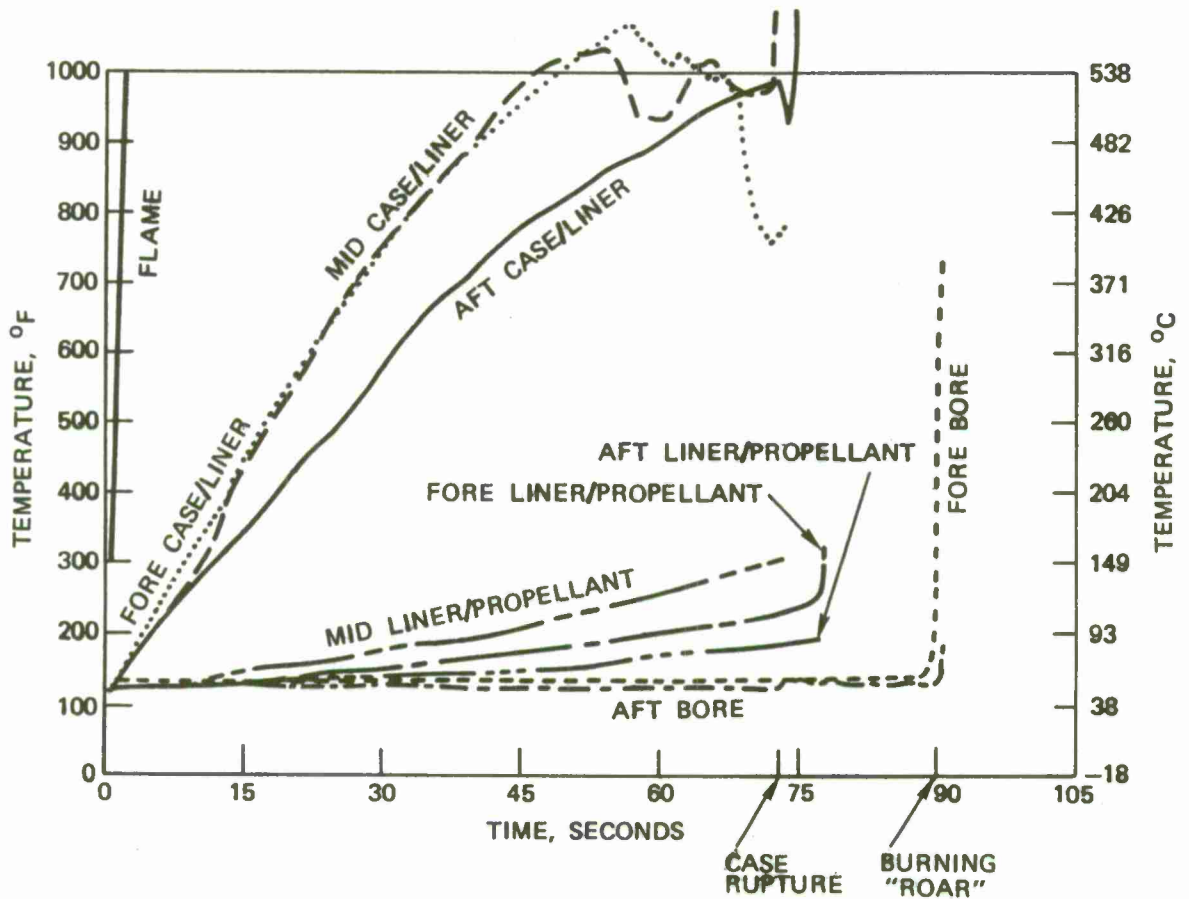
FIGURE 36. Temperatures During Cook-Off of SD-723/LR-29/RV-7 Model Motor Test.

The thermocouple data for this test (Figure 36) show internal case wall temperatures above  $538^{\circ}\text{C}$  ( $1000^{\circ}\text{F}$ ) with some cooling before rupture. The cooling may have been due to material movement and pyrolysis gases flowing. The highest temperature of three liner/propellant locations at time of reaction was  $149^{\circ}\text{C}$  ( $300^{\circ}\text{F}$ ). Some disturbance of bore temperature occurred at reaction, but burning of the bore did not initiate until 88 seconds (15 seconds after case rupture). The video and movie coverage verify the web burning through from the OD at that time:

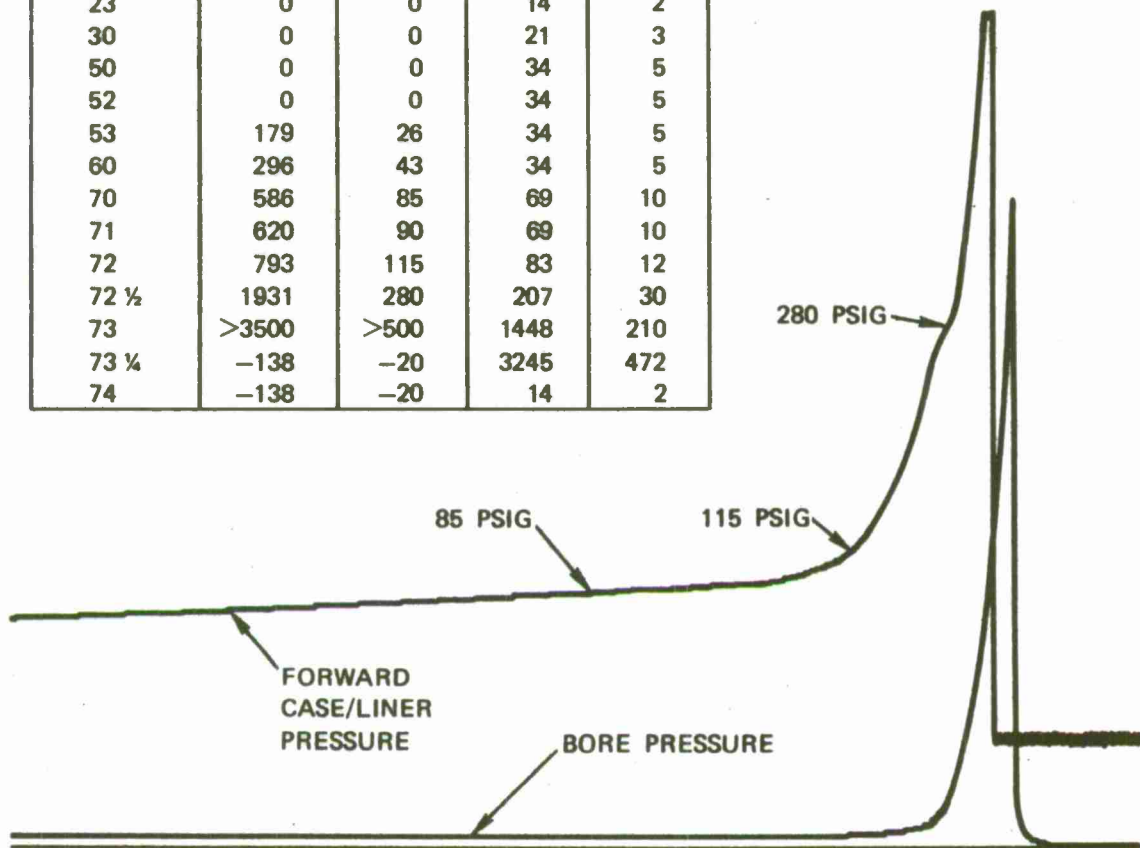
FIGURE 37. Pressure Measurements Near Reaction of Dual-Liner Model Motor Cook-Off Test.

As can be seen in Figure 35, the case/liner pressure tap location was changed to the forward instead of the midbottom location as previously done. Figure 37 presents the pressure data, which follow the typical pattern of case/liner pressure rising quite rapidly just prior to rupture and bore peak pressure occurring just after "rupture."

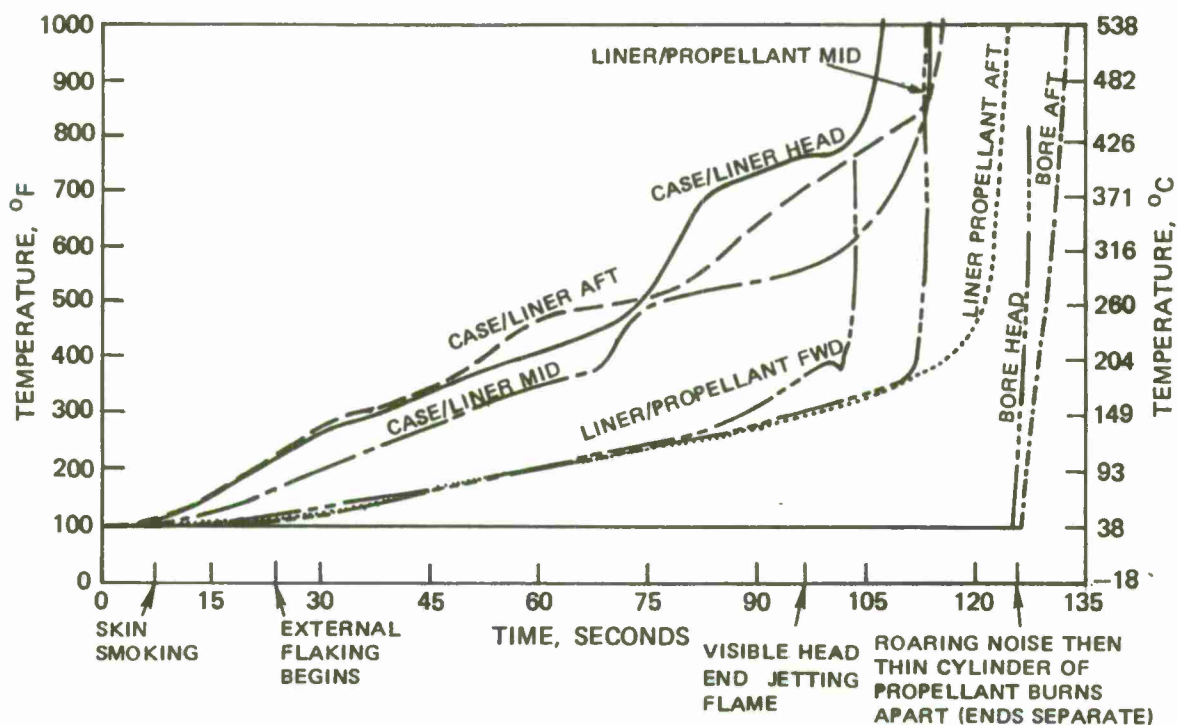
FIGURE 39. Temperatures During Cook-Off.

Figure 39 depicts the thermocouple data and indicates the visible activities (marked at times of occurrence). The first visible flame did not emanate from the bottom of the test item. It occurred at 93 seconds and the forward liner/propellant thermocouple was the first to indicate flame (fast rise to saturation) at 103 seconds.

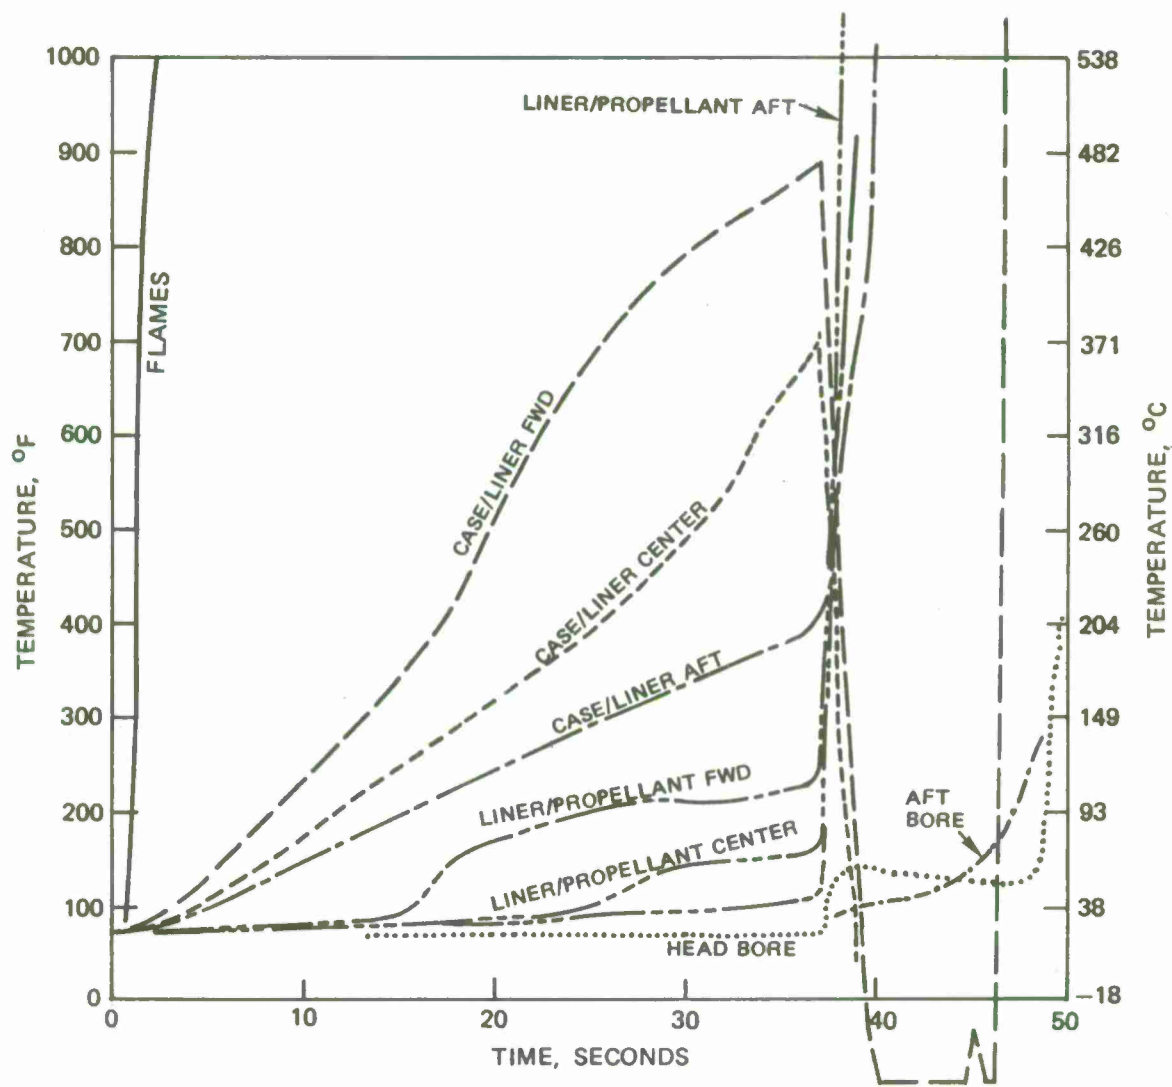
FIGURE 40. Temperatures During Cook-Off of NPCL-13 Model Motor.

A second test using nitroplasticized polycaprolactone (NPCL) binder propellant in the extended model motor hardware was conducted. The smokeless NPCL-13-7557 propellant was cast onto LR-29 liner with this liner having an undercoat of polyether polyurethane liner. Cook-off over the propane burners facility resulted in case rupture occurring at 37 seconds. This exactly duplicated the previous test with this type of propellant. The thermocouple data (Figure 40) show the bottom forward test section case ID temperature to be 478°C (893°F) at reaction time with center and aft temperatures being much lower, which is somewhat atypical. Maximum liner/propellant temperature was 109°C (229°F) (at the forward end of the test section). The aft bore temperature jumped at reaction time (37.4 seconds) but then continued to drift upward to about 51.5 seconds when rapid rise started. The forward bore temperature also jumped at 37.4 seconds, but then drifted downward (cooled) until 48.7 seconds when rapid rise (flame) was indicated. This probably means gas leaked into the bore at the aft seal, which correlates with the abnormal, soft liner observed before assembly. The reaction occurred early and, again, this must correspond to the lower thermal stability of the propellant. The case temperature was lower; thus, the pressure required to rupture the case was higher.
