NWC TP 5921

# Reduction of Fuel Fire Cook-Off Hazard of Rocket Motors

by  
Ronald F. Vetter  
*Propulsion Development Department*

JUNE 1977

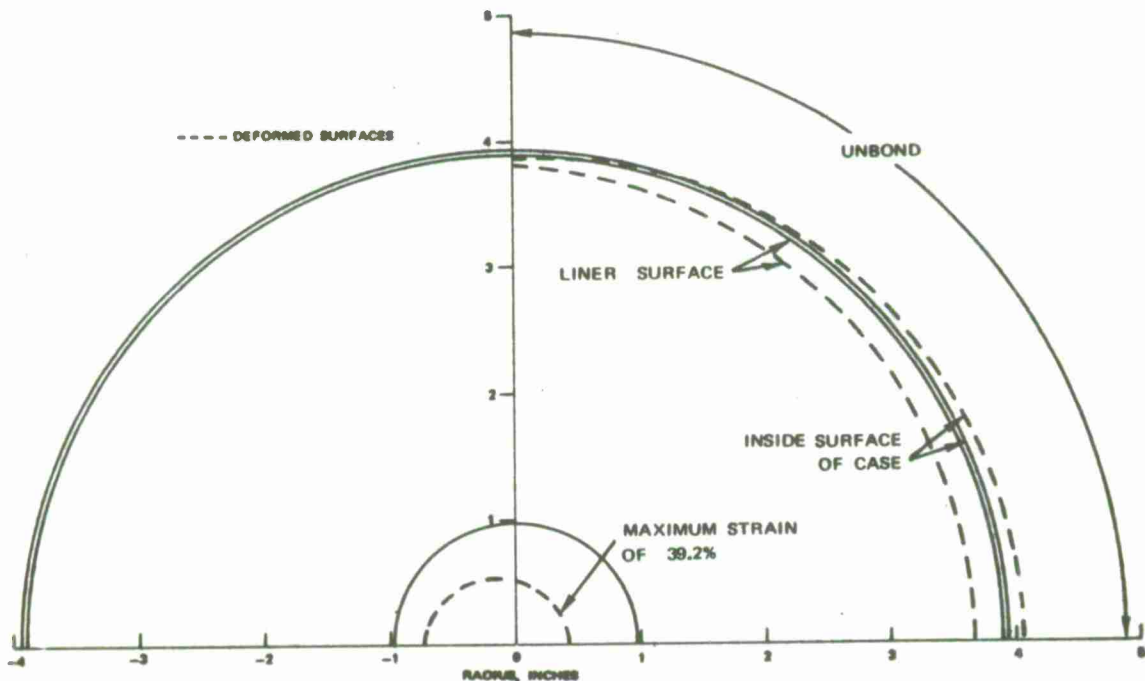
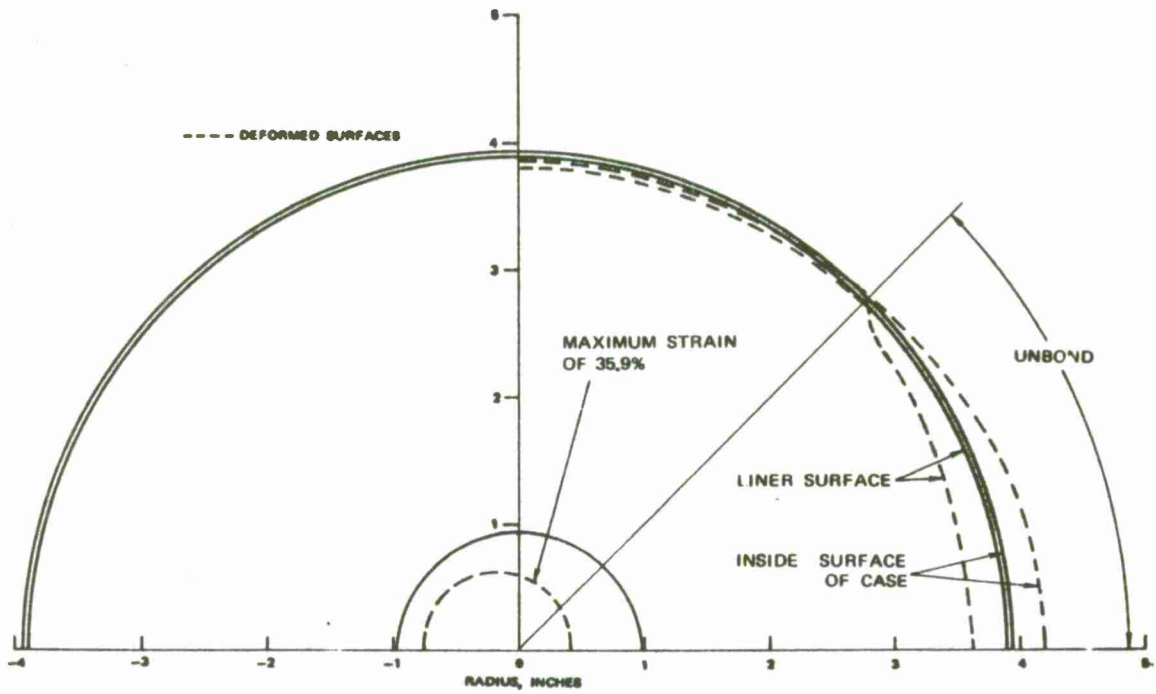
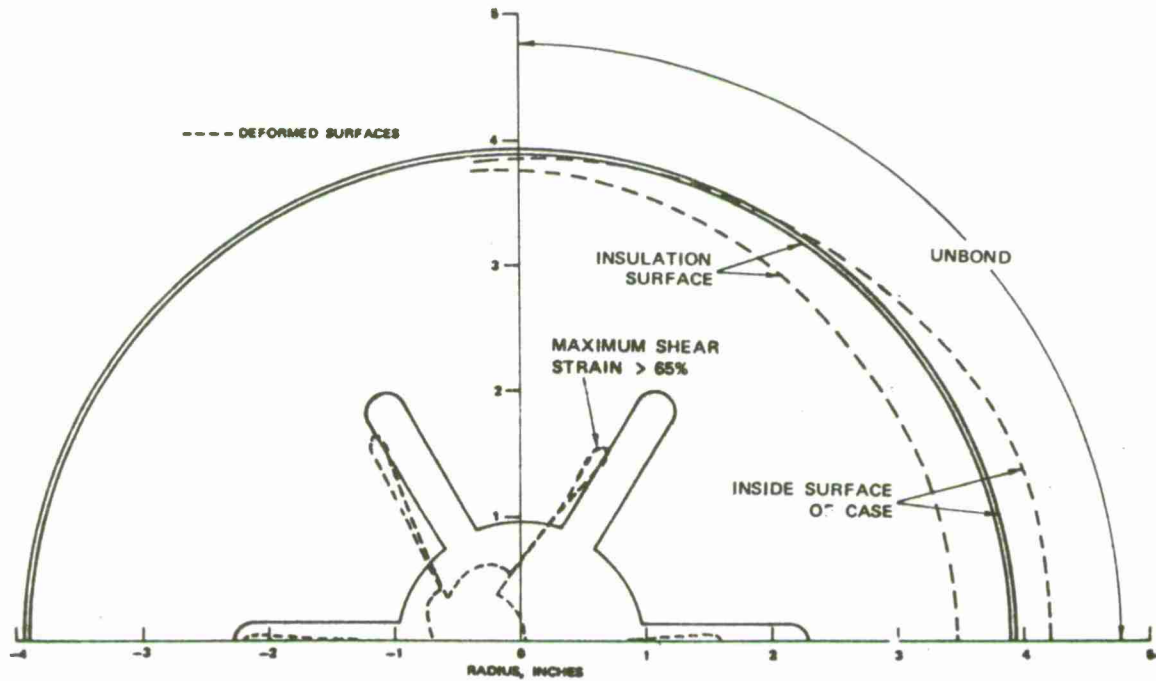
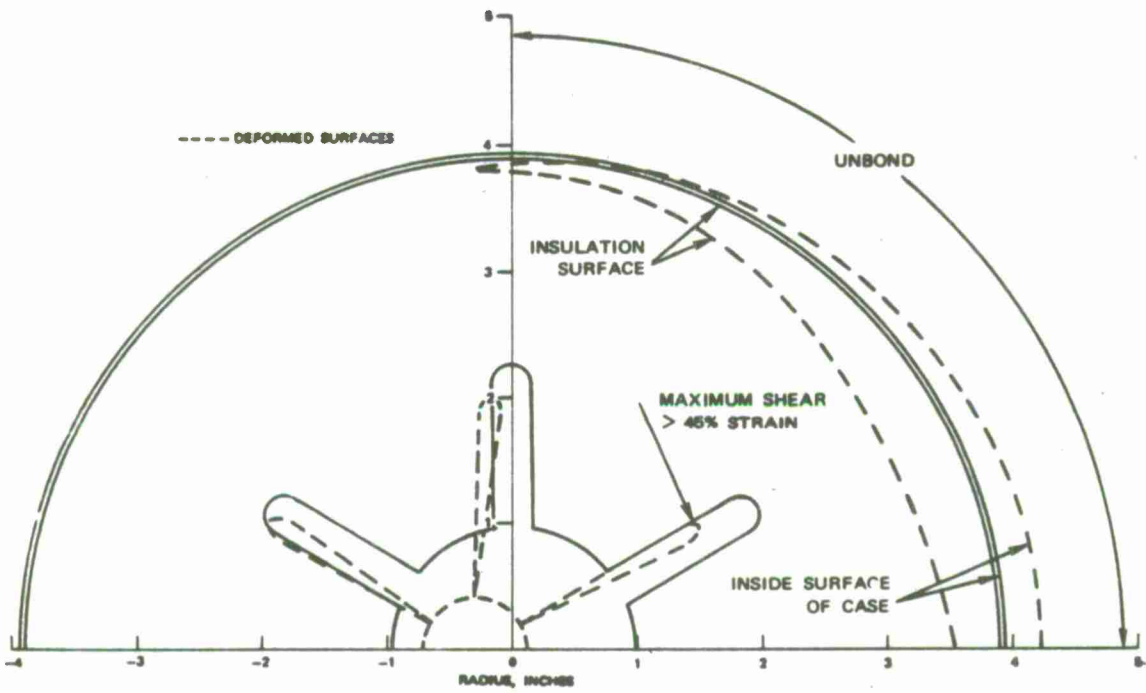
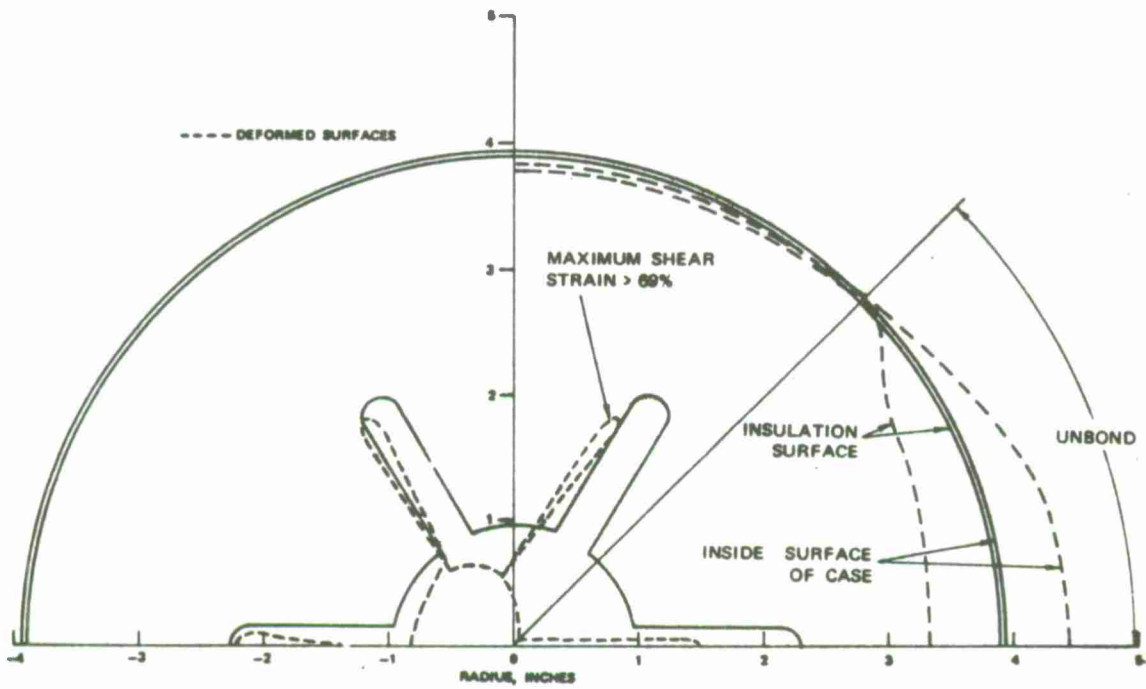
Mr. Ken Bischel of NWC used stress analysis computer codes to determine those deformations likely to occur under conditions where pyrolysis gases exist along with unbonds. Such deformations were calculated for 8-inch-diameter hardware with HTPB propellant properties. The pressure rise profile and values were arbitrary but resemble the data from the instrumented motors. A calculation assuming 345 kPa (50 psi) in 5 seconds, followed by 3450 kPa (500 psi) in 0.5 second, entirely collapses the star perforation. Such deformations would require appreciable gas volume, but it is easy to visualize that high peeling and tension loads are created at the edges of gas pockets and particularly at the motor ends. If propellant is thereby exposed to the heated fuel vapors, the propellant could ignite.

Figures A-1 through A-5 portray the plane strain deformations produced by one-quarter or one-half perimeter unbonding and assumed gas generation to produce a pressure of 345 kPa (50 psi) smoothly over 5 seconds time (during which time, the propellant has a modulus of 400 psi/in/in and the liner a modulus of 130 psi/in/in) followed by further pressure rise to 1033 kPa (150 psi) (during which rise time of 0.5 second the propellant and liner moduli are raised to 650 and 200 psi/in/in, respectively). The cylinder and star grain perforations were used in 20 cm (8-inch) diameter motor size.
