MTMC REPORT OA 81-4a-27

# ANALYSIS OF MTMC PARTICIPATION IN THE REFORGER 81 EXERCISE

MAY 1982

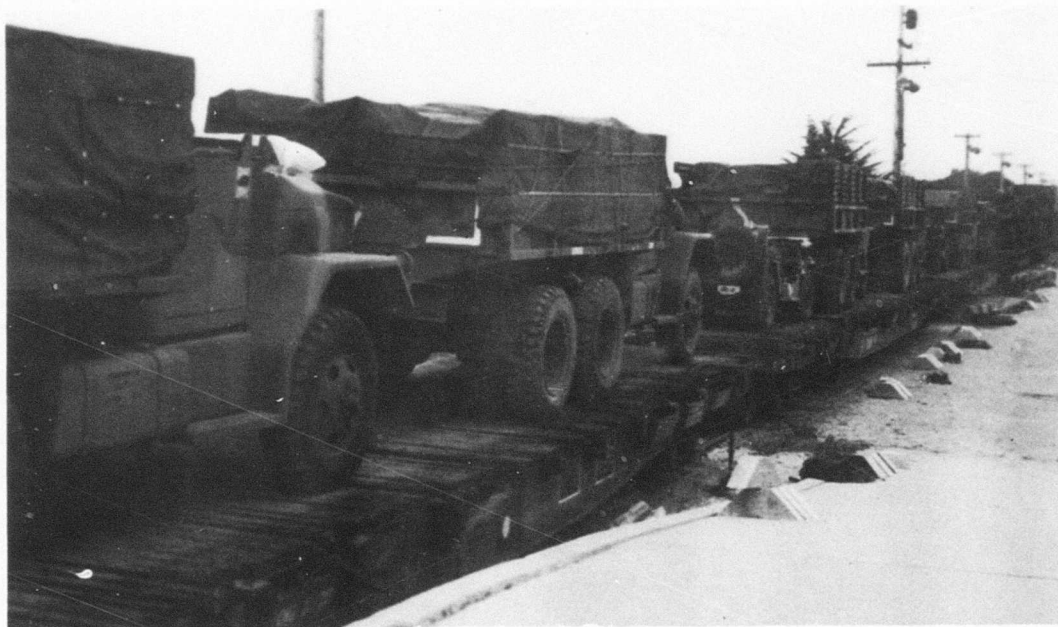
Figure 4-4. Fort Ord cargo beds fully used.

(9) Cargo was loaded into the beds of trucks and trailers, vehicles were reduced to shipping configurations IAW AR 220-10 (fig 4-4), and thus, the CONEX rail requirement was reduced from 47 to 8 CONEXs. Cargo was well secured in the cargo beds and was covered with tarps.

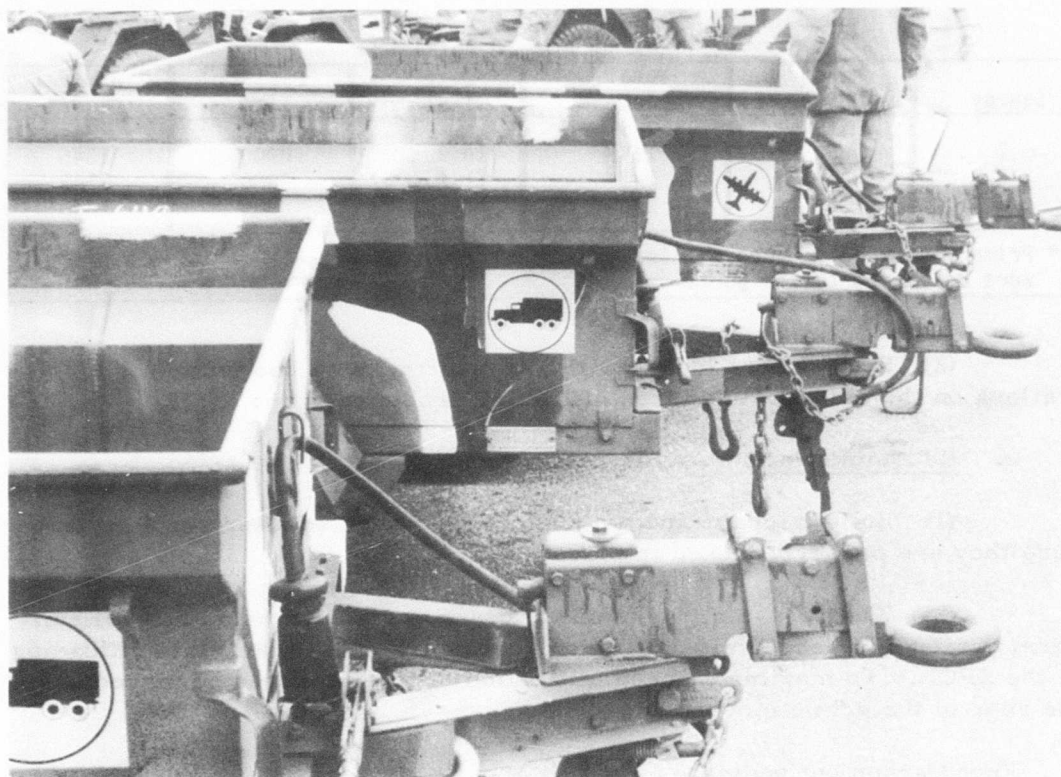
Figure 4-5. Plastic SPOD mode-designation stickers.

(11) The markings required by the REFORGER planning group to designate the mode of transportation at SPOD for convoy, sea/air interface, or rail movement were silk-screened onto plastic stick-on patches that were applied to the sides of the vehicles (fig 4-5).

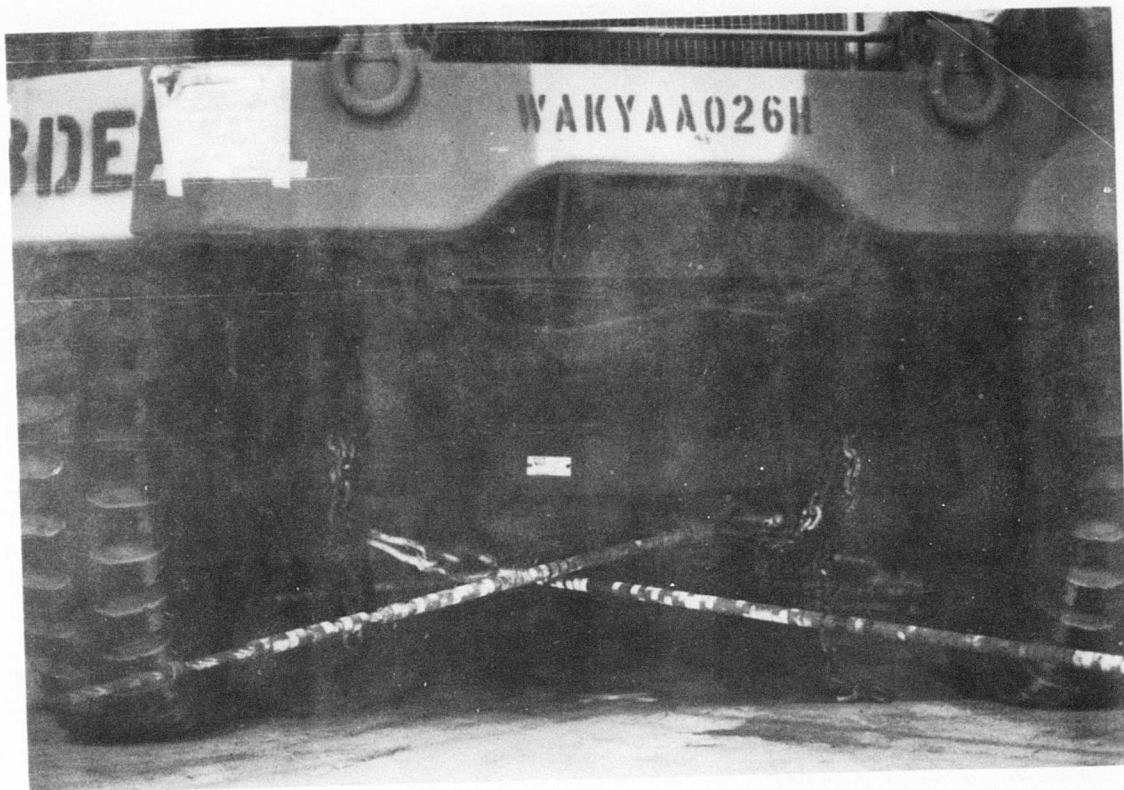
Figure 5-4. Lashings applied over axles on USNS Meteor.

(4) Initially, the prestow plan was precisely followed, but stevedore teams left many large gaps between vehicles, and a generally loose stow was found in the lower holds of hatches 3 and 4 (fig 5-3). Several loose lashings were found, and some lashings had been placed across brake lines (fig 5-4) and around suspension parts of 1/4-ton trucks. As operations continued, stevedores became more proficient and loose stows and improper lashings became the exception rather than the rule. A significant problem area occurred, however, when on several occasions, on-duty ship's officers (mates), other than the chief mate, entered the holds and informed the military stevedores that the secured lashings were incorrect and required them to be redone. Two complete hatches had to be relashed. The main problem involved precisely which lashing points were to be used on the various types of vehicles in the holds. The chief mate had the final word. He was also the cargo-accepting authority for the ship; however, he was not always available to settle lashing disputes between the stevedores and the ship's crew. This situation resulted in a great deal of lost time, double lashing of many vehicles, and a definite lowering of the morale of the Army stevedores.

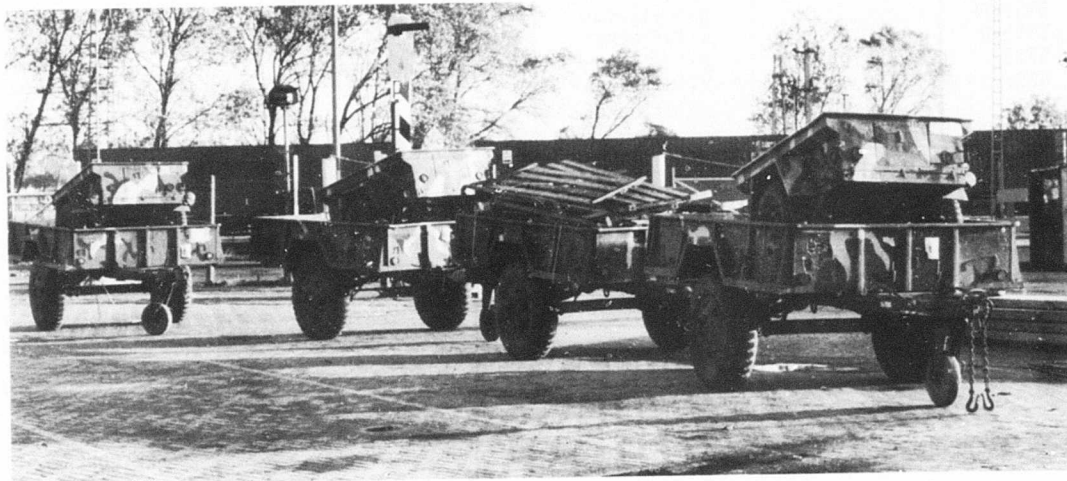
Figure 7-3. Smaller vehicles loaded onto larger vehicles.

(3) Since the ship mix changed, load planning had to be redone for four breakbulk ships. The change in vessel types and the subsequent loss of cargo space influenced the decision to consolidate equipment by nesting empty trailers and by loading smaller vehicles onto the cargo beds of larger vehicles (fig 7-3).
