TECHNICAL NOTES

No. 842

TIDEWATER AND WEATHER-EXPOSURE TESTS ON METALS

By Willard Hutchler and W. G. Galvin
National Bureau of Standards

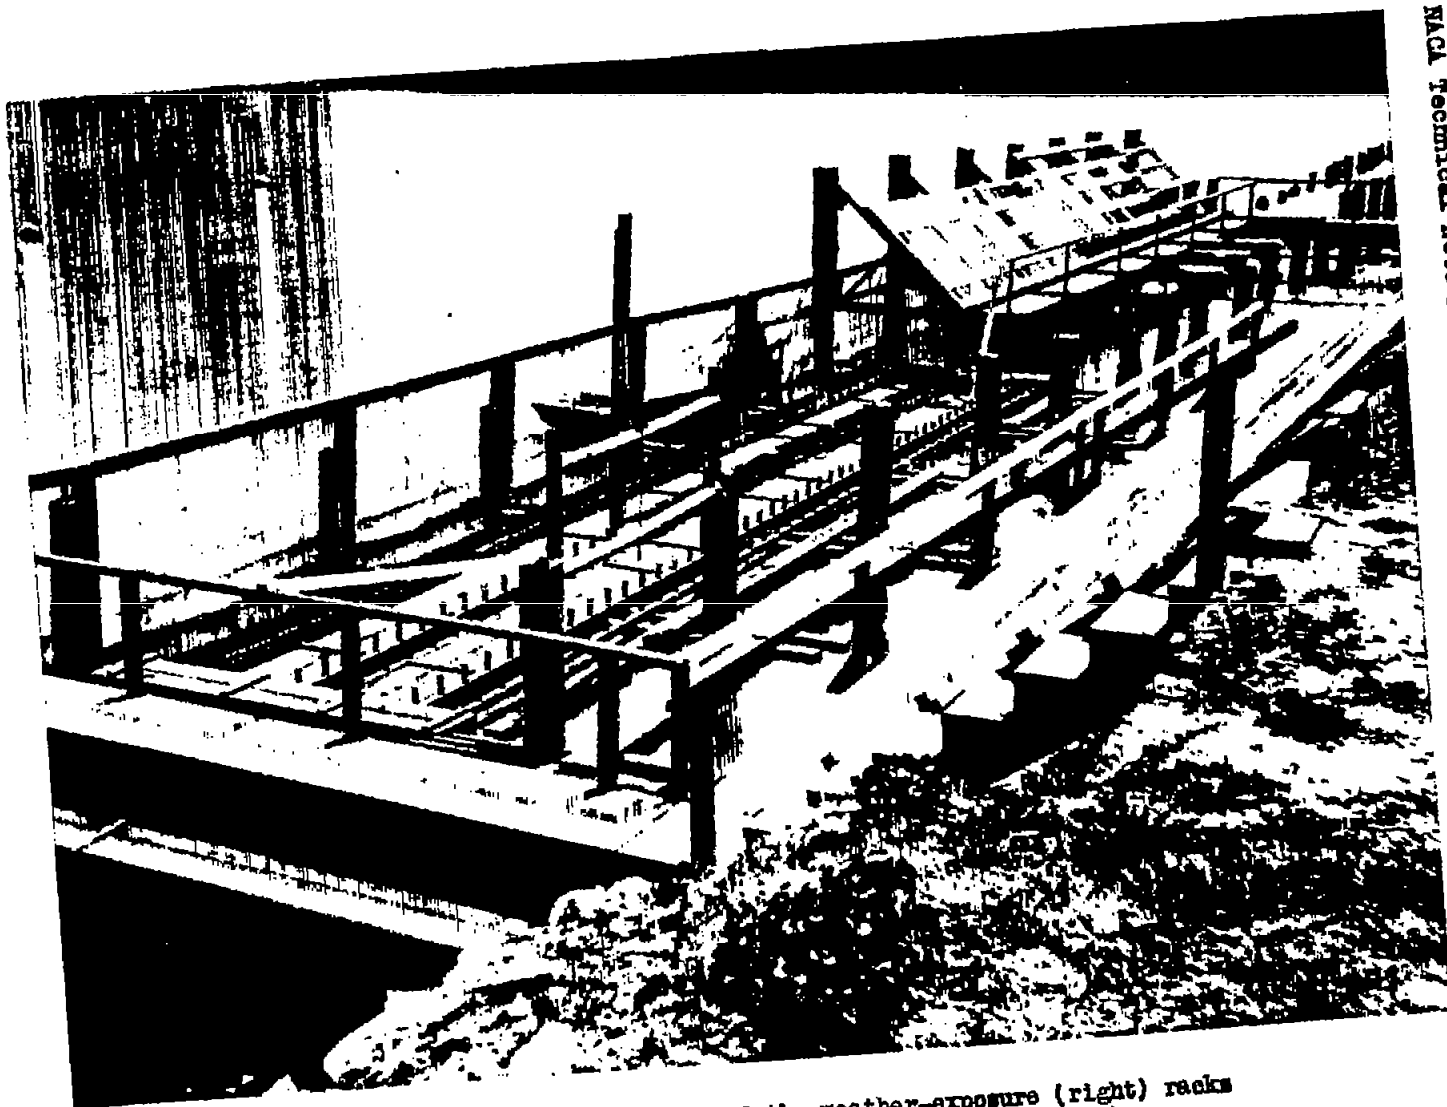
Figure 1.- The tidewater (left) and the weather-exposure (right) racks at Boush Creek, Hampton Roads Naval Air Station (2).

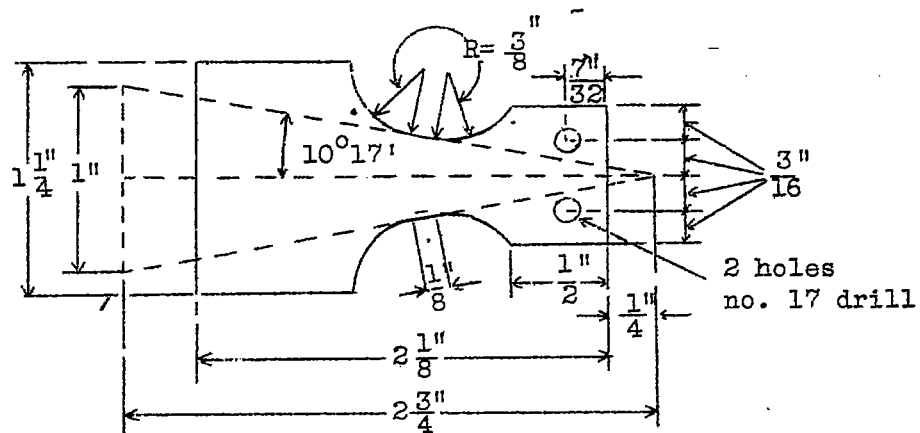
Krouse sheet fatigue specimen

Figure 30.- Sketch showing design and dimensions of specimens for tests in the Krouse flexural fatigue machines. x 1.
