# WARTIME REPORT

ORIGINALLY ISSUED  
February 1945 as  
Advance Restricted Report E5B07

EFFECT OF PROGRESSIVE RING FAILURE ON PISTON DESTRUCTION

By Max J. Tauschek and Lester C. Corrington

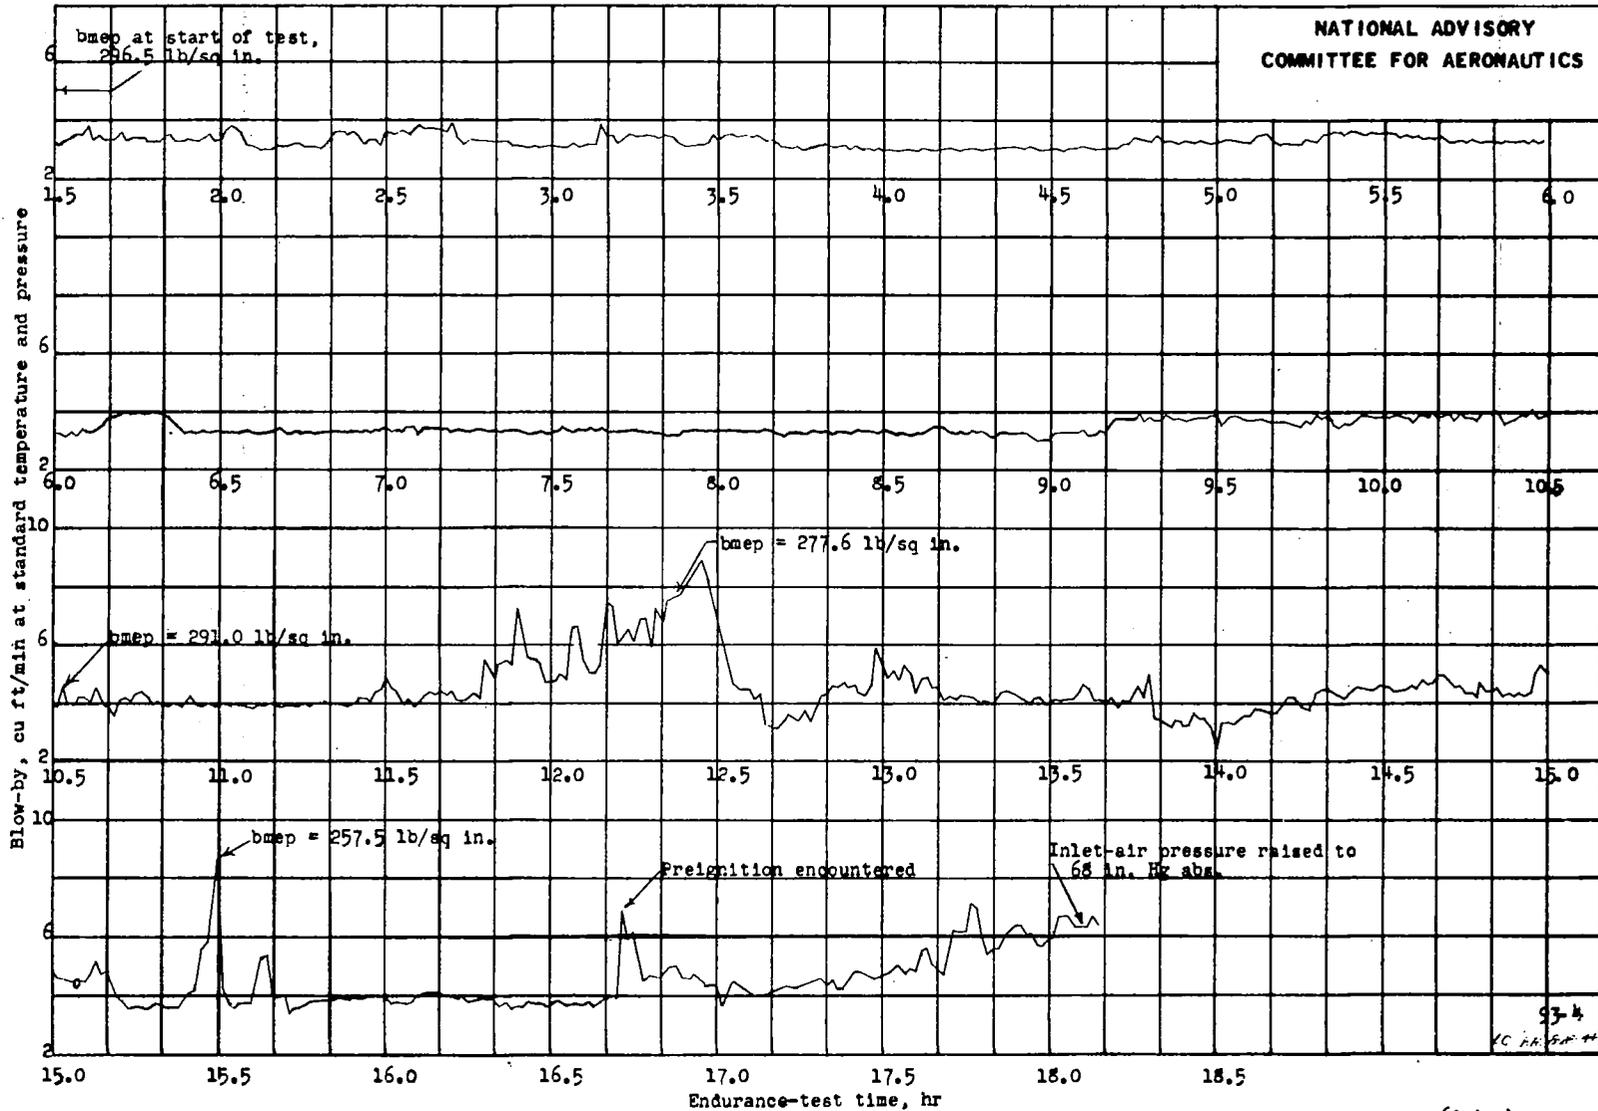
Blow-by and crankcase pressure. - The curves of the rate of blow-by and the crankcase pressure are shown in figures 4 and 5. Because the crankcase pressure is directly related to the blow-by rate, these curves are similar. It must be borne in mind, in the interpretation of the results of the crankcase-pressure curve, that the magnitudes of the crankcase-pressure values are entirely dependent upon the system used for the removal of the blow-by gases from the crankcase; a system having many restrictions, such as small piping, a flowmeter, and numerous valves, will result in high pressures, whereas a system having fewer obstructions to the gas flow will result in low pressures. The actual pressure in the crankcase was somewhat higher than the values measured because the manometer was connected to the blow-by line some distance from the crankcase.

Figures 4 and 5 indicate that, after failure of the top and second rings had taken place (beginning of endurance test), an increasing degree of failure of the compression rings did not affect the sealing qualities of the piston and ring assembly to any marked extent. The rate of blow-by and the crankcase pressure at the beginning of the test were approximately the same as those values at the

Figure 4. - Effect of running time on rate of blow-by for first endurance test. Engine speed, 2600 rpm; inlet-air pressure, 60 inches of mercury absolute (except as noted); inlet-air temperature, 100° F; fuel-air ratio, 0.095; oil flow to piston, 2.0 pounds per minute.

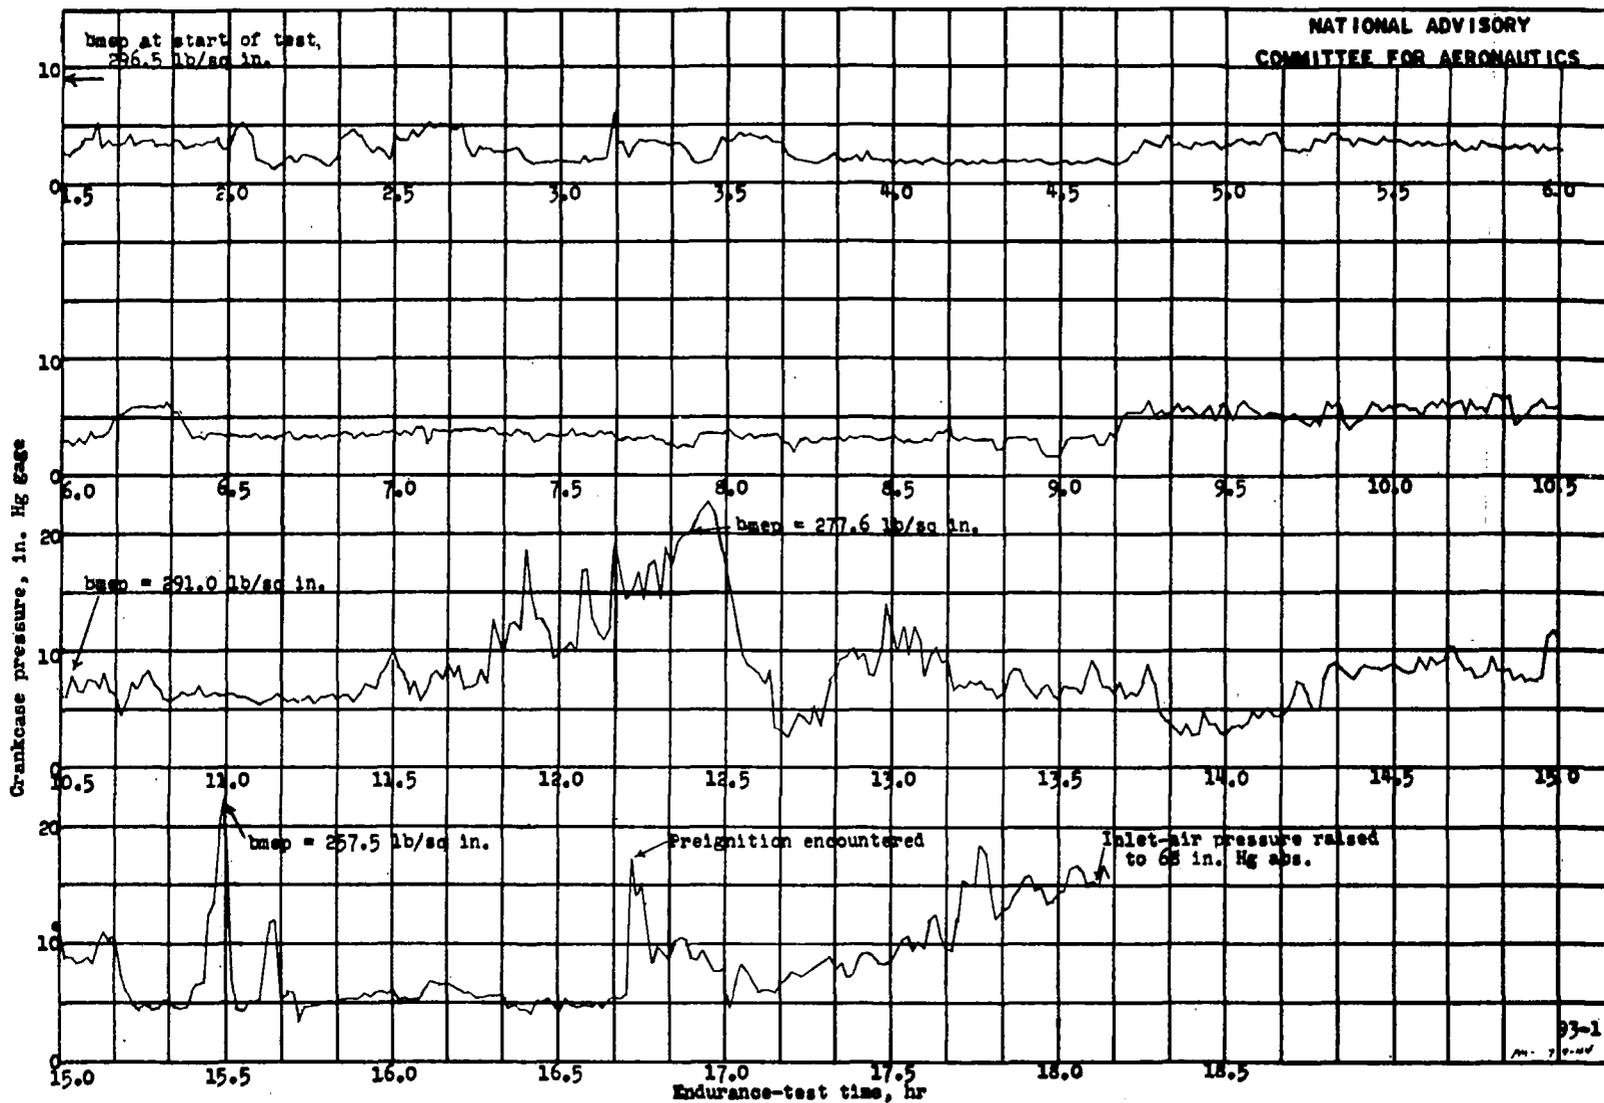
Figure 5. - Effect of running time on crankcase pressure for first endurance test. Engine speed, 2600 rpm; inlet-air pressure, 60 inches of mercury absolute (except as noted); inlet-air temperature, 100° F; fuel-air ratio, 0.095; oil flow to piston, 2.0 pounds per minute.

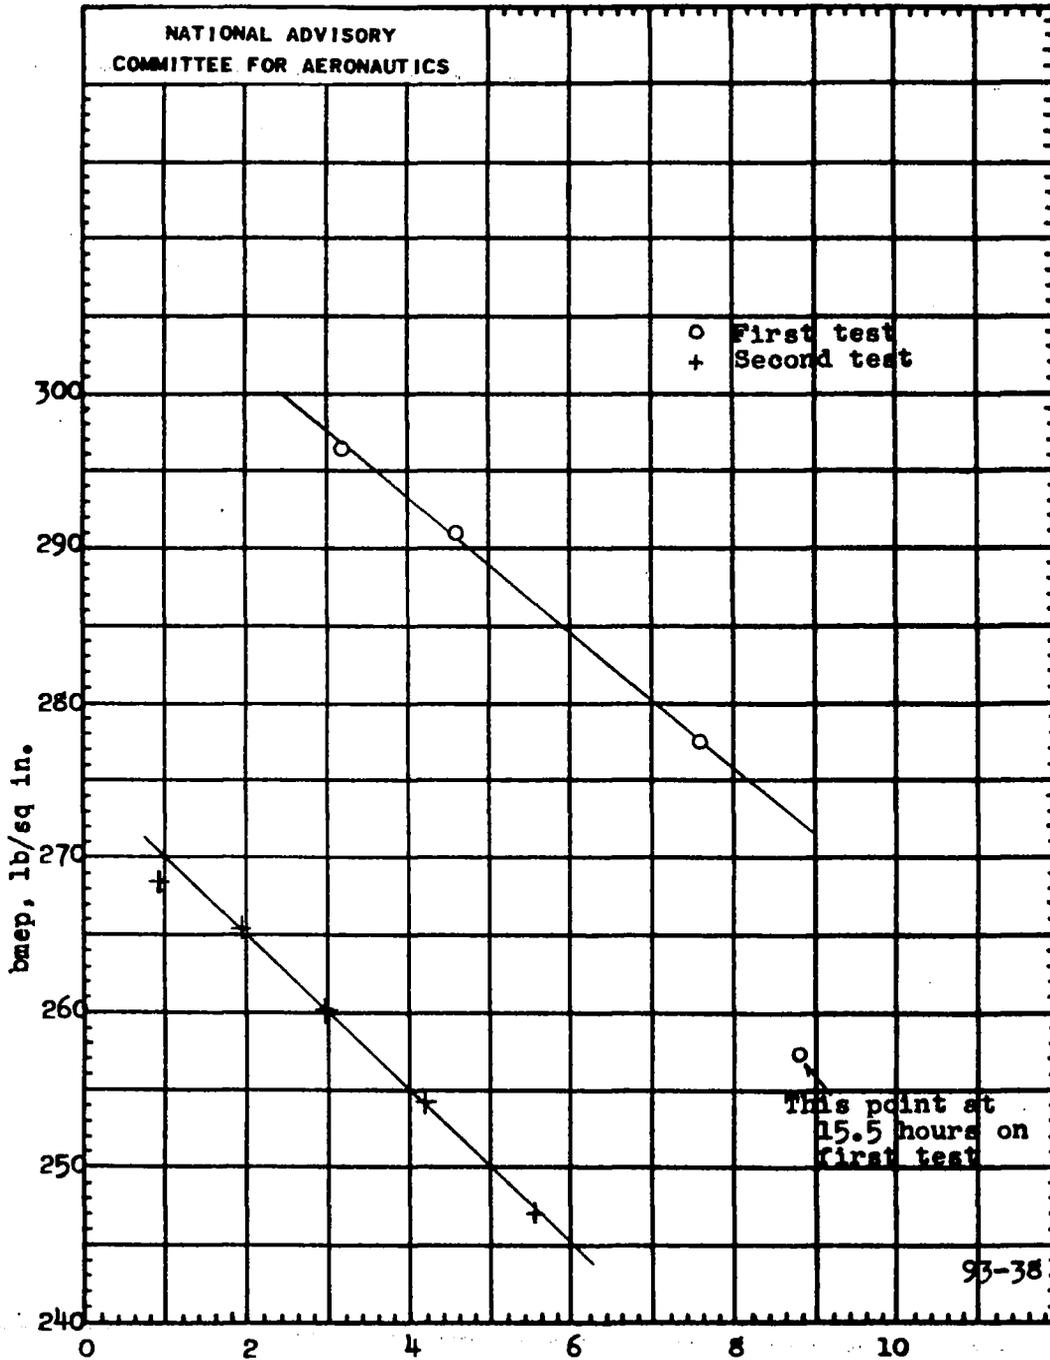
The sudden rise in rate of blow-by at 15.5 hours may also have been caused by preignition although none was detected by the time-pressure diagram on the oscilloscope. The loss in power output recorded at this point is somewhat higher than would be expected from blow-by alone (fig. 6), suggesting that preignition may have advanced only a few degrees, become stable, and shortly afterward disappeared. This type of preignition has been known to occur many times in other tests and would probably be unnoticed on the time-pressure diagram.

Blow-by, cu ft/min at standard temperature and pressure  
 Figure 6. - Effect of rate of blow-by on brake mean effective pressure. Engine speed, 2600 rpm; inlet-air temperature, 100° F for first test, 200° F for second test; fuel-air ratio, 0.095 for first test, 0.085 for second test; oil flow to piston, 2.0 pounds per minute for first test, 0.5 pound per minute for second test.

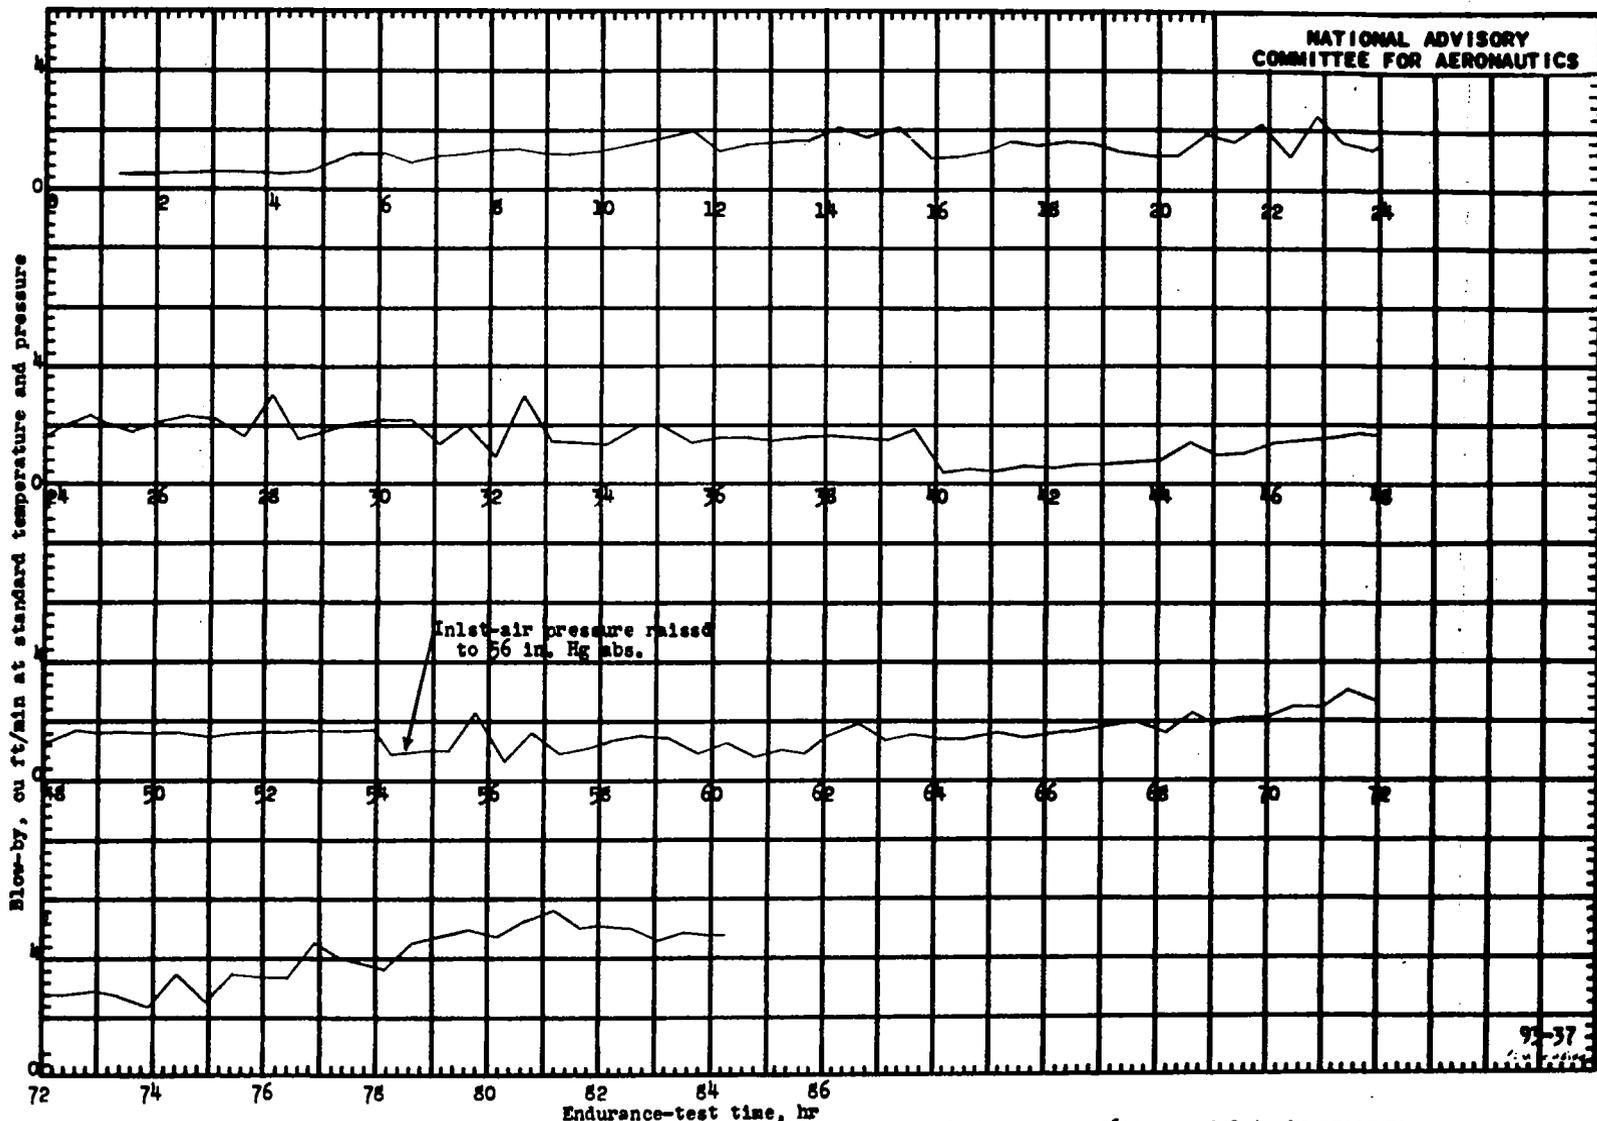
Blow-by and crankcase pressure. - The curves of rate of blow-by and crankcase pressure for the second test are shown in figures 10 and 11. These curves show a marked increase in the blow-by rate and the crankcase pressure after the first 4.5 hours of running, which indicates the beginning of compression-ring failure probably by sticking of the top ring. Unpublished data taken on this engine have shown that 0.5 cubic foot per minute is an average value for the rate of blow-by with a new piston and ring assembly when operating

Figure 10. - Effect of running time on rates of blow-by for second endurance test. Engine speed, 2600 rpm; inlet-air pressure, 50 inches of mercury absolute (except as noted); inlet-air temperature, 200° F; fuel-air ratio, 0.085; oil flow to piston, 0.5 pound per minute.

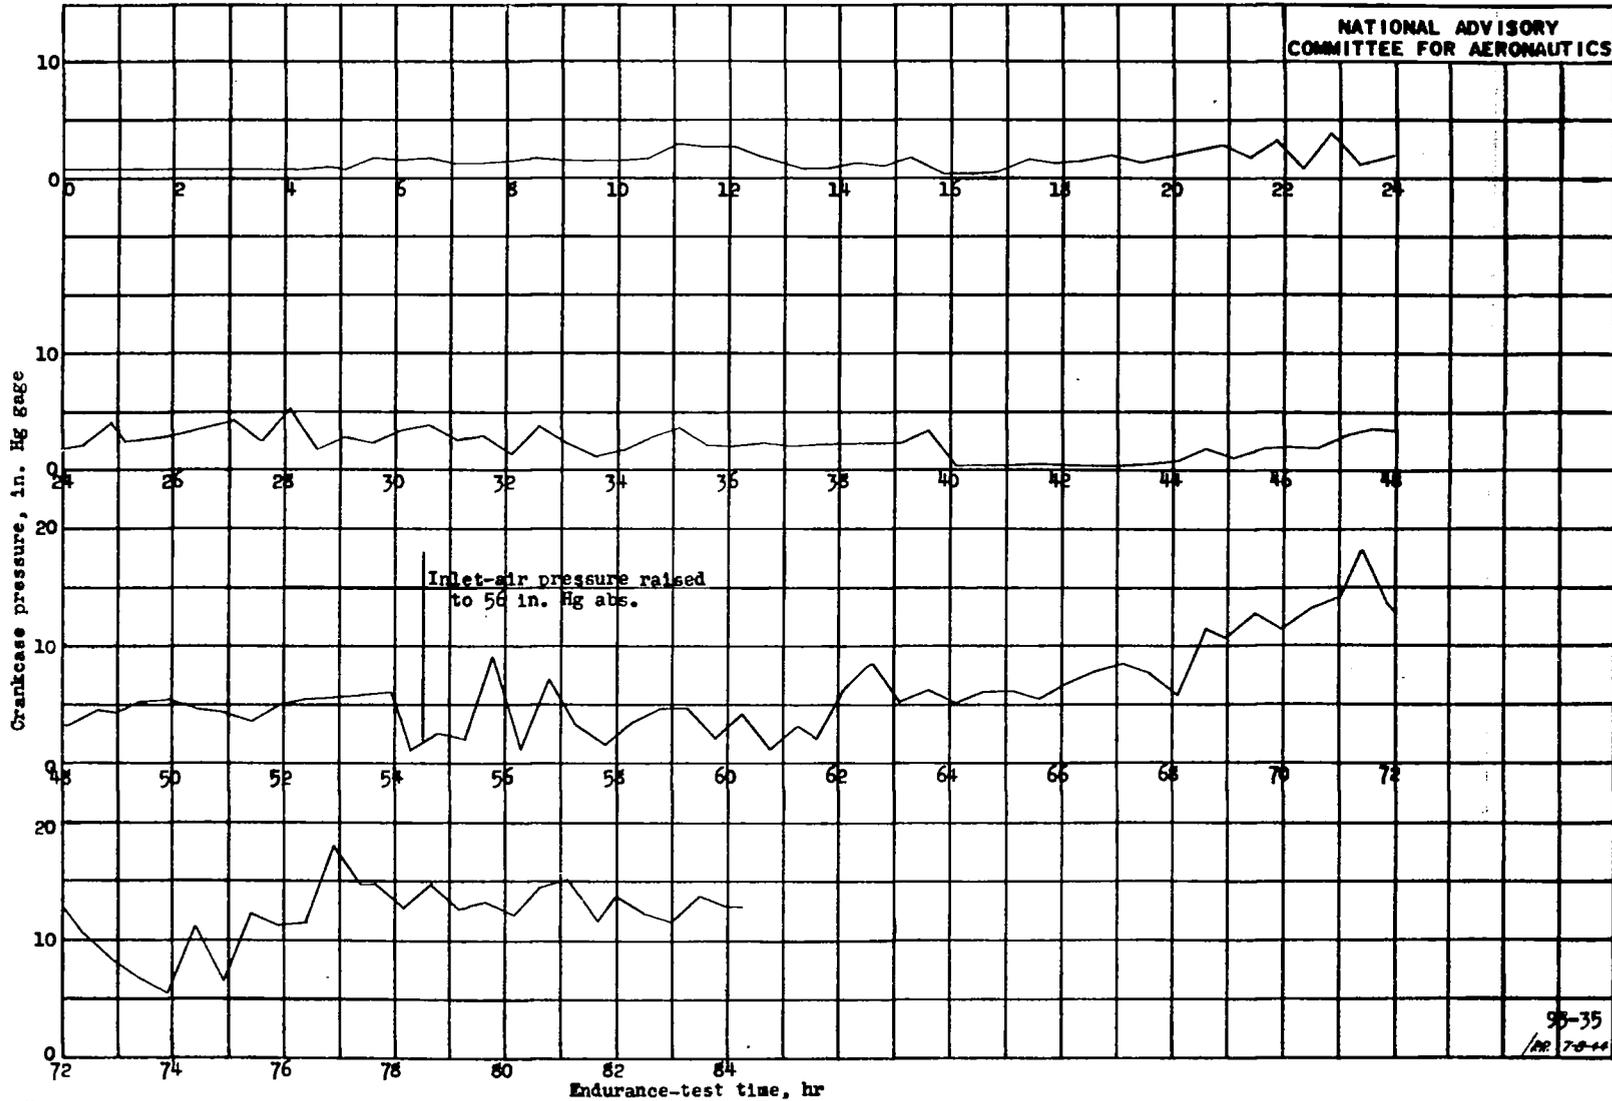
Figure 11. - Effect of running time on crankcase pressure for second endurance test. Engine speed, 2600 rpm; inlet-air pressure, 50 inches of mercury absolute (except as noted); inlet-air temperature, 200° F; fuel-air ratio, 0.085; oil flow to piston, 0.5 pound per minute.

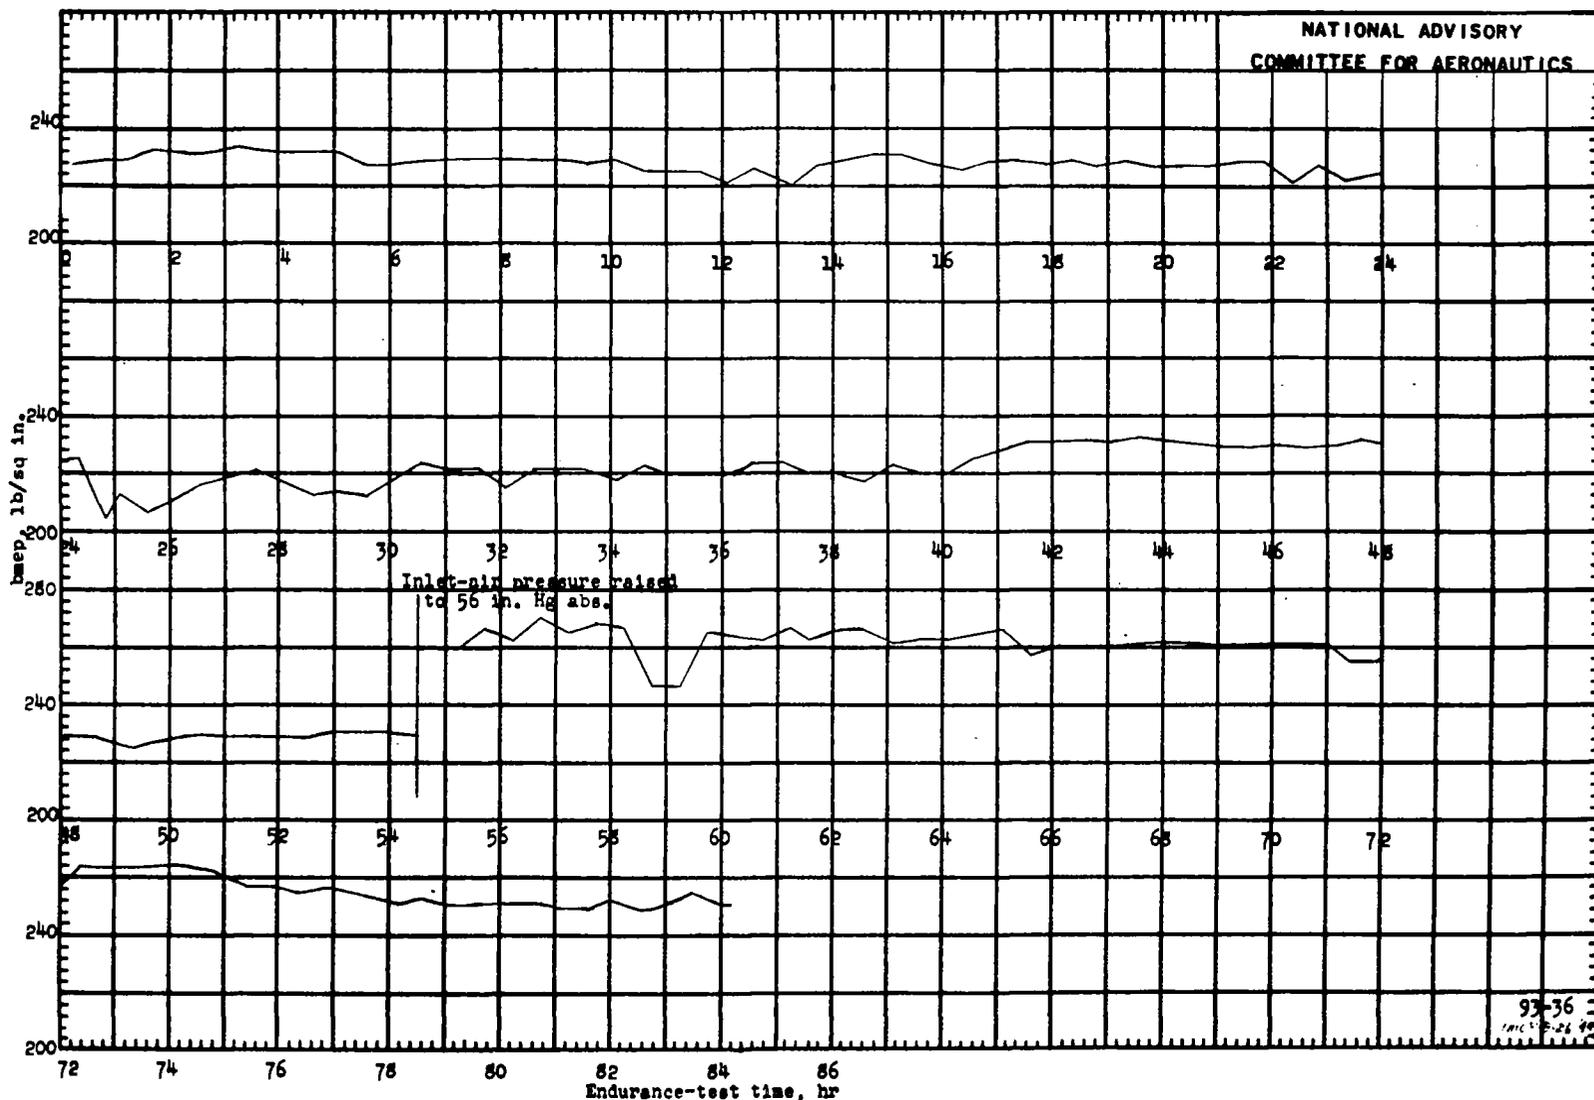
Figure 12. - Effect of running time on brake mean effective pressure for second endurance test. Engine speed, 2600 rpm; inlet-air pressure, 50 inches of mercury absolute (except as noted); inlet-air temperature, 200° F; fuel-air ratio, 0.085; oil flow to piston, 0.5 pound per minute.
