COMPARISON OF BULLET RESISTANCE OF NEW AND AGED POLY-CARBONATE

J.B.R. Heath, R.W. Gould, E.B. Stimson
National Aeronautical Establishment
National Research Council of Canada
Ottawa, Canada, K1A 0R6

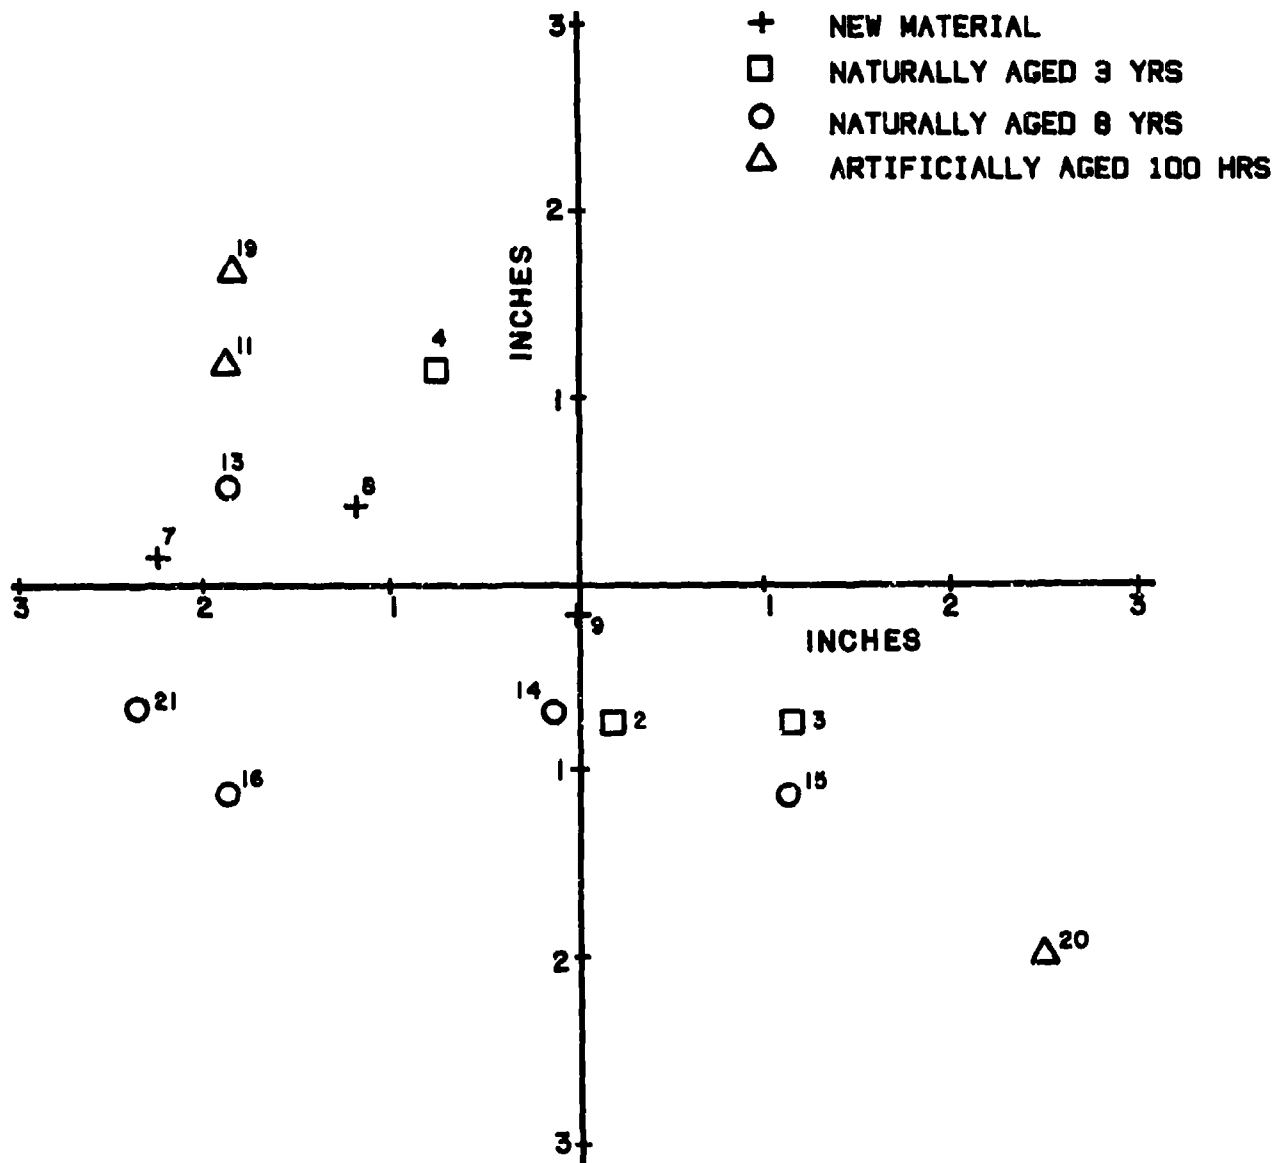
FIG. 21 BULLET POSITIONS ON DEVIATION SCREEN AFTER PANEL PENETRATION

Bullet deviation, after penetration, is plotted in Figure 21, and as can be seen from the scatter, seems to be independent of material history.

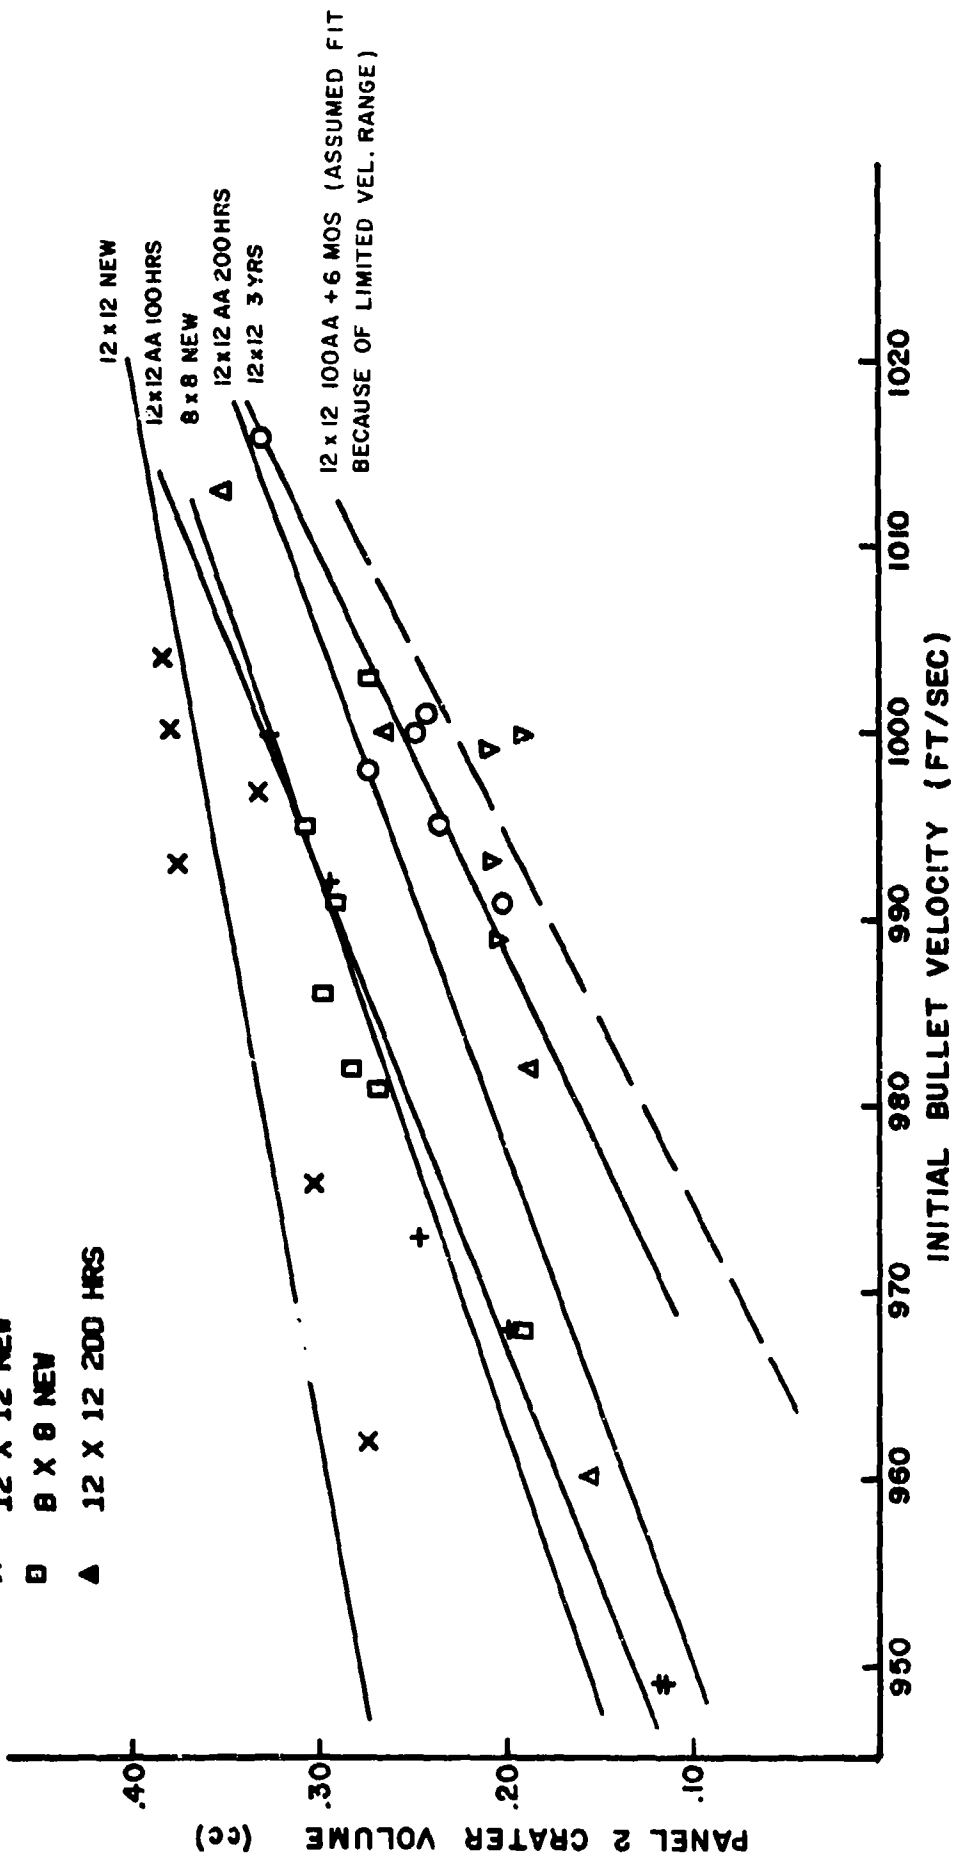
FIG. 22

The results of Part II are summarized in Table 3, and Figure 22 shows a plot of crater volume versus initial bullet velocity. It should be noted that bullet penetration of panel 2 did not occur in any of the tests. Figure 23 shows typical impact damage in sections taken through panels 1 and 2. The following sections detail the results of the various tests.

Figure 22 further supports some points discussed in the previous parts. It is quite evident that material behaviour, particularly yielding on impact, had changed as a result of both artificial heat aging, and natural aging. Also, quite evident is the difference in behaviour between the artificially heat aged (100 hours) material that had been processed some six months before testing and the material processed days before.
