TITLE: Minutes of the Explosives Safety Seminar (22nd) Held in Anaheim,
California on 26-28 August 1986, Volume 1.

DEBRIS HAZARD AT A ROCKET
MOTOR TEST CELL FACILITY--
AN "ACCIDENTAL" STUDY

Patricia Moseley Bowles
and
Michael A. Polcyn

Southwest Research Institute
San Antonio, Texas

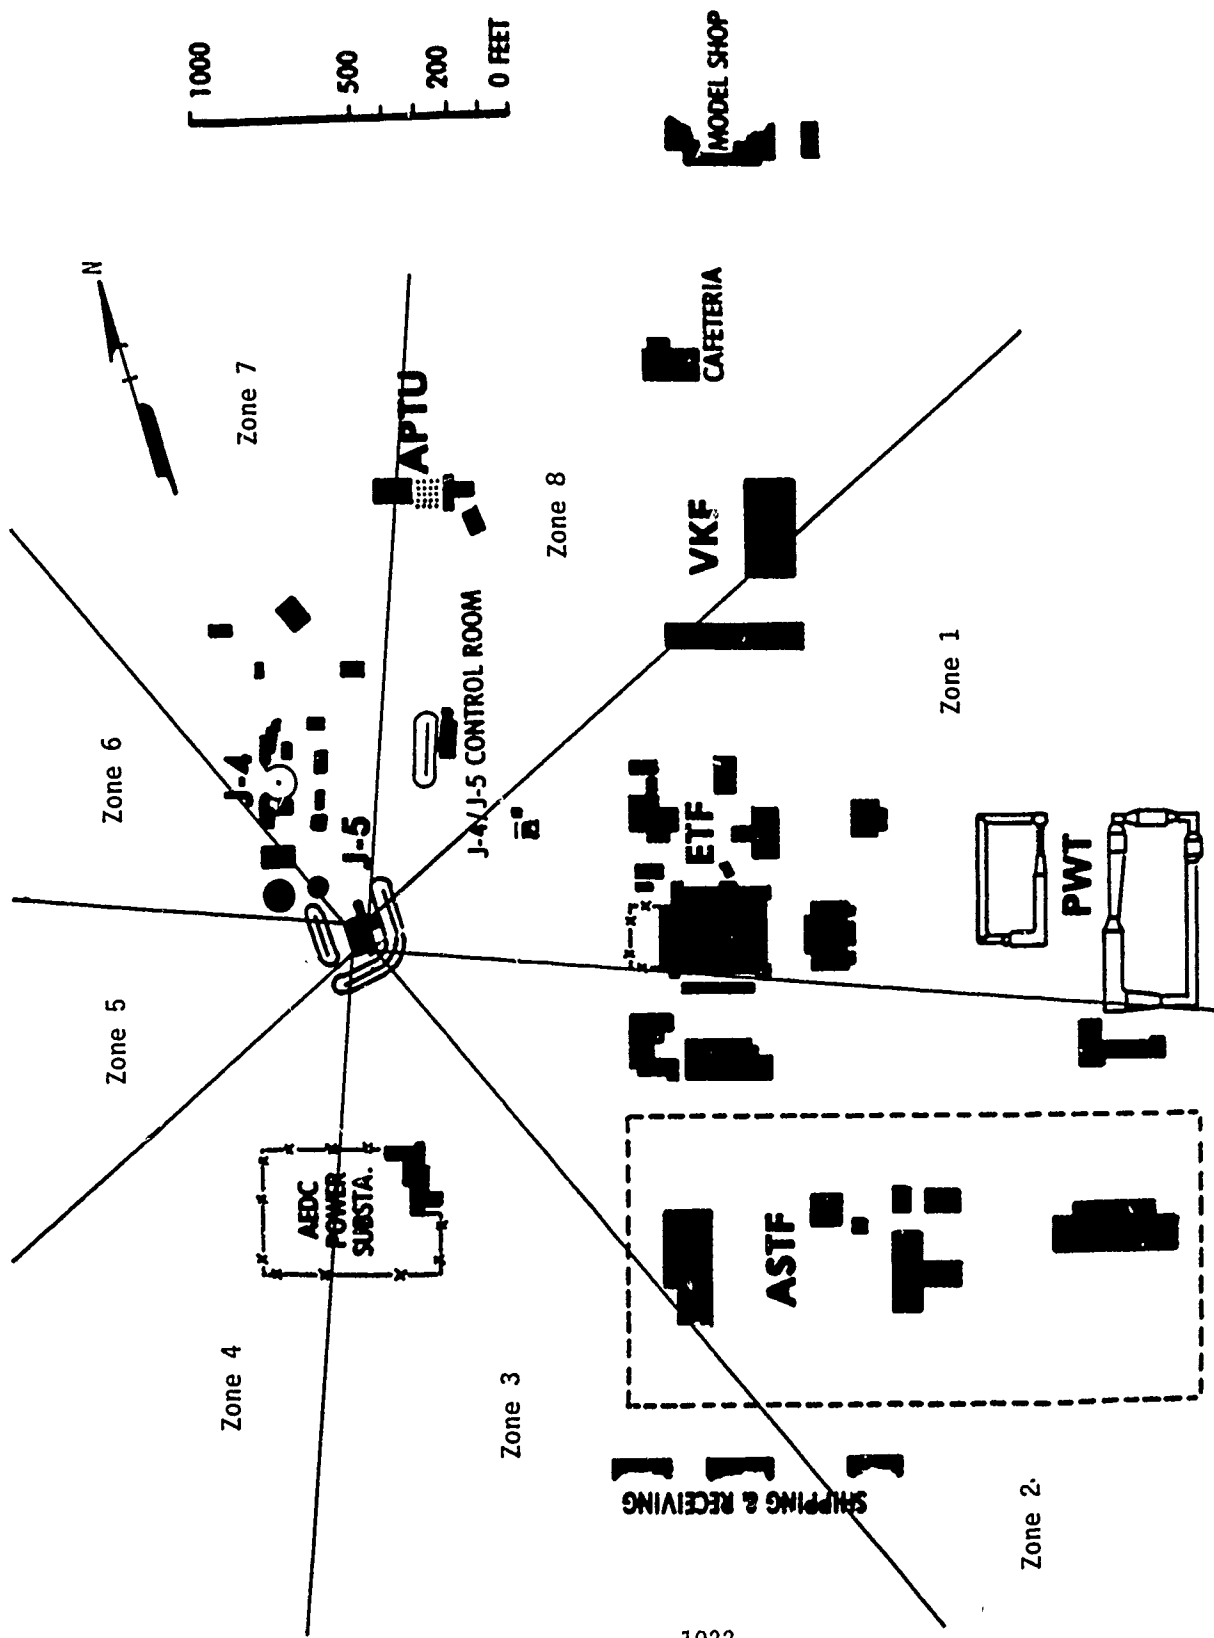
Figure 5. Debris Zones for an Explosion in J-5

Elevations of the J-5 enclosure building and an expanded detail of the test cell are shown in Figures 2-4. Since the J-5 test cell and enclosure building are similar to the configuration described in Reference 1, debris were expected to be similarly distributed in zones around the enclosure building. The zones which were established for examining hazardous debris densities are shown in Figure 5. Debris densities were estimated in zones 1, 3, 5 and 7 since the number of debris landing in the other zones was assumed to be minimal. Building debris will be dispersed in directions normal to the walls of the enclosure building. The heaviest concentration of motor casing and test cell fragments was predicted in zone 5 because it extends perpendicular to the horizontal axis of the test cell. Approximately 70% of the total fragments and debris will land in zone 5. Although zone 1 extends in the direction opposite of zone 5, fewer casing and cell fragments will land there since a 5 foot thick seismic mass (see Figure 2) supports the test cell on that side. The seismic mass will stop all but high trajectory fragments. About 20% of the total debris will land in zone 1. The remaining 10% of the debris will be distributed in zones 3 and 7, with slightly more debris landing

in zone 3. The percentage of debris landing in zones 2, 4, 6 and 8 is insignificant. It should be noted that while the percentage of fragments landing in zones 3 and 7 is relatively low, the cell endcaps and hatch covers will most likely impact in these areas. Thus, the damage potential of these large debris is a more important consideration than hazardous debris density in the immediate J-5 area. In summary, the distribution of fragments and building debris was expected to be highly directional with heavy debris concentrations in zones normal to the walls of the enclosure building. Debris paths and concentrations of major debris observed during the mishap investigation lend new support to this theory.

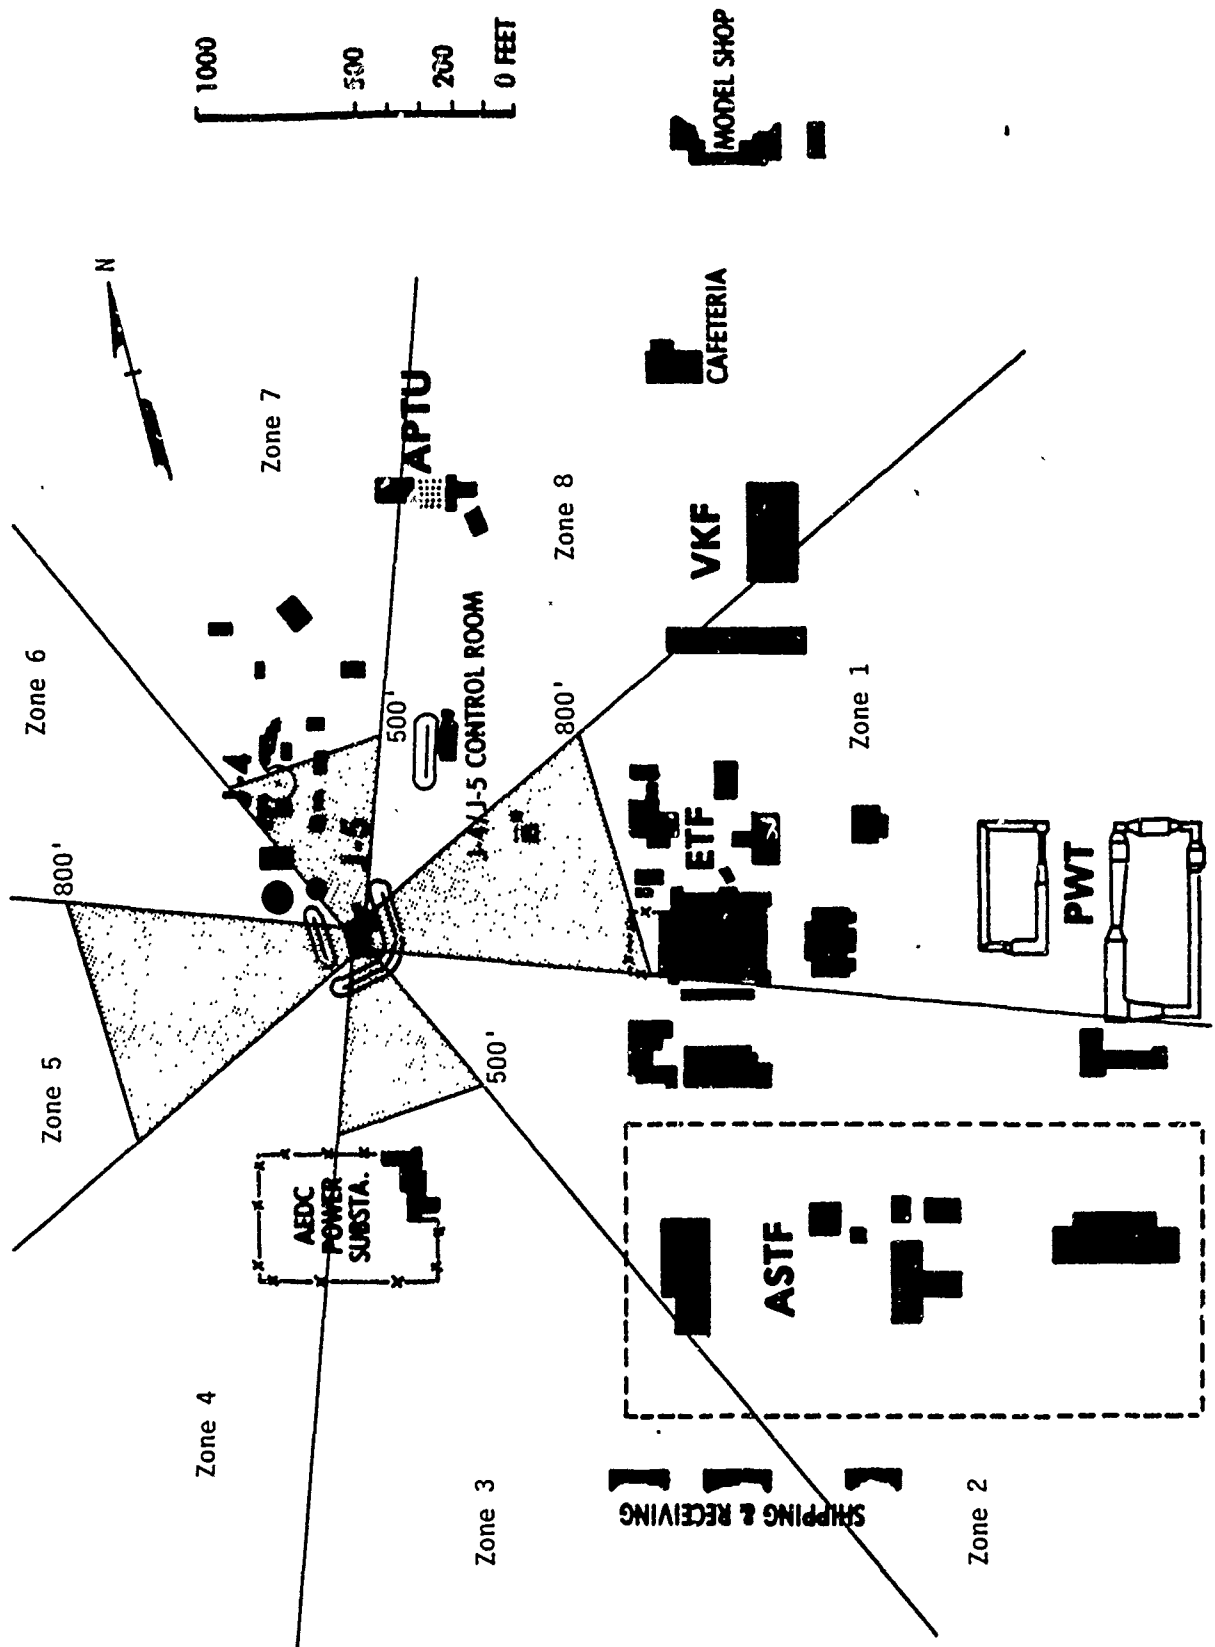
Figure 7A. Hazardous Debris Areas for a 20,000 lb TNT Equivalent Detonation

The hazardous zones predicted for a 20,000 lb TNT equivalent propellant detonation are shown in Figure 7A. The limit distances indicate the threshold of hazardous fragment density, defined as more than one fragment with kinetic energy greater than 58 ft·lb per 600 square feet. Impact locations of a few of the larger cell and building debris from the mishap are shown in Figure 7B. The location of the impacts furthest from the test cell in each zone are indicated on the figure. Note that these are locations of single fragments and do not correspond to the limit distances for hazardous fragment density for the mishap. The hazardous density for the mishap was limited to the bermed J-5 area.
