TITLE: Minutes of the Explosives Safety Seminar (22nd) Held in Anaheim,  
California on 26-28 August 1986. Volume 2.

MULLER MIXER FIRE  
"LESSONS LEARNED"

MORTON THIOKOL, INC.

Longhorn Division

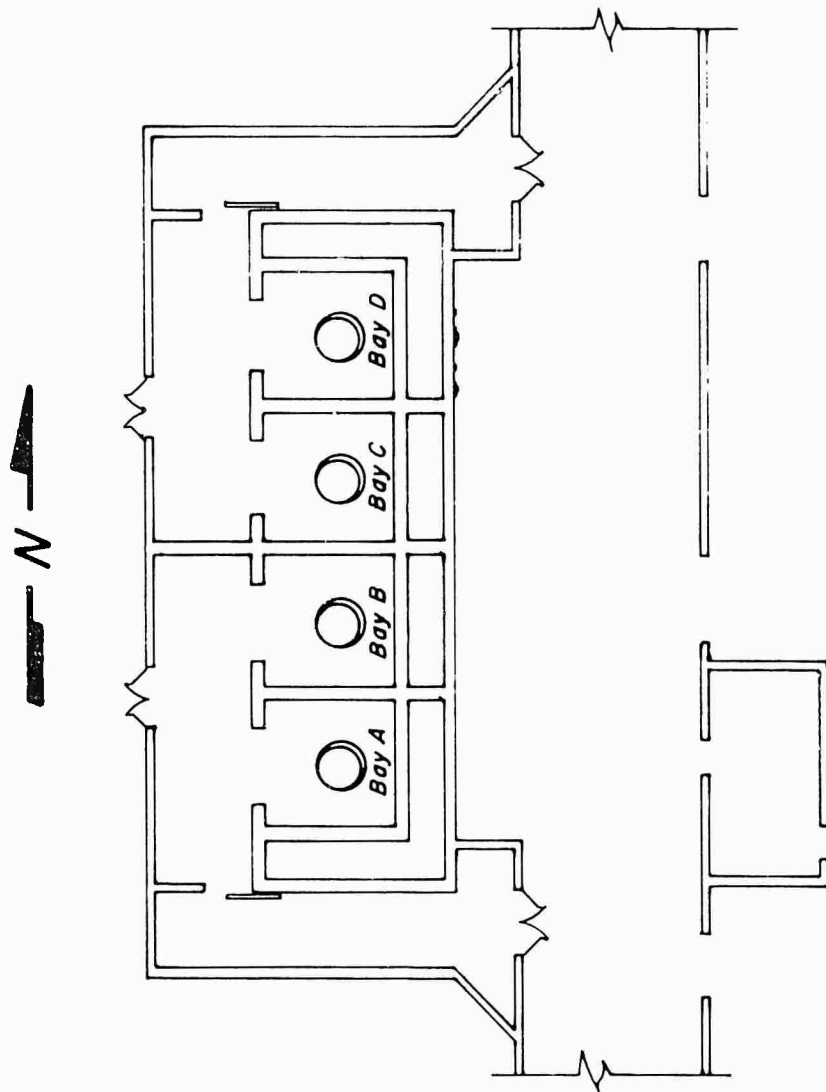
Figure 1

Longhorn AAP has used this blade to bowl contact mulling procedure since the mid-60's. The mixer wheels/plows revolve at approximately 18 RPM and are driven by an 1800 RPM 3 H.P. motor through a double belt sheave and gear box. The bowl diameter is approximately 39 inches and 12 inches deep with the mulling wheels/plows geared to move in a counterclockwise rotation. All bays are equipped with closed circuit TV monitors, Backrack explosive vapor alarms, Detronics UV rapid acting deluge and fusible link wet pipe fire protection systems with electrically interlocked emergency exit doors, fire door and vapor alarms to remote controls. Also provided is 100 percent make up air with temperature and humidity control, vapor/dust removal systems connected to an external wet type Rotoclone dust collector that is electrically interlocked to the control panel. Walls between bays and control room are substantial dividing walls of 12 inch thick reinforced concrete with three feet of sand fill between bay and control station walls. (Figure 1 illustrates B11 configuration)
