TITLE: Workshop on Avionics Corrosion Control: Meeting of the Structures and
Materials Panel of AGARD (62nd) Held in Hovik (Norway) on 16-17 April 1986.

CORROSION OF ELECTRONIC COMPONENTS

Dr Bill Dobbs

Electronic Failure Analysis Group
Air Force Wright Aeronautical Laboratories/Materials Laboratory
Wright-Patterson AFB OH 45433-6533
USA

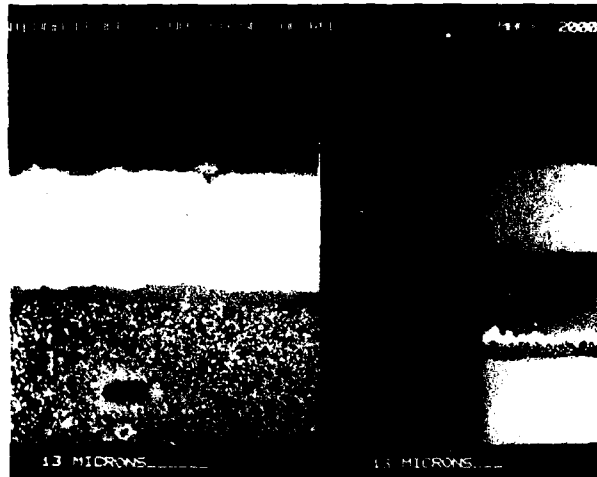
Figure 11. X-ray map of cross-sectional area of copper/tin plate on aluminum blade of beacon. See Figure 13.

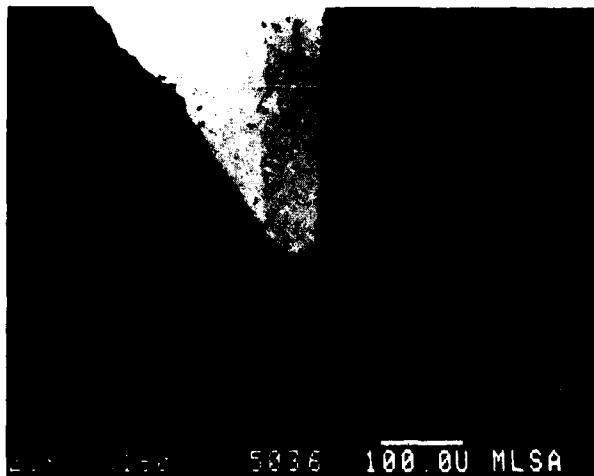
Figure 20. SEM micrograph of cross-sectional area of PWB. Constitutive parts from the left are: void, conformal coating, solder, copper, and epoxy/fiberglass board matrix. See Figure 21.

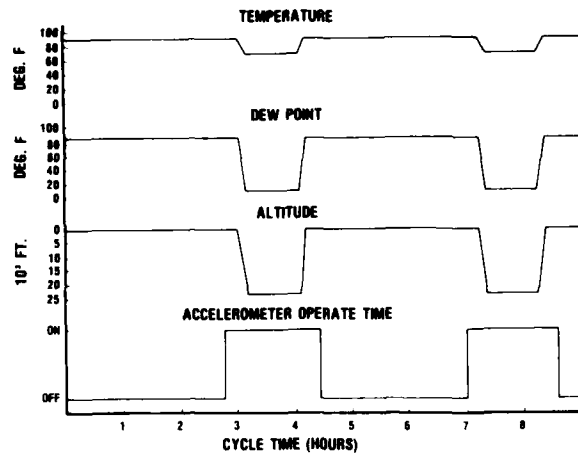
An aircraft accelerometer was environmentally sealed instead of hermetically sealed. After extended use the accelerometer failed. Several accelerometers were tested in the Combined Environmental Reliability Test (CERT) chamber to establish the failure mode. The stresses used in the CERT chamber were selected to approximate the actual aircraft environment. The stresses included temperature cycling, humidity cycling, and altitude cycling, Figure 38. The accelerometer was electrically operational during a certain part of the cycle. After the accelerometer went through one hundred fifty cycles, it failed. The package was opened, Figures 39 and 40, and it was easily seen that corrosion residues were shorting out various parts of the circuits. This failure may be eliminated by hermetically sealing the accelerometer package.

Figure 38. Spectrum of CERT stresses applied to accelerometer.

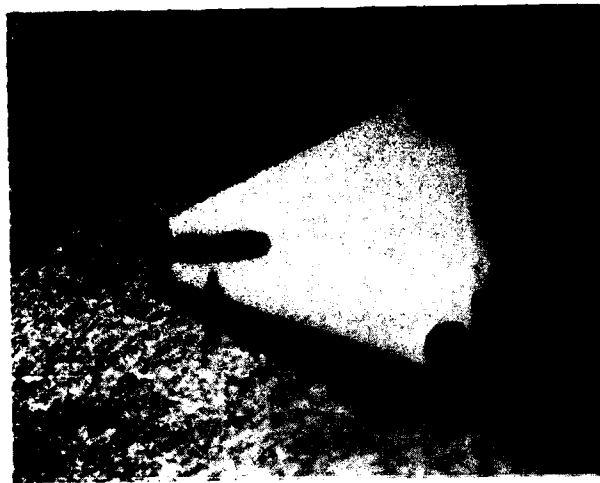
Disk recorder heads, Figure 41, were failing at a very high rate. This was happening in an area where the recorder operator was smoking cigarettes. Some of the particulate matter in the smoke was being trapped between the disk and the head. This contamination with the moisture available from the air was causing pitting corrosion in the head, Figure 42. It was recommended that the operator not smoke in the recording area and that the heads not be cleaned with a halogenated cleaning solvent. Use an alcohol.

Figure 41. Disk recorder head. Arrow marks metallic head.

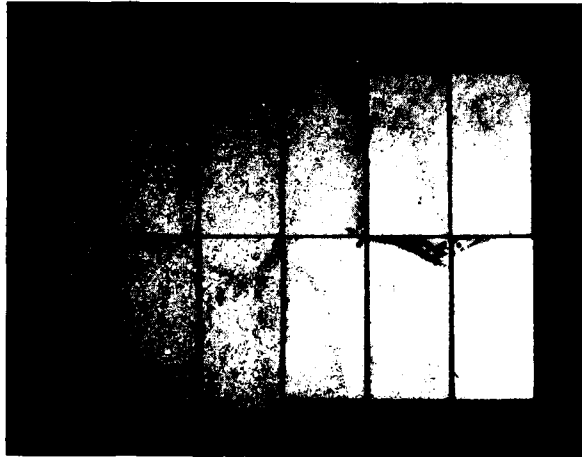
Twelve nickel/boron coated aluminum plates, Figure 51, were given electrical and environment tests. Samples 1, 2, and 3 were 6062 aluminum and samples 4 and 5 were 2024 aluminum. The nickel/boron coating was 90% nickel with 10% boron diffused into it. A piece was cross-sectioned and it was found that the coating was made in two layers, Figure 52, each layer 0.625 mil thick. The faying surfaces were prepared for test by overlapping the pieces and drilling holes through the panels. The two plates were bolted together with nylon screws, Figure 53. A torque wrench was used to apply one inch pound of torque to each bolt.

Figure 51. Twelve nickel/boron plated aluminum panels to be tested.
