Industrial Case Histories

Kevin R. Guy

C J Analytical Engineering, Inc
R.R. #1 Box 353
Francisco, Indiana 47649
cjinc@cyanalytical.com

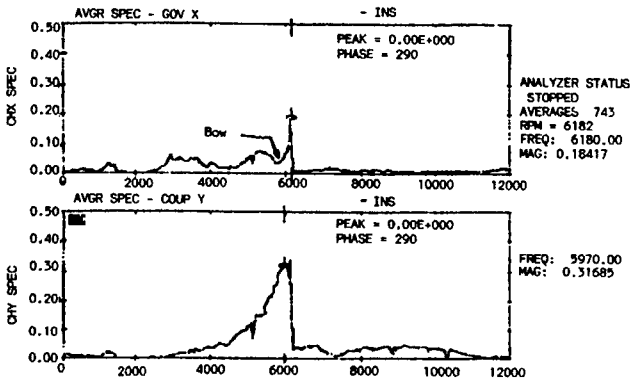
Figure #4

Corrective Action: Since the second balance plane (exhaust end) was closer to the mid span and we were trying to balance a first mode it was decided to place weights in this ring. Also, since this ring was closer to bearing #2 and the highest vibration was on bearing #1 a two plane balance program was entered. The unit was successfully balanced below the first critical; however, the unit again tripped at the second critical. A second two plane balance program was started below the second critical. During the balancing at the second critical two other problems developed. The unit suffered a rub and a bow was detected in the coastdown data (figures #4 & #5). The rub was not initially detected and several balance runs were lost to the rubbing.

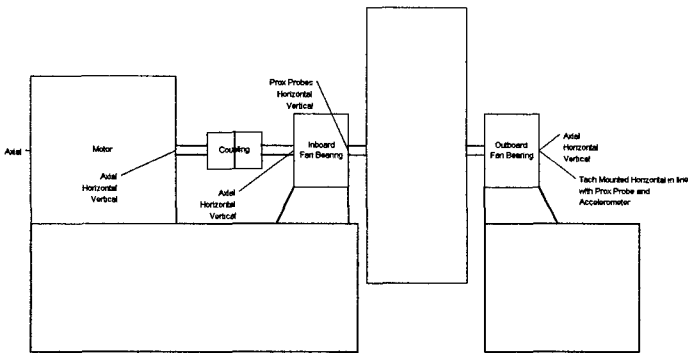
Once this testing was completed operational data was collected. Figure #6 contains a layout of the test points.

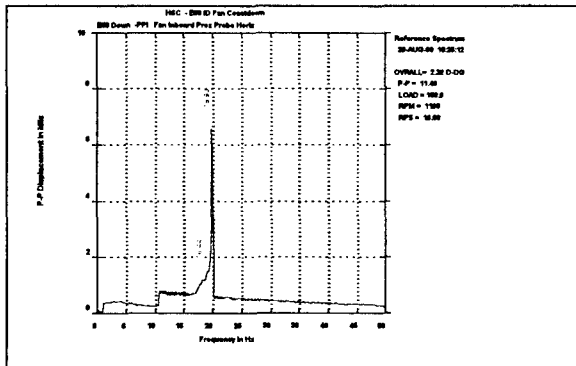
Figure #8

Phase and amplitude data showed thermal vectors as high as 6.8 mils (Figure #7). Coastdown data indicated the vibration dropped off almost immediately as the power was cut (Figure #8). This is a definite indication the fan is running very close to a natural frequency. In 52.5 cycles, the shaft vibration drops by over 76%

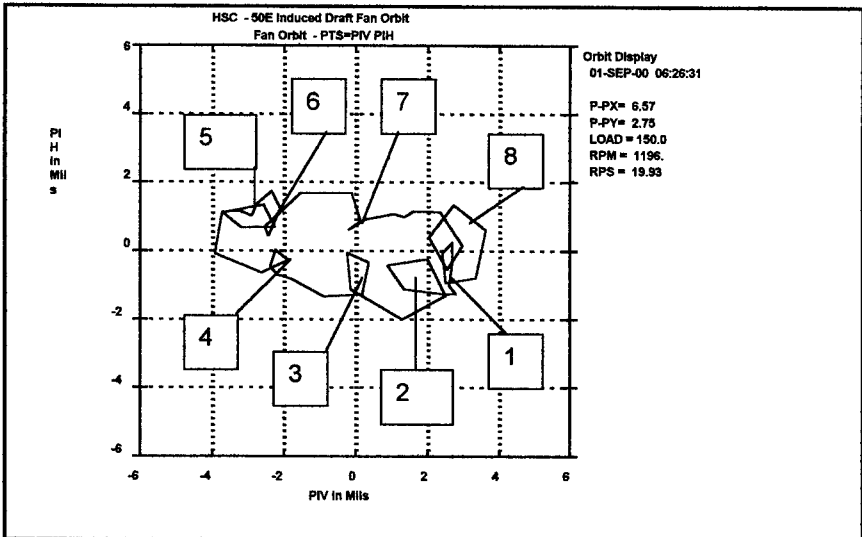
Figure #10

The internal loops indicate a forward whirl of the shaft. The frequency of the vibration is found from the following formula:

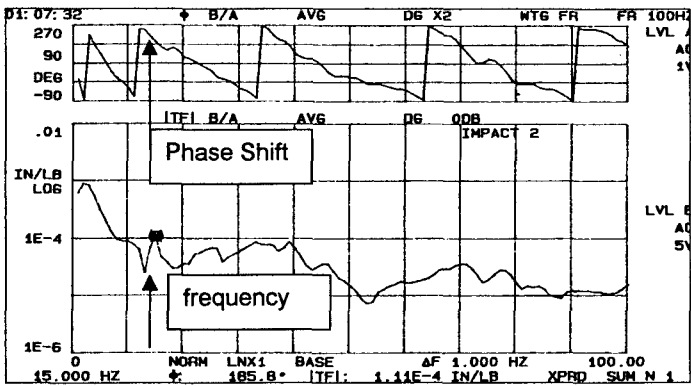
Figure #14

The Shaker tests indicated distinct natural frequencies around blade pass Figure #13). The amplification (Q Factor) from the tests were from 5.3 to 10.5 plus. Impact test (Figure # 14) and Shaker Test results can be found in Table III.

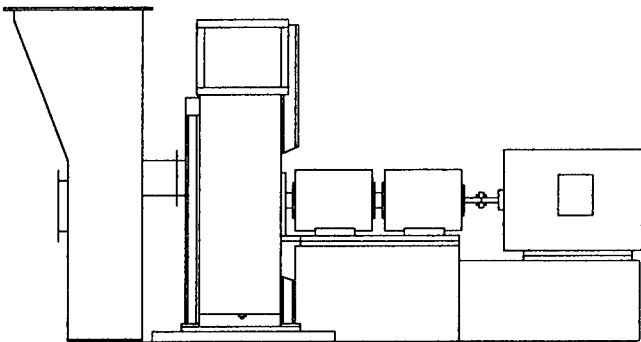
Figure #16

Problem: This plant has had a history of recurrent vibration problems on their primary air fans. Looseness problems show up several times per year. The fan is an overhung design (figure #16). The replacement of the straight bore babbitt bearings is followed by a balancing of the fan using seismic readings. The fan is easily balanced below 1.0 mils (pk-pk). However; the vibration is always back into alarm with in a few weeks.

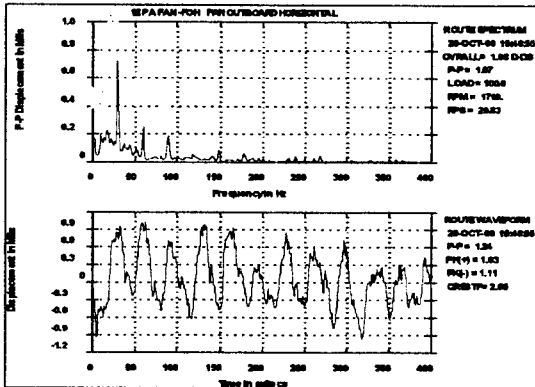
Figure #19

The fan was balanced with seismic sensors. This has been the balancing procedure since the fan was put in operation in the early 1980's. The fan was balanced in one shot using past sensitivities and lag angles. Vibration levels were below .80 mils (pk-pk) at operating speed (Figure #19).

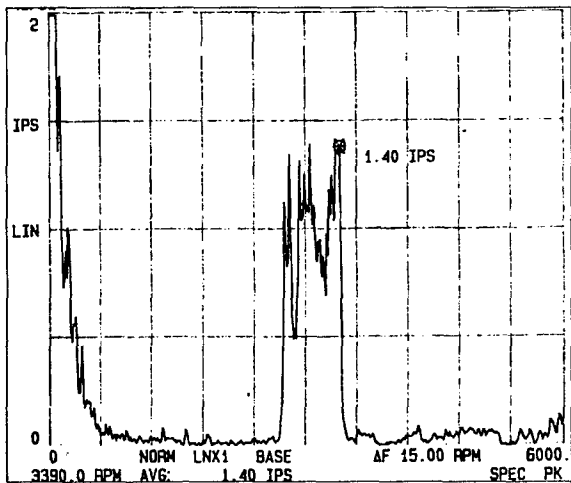
Test Data and Observations: The initial request was to find if the unit could be relied upon for load sales the next day. Vibration data collected on the turbine indicated a ratty vibration spectrum with most of the vibration below running speed. Figure #22 shows the outboard pump bearing with over 1.40 in/sec of vibration at 3390 cpm. The inboard pump bearing had high vibration (>.75 in/sec) at 2900 cpm. This data indicate two possible problems. First the 3390 cpm frequency was a problem caused by rubbing of the rotating and stationary balance components of the pump. This was determined from past documented data on boiler feed pump vibration problems. Second, the spectrum from the inboard end of the pump indicated a frequency that was too low to be a rubbing problem in the pump.

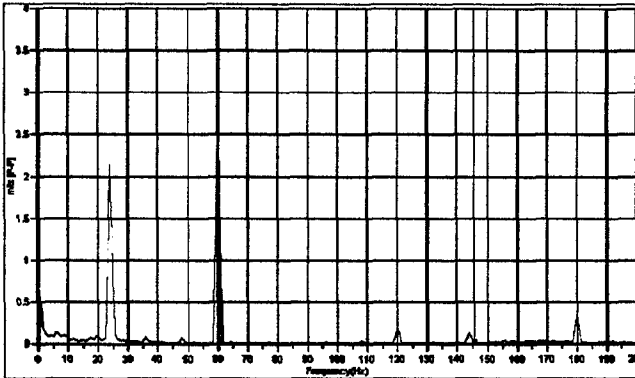
Figure #24

The data indicated the vibration was all subsynchronous (Figure #24). An oil whip problem was detected during the over speed testing of the unit (Figure #25); however, this was only present during the running of the over speed tests. During the over speed testing; the subsynchronous vibration was locked on 24.75 Hz

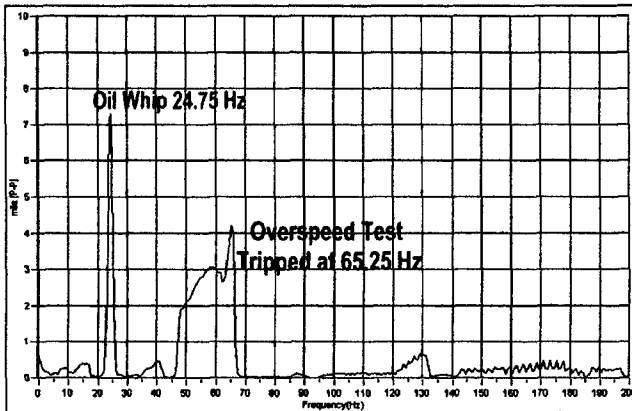
Figure #25

(1485 cpm) and appeared instantaneously. The onset of this whip during overspeed testing was at a shaft speed of 3510 rpm (58.5 Hz).

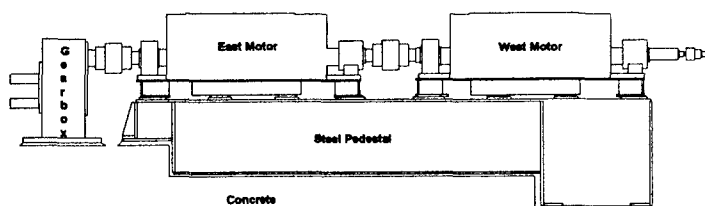
Figure #39

Problem: Immediate problems were suffered during the initial running of two new DC motors. The motors were a retrofit of older drive motors on an aluminum rolling mill. The new motors (two motors in series – Figure #39) were supplied by General Electric with a maximum operating speed of 1500 rpm. The motors are a complete retrofit including the motor frame and pedestal. It should be noted the steel pedestal for the system is hollow. A sister installation of this system is installed in another plant and operating without vibration problems throughout the speed range.

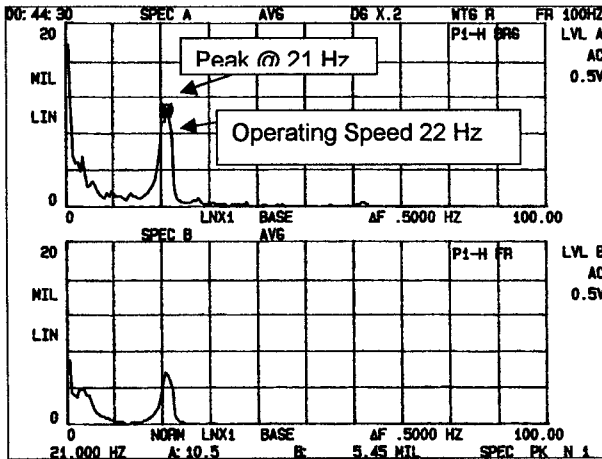
Figure #40

Symptoms: The motors were still not in operation; however, during trial runs high vibration amplitudes were found on the west motor while running around full rolling mill speed, 1260 rpm (21 Hz). While there was vibration on the east motor the amplitudes were acceptable. During the setup of equipment for testing the motor accidentally turned on and went up to just above operating speed (Figure #40). This data indicated the vibration increases suddenly when the motor speed is at the top end of the operating range.

The operating speed reached 22.0 Hz with the peak vibration at 21.0 Hz.

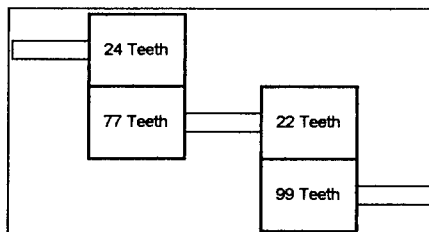
Symptoms: During the equipment baseline check out and acceptance process high vibration was experienced on the input shaft of the gearbox in the horizontal direction. Vibration amplitudes of over .60 in/sec 0-pk were documented. The plant had set overall alarm settings of .10 in/sec 0-pk. The vibration appeared to occur in only one area of the speed range. Figure #43 is a schematic of the gearbox layout.

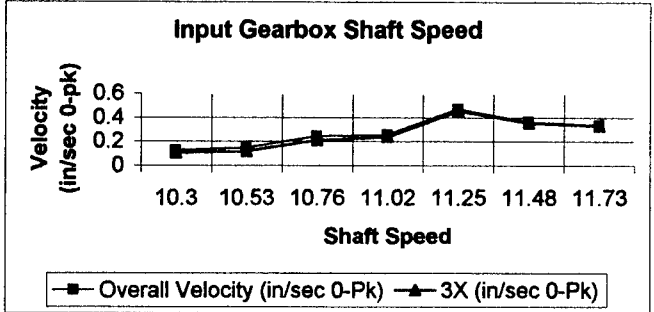
Test Data and Observations: The motor was operated through out its speed range and the overall vibration was recorded from 2100 fpm to 2450 fpm. Figure #2 shows us this is from 10.3 Hz to 11.73 Hz on the motor . The overall vibration data plotted against motor speed is in figure #45. Figure #45 illustrates how the vibration peaks when the motor is operating at 11.3 Hz. Vibration spectral plots were taken at various speed setting. Figure #46 shows the vibration at a motor speed of 9.88 Hz and Figure #46 shows the data from a motor speed of 11.25 Hz. The Data at 11.25 Hz shows a vibration at 3X running speed of the motor. The time data is essentially a pure sine wave.

Corrective Action: The plant turned over the data to the equipment supplier and instructed them to redesign the equipment foundation.

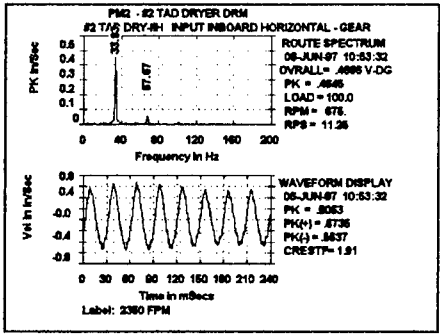
Figure #47

The excitation frequency at 33.9 Hz is equal to the dominant frequency of 33.81 Hz in figure #47. This is a definite indication that the excitation frequency of the motor is exciting a natural frequency when the motor speed is 11.25 Hz.

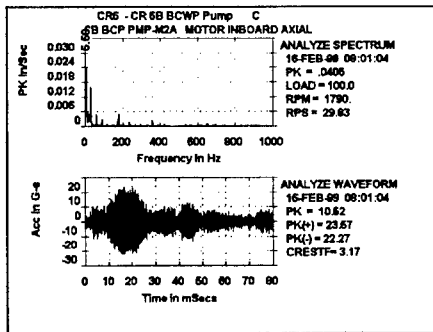
Figure #50

This data was collected with 400 lines of resolution with an Fmax of 5000 Hz. The resolution for this plot is 37.50 Hz per bin. Because of the bin width, frequency identification would be difficult. Timewave data shows peak acceleration at 23.57 g's. Looking at the same data on a smaller frequency range shows the 1X vibration along with a frequency at 5.58 Hz (Figure #50). A walk down of the unit revealed a high pitch squeal around the pump. The motor pump train operates at 29.58 Hz with radial bearings in the motor, top, and bottom of the pump. Below the upper pump bearing are two thrust bearings.
