HEADQUARTERS AIR PROVING GROUND COMMAND Eglin Air Force Base, Florida

> FINAL REPORT ON OPERATIONAL SUITABILITY TEST OF THE RB-57A AIECRAFT

PROJECT NO. APG/TAS/122-AB

20 April 1955

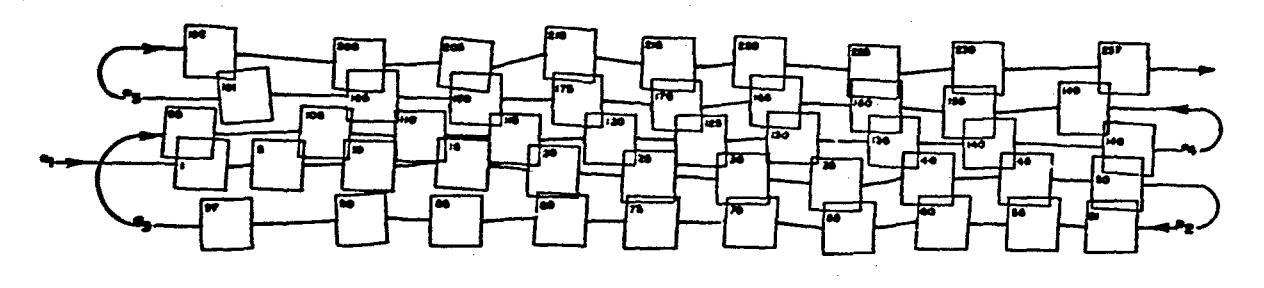
UNCONTROLLED _____ EGLIN A.F.B. AREA T-II CAMERA 6° F/L _____ ALTITUDE 15,840 FT 12 MAY 1954 _____ PHOTO SCALE 1 : 31,680 FLIGHT LINE CONTROL: T-I OPTICAL SIGHTHEAD

BROXEN LINES INDICATE PROBABLE PHOTO COVERAGE ONLY. CAMERA MALFUNCTION OCCURRED ON FLIGHT LINE *3. PHOTO POSITIONS (BROKEN LINES) BASED ON MSQ-1 GROUND CONTROLLER'S OVERLAY OF FLIGHT PATH OF AIRCRAFT.
