WADD TECHNICAL NOTE 60-296

F-102 HIGH-ALTITUDE FLAMEOUTS IN AND AROUND THUNDERSTORMS

JANUARY 1961

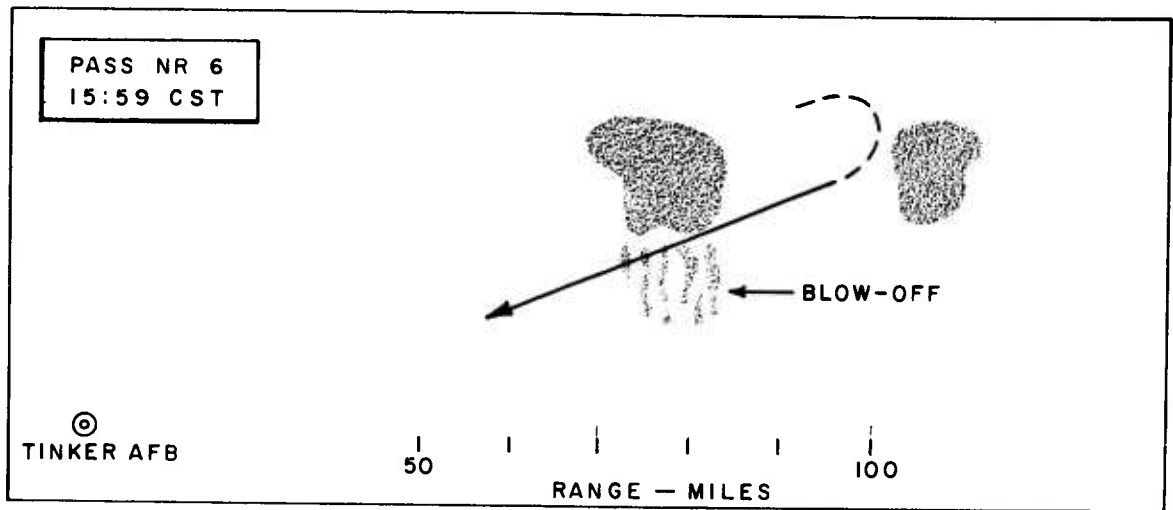
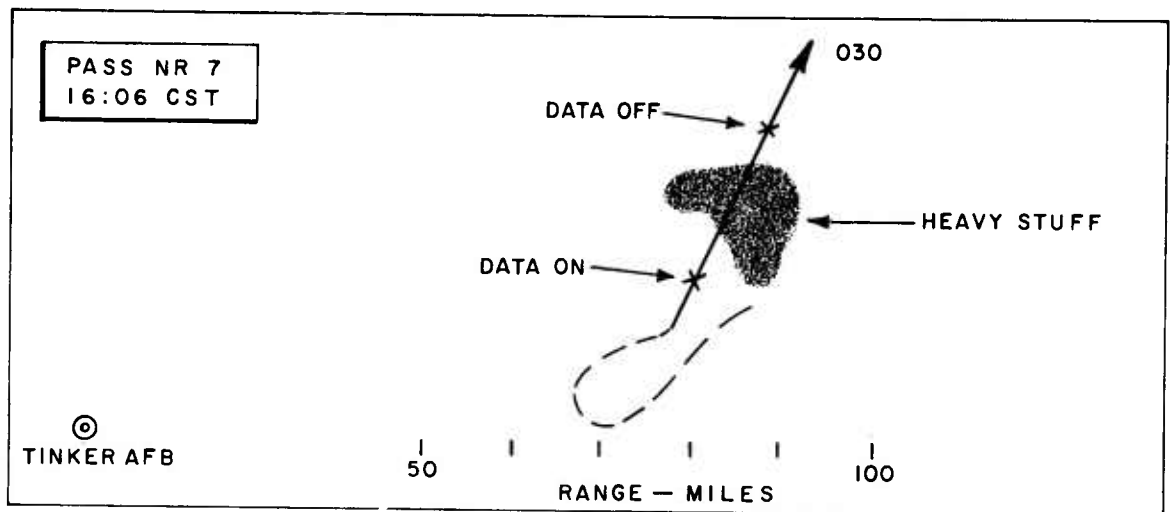
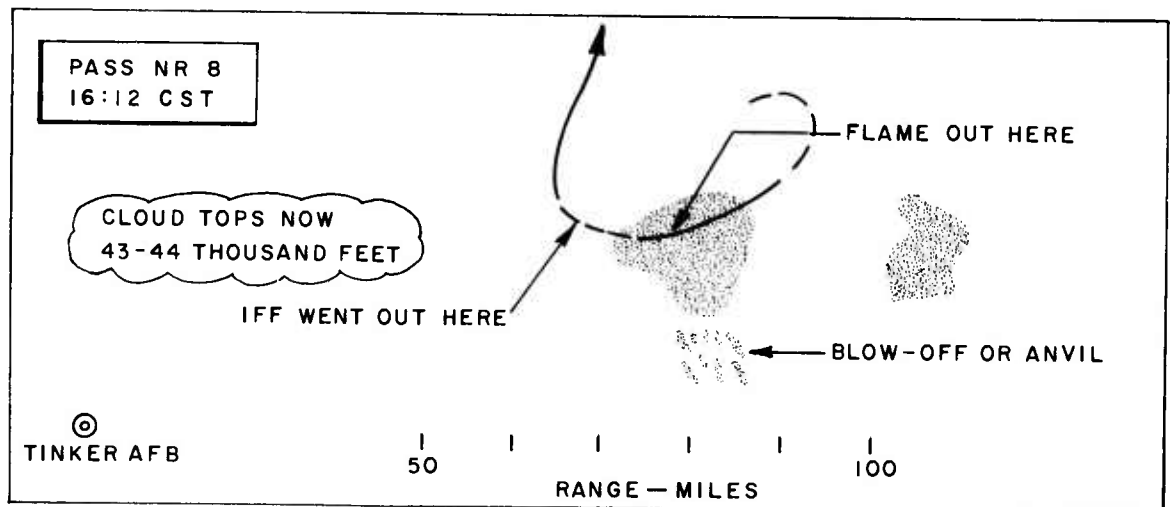
Figure B5. (Continued)

15:45 - Heading 210° at 38,000 feet. Experienced moderate turbulence and some moisture. After four stalls the airspeed dropped off 40 knots. RPM hung up at 78 percent for a while and then gradually increased to 79 percent. Fuel flow was stuck at 1500 PPH, EGT 400°, EPR 1.75. The aircraft broke out of the storm at 36,000 ft and engine recovery from this point was good. 23 stalls were experienced. They were not as strong as previous stalls but were spaced close together causing a rapid loss of EPR and RPM.
