MINISTRY OF AVIATION

TROPICAL TESTING ESTABLISHMENT
PORT HARGOURT, NIGERIA

THE BEHAVIOUR OF PAINTS
IN THE TROPICS

November, 1961

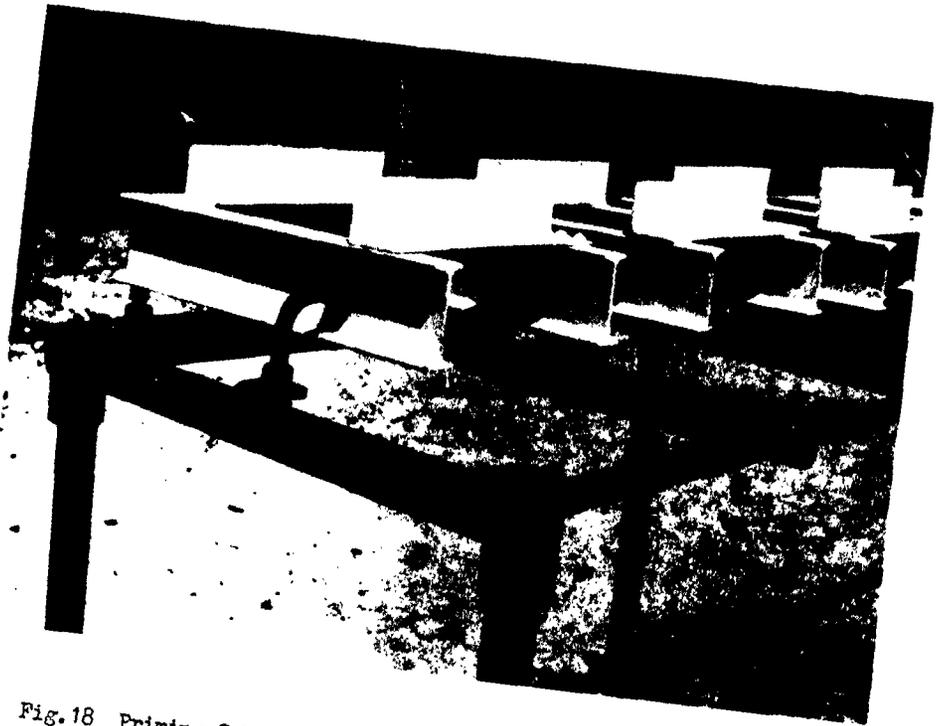
Fig. 18 Priming Schemes for Metallic Coatings (Trial sponsored by the British Iron and Steel Research Association). The method of exposing the complex shapes is shown.

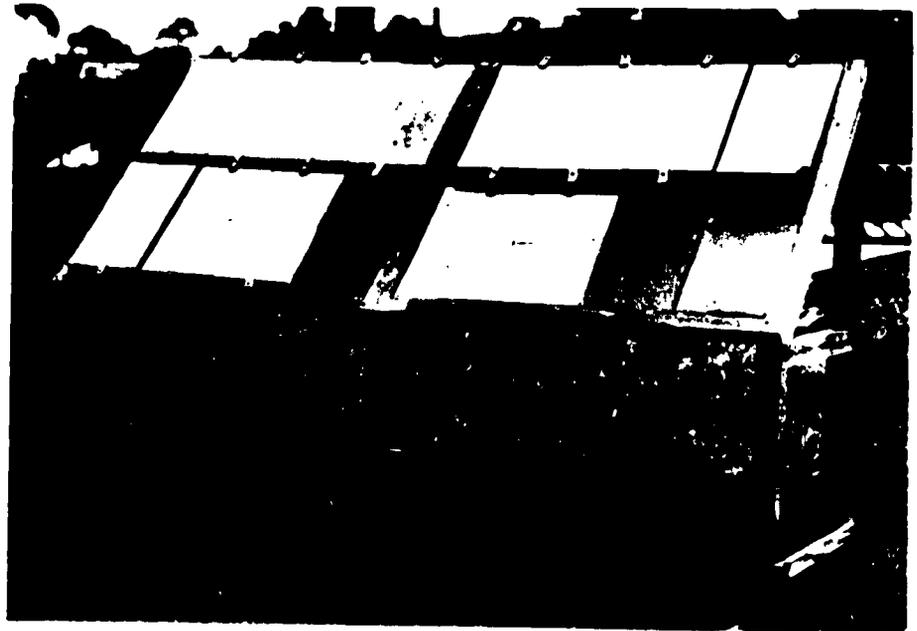
Fig.21 General Purpose Paints (Red Hand Compositions Co.) exposed at town site, Port Harcourt. The four panels on the right-hand side of the bottom row are asbestos cement and the remainder are wood. (Note heavy dirt collection on one of the wooden panels, Serial No. B1-4.)

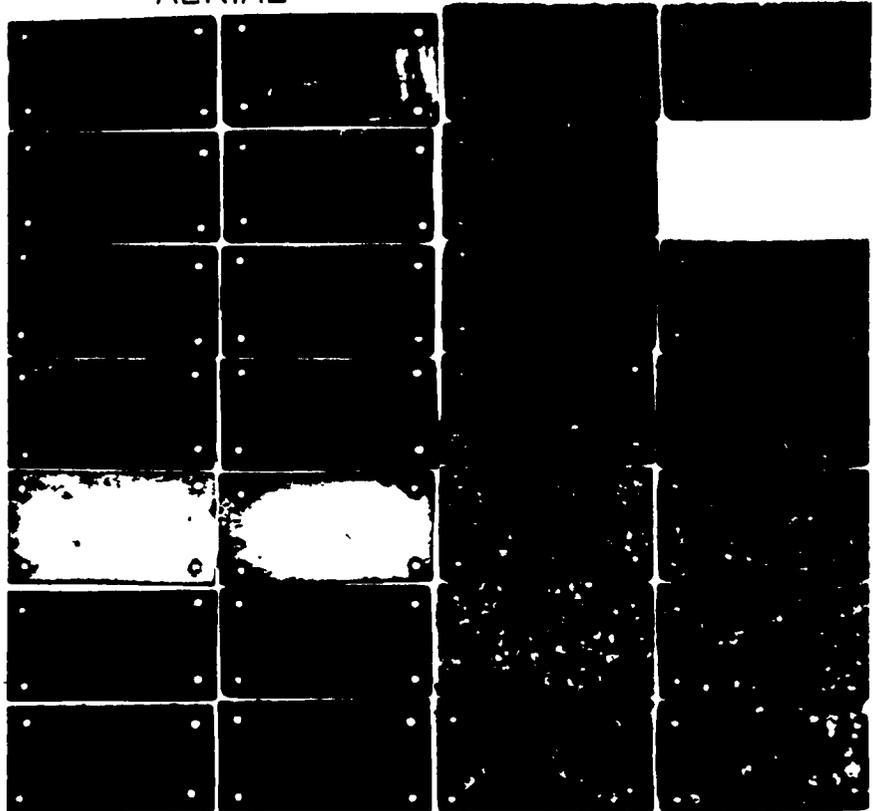
The specimens on aerial exposure at Wilmot Point, Lagos remained in very good condition throughout the ten months exposure period (Fig.45).

Fig.45 "Avare" Silica/Graphite Paints (C.R. Averill, Ltd.) and Chlorinated Rubber Paints (Tretol, Ltd.) after 10 months exposure. The two columns on the left were exposed at Wilmot Point, Lagos and those on the right in the wind/water zone of the lagoon site. The order of the specimens is, reading from top to bottom, A10-1 to A10-6. The bottom row contains the Chlorinated Rubber Paints (System A9-1).

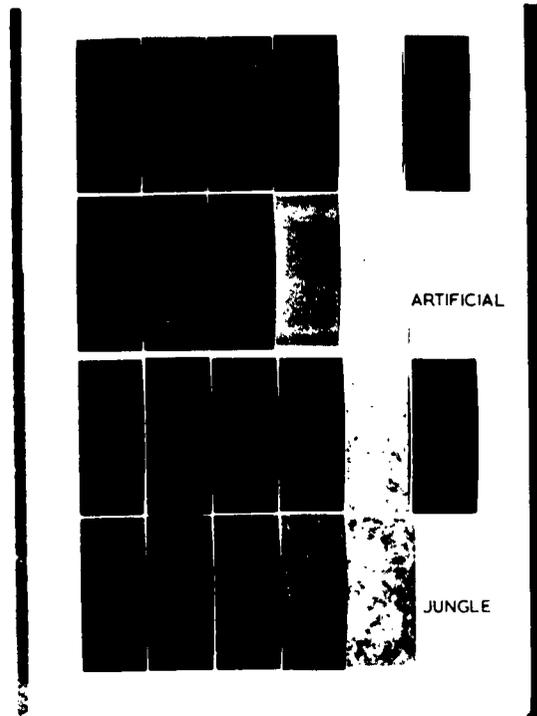
The sponsors also exposed a similar set of panels in a weatherometer at the F.I.A.T. Laboratories in Turin, for a total of five hundred hours, to a cycle consisting of sixty-four minutes exposure to light alone and sixteen minutes to light and water spray. After this treatment, the finishes showed little deterioration; there was a slight loss of gloss but this was restored by polishing (Fig.50).

Fig.50 Car Finishes (F.I.A.T., Turin). The two top rows were exposed to artificial weathering tests for 500 hours and the two bottom rows were exposed in the jungle clearing, Nkpoku for 6 months. The specimens are in order from left to right and top to bottom.

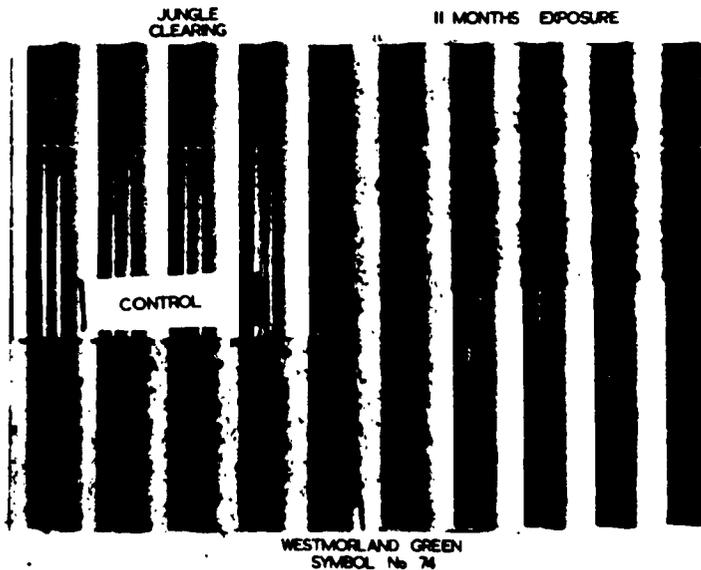
Fig.61 Turnall Colourglaze (Turners Asbestos Cement Co.)
 Specimen C2-2 after 11 months exposure in the
 jungle clearing showing heavy, superficial
 biological growth, easily removed on washing.
 (The bottom right hand corner has been cleaned.)

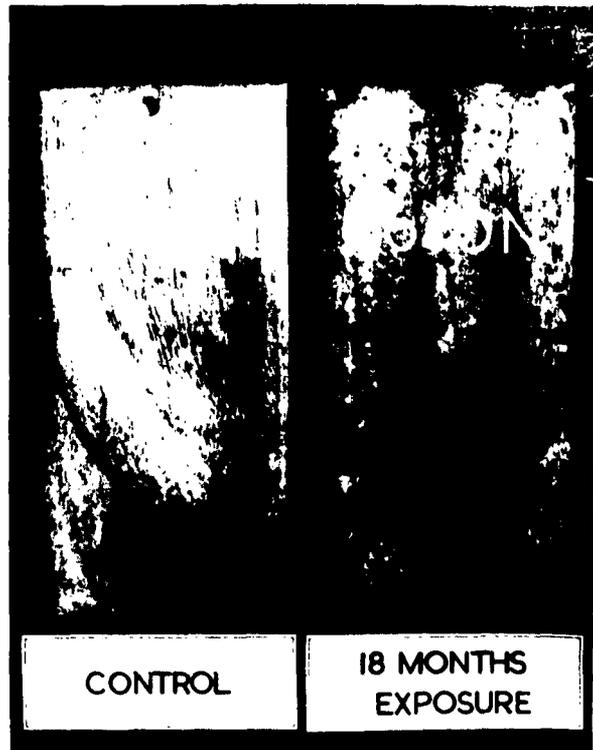
Fig.63 Commercial Varnishes (International Paints Ltd.). Specimen E1-2 after 18 months exposure at town site.

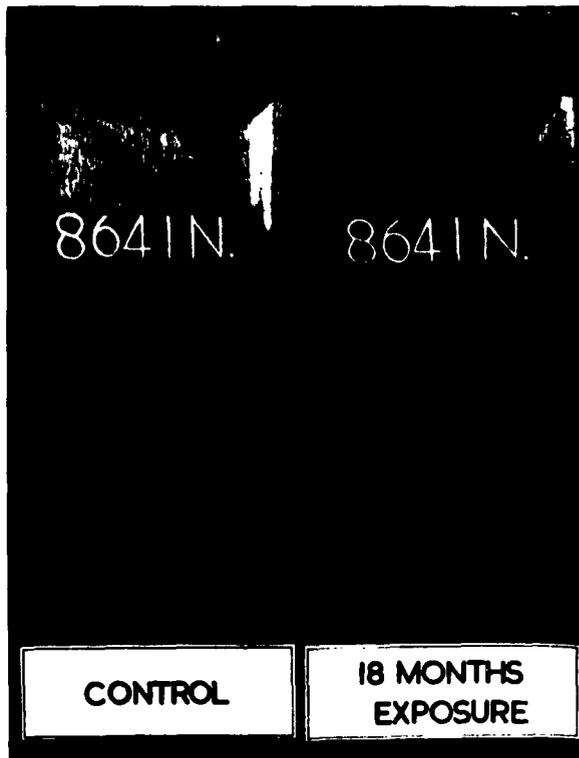
All four specimens lost their initial high gloss fairly rapidly and after twelve months it had entirely disappeared. The gloss was only partially restored on polishing the surfaces. Specimen E1-3 ("Group 37" Varnish) darkened considerably, changing to a fairly dark red-brown after about nine months exposure (Fig.64). Crowsfoot checking covered the whole surface of E1-1 ("309" Yacht Varnish) after nine months and this increased and developed into crowsfoot cracking during the remainder of the trial (Fig.62). Heavy flaking of E1-4 ("Episeal" Varnish) developed; this commenced at the rounded edges after about nine months and gradually spread towards the centre of the panel. After eighteen months, about 75 per cent of the varnish film had flaked off (Fig.65). Towards the end of the trial, only slight flaking of the other three varnishes was recorded, E1-1 and E1-2 at the rounded edges and E1-3 at the crack in the substrate below the top securing hole (Fig.64).

Fig.64 Commercial Varnishes
(International Paints Ltd.).
Specimen E1-3 after 18 months
exposure at town site,
showing considerable
darkening.

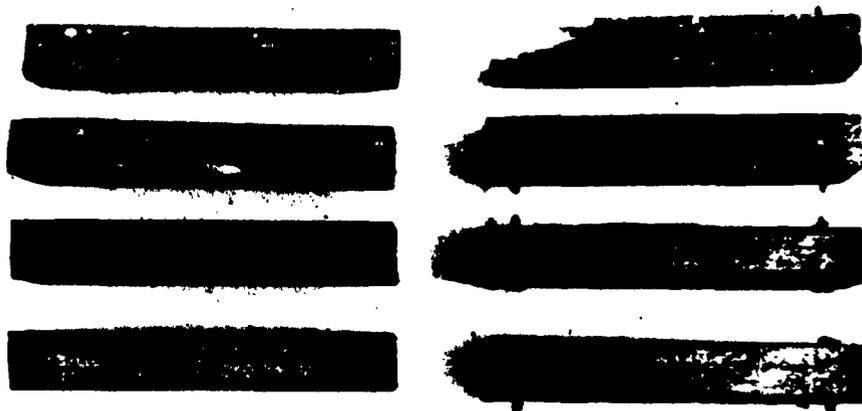
After four months in the Bonny River, there was no teredo attack on the painted panels, although the unpainted wood control panels had sustained severe damage (Fig. 82).

Fig.82 Anti-fouling Anti-teredo Copper Paint (Red Hand Compositions Co.) after 4 months immersion in the Bonny River, Port Harcourt. The panels have been sectioned to reveal teredo attack. The four panels at the top were unpainted wood controls and the four at the bottom were painted. The four at the left were fully immersed and those at the right were exposed in the wind/water zone.
