COOPERATIVE MARINE PILING INVESTIGATION: PHASE I -
PILE DRIVING AT COCO SOLO, CANAL ZONE

TN-473

29 April 1963

U. S. Naval Civil Engineering
Laboratory
Port Hueneme, California

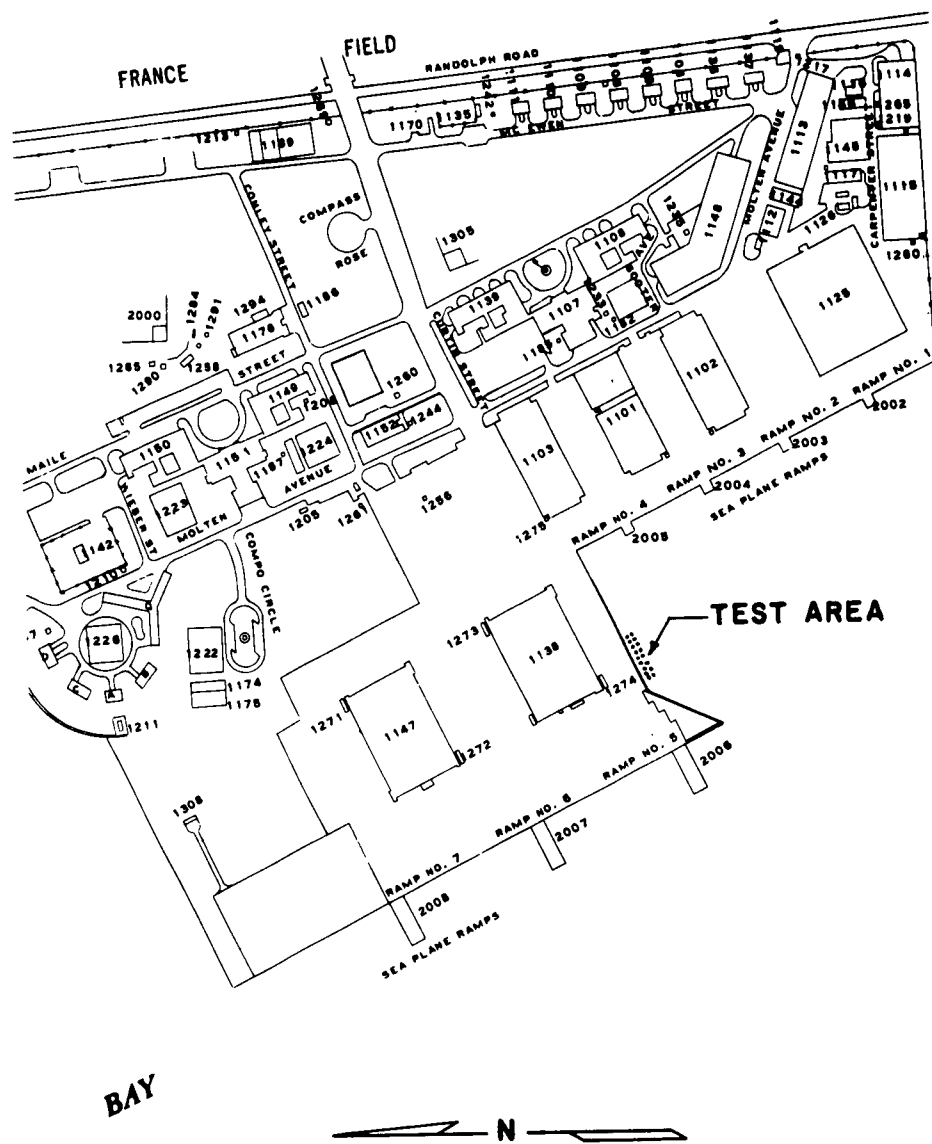
Figure 7. Map of Test Area

The piles were driven in the area between Seaplane Ramps 4 and 5 and along the pier adjacent to the hangar, Building 1138, shown in Figure 7. The water depth varied from 5 feet at the edge of the pier to 6 to 7 feet at a distance of 6 feet outboard from the pier. The first block of piles was driven off the mid-point of the pier and the other blocks were driven seaward from the first block.
