**ROCKETDYNE**

R-5316

FINAL REPORT, DEVELOPMENT OF DOWNRATED  
ATLAS YLR101-NA-15 VERNIER ENGINE

Contract AF04(695)-306

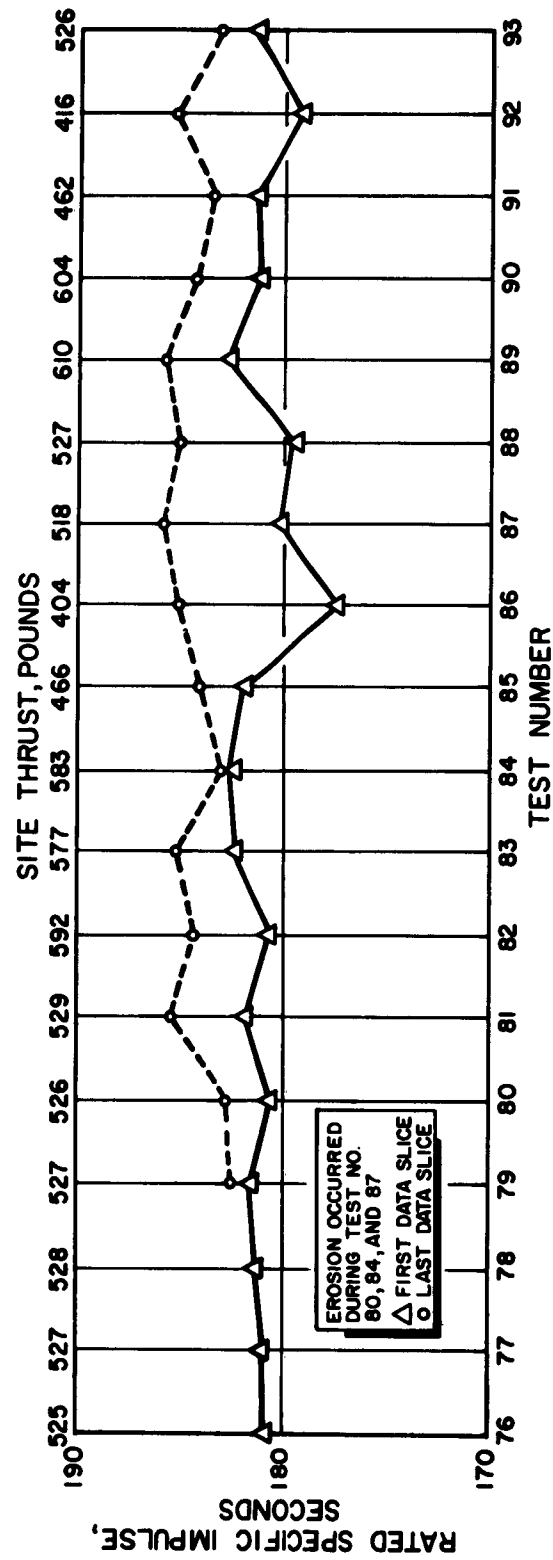
Figure 14. Rated Specific Impulse During Testing With Engine S/N 0003-5

Although the thrust chamber erosions experienced during the Phase I testing were quite severe (Fig. 8), engine transient and steady-state performance were not affected by the damage. Figure 14 is a plot of rated tank-fed specific impulse during testing of engine S/N 0003-5. No significant decrease in specific impulse or operating level occurred as the chamber erosion progressively worsened. The bulk fuel temperature was measured at the fuel injector manifold during the tests on engine S/N 0003-5. During the first 10 to 12 seconds after ignition of each engine, this temperature rose about 120 degrees above the engine fuel inlet temperature. After 60 seconds, the temperature stabilized at 30 to 50 degrees above the fuel inlet temperature. No data are available for comparison, but it is probable that, except for localized hot spots, this stabilized differential temperature was sufficiently low to rule out an excessively high thrust chamber wall temperature.

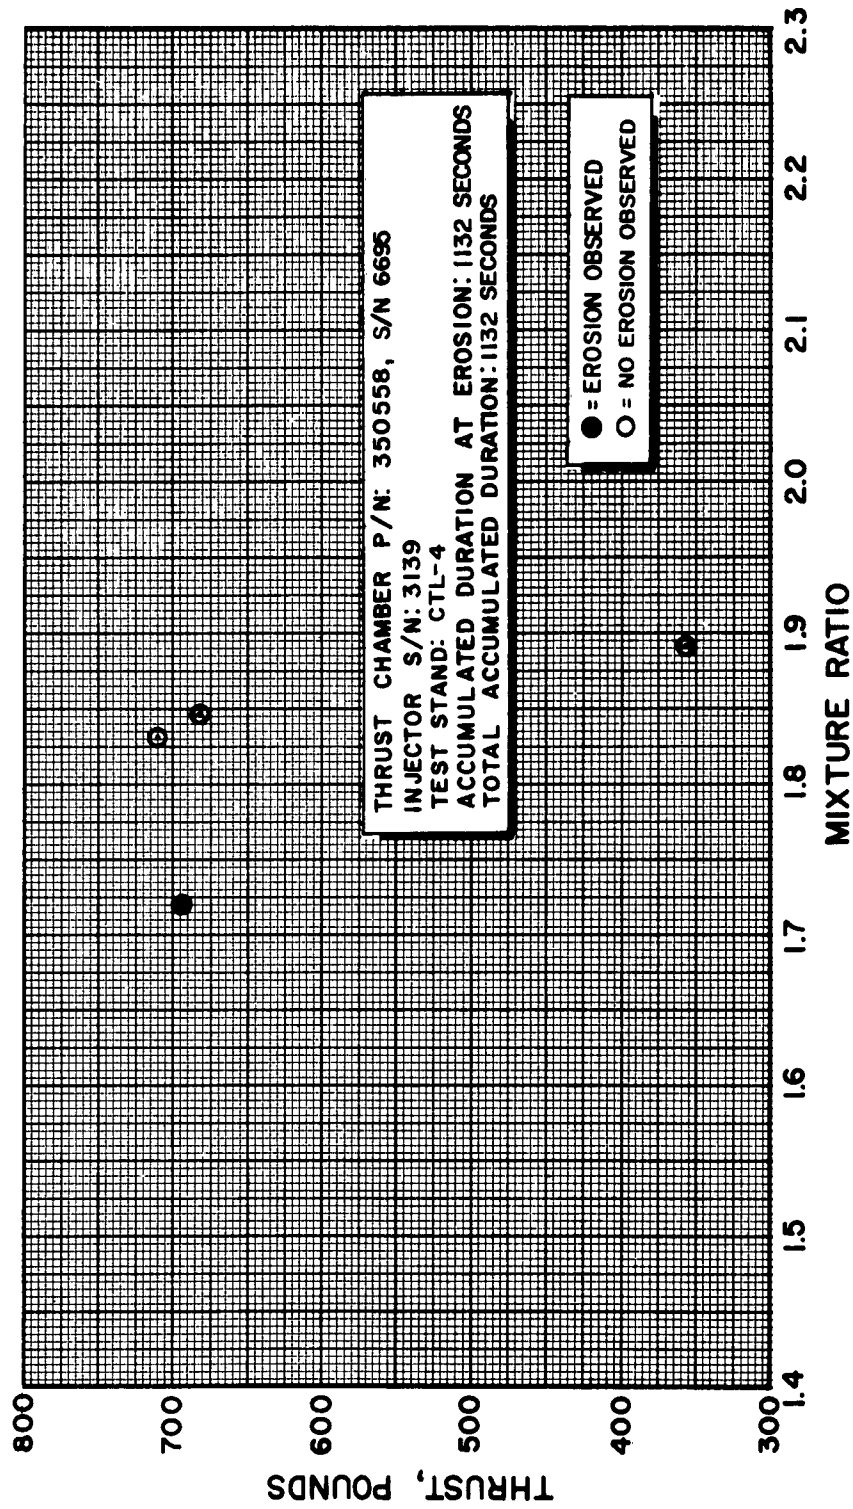
Figure 27. Operating Regime of Injector P/N E0 119924  
Tested with Thrust Chamber S/N 6695

Testing of the P/N EO 119924 injector was terminated after the fourth duration test because of heavy thrust chamber erosion (Fig. 26). Because the oxidizer tank pressure was increased to reach the planned mixture ratio, the cause of erosion has not been definitely established. However, calculation of transition mixture ratio showed no cause of thrust chamber erosion resulting from this shift in tank pressure. The thrust chamber inner-wall erosion was located 3 inches upstream of the throat and was through the wall. Minor nickel and parent metal erosion was evident at several other points. No evidence of erosion was detectable during the test or during close examination of the data. No further testing was attempted on this unit. The operating regime for the P/N EO 119924 injector is shown in Fig. 27.

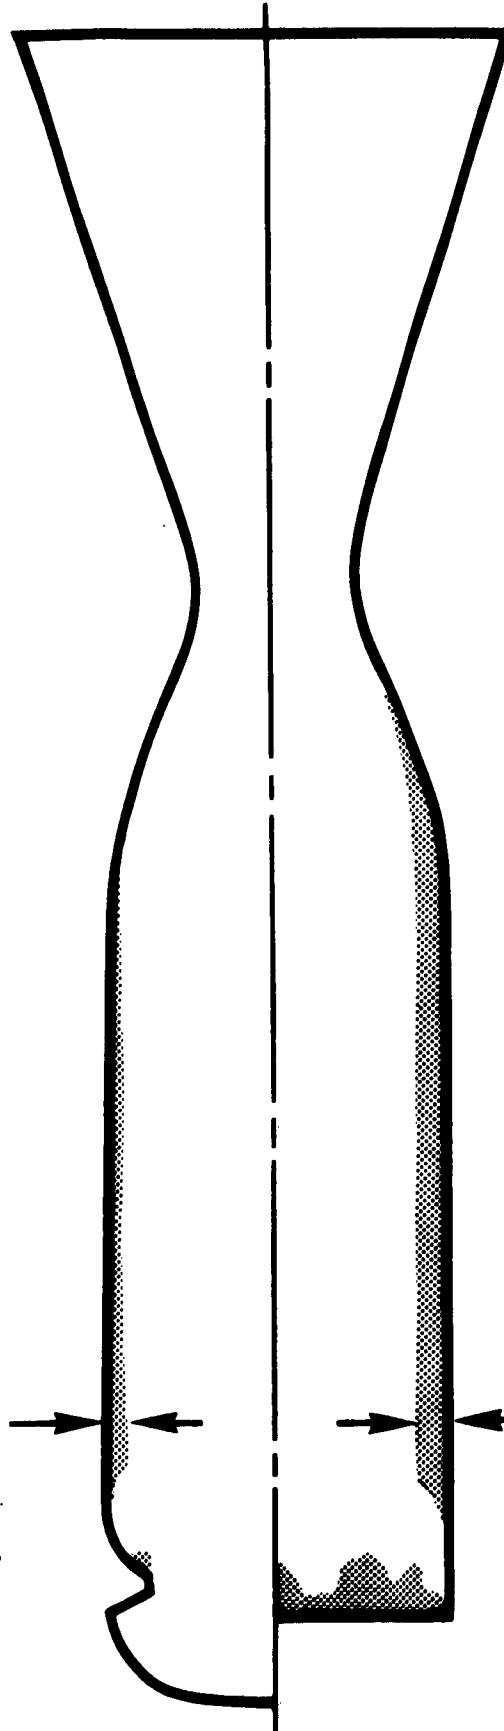
THRUST CHAMBER USING FLAT - FACE INJECTOR

Carbon Buildup. Carbon buildup (Fig. 36) was found in the thrust chamber and on the injector face throughout the flat-face injector testing. Hard carbon up to 1/2-inch thick formed on the injector face upstream of the impinging propellant streams, and some pieces of carbon found in the test area showed the orifice pattern. The first three tests on each injector generally exhibited the heaviest carbon buildup, but random buildup was also evident during later tests. Soft carbon on the wall of the thrust chamber in line with each injector fuel orifice spoke gradually built up to a maximum thickness of 0.125 inch after several tests. Carbon buildup in the thrust chamber throat was not evident during the series.

A lesser degree of carbon buildup (Fig. 36) also was visible in the thrust chamber following splash-plate injector tests. Hard carbon on the wall at the injector end reached a 0.040-inch thickness, but decreased to zero thickness approximately 4 inches downstream. No carbon buildup was visible on the splash-plate injector face or in the thrust chamber throat, although it was assumed to have been in the throat as a result of the shifting performance and carbon particles found in the test area.

0.125 - INCH MAXIMUM
