Technical Note N-622

TSUNAMI DAMAGE AT KODIAK, ALASKA, AND CRESCENT CITY,  
CALIFORNIA, FROM ALASKAN EARTHQUAKE OF 27 MARCH 1964

U. S. NAVAL CIVIL ENGINEERING LABORATORY  
Port Hueneme, California

The objective of this task is to survey and report on damage to waterfront structures at the Kodiak Naval Station and city of Kodiak, Alaska, and at Crescent City, California, by water waves generated by the 27 March 1964 Alaskan Earthquake.

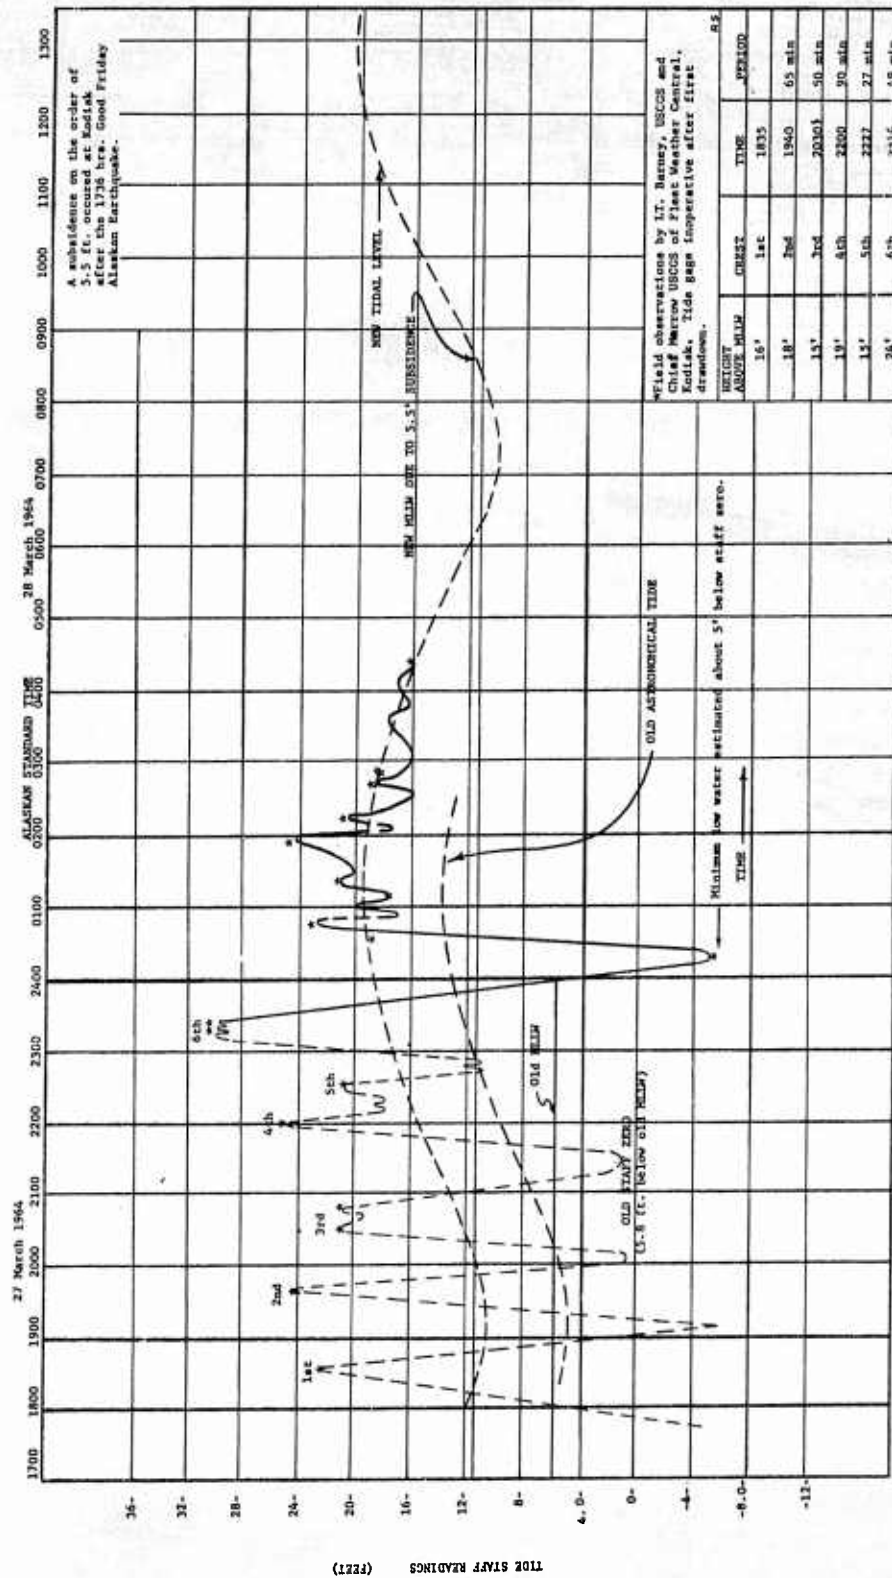
Figure 19. Reconstructed Tsunami Profile at Kodiak Naval Air Station, Alaska.

The log of Barney and Morrow, from which the Figure 19 marigram was reconstructed, follows. Times are AST.

- 1750 - Tide Station inoperative due to earthquake damage.
- 1810 - Cape Chiniak reports 30-foot tsunami.
- 1820 - Water rising rapidly. No recession has previously occurred.
- 1835 - Water crested 22 feet above Tide Staff zero.

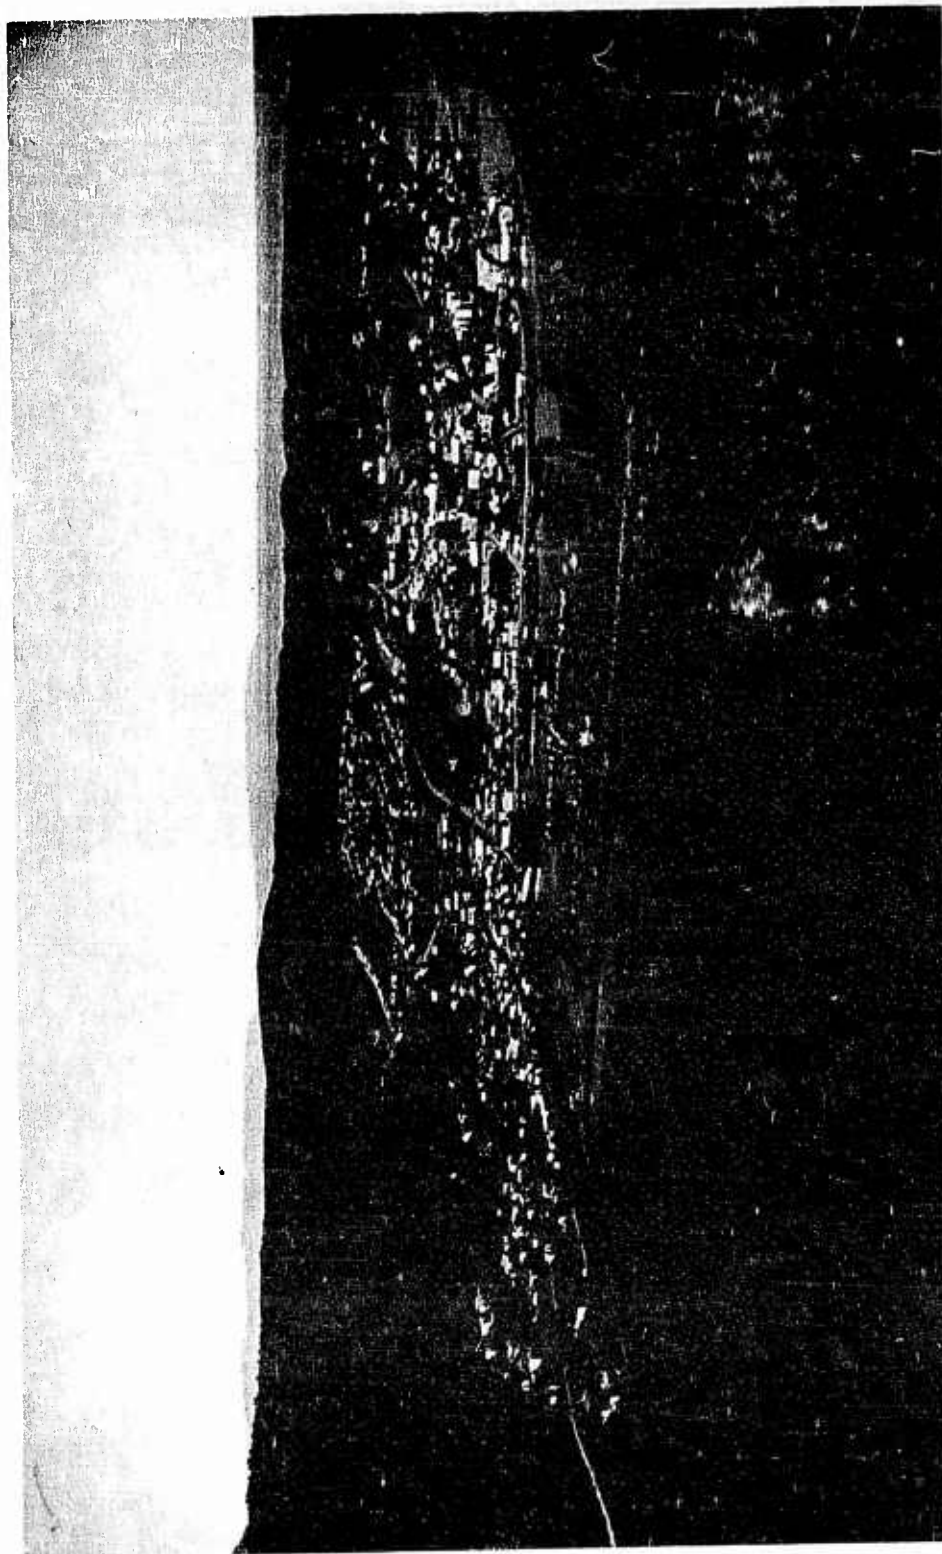
Figure 22. Aerial photo of City of Kodiak, center of one of the largest fishing fleets in Alaska.  
Solid line shows highest level reached by waves. (Photo by Alf Madsen)

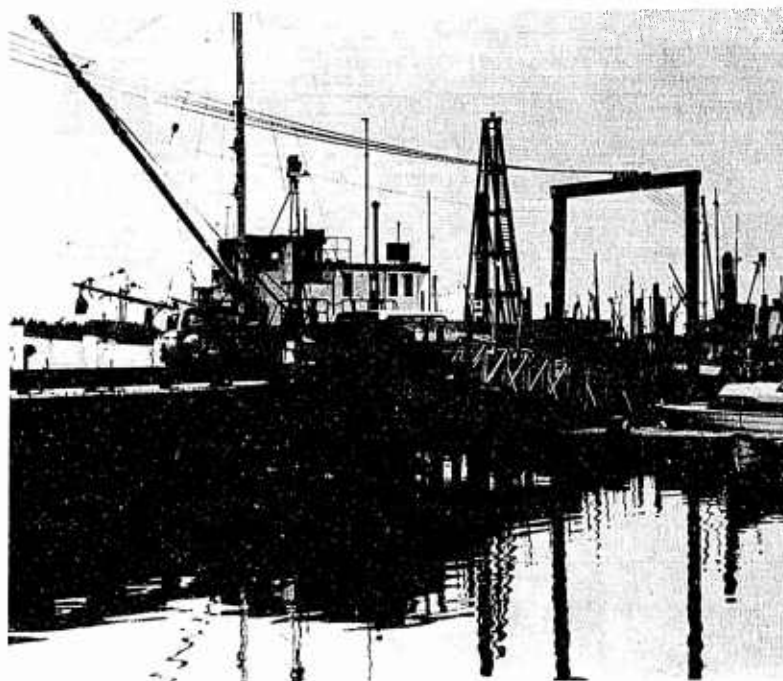
Figure 24. Fishing fleet two hours before the quake. Some boats were maneuvered to safer coves by their owners, while those unmanned rammed into the business section of the city. (PIO, Kodiak NAVSTA)

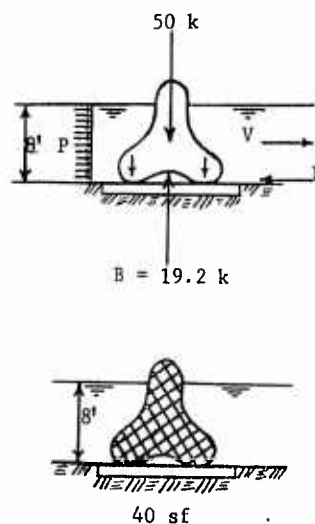
Standing sentinel-like at the city limits and greeting visitors to Crescent City from the South is a giant concrete tetrapod weighing 25 tons. This was erected as a monument in 1958 to mark the first place in the Western Hemisphere where the tetrapod was used in the construction of a breakwater. During the tsunami flooding (Figure 37A) this tetrapod was displaced from its pedestal. It is calculated that a water speed of 14 miles per hour would be necessary to slide this tetrapod from its base (Figure 37B). However, one witness claims he saw a large log bump and shove the tetrapod.

Calculation to find water velocity to slide large tetrapod off base:

$$\begin{aligned}
 \text{Wt.} &= 25 \text{ T; Coef. of Frict.} = 0.65 & \text{Total vol.} &= 325 \\
 \text{Vol.} &= 325 \text{ cf; Drag coef.} = 1.2 & \text{Vol. in air} &= 25 \\
 B &= 300 \text{ cf} \times 64 \text{ pcf} = 19.2 \text{ K} & \text{Subm. vol.} &= 300 \\
 N &= 50 - 19.2 = 30.8 \text{ K} \\
 F &= 0.65 \times 30.8 = 20 \text{ K} \\
 P &= 20/40 \text{ sf} = 500 \text{ psf.} \\
 V &= \frac{500 \times 32.2 \times 2}{1.2 \times 64} = 20 \text{ fps} = 14 \text{ MPH}
 \end{aligned}$$

Figure 37B. Unit pressure and approximate velocity required to slide 25 ton tetrapod.

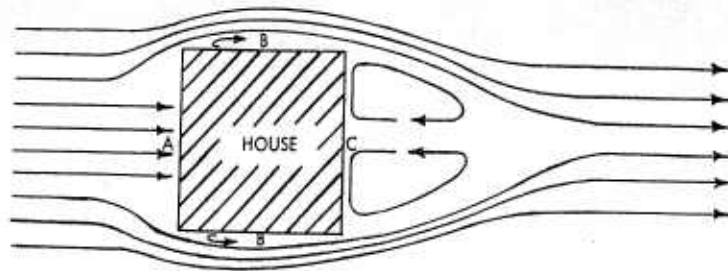
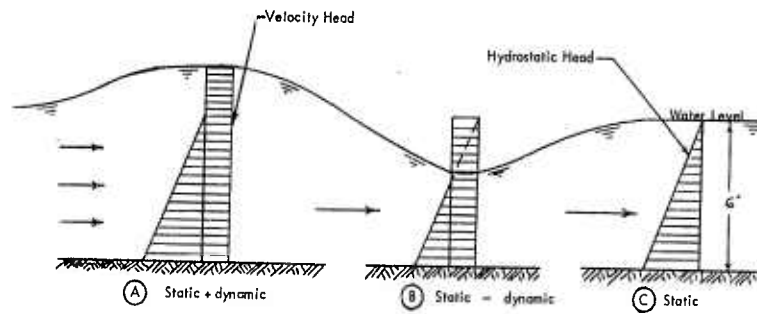
Figure 61A. Flow around typical house.

| $V = 5 \text{ fps} \rightarrow 384 + 24 = 408 \text{ lbs/sf}$ | $384 - 24 = 360 \text{ lbs/sf}$ | $384 \text{ lbs/sf}$ |
| $V = 10 \text{ fps} \rightarrow 384 + 100 = 484 \text{ lbs/sf}$ | $384 - 100 = 284 \text{ lbs/sf}$ | $384 \text{ lbs/sf}$ |

Figure 61B. Fluid pressure diagram around typical house.

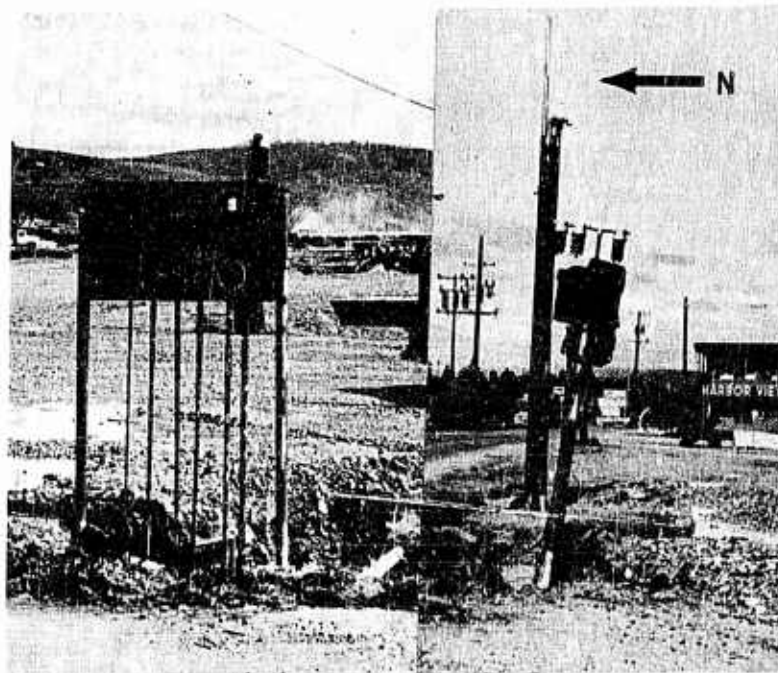
Prob: Find load per  $\text{in}^2$  which will produce yielding of post at base.

Assume:  $S = 30 \text{ KSI}$   
 $I_{\text{post}} = 1.18 \text{ in}^4$   
 $ID = 2.468$   
 $OD = 2.375$   
 $C = 1.437$   
 $C_D = 0.35$   
 $\bar{y} = \frac{\sum \Delta y}{\sum A} = \frac{82,080}{1,512} = 54.2"$

Figure 65 . Wave force and approximate velocity needed to produce yielding of light box at Crescent City Harbor. Bottom photo shows the front and side views of the light box.
