Report No. HTC-AD 64-10

Final Report

20MM MARK 4 GUN POD
250,000 ROUND RELIABILITY IMPROVEMENT
PROGRAM

2 February 1964

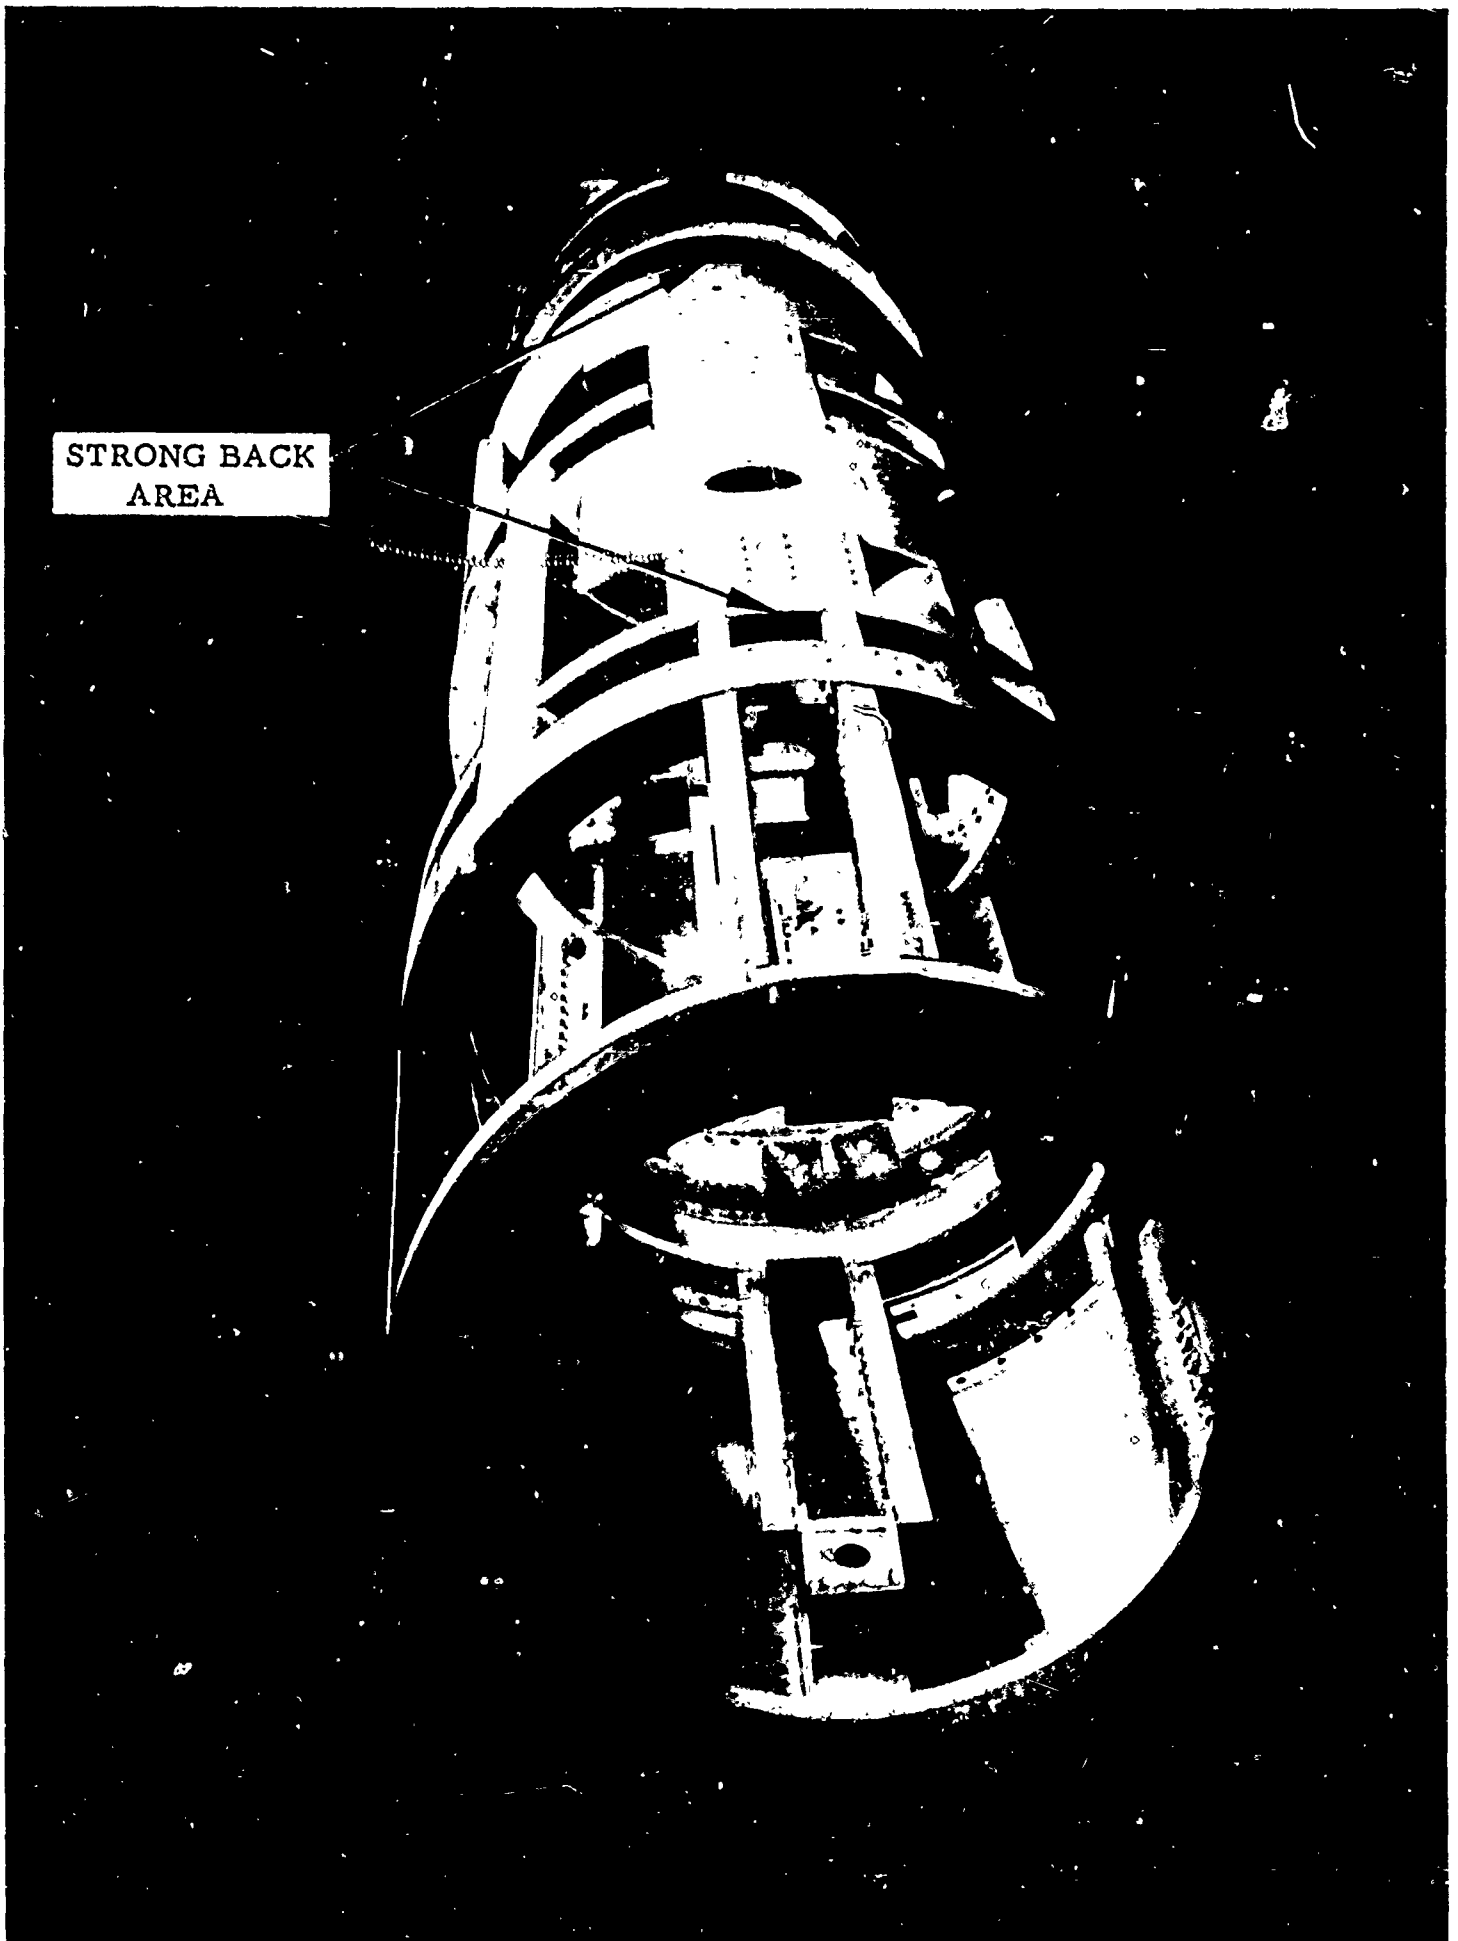
Figure 8. Strongback for F100

A number of improvements were made in the Mk 4 Mod 0 Gun Pod over the EX-1 Gun Pod used in the previous 300,000 round reliability test. The pod structure was strengthened by changing the forward strongback to stainless steel and beefing up the sway brace areas as shown in Figure 8. This made the pod capable of being flown at speeds up to Mach 1.2 on wing pylons. In addition the fore and aft loads were taken out in the forward lug as opposed to the aft lug on the EX-1, and the rear lug was provided with azimuth adjustment or $\pm 1^\circ$. The adjustable rear mount is shown in Figure 9. The bulkhead at Station 108 was changed to cast aluminum with a stronger stainless steel channel in order to take the fore and aft magazine loads out at this station rather than at the aft end of the magazine as was done in the EX-1 gun pod. This allowed the aft magazine support to be lighter and less complex, and also helped to control the tolerance buildup in the magazine drive gear. The location of the cast bulkhead is shown in Figure 10.

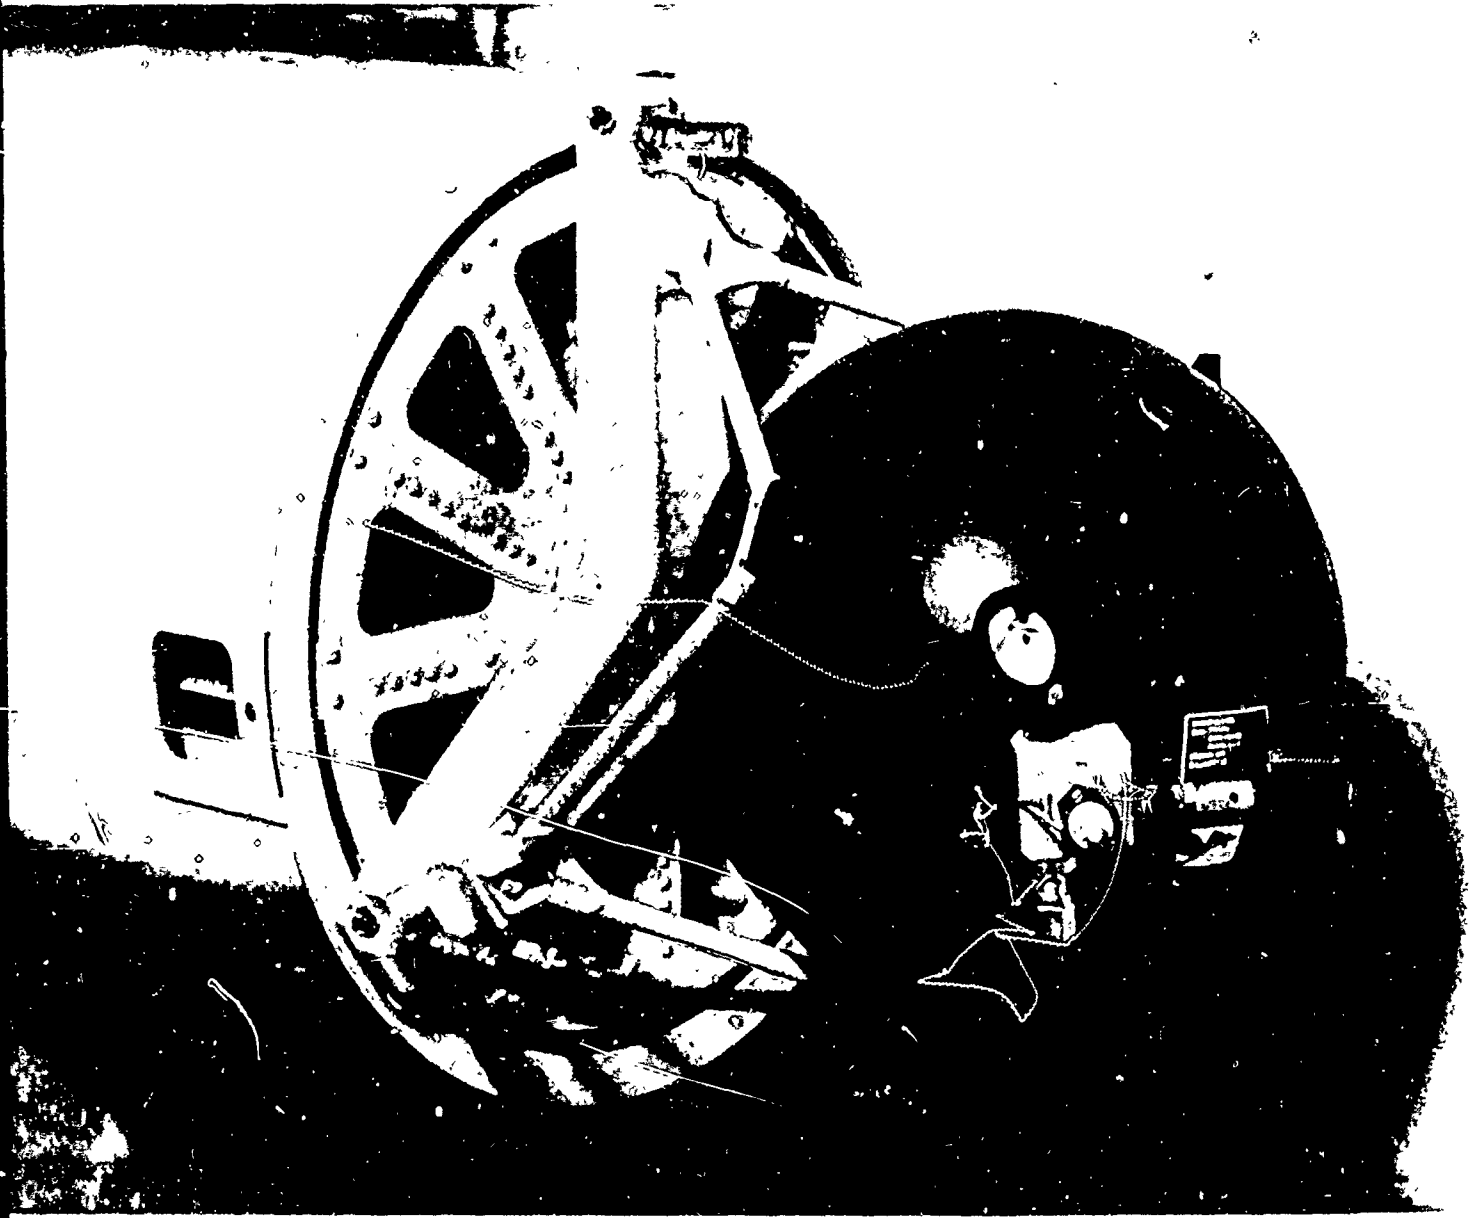
Figure 11. Motor Mount Type Structure for Pneumatic Reservoir Installation

A motor-type mount was incorporated in the design to hold the 3000 psi pneumatic reservoir to the aft magazine support. This proved superior to the strap type on the EX-1, and no trouble was encountered in the reservoir mount or rear magazine support. Figure 11 shows the installation of the main pneumatic reservoir.

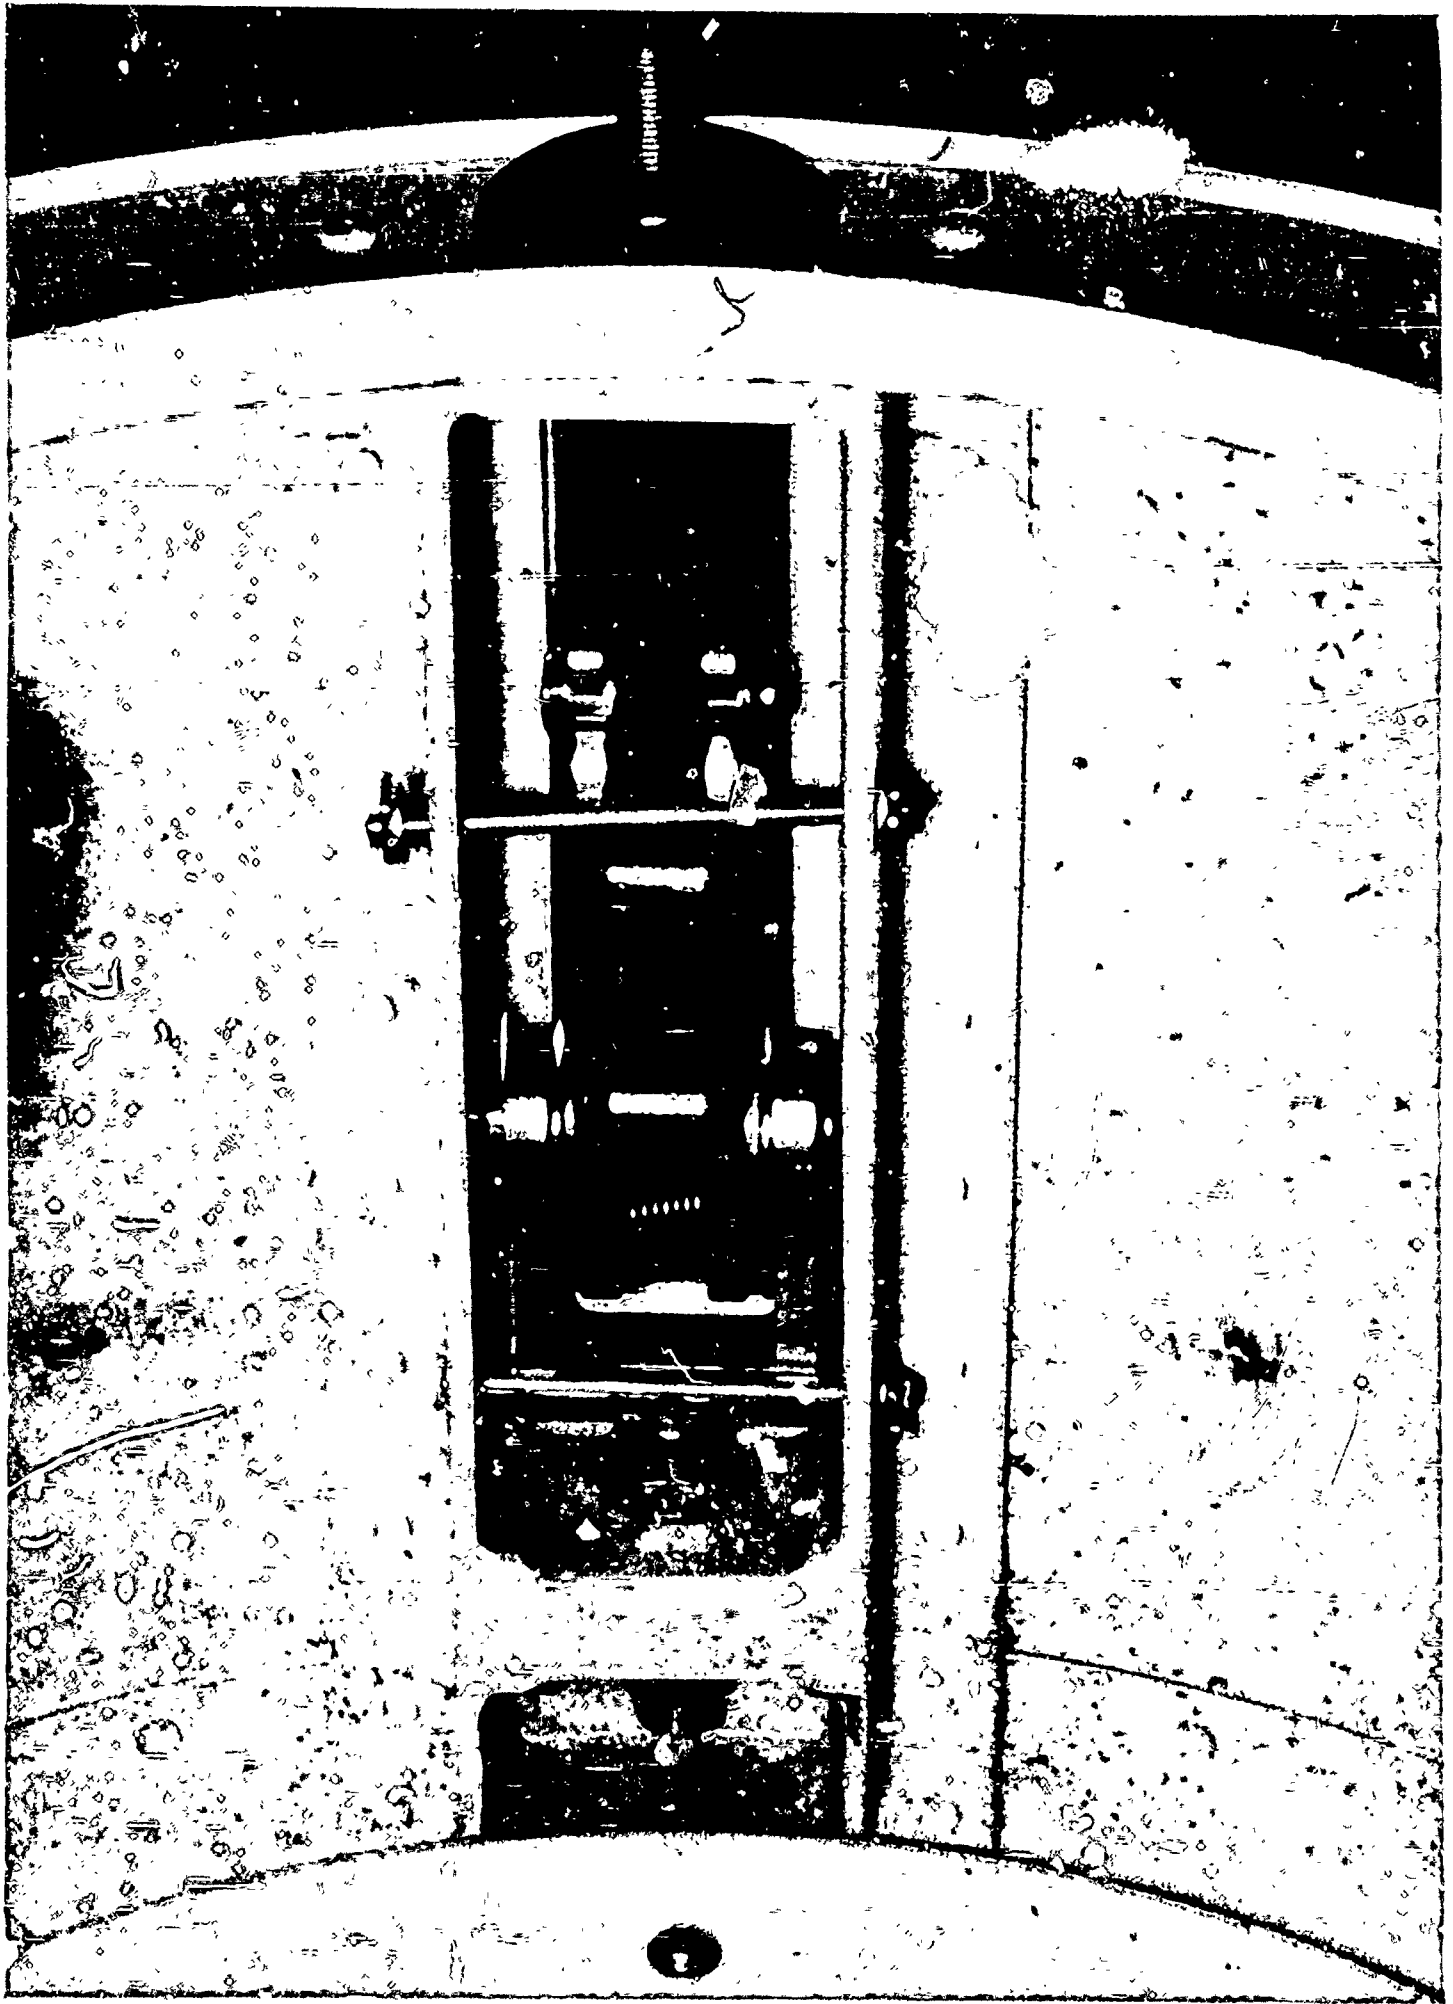
Figure 16. 10,000 lb. Nose Latches

Several changes were made in the pod nose. The safety pads for the trunnion latches were made more rugged, so the nose could not be put on the pod unless the trunnions were locked. A stronger nose latch was found to be necessary due to the increased forward loads of the blast suppressor. A 6000 lb. latch was first used, since it was interchangeable with the original 4000 lb.

latch. This latch did not have the desired safety factor, however, and a 10,000 lb. latch was installed. There have been no latch failures with the 10,000 lb. latch installation. The blast suppressor was cast of 17-4PH corrosion resistant steel. The nose changes are shown in Figures 15, 16, 17, and 18.

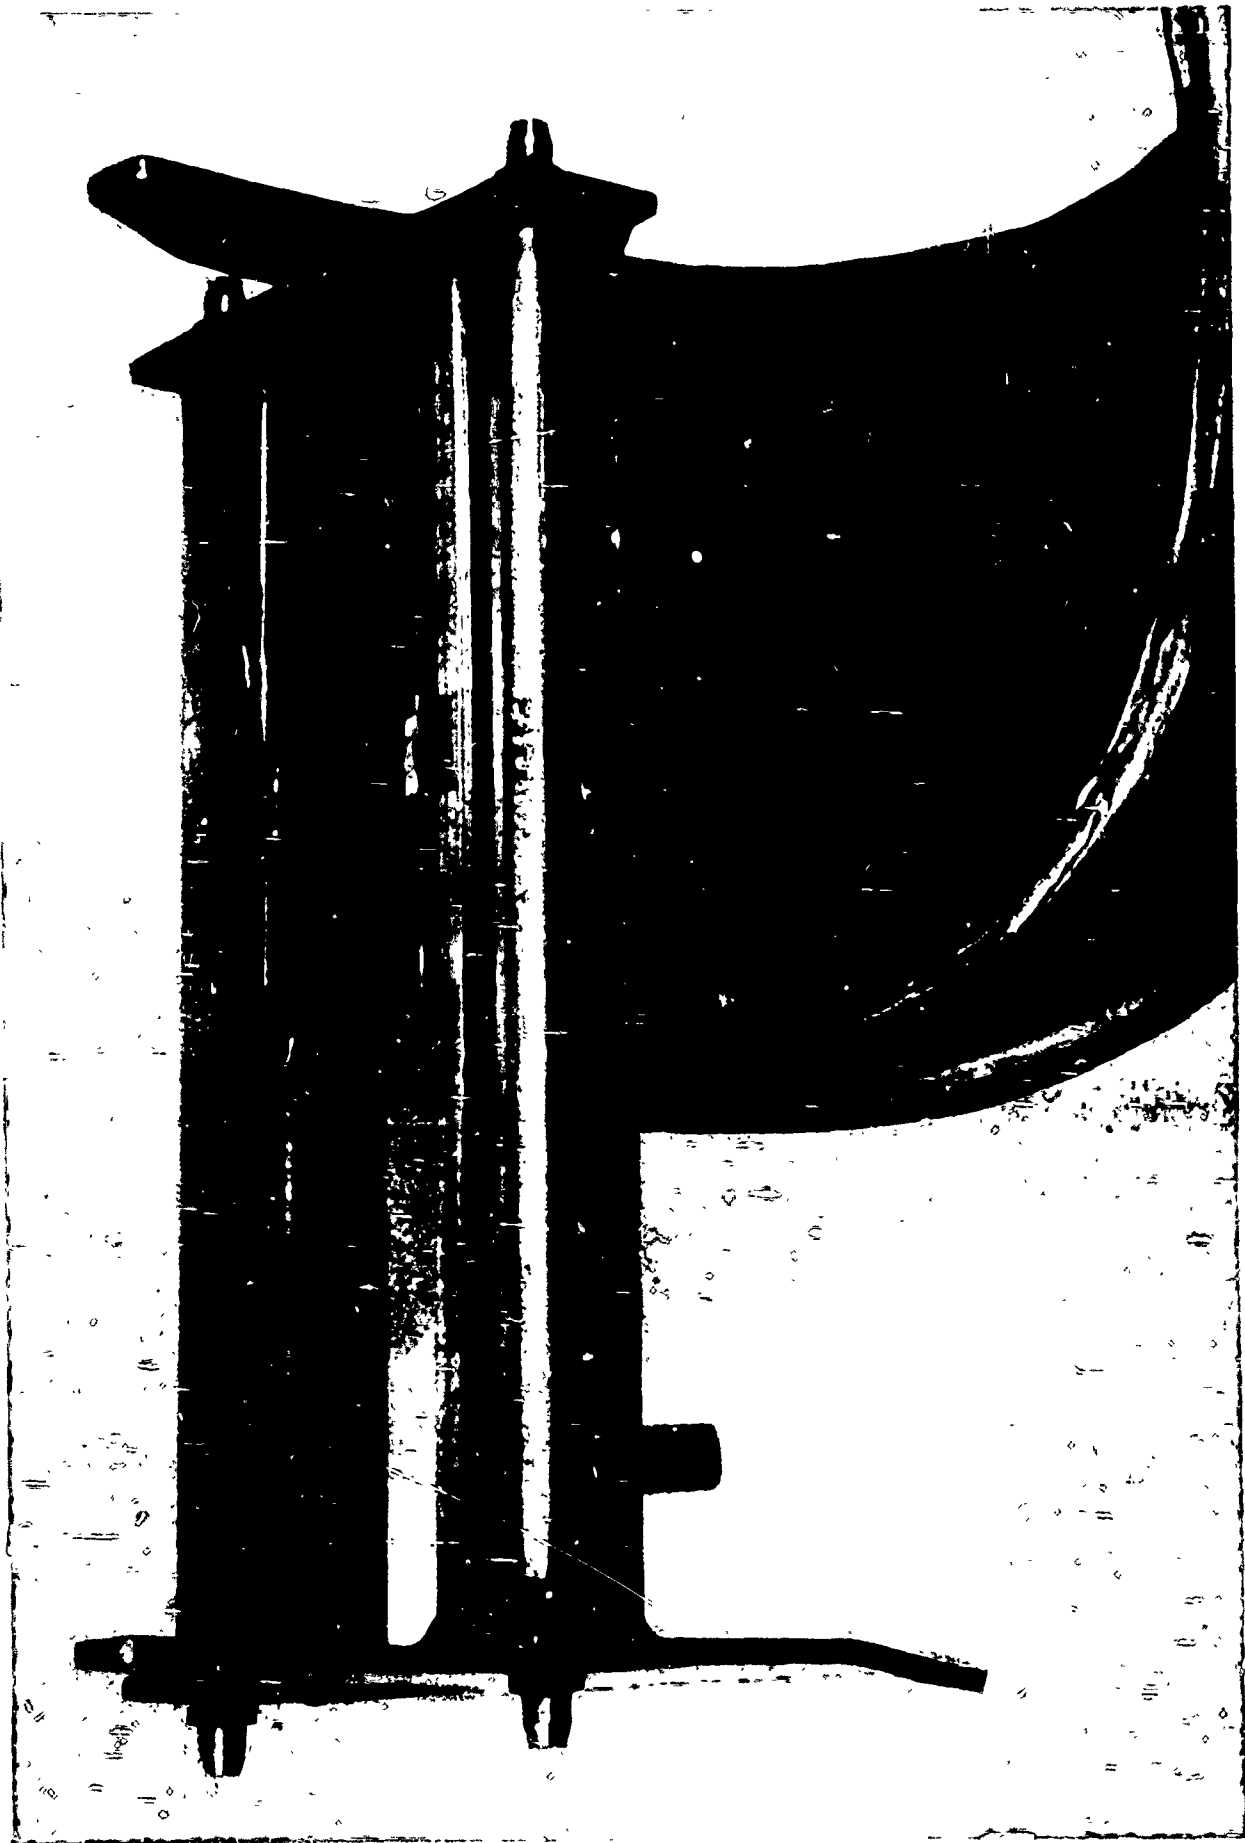
Figure 19. Feed Chute Assembly

The feed chutes were reshaped for smoother ammunition flow and were made of heavier gauge material where needed. The loader attaching end was strengthened with channel sections to eliminate deformation. Figure 19 shows the strengthened feed chute. No trouble was encountered with this chute and one set was fired 87,000 rounds before being replaced. The pod structure was also improved by strengthening the feed throats and making the main access doors removable.

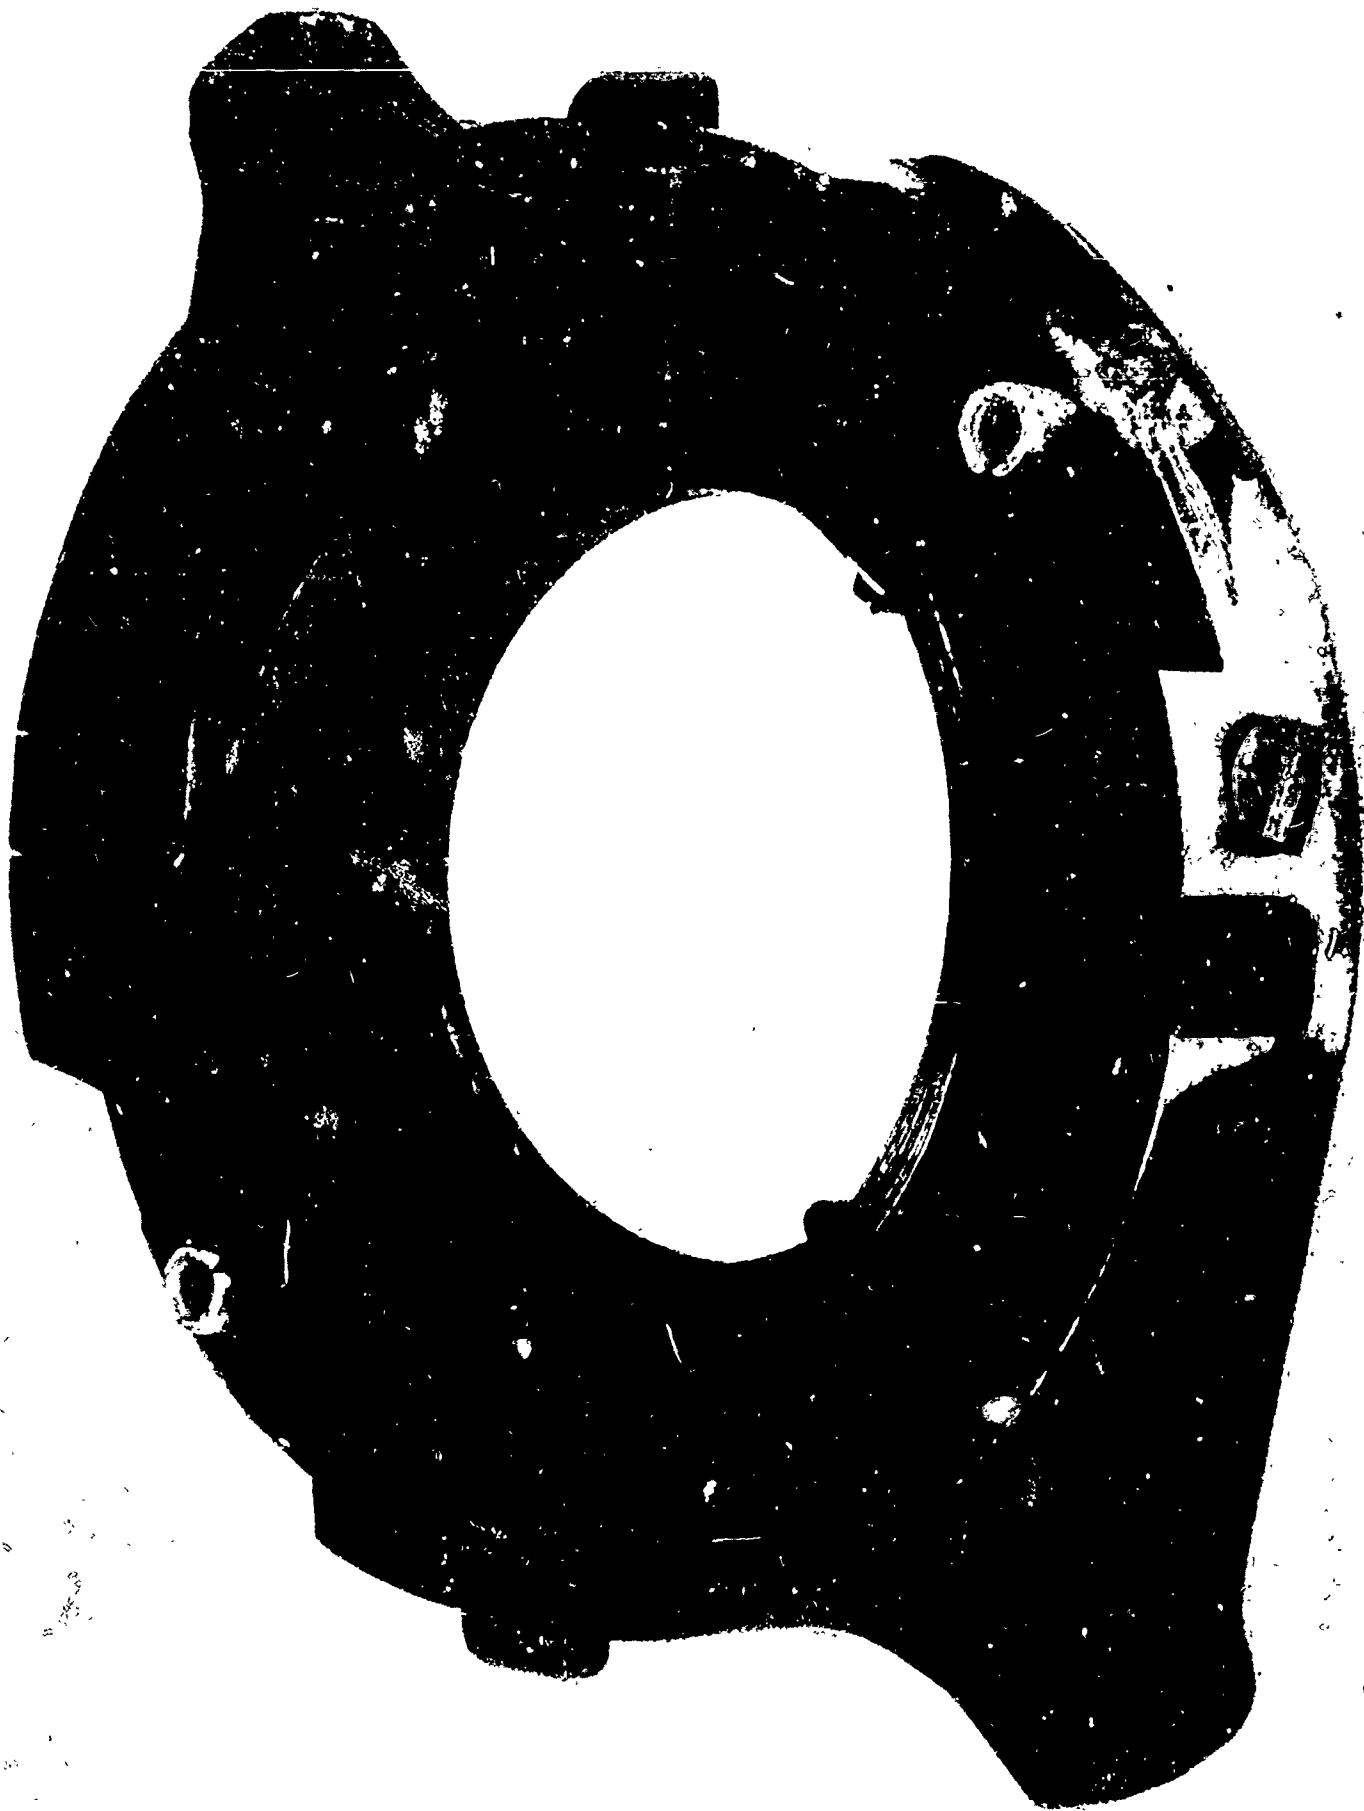
Figure 25. Round Positioner Assembly

The gun junction box housing was changed from a welded-up structure to an aluminum casting as shown in Figure 24. A stiffer ring spring round positioner was added to the Mk 11 Mod 5 Gun, and this increased the force on the latches and detents to 50 lbs. in order to eliminate pre-ejection. Figure 25 shows the new ring spring round positioner.

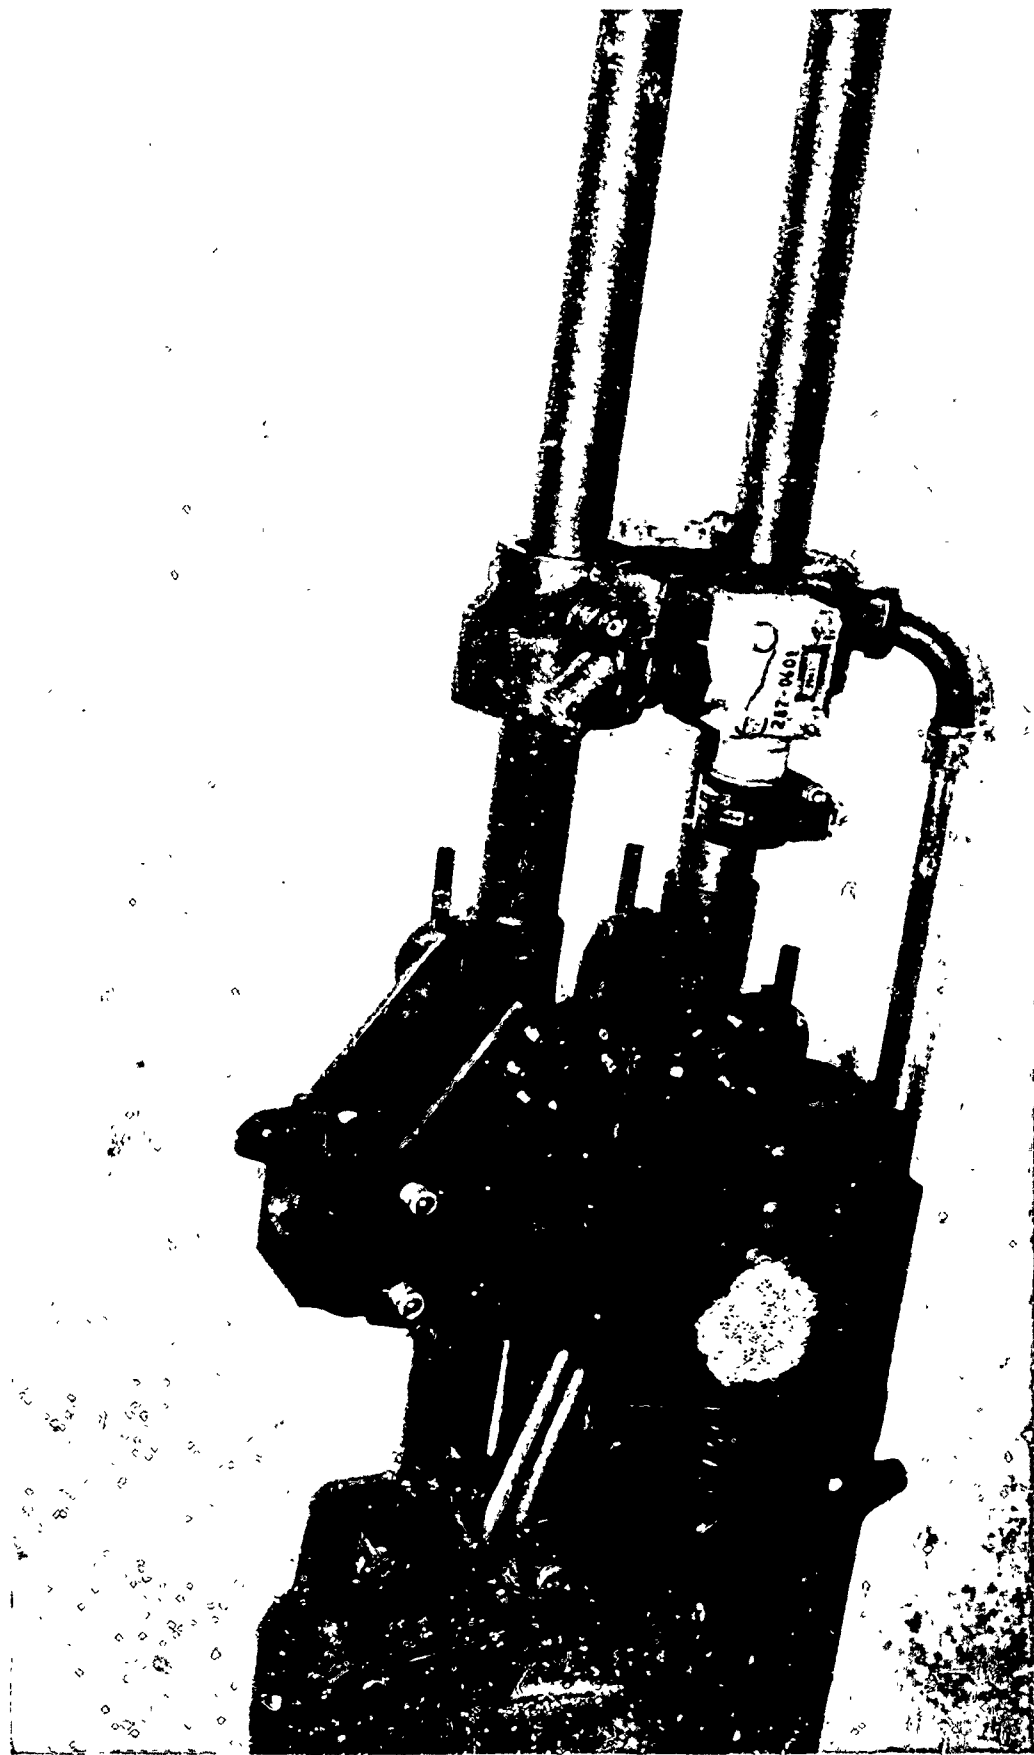
Figure 34. Booster Decoupled from Receiver

An experimental quick disconnect booster block was built in October, and approximately 13,000 rounds have been fired with this part with good results. The booster block attaches to the receiver with four quick disconnects. By rotating the quick disconnects 180 degrees, the booster is locked in place. The booster block also locks the barrels in place by preventing barrel rotation. To remove the barrels the booster block is removed from the gun and the barrels are then rotated to decouple them from the interrupted threads in the breech. Figure 34 shows the booster block decoupled from the receiver. In the final design of the booster housing, it is anticipated using three quick disconnects instead of four in

order to make the part simpler, and reduce the tolerances involved with the four quick disconnect system.

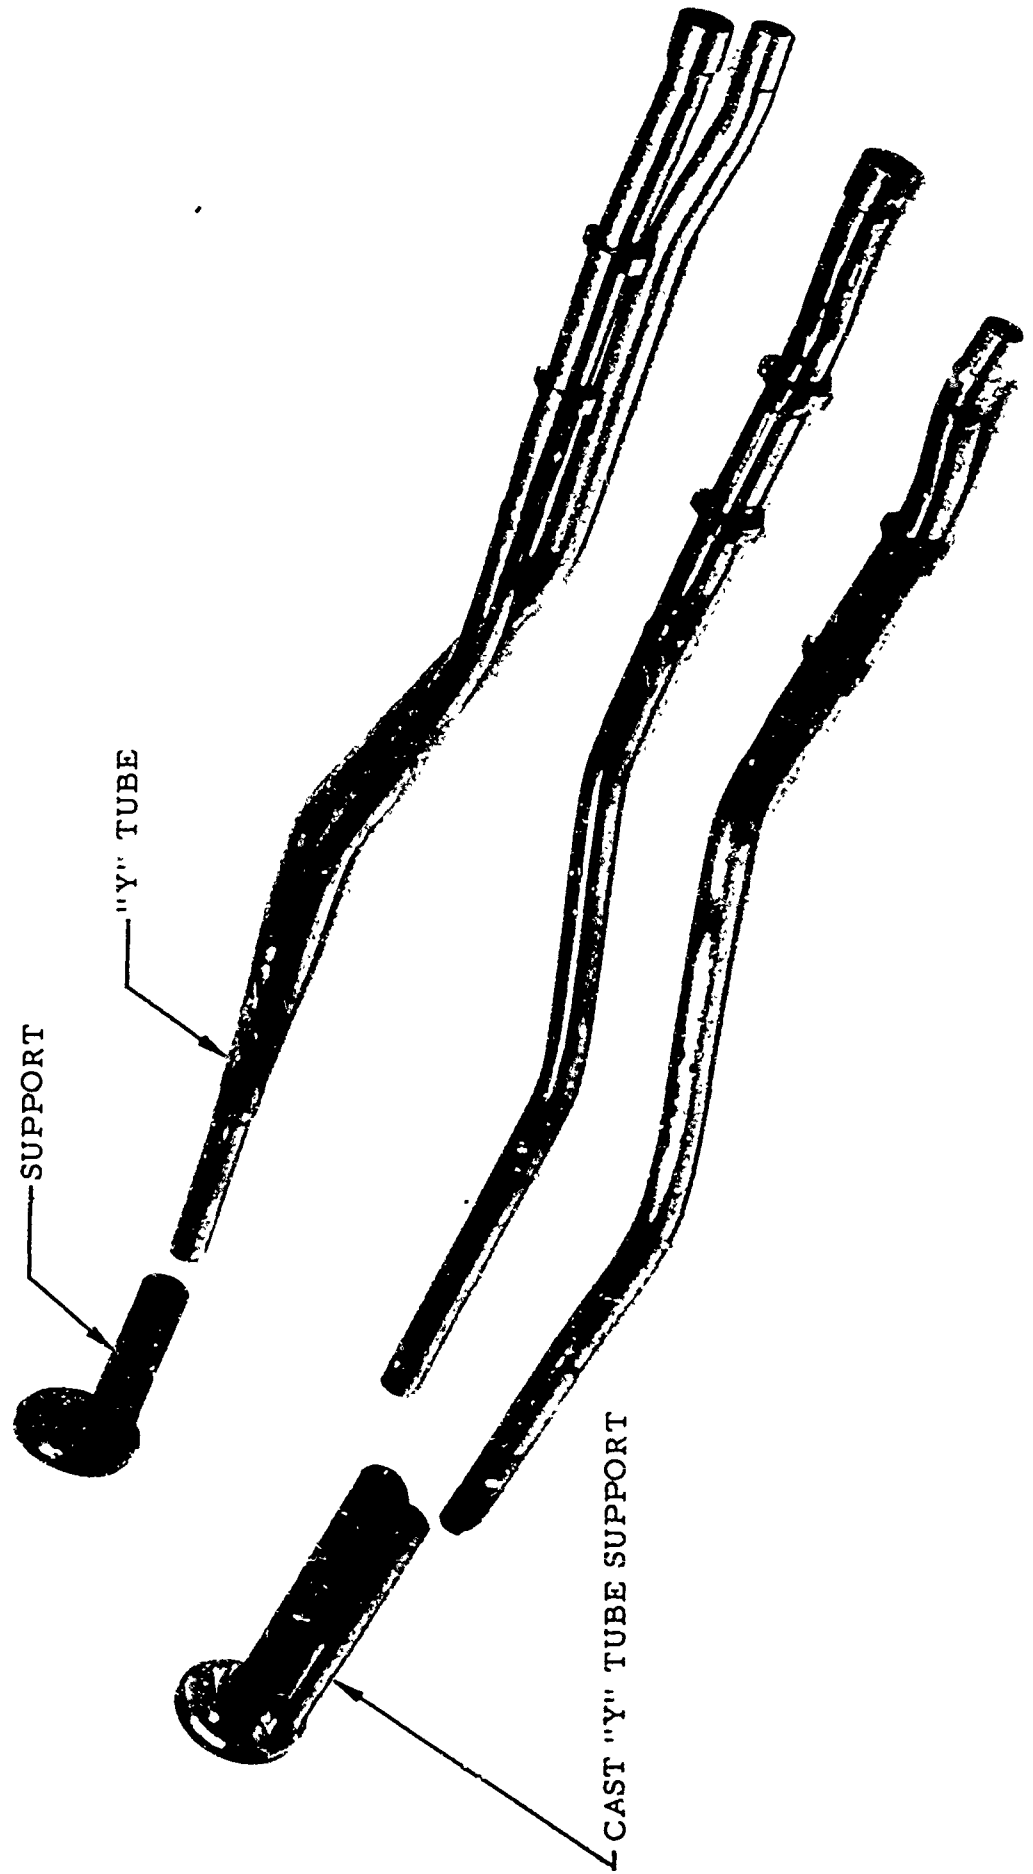
Figure 35. "Y" Tube Improvements

to allow for carbon build up between the two parts and still permit reciprocating action without binding. Figure 35 shows the two types of gas ejection systems.
