VUF-1010
FINAL REPORT

VELA UNIFORM PROJECT **SHOAL**

STRUCTURAL SURVEY OF PRIVATE MINING PROPERTIES

U.S. BUREAU OF MINES

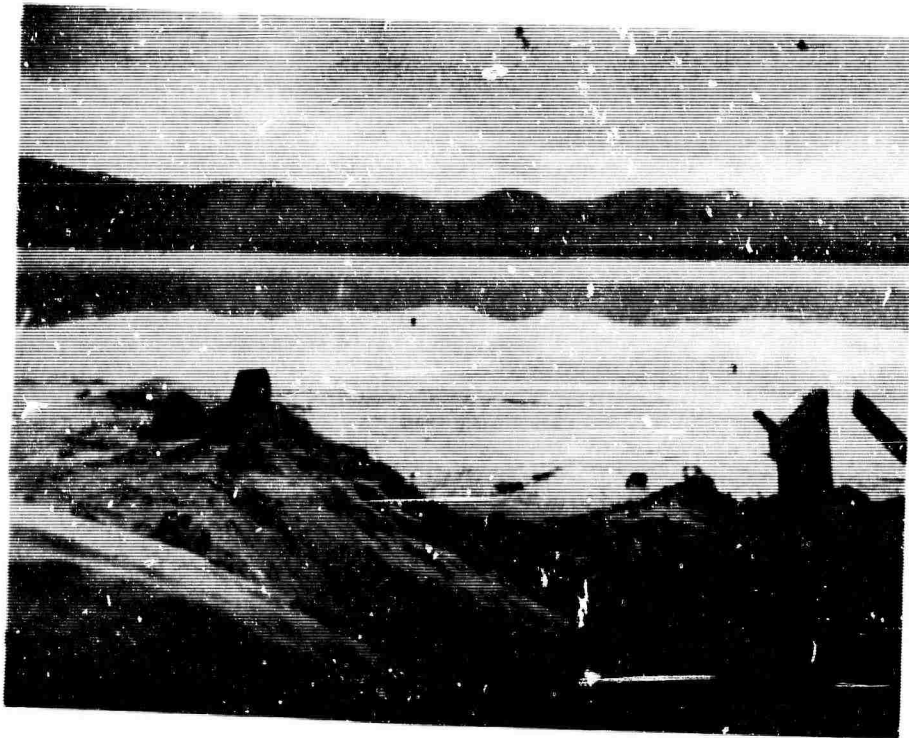
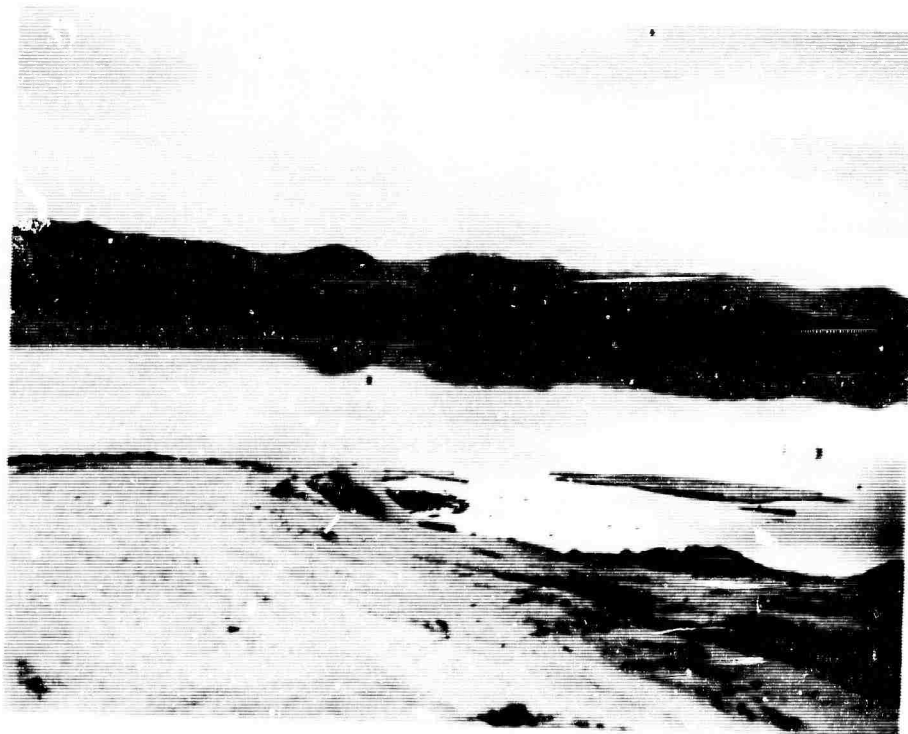
Photo 1-1-1. Preshot. September 30, 1963

Photo No. 1-1-1. At central salt pile looking southeast across the settling salt pond toward surface zero about six miles distant. A heavy rain occurred between the pre- and postshot surveys, raising the water level.

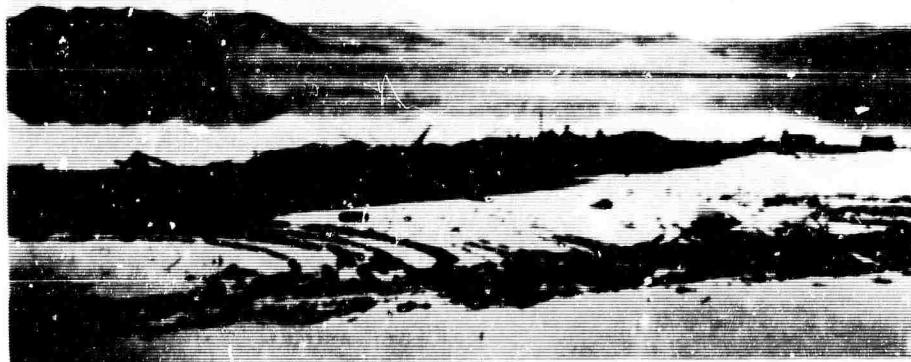
Photo 1-2-2. Freshot. September 30, 1963.

Photo No. 1-2-2. Northeast across the salt pond and toward the north end of the Sand Springs Range.

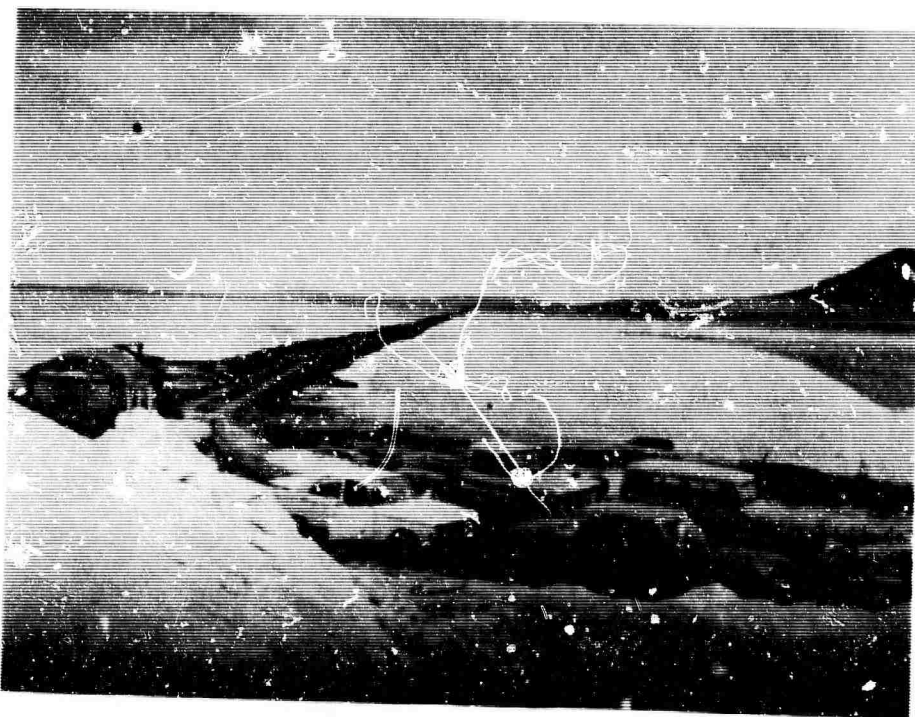
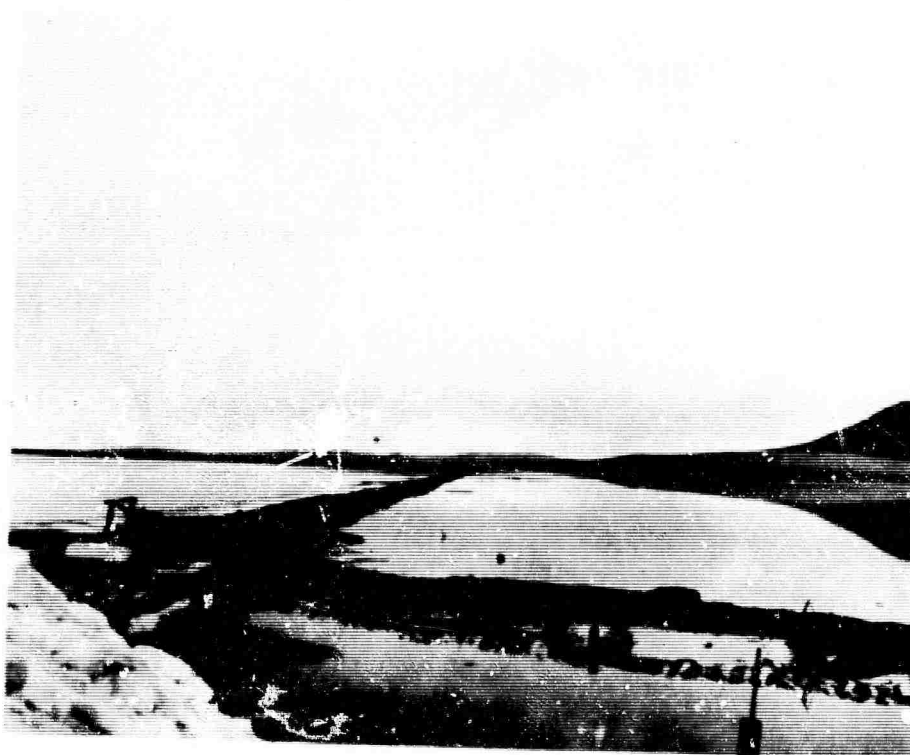
Photo 1-3-3. Preshot. September 30, 1963.

Photo No. 1-3-3. Northwest along the access road and northern portion of the salt pond.

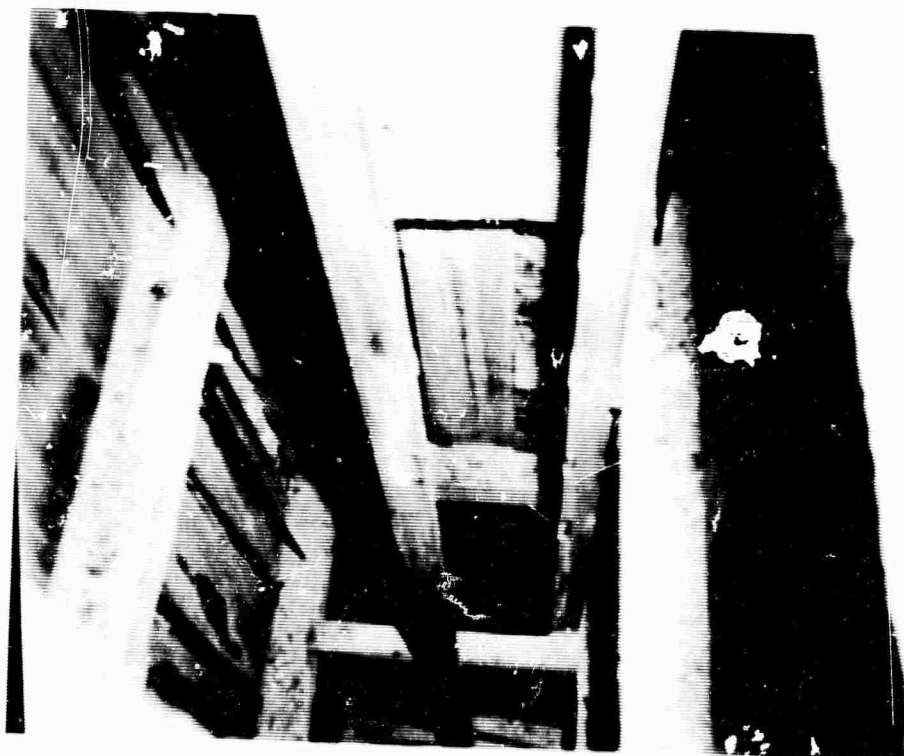
Photo 2-1-4. Preshot, September 30, 1963.

Photo No. 2-1-4. North two-compartment vertical shaft. Some lagging gone, no partition with manway. Timbered dimensions are 6 x 4 feet. This shaft is reportedly 225 feet deep, but is blocked with debris and water at an estimated 50 feet.

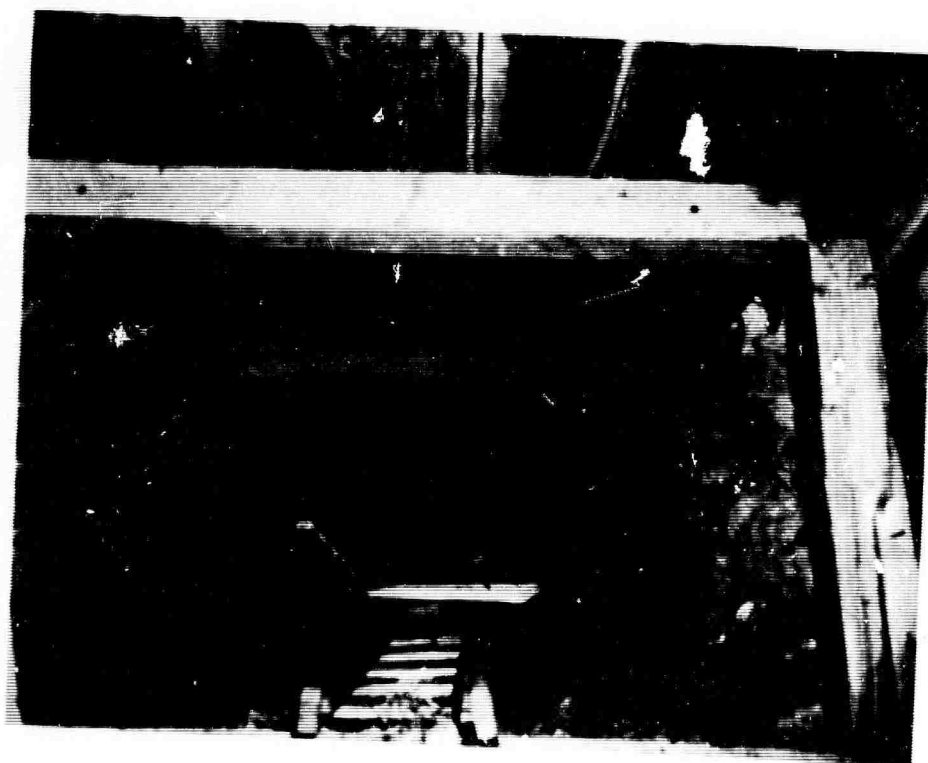
Photo 2-2-5. Preshot. September 30, 1963.

Photo No. 2-2-5. Northeast one-compartment shaft inclined at 65 degrees for about 20 feet, then inclined at an estimated 45 degrees. Some sets and lagging caved, with debris in shaft. Timbered dimensions are 8 x 6 feet. Shaft sunk in 1953 and is only about 30 feet deep.

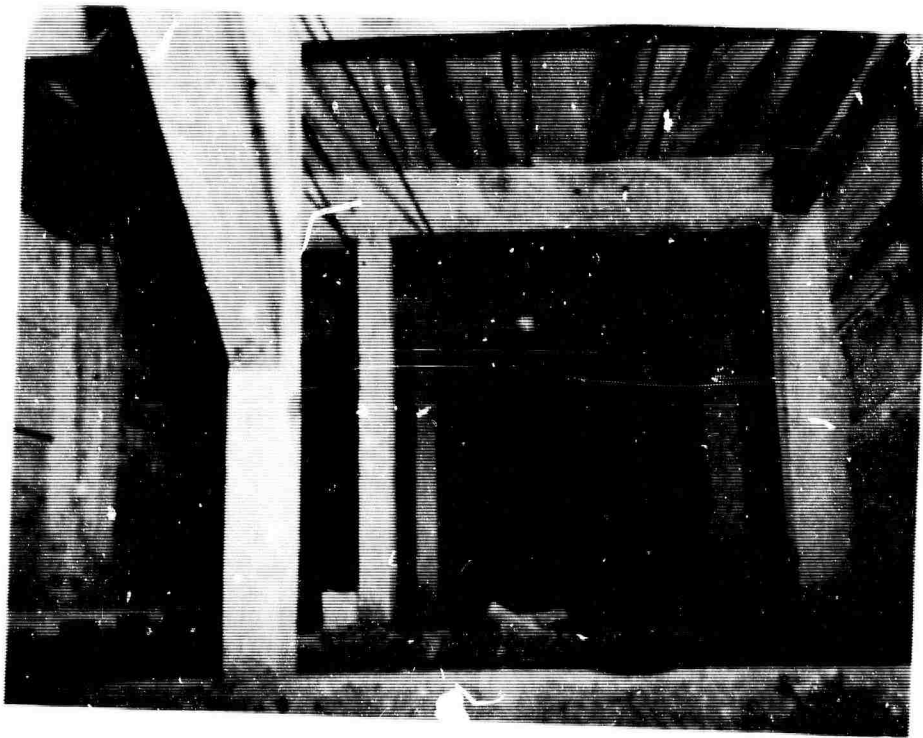
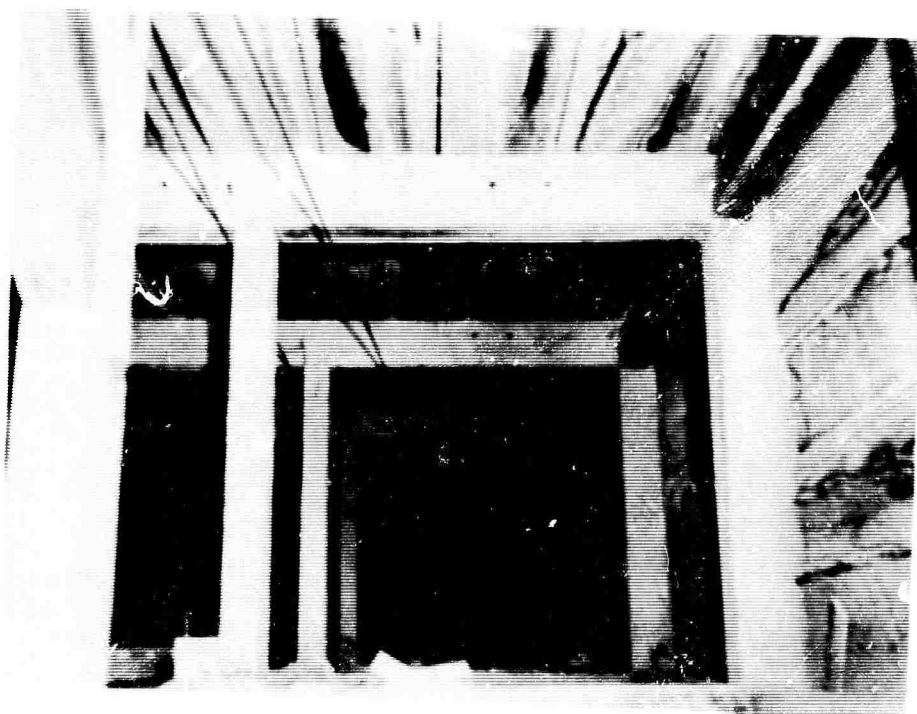
Photo 2-4-7. Preshot. September 30, 1963.

Photo No. 2-4-7. Southwest two-compartment shaft inclined at 60 degrees. Sets, lagging, and ladder in place. No partition with manway, nor cage guides. Timbered dimensions are 9 x 6 feet. Reportedly about 200 feet long.

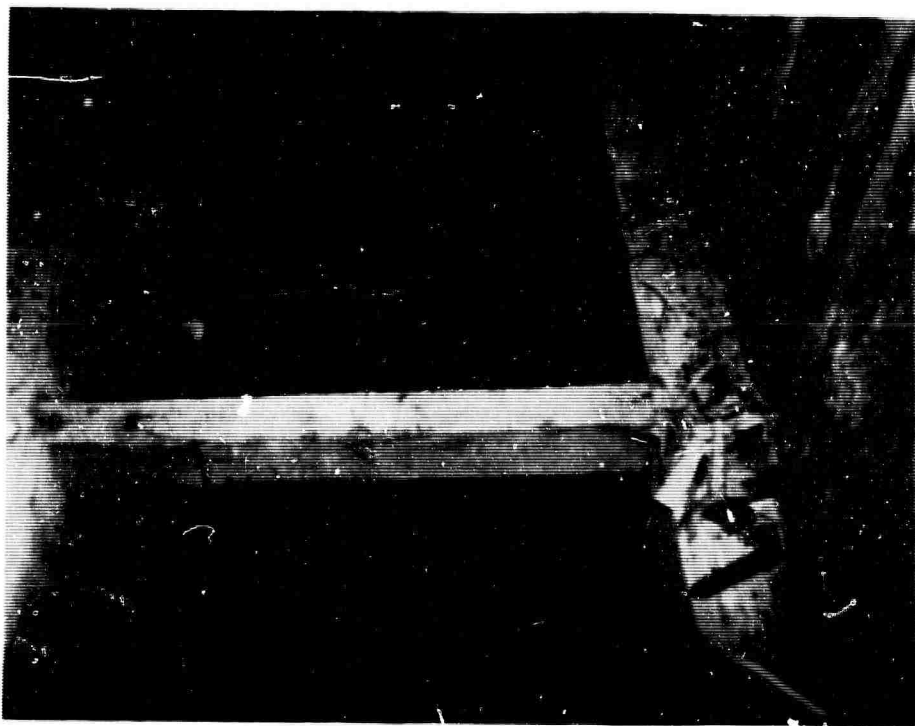
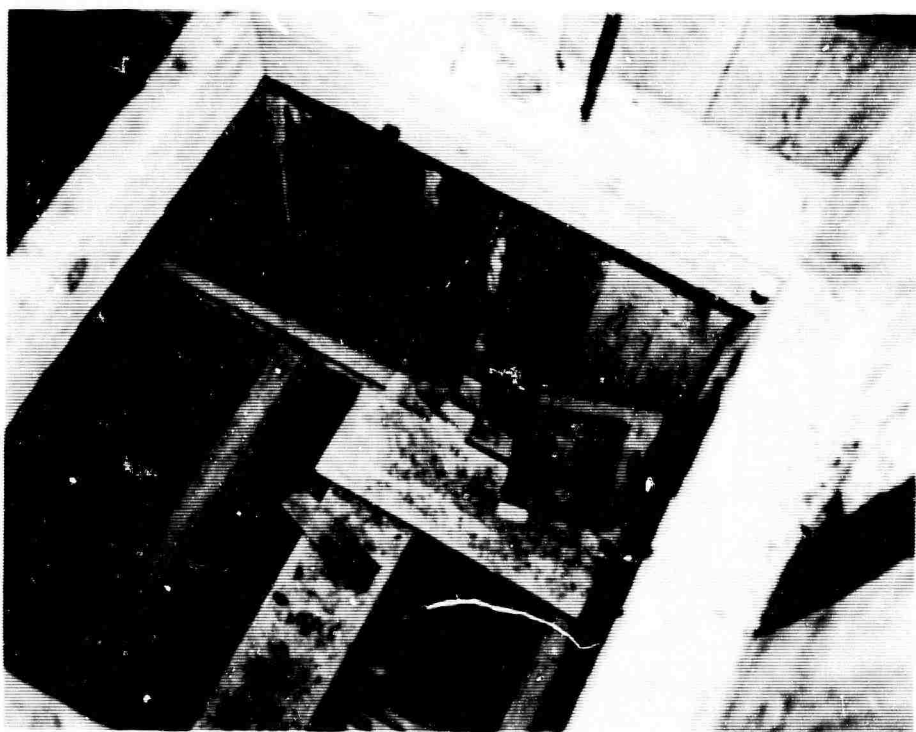
Photo 2-5-8. Preshot. September 30, 1963.

Photo No. 2-5-8. Northwest two-compartment vertical shaft, reportedly 250 feet deep. Lagging, sets, and ladders with landings every two sets in place. No partition with manway, nor cage guides on manway side. Timbered dimensions are 10 x 6 feet.

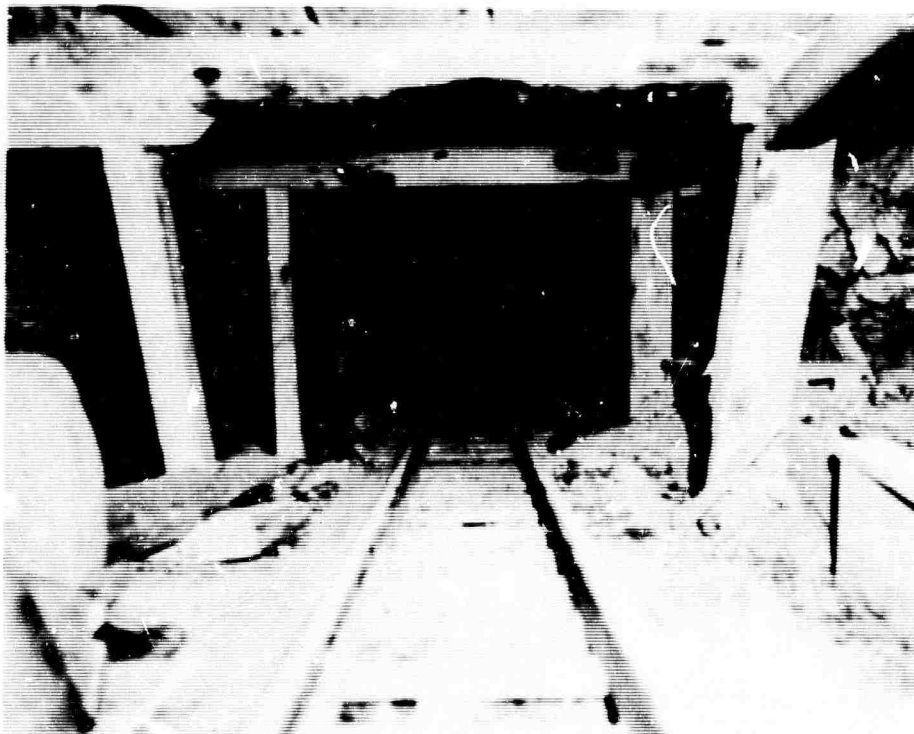
Photo 3-1-9. Preshot. September 30, 1963.

Photo No. 3-1-9. Two-compartment haulage shaft inclined at 45 degrees to intersection with main vertical shaft at about 60 feet. Sets and combination ladder and skip guides in place. No lagging or partition with manway. Shaft is in caved condition near surface. Timbered dimensions are 8 x 4 feet. The main shaft reportedly is about 500 feet deep.

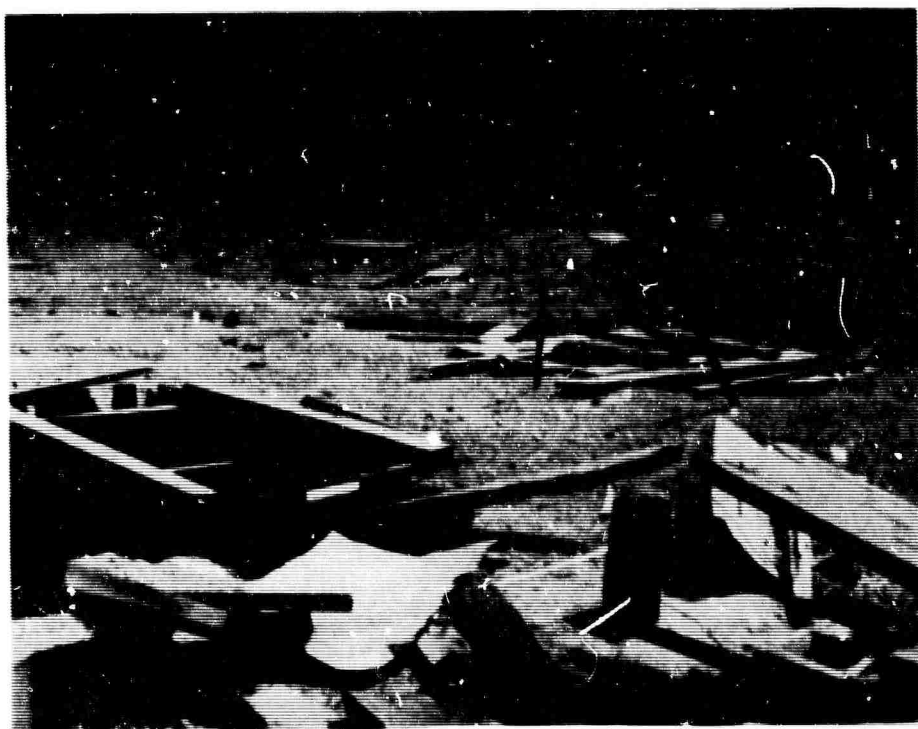
Photo 3-2-10. Preshot. September 30, 1963.

Photo No. 3-2-10. Surface view of inclined shaft on left, main shaft on right. Collars of both shafts are partially dismantled and in a caving condition especially near the surface. A large amount of timber debris covers the surface area.

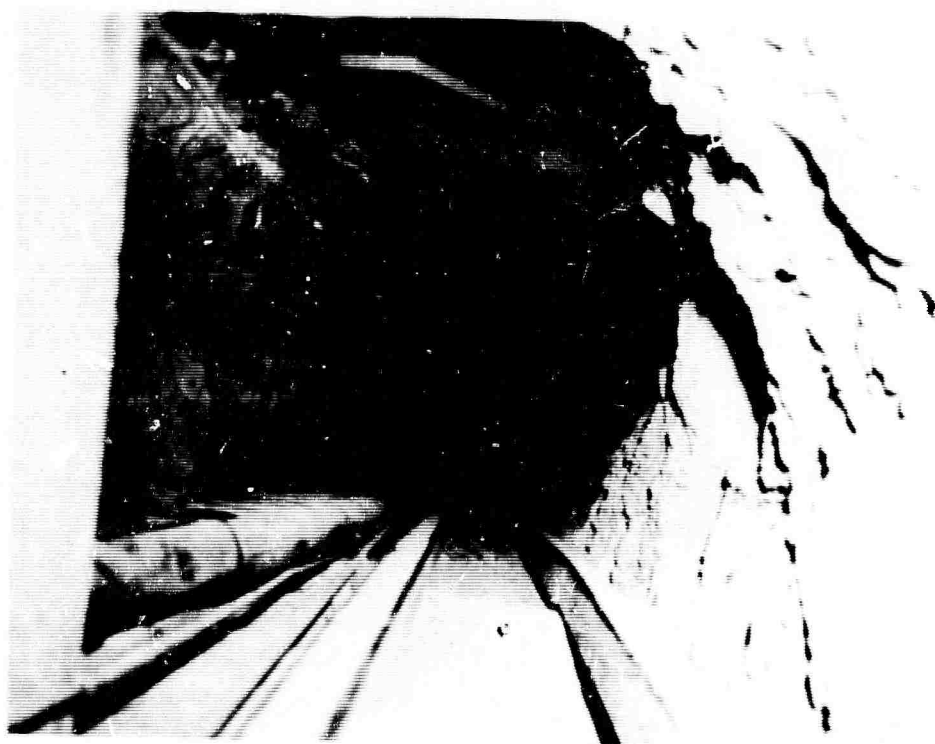
Photo 4-1-11. Preshot. September 30, 1963.

Photo No. 4-1-11. View at 100-foot level of main shaft looking down to 150-level. Shaft inclined at about 35 degrees to lower level.

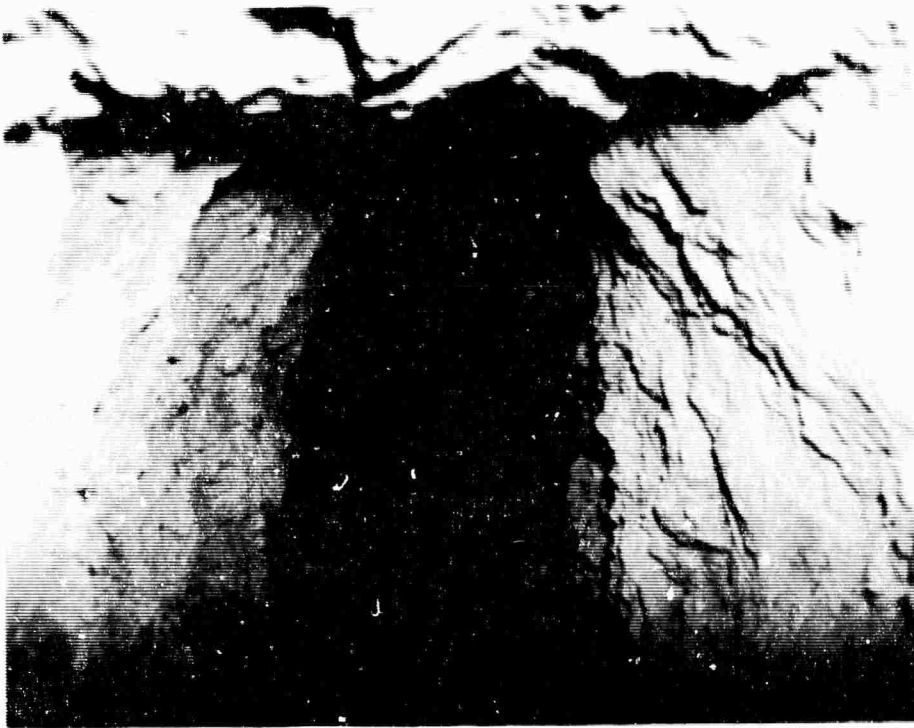
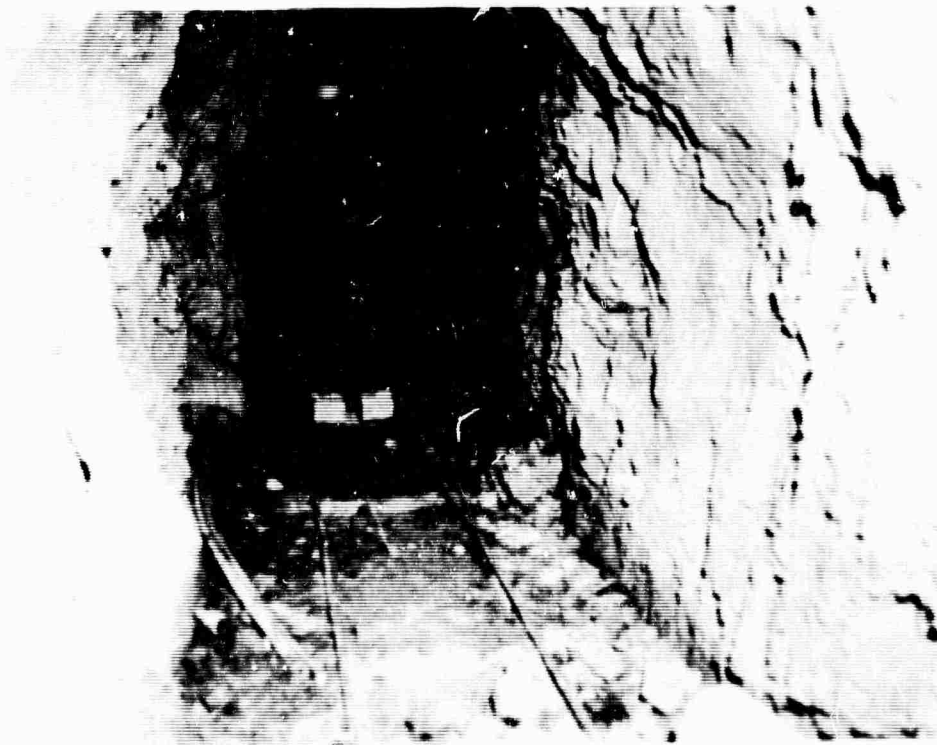
Photo 4-2-12. Preshot. September 30, 1963.

Photo No. 4-2-12. View looking back along 150-foot level development drift toward shaft station. Miscellaneous equipment scattered along drift.

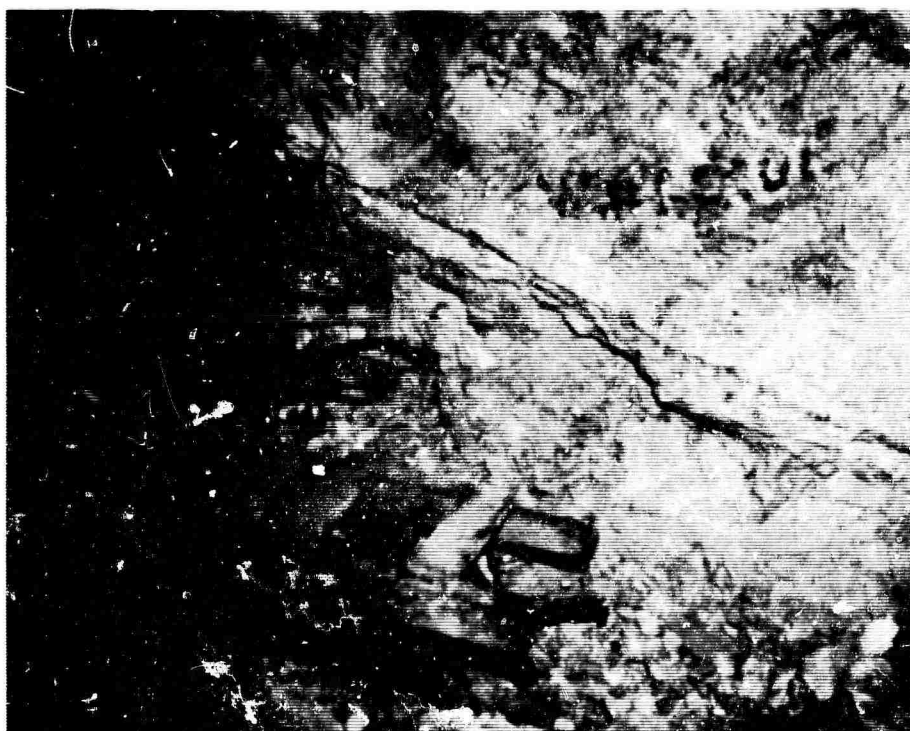
Photo 4-4-14. Preshot. September 30, 1963.

Photo No. 4-4-14. Rock walls at the intersection between development drift and cross-cut on 150-foot level.

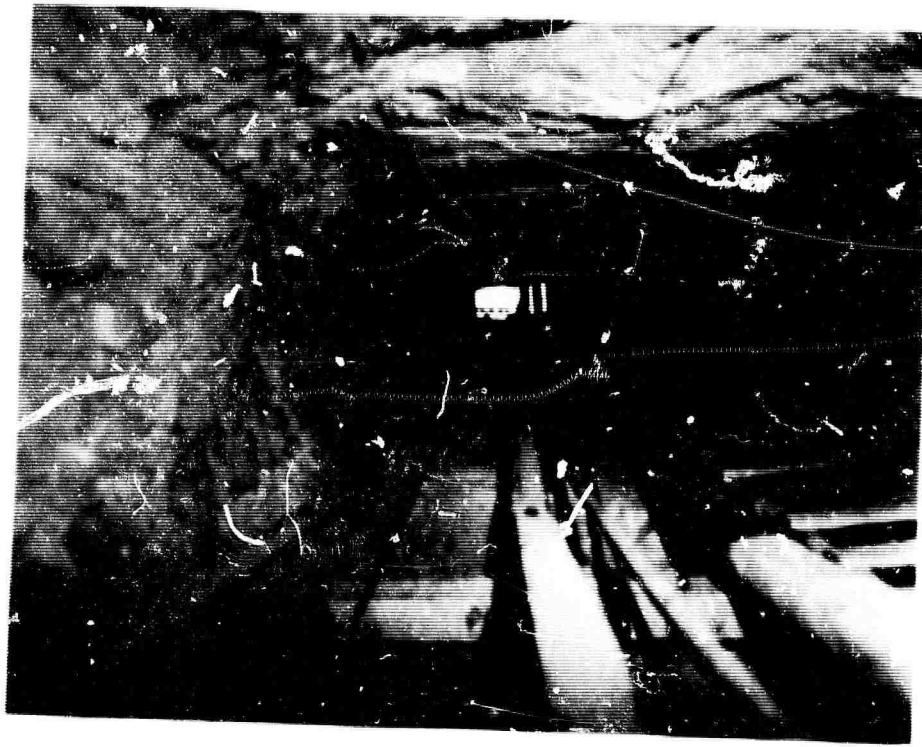
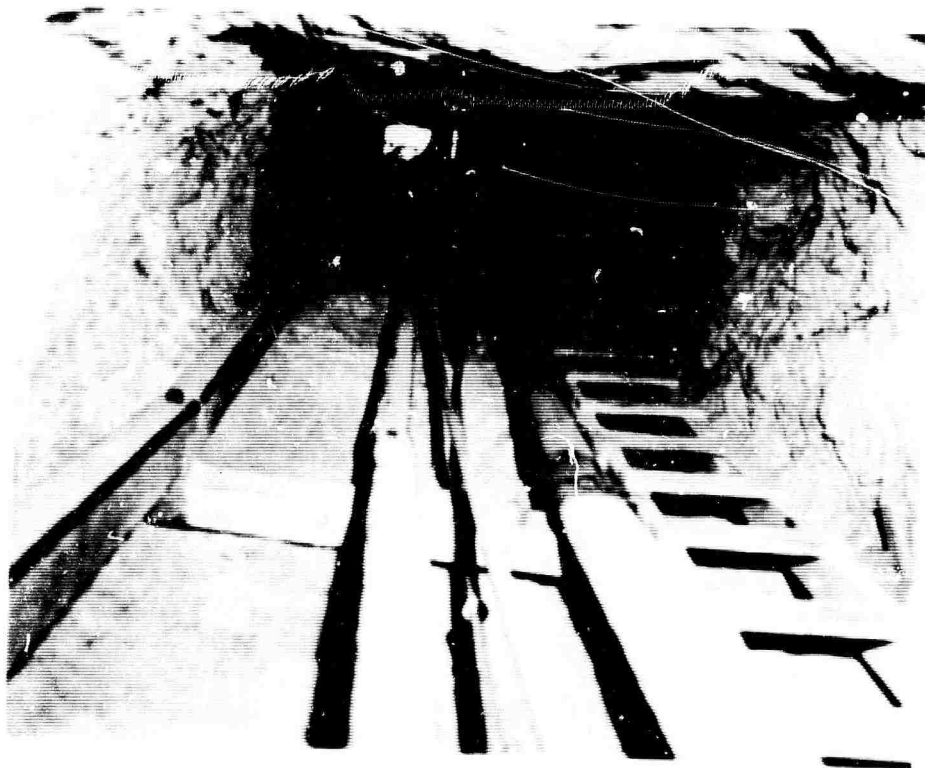
Photo 4-5-15. Preshot. September 30, 1963.

Photo No. 4-5-15. At the 100-foot level shaft station looking upward. The inclination of the upper shaft is 55 degrees to the 100-foot level and 35 degrees to the 150-foot level. No constructed shaft structure but occasional 6 x 6-inch timber stulls are used for support. Rock dimensions are irregular about 8 x 5 feet. Ladderway, bucket guides, ventilation pipes and air line in place.

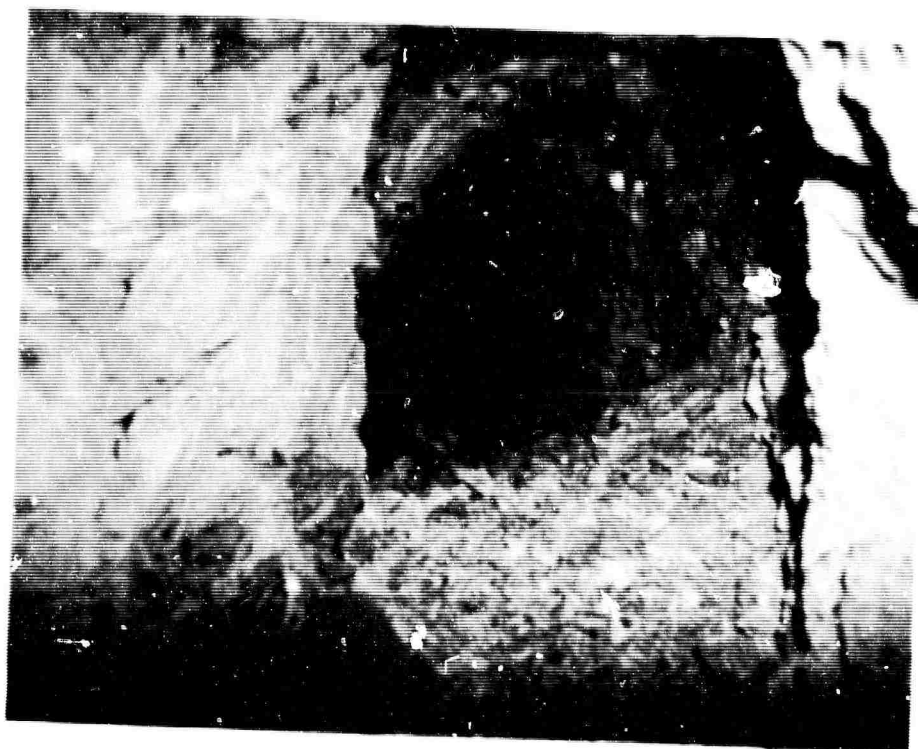
Photo 4-7-17. Preshot. September 30, 1963.

Photo No. 4-7-17. Minor rock falls along main drift crossing contact with shear zone on the 100-foot level. The drift dimensions are about 6 x 4 feet and the bearing is about north-south. All development drifts are unsupported.

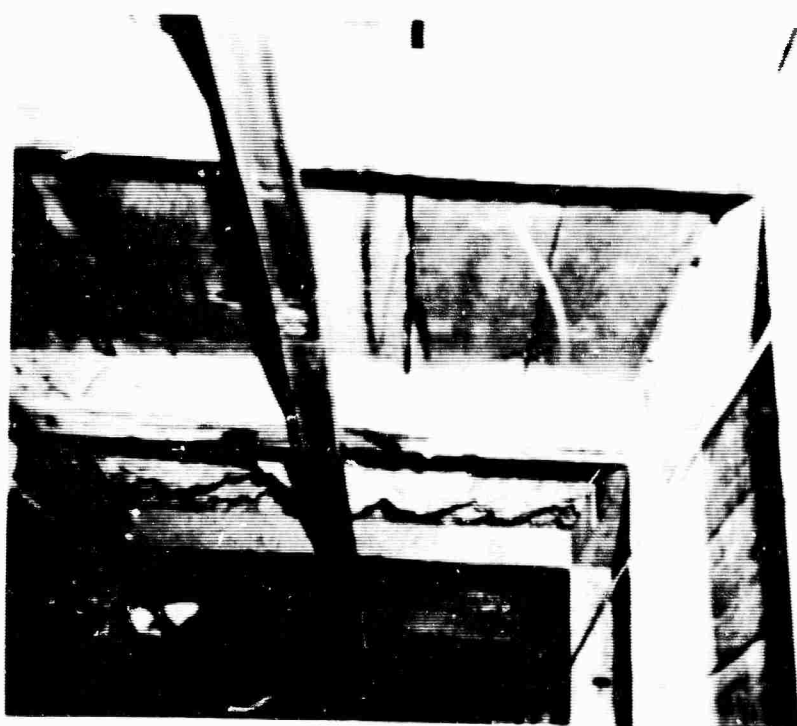
Photo 5-1-18. Preshot, September 30, 1963.

Photo No. 5-1-18. Main vertical shaft. Timbered dimensions are 7 x 5 feet. Reported depth is about 600 feet. Lagging, sets, and cage guides in place. Some sets in good rock have no lagging. One compartment timber construction without manway.

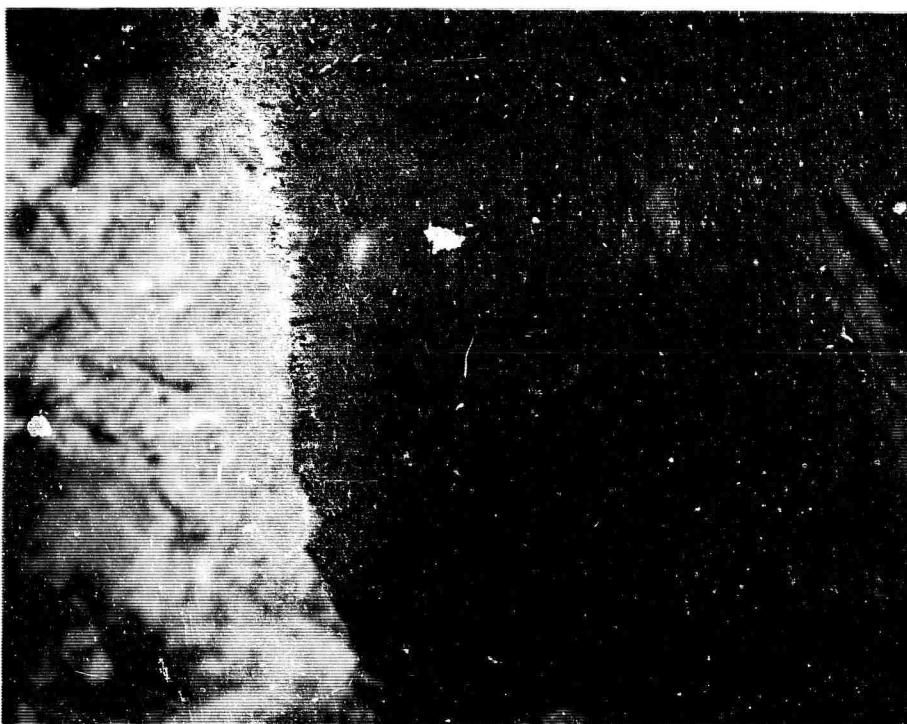
Photo 7-2-24. Preshot. October 1, 1963.

Photo No. 7-2-24. Prospect shaft inclined at estimated 30 degrees for about 25 feet and then continued at 60 degrees. Rock dimensions are about 5 x 5 feet. Shaft is entirely unsupported. Combination ladder and bucket guides in place.

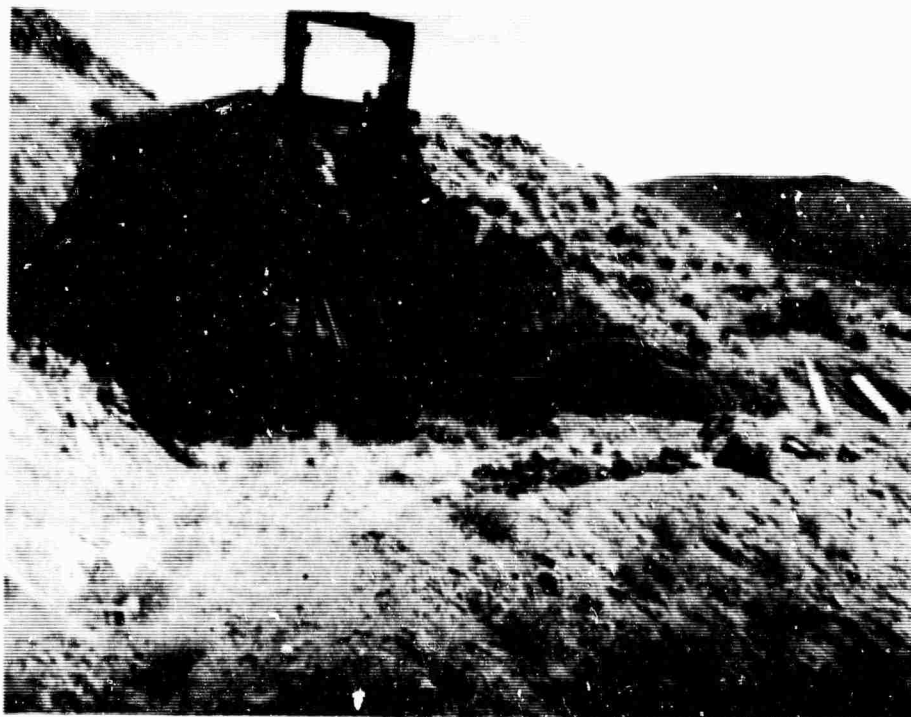
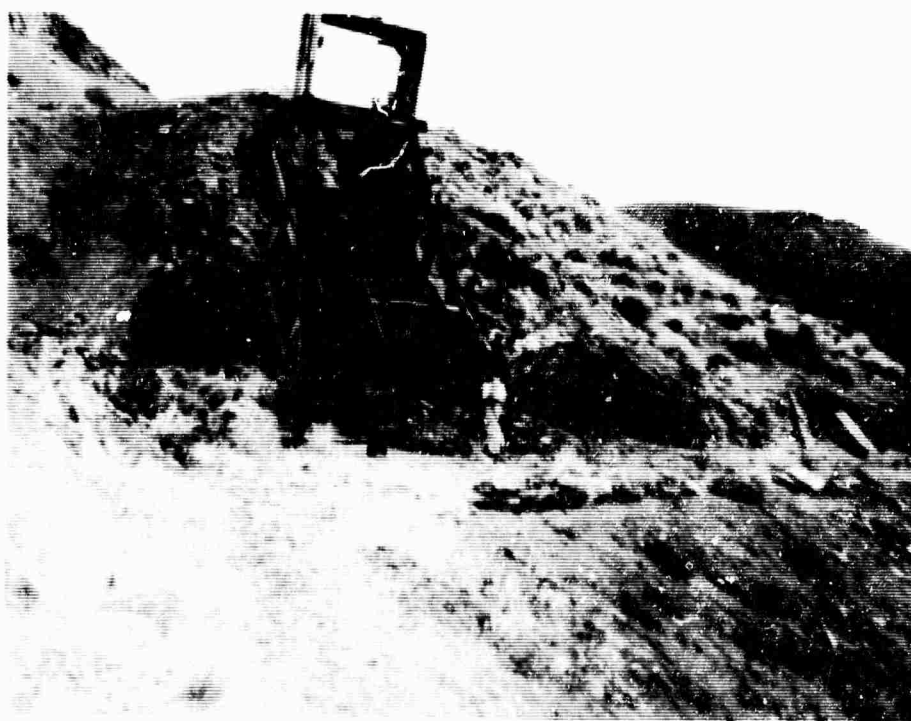
Photo 8-1-25. Preshot. October 1, 1963.

Photo No. 8-1-25. Surface area around Red Ant No. 2 headframe and shaft. Steep rock slopes and open cut shown on north side, toward surface zero, with rock slopes undercut and near vertical.

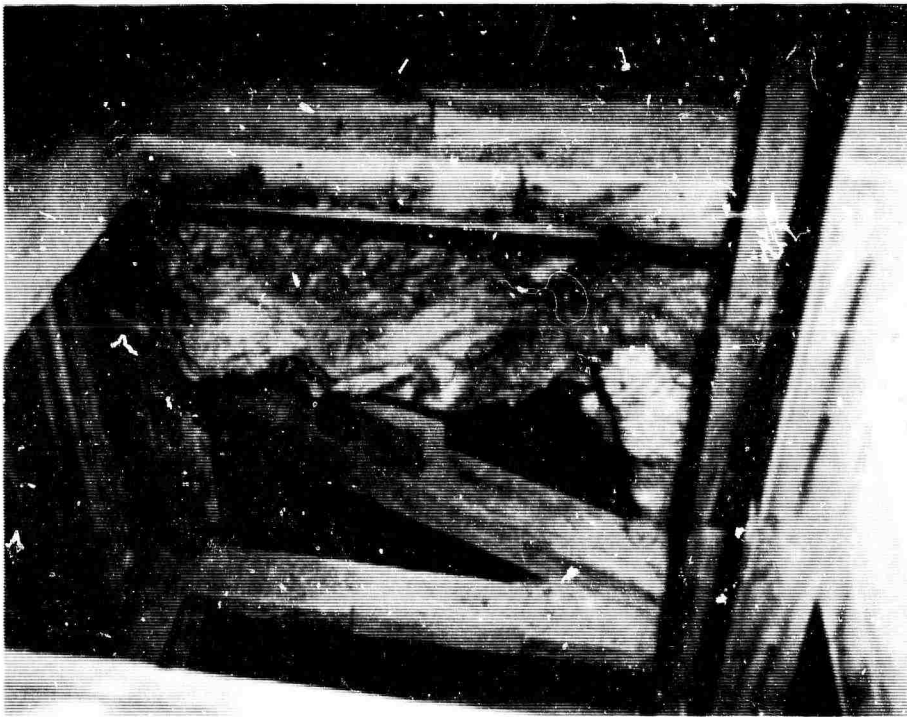
Photo 8-2-26. Preshot. October 1, 1963.

Photo No. 8-2-26. Vertical one-compartment shaft of Red Ant No. 2 at first level about 15 feet below collar. Timber sets and lagging in place to first level. Partially timber supported to Red Ant No. 2 adit level at about 40 feet in depth. Ladder and bucket guides in place.

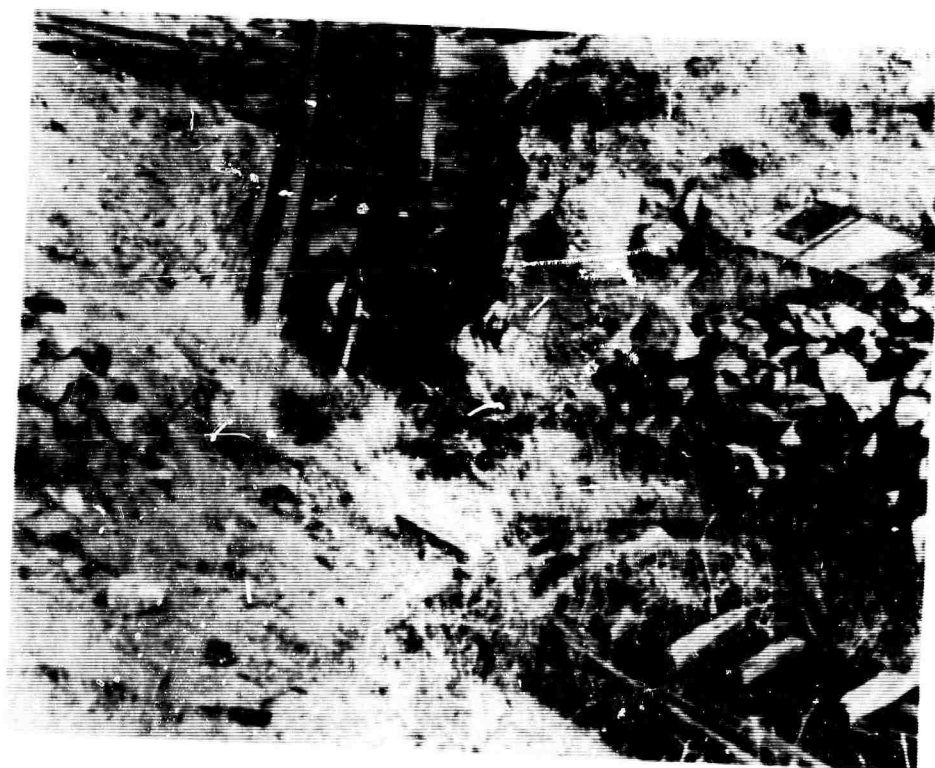
Photo 8-5-29. Preshot. October 1, 1963.

Photo No. 8-5-29. Portal of Red Ant No. 2 adit on hillside below shaft. Four portal sets of 4 x 4-inch timber with timber cribbing for mine dump.

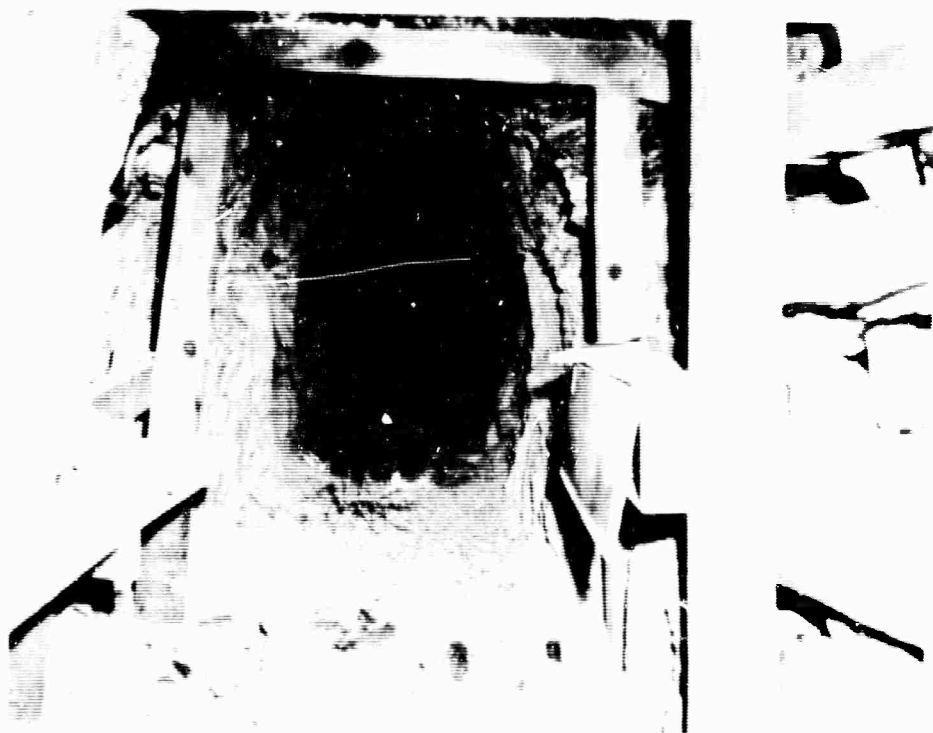
Photo 8-6-30. Preshot. October 1, 1963.

Photo No. 8-6-30. Red Ant No. 2 adit from portal. Rock dimensions are irregular, about 6 x 4 feet. The adit extends about 150 feet with a short cross-cut to the Red Ant No. 2 shaft. It was driven along a fault zone in blocky limestone, and has no support beyond the portal timber sets.

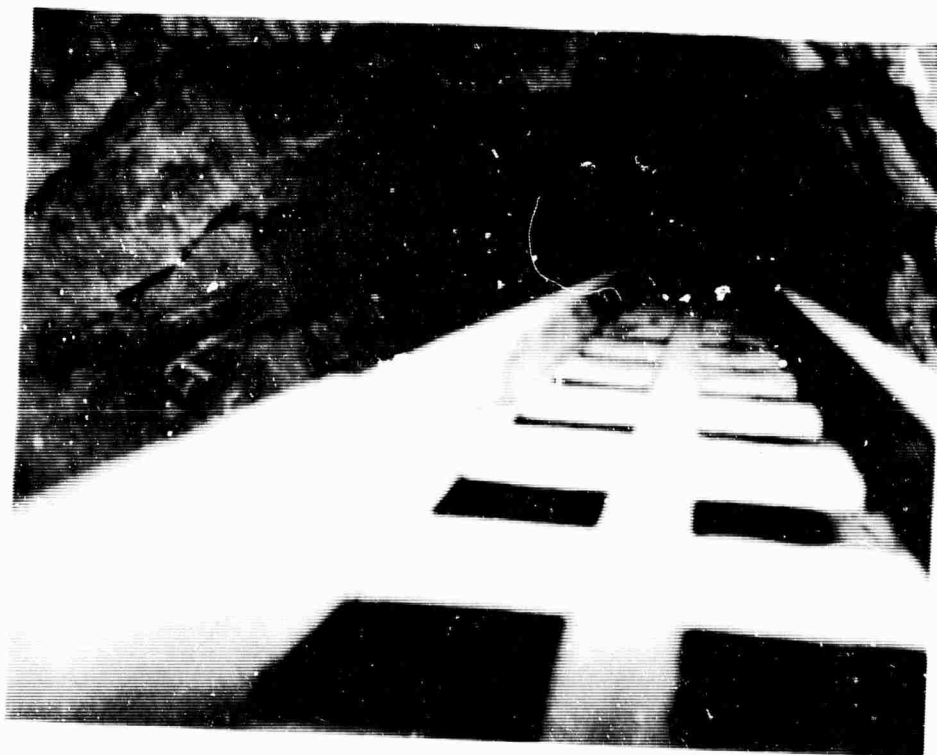
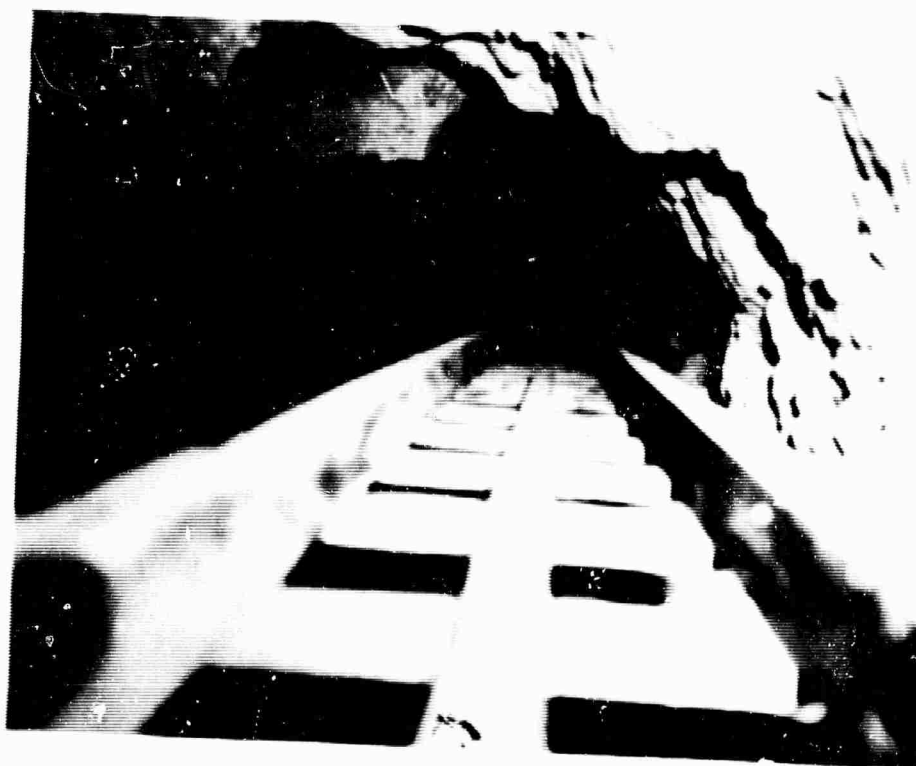
Photo 8-7-31. Preshot. October 1, 1963.

Photo No. 8-7-31. East End Mine exploratory shaft inclined at estimated 45 degrees. Rock dimensions are irregular, about 4 x 4 feet. The shaft is about 40 feet in depth. Except for one timber collar set, the shaft is unsupported. Combination bucket guides and ladder in place.

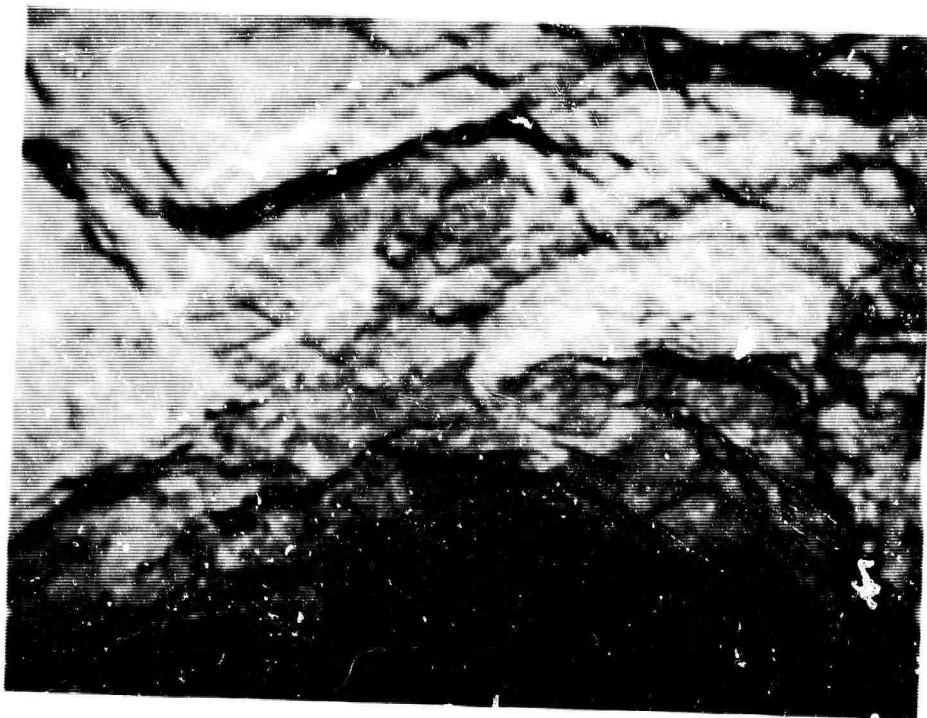
Photo 9-1-33. Preshot. October 1, 1963.

Photo No. 9-1-33. Rock back in exploratory shaft inclined at estimated 30 degrees to the southeast and about 40 feet in length. Rock dimensions are irregular, about 5 x 4 feet. The shaft is entirely unsupported, and the floor is covered with backfill and rubble.

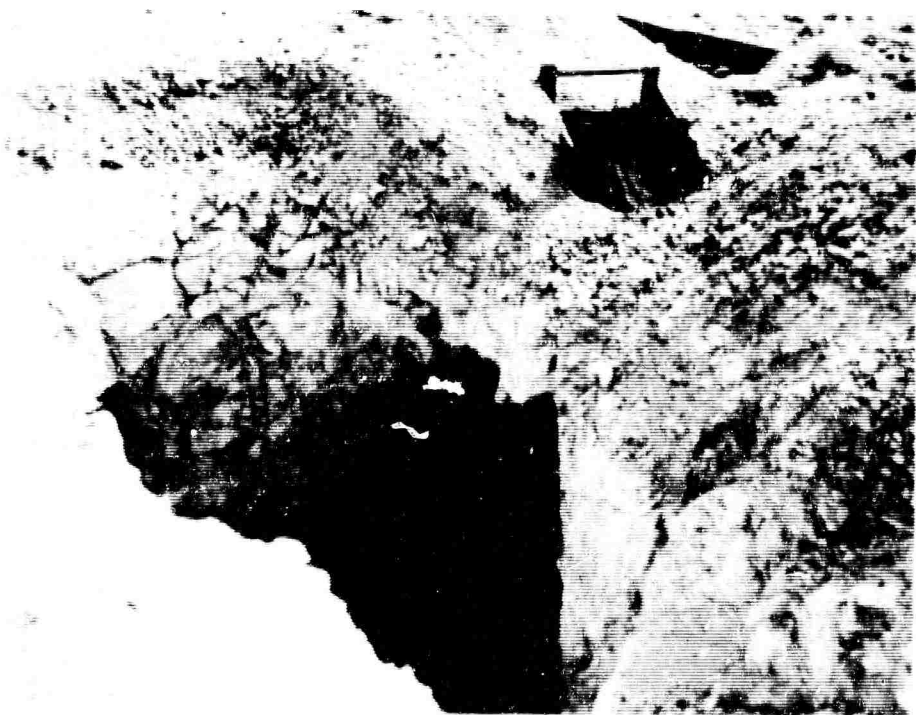
Photo 10-1-36. Preshot. October 1, 1963.

Photo No. 10-1-36. Open stope mined to surface. Irregular width about 6 to 8 feet, and less than 100 feet in depth. Randomly placed timber stulls are used for support. The rock is heavily fractured.
