VUF-1010
FINAL REPORT

VELA UNIFORM PROJECT **SHOAL**

STRUCTURAL SURVEY OF PRIVATE MINING PROPERTIES

U.S. BUREAU OF MINES

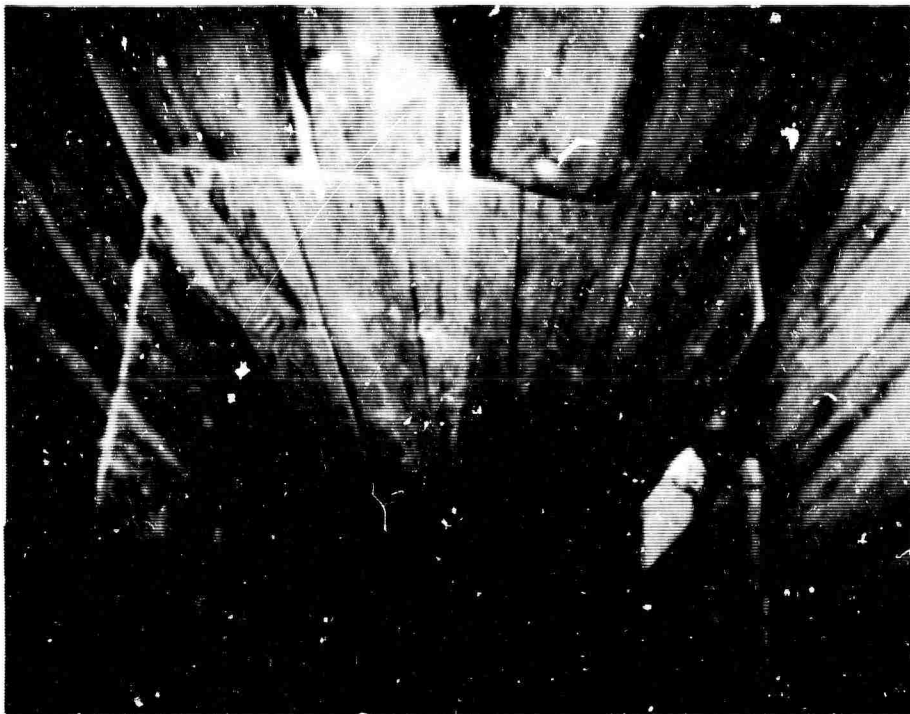
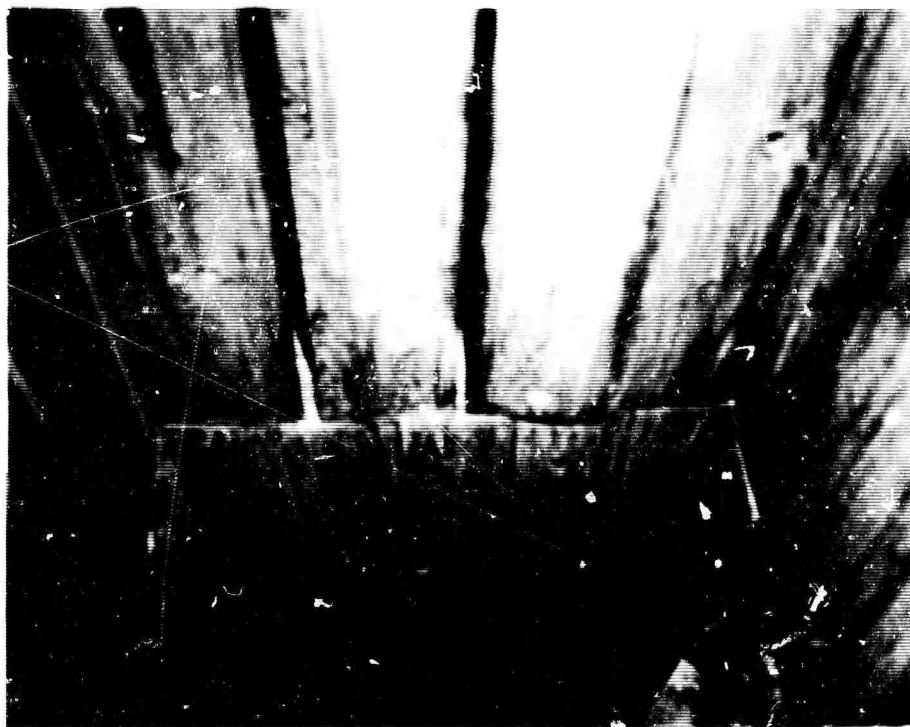
Photo 10-3-38. Preshot. October 1, 1963.

Photo No. 10-3-38. Hoisting compartment of east vertical shaft. Timbered dimensions are about 6 x 5 feet. Sets and lagging in place but some lagging gone. No cage guides.

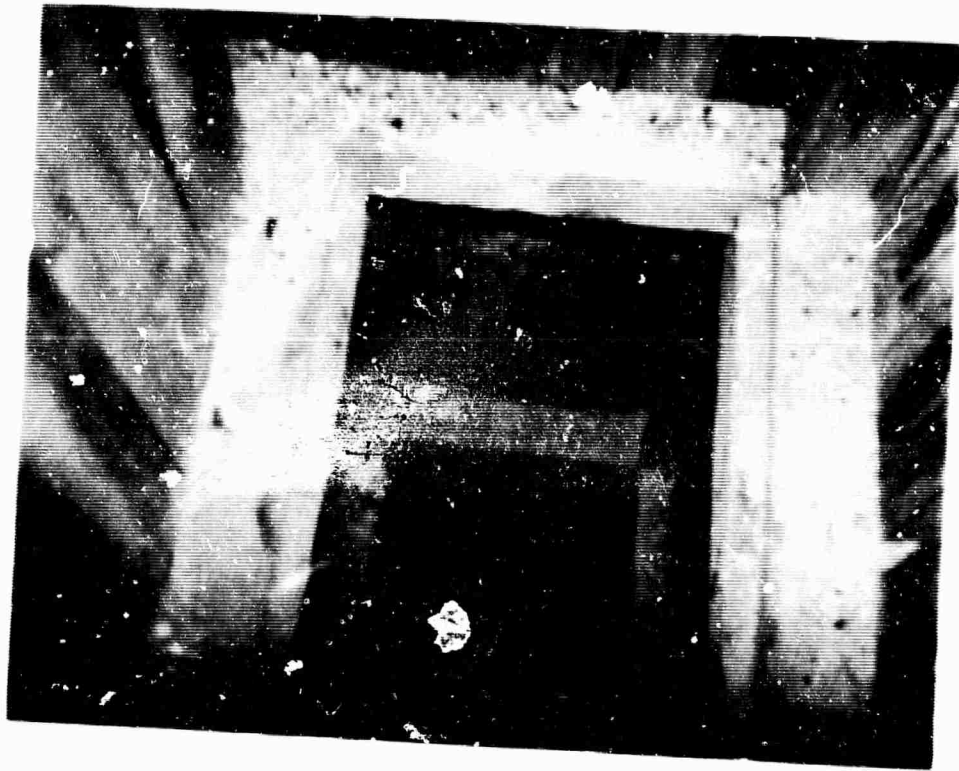
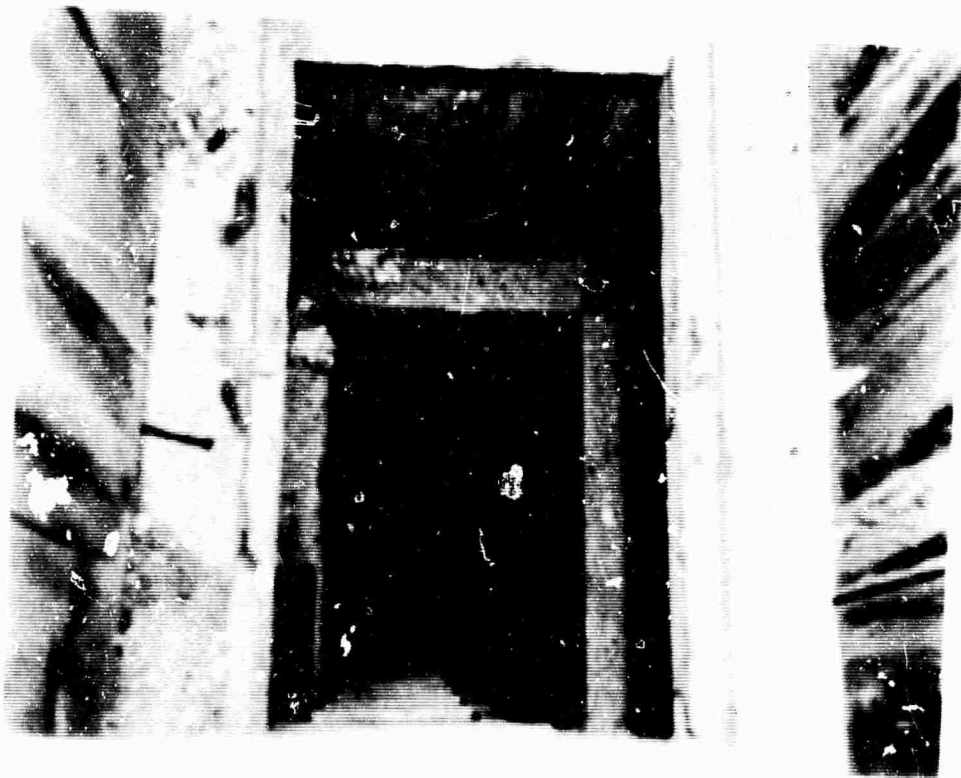
Photo 10-4-39. Preshot. October 1, 1963.

Photo No. 10-4-39. Manway compartment of east vertical shaft. Timbered dimensions are about 5 x 3 feet. Sets and lagging in place but some lagging gone. Manway ladder in place.

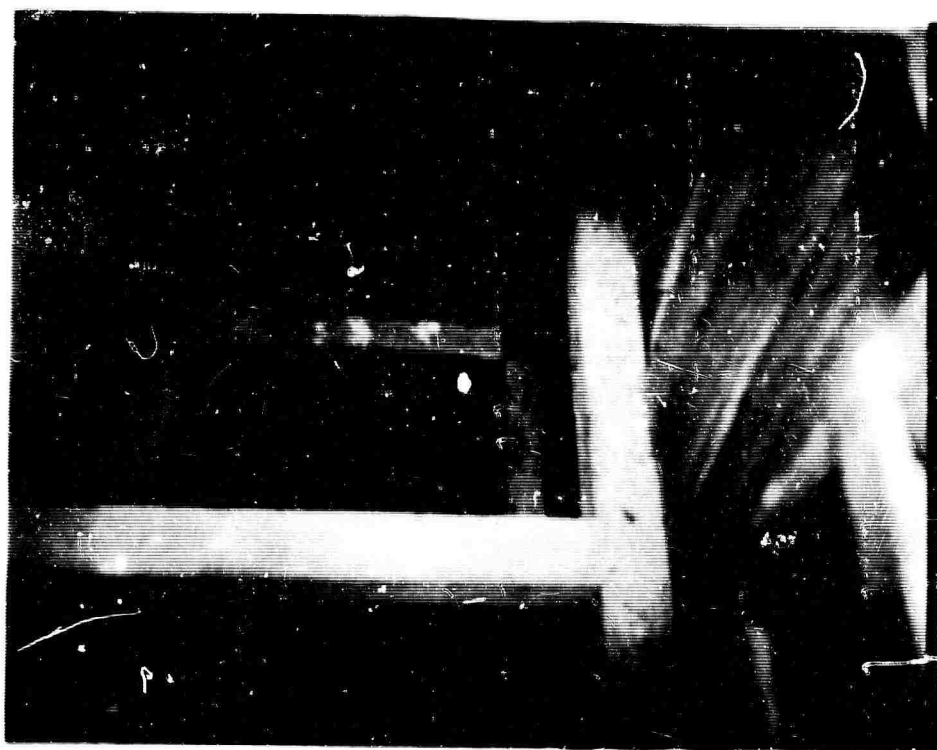
Photo 10-7-42. Preshot. October 1, 1963.

Photo No. 10-7-42. Main vertical two-compartment shaft. Timbered dimensions are about 8 x 5 feet. Reportedly 300 feet in depth. Lagging, sets, and ladder in place. No cage guides or manway partition.

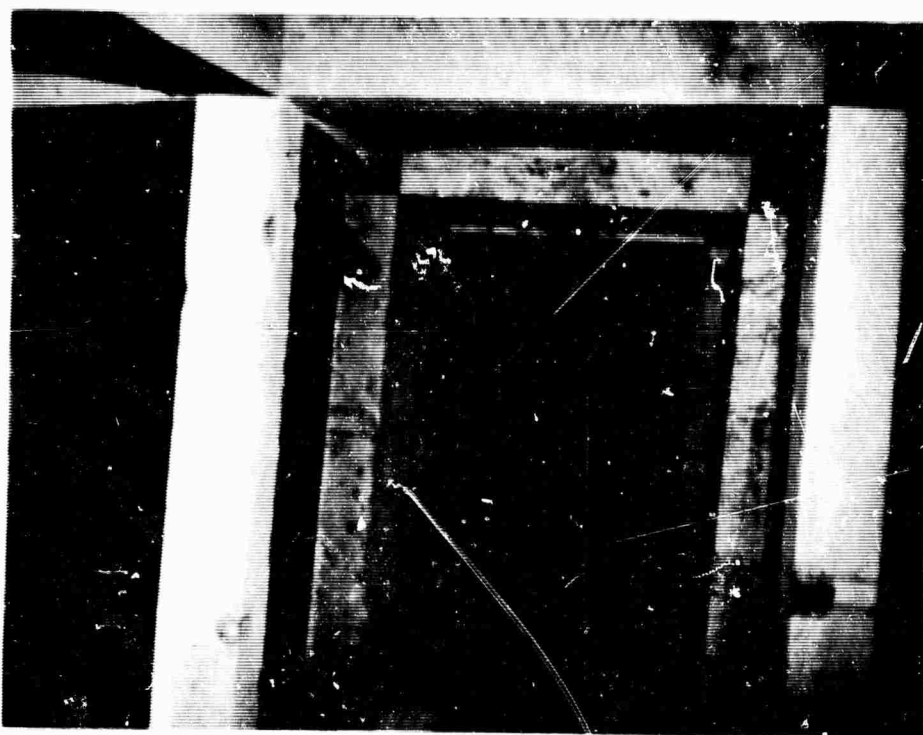
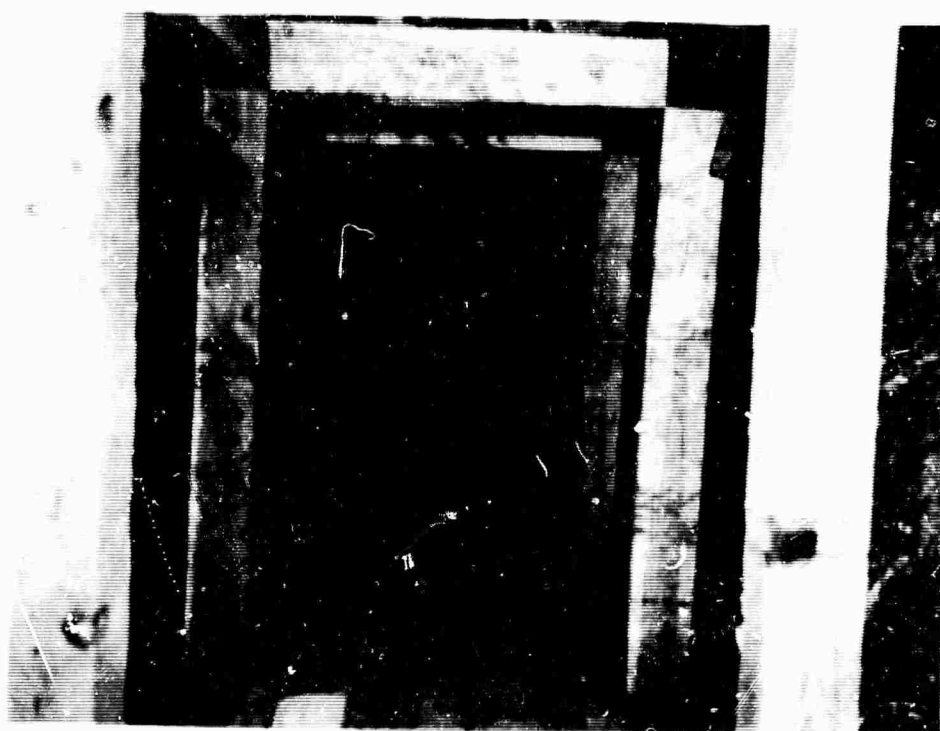
Photo 11-2-45. Preshot. October 2, 1963.

Photo No. 11-2-45. Lengthwise view of 250 stope two sets below the 100-foot level. This stope is square set on irregular 5 x 5-foot centers with 8 x 8-inch timbers. Some areas are supported by timber cribbing. Estimated stope dimensions are 100 feet in length and 25 to 75 feet in width. In vertical dimension the 250 stope extends for several levels. Some timber posts and caps in square sets have been crushed and squeezed by ground movement. The bearing of the stope is about north-south.

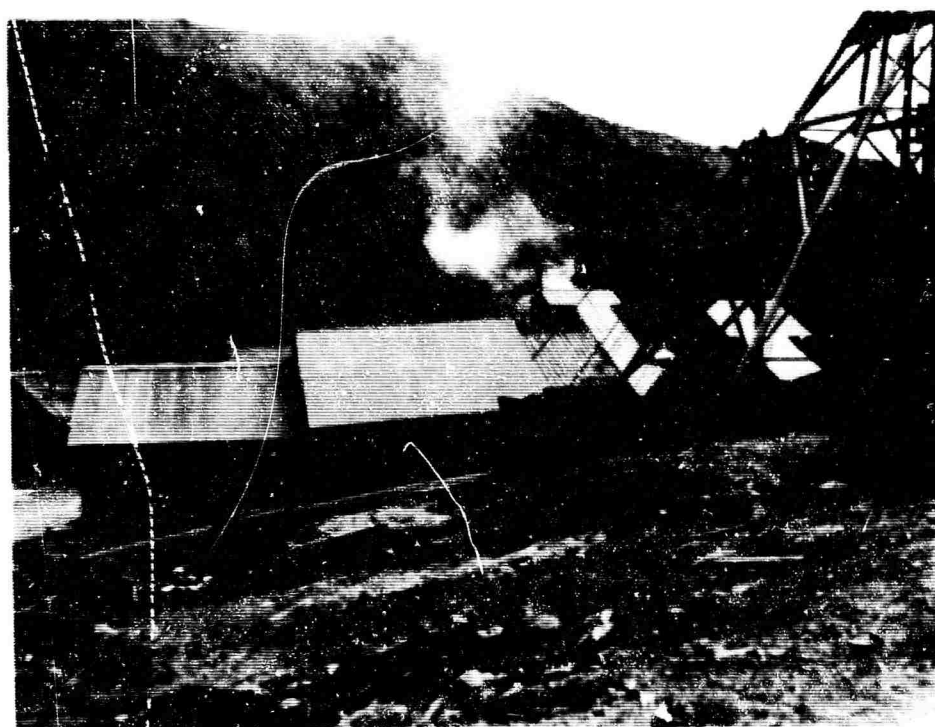
Photo 11-15-58. Postshot. October 28, 1963.

Photo No. 11-15-58. Subsidence by undermining from the 250 stope has caused a four degree northward tilt to hoist house. The concrete foundation for the hoisting equipment has a large crosswise crack immediately behind the main drum. The hoist consists of a cylindrical double drum electric powered system mounted on a steel frame.

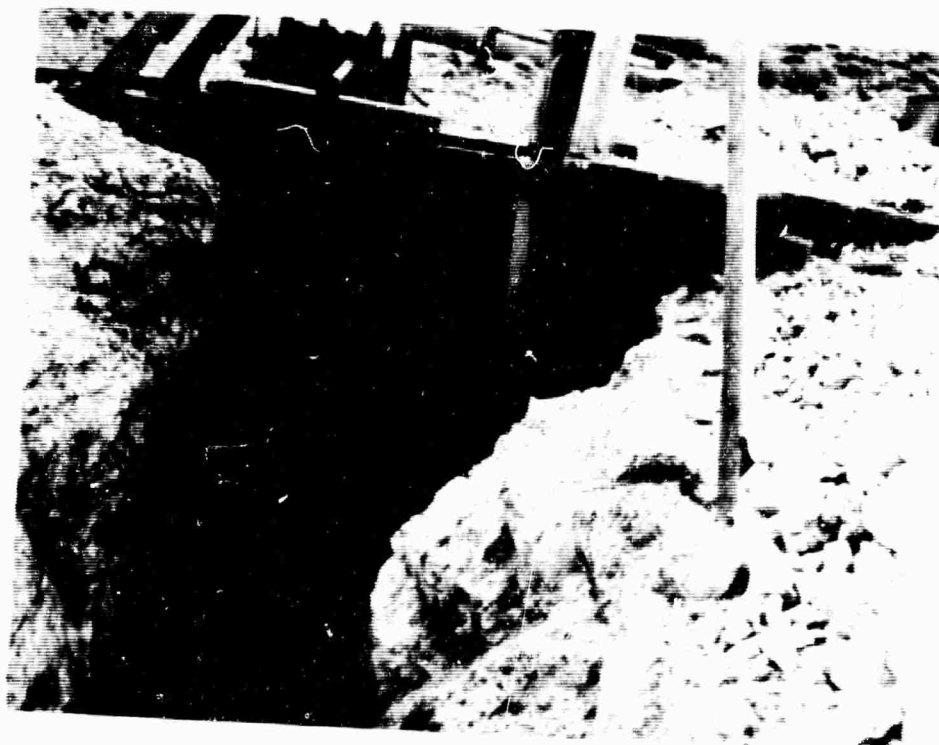
Photo 12-1-59. Preshot. October 2, 1963.

Photo No. 12-1-59. Vertical prospect shaft about 25 feet in depth with stope mined to surface around shaft. Timber prospect headframe with steel hand winch in place on surface. The shaft consists of four timber legs with a ladder in place. The stope contains two timber stulls.

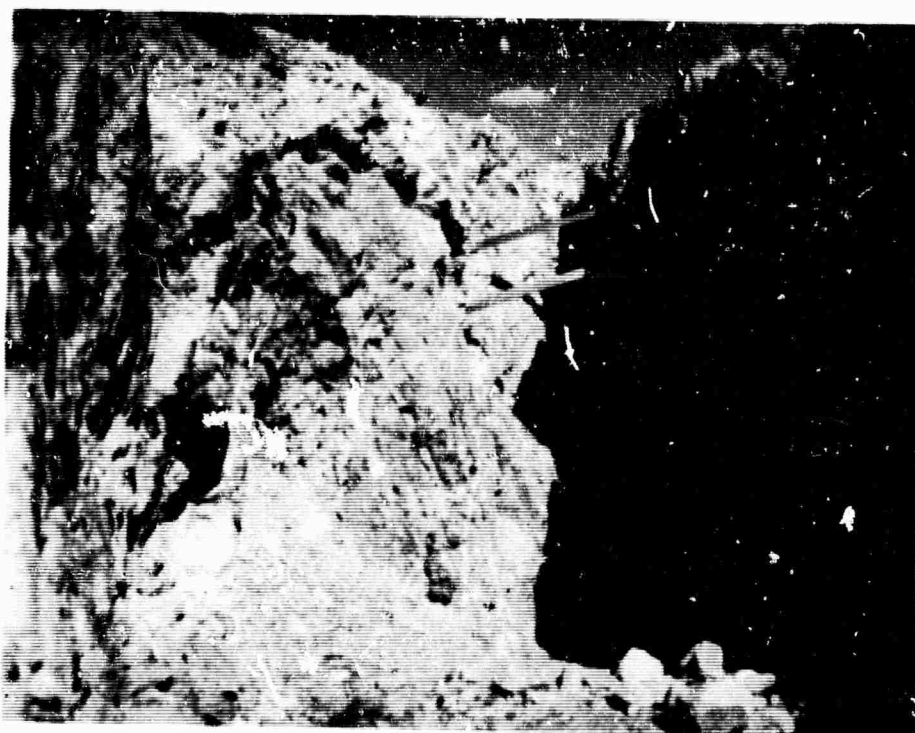
Photo 13-2-61. Preshot. October 2, 1963.

Photo No. 13-2-61. Open cut about 100 feet long, up to 15 feet deep, and of irregular width up to 6 feet. Two 6 x 6-inch timber stulls are used for support.

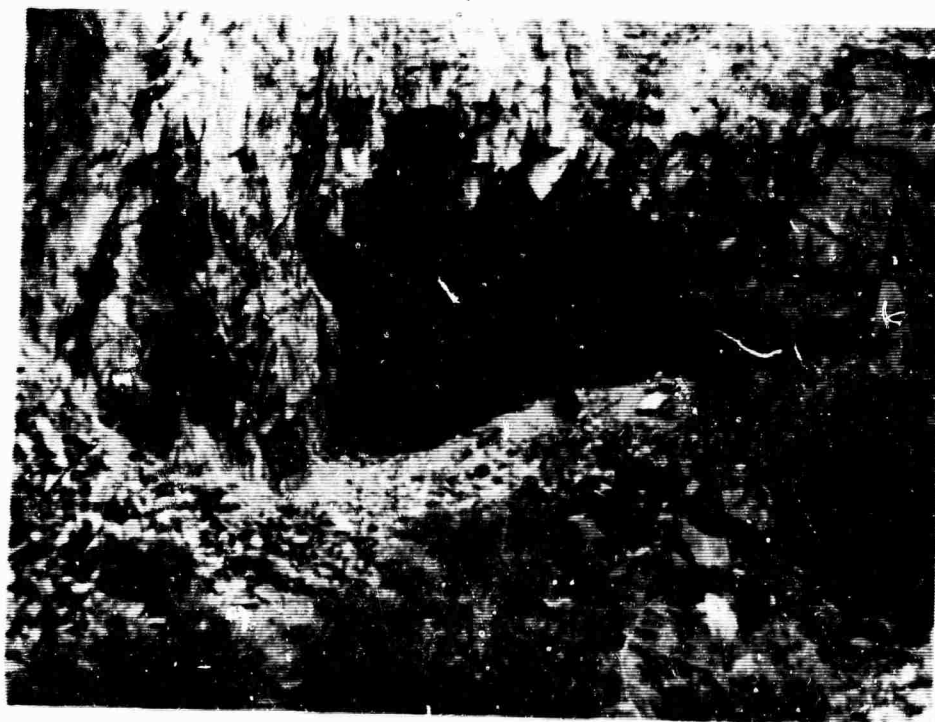
Photo 13-4-63. Preshot. October 2, 1963.

Photo No. 13-4-63. Entrance to west adit. Rock dimensions are about 7 feet wide, 6 feet high, and several hundred feet long. The rock is fractured and weakened above the adit portal. Some rock falls have previously occurred at the portal and along the adit. No support was used for this adit.

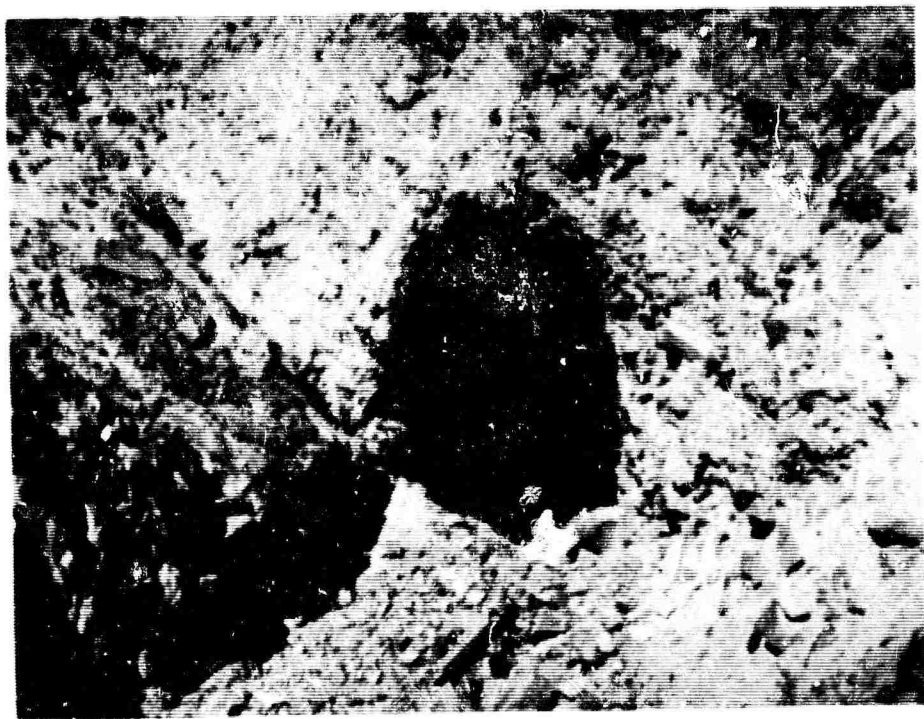
Photo 13-5-64. Preshot. October 2, 1963.

Photo No. 13-5-64. Entrance to east adit. Rock dimensions are about 6 x 3 feet and several hundred feet in length. Some rock falls have previously occurred at the portal and along the adit. No support was used for this adit. The portal has been driven in semi-consolidated alluvium.

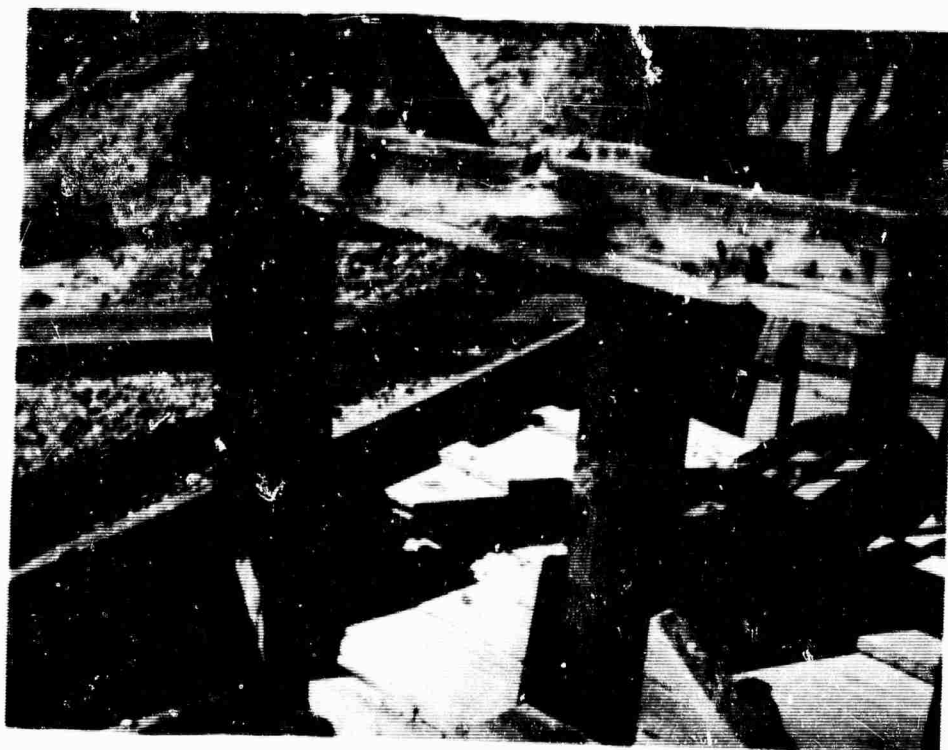
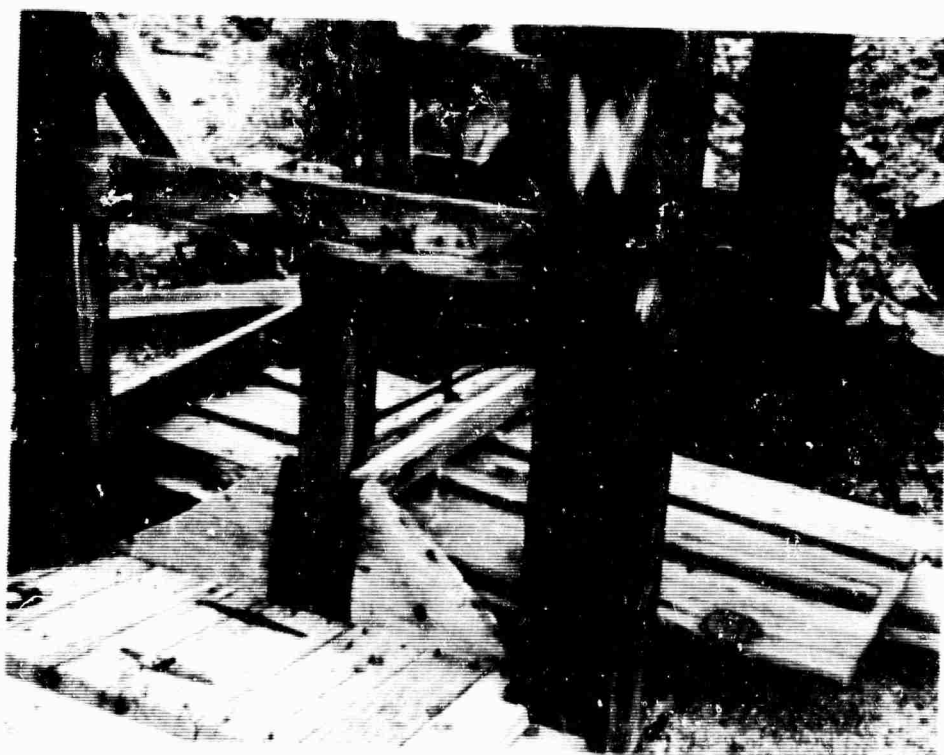
Photo 13-6-65. Preshot. October 2, 1963.

Photo No. 13-6-65. Collar of main vertical shaft. The timbered dimensions are 8 x 5 feet. The shaft is reportedly 150 feet deep. The cage compartment is blocked by timber planks. The manway is accessible with timber sets, lagging, cage guides, and ladder in place. No partition with manway.

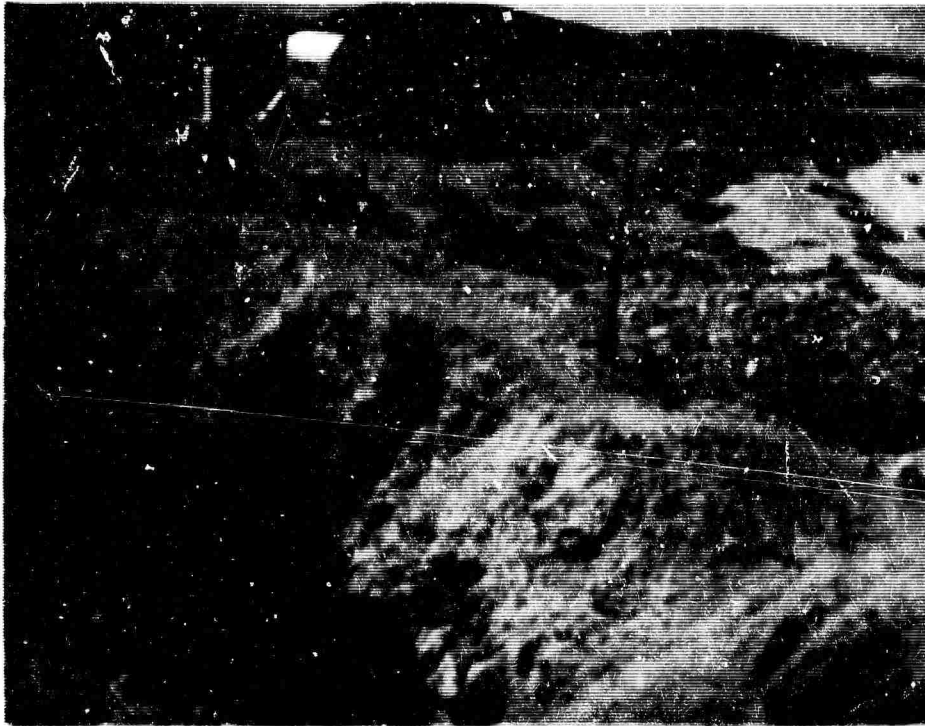
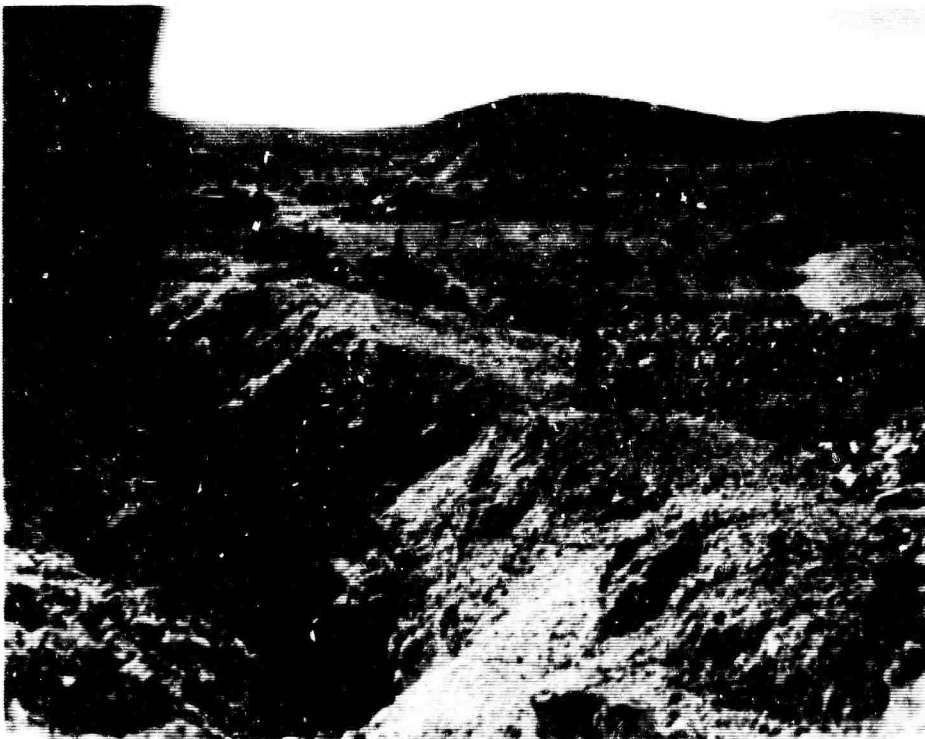
Photo No. 14-1-66. Nearly vertical open stope mined to the surface immediately to the south of the main shaft. Irregular width 3 to 8 feet, and 100 feet or more in length and depth. The trailer in the center background lies near the edge of the open stope. The trailer burned down from unknown causes on October 19, 1963.

Photo 14-1-66. Preshot. October 3, 1963.

Photo 14-1-66. Postshot. October 31, 1963.

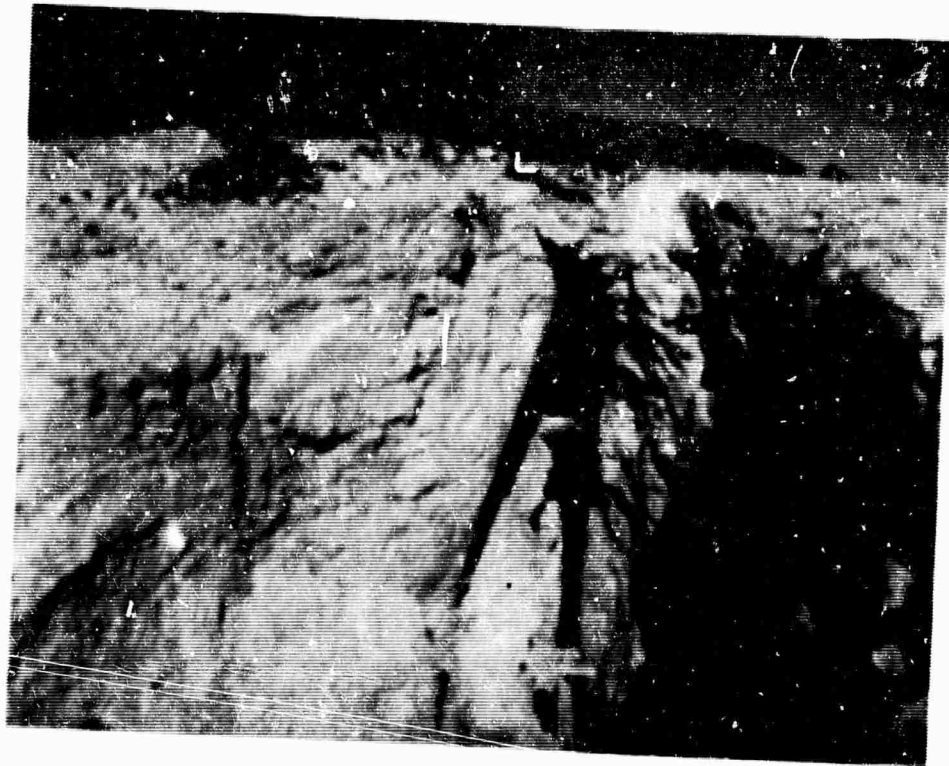
Photo No. 14-2-67. Nearly vertical open stope mined to the surface immediately to the north of the main shaft. Blacksmith shop in background lies on edge of open stope. Irregular width up to 15 feet, and 100 feet or more in length and depth. At the surface the stope has overhanging walls. No support was used other than occasional timber stulls.

Photo 14-2-67. Preshot. October 3, 1963.

Photo 14-2-67. Postshot. October 31, 1963.

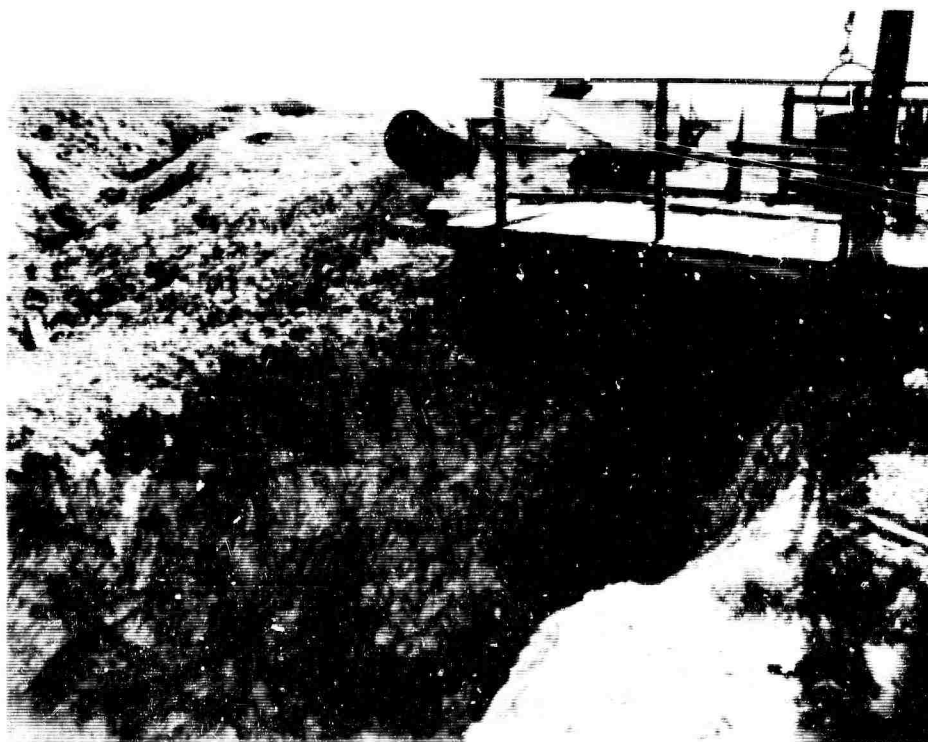
Photo No. 14-3-68. Open stope shown in previous photo and showing exposed collar set of main shaft in center background. Overhanging rock walls shown.

Photo 14-3-68. Preshot. October 3, 1963.

Photo 14-3-68. Postshot. October 31, 1963.

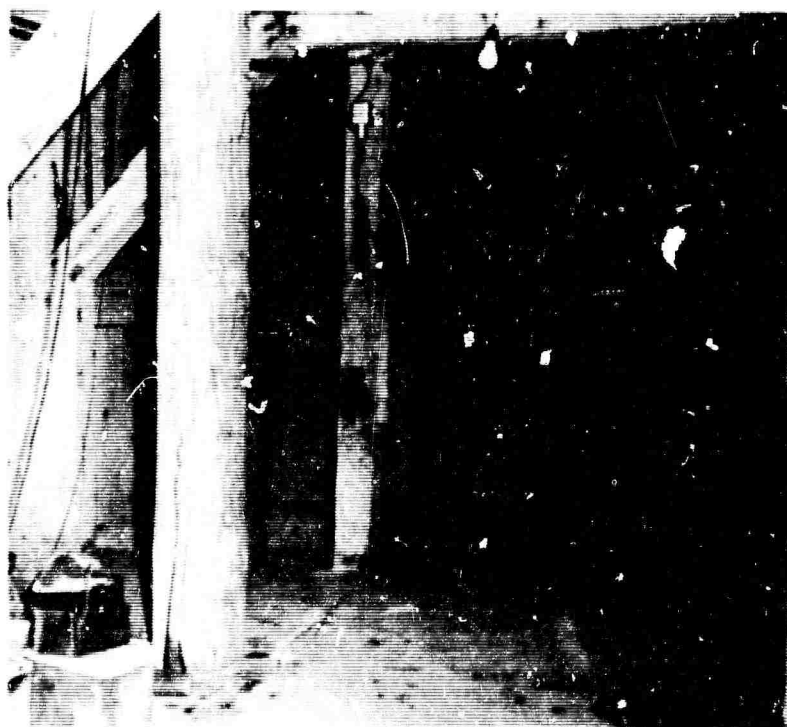
Photo No. 15-1-70. Shaft station on 350-foot level. The timbered dimensions of the shaft are 16 x 6 feet. The shaft is three-compartment, all timbered, with only one compartment in use for shaft rehabilitation work.

Photo 15-1-70. Preshot. October 10, 1963.

Photo 15-1-70. Postshot. October 31, 1963.

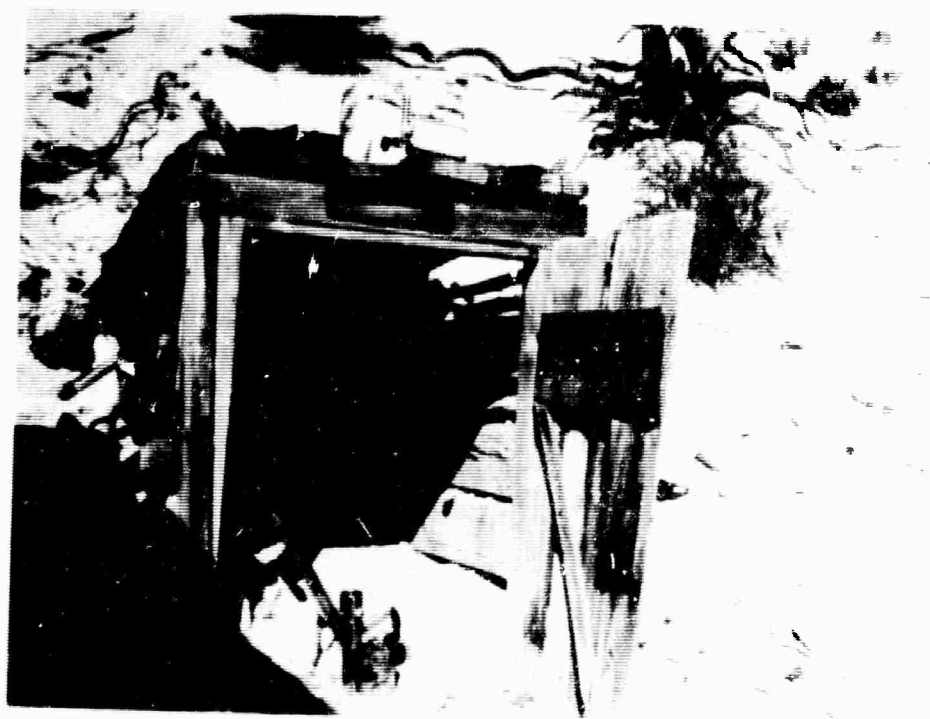
Photo No. 16-3-77. Portal of central adit. The adit bearing is about east-west and the length is about 400 feet. Five 6 x 6-inch timber sets on irregular 6 x 4-foot spacing with timber sprags for lagging are at the portal, otherwise the adit is unsupported. The adit dimensions are about 6 feet in height and 4 feet in width.

Photo 16-3-77. Preshot. October 22, 1963.

Photo 16-3-77. Postshot. October 31, 1963.
BUFFALO HUMP MINE

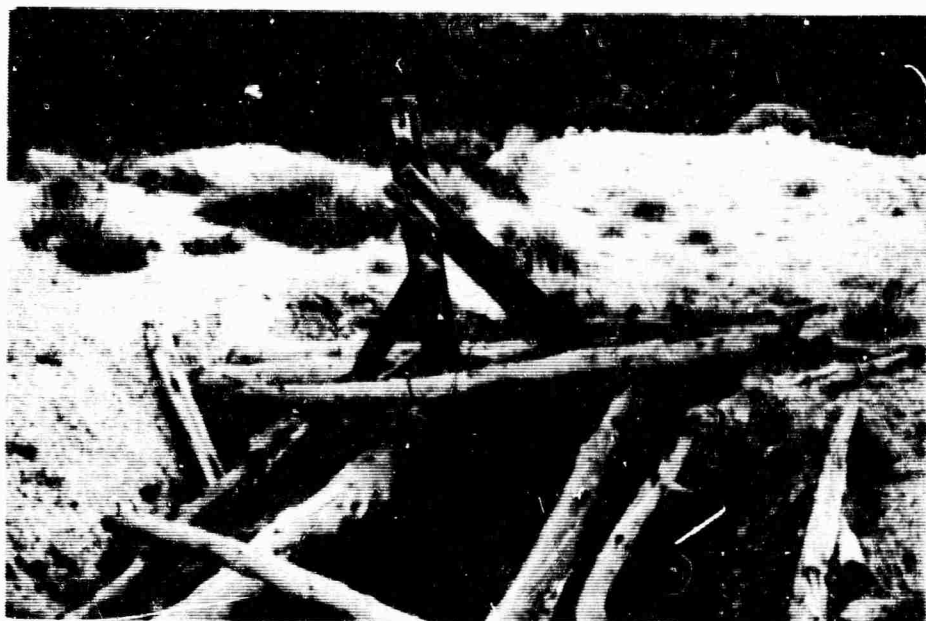
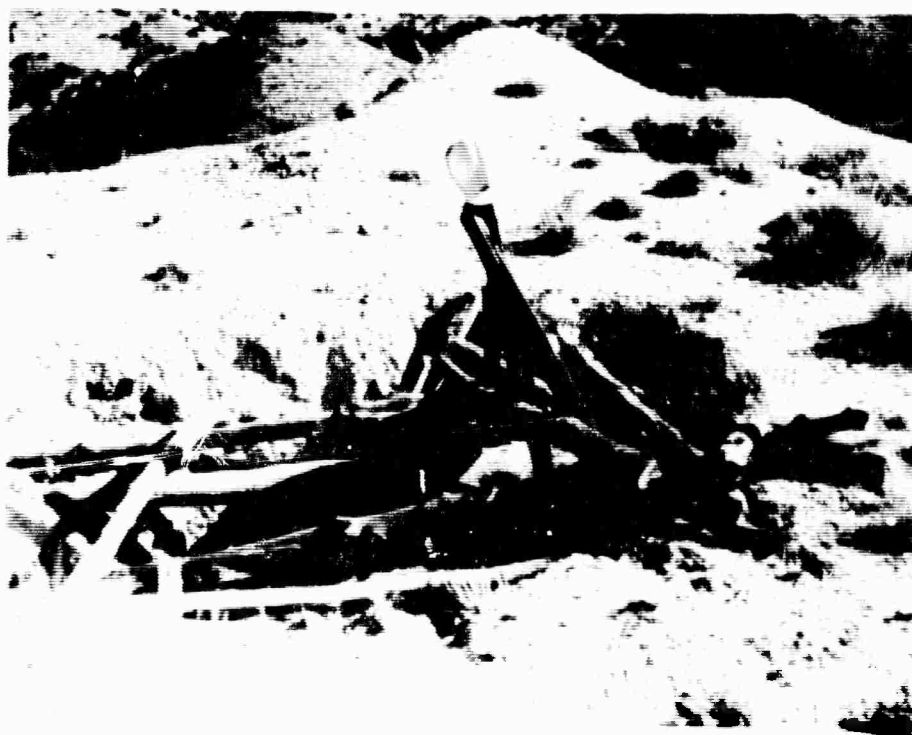
Photo No. 16-4-78. Surface view of main vertical shaft looking to south-east. Some uncut timber sprags are laid across the collar. No support was used in this shaft. The rock dimensions are about 5 x 5 feet. The shaft is caved and sealed with debris about 30 feet below the surface.

Photo 16-4-78. Preshot. October 22, 1963.

Photo 16-4-78. Postshot. October 31, 1963.
