U. S. NAVY SUPPLY OFFICE-SCHOOL
NAVAL SUPPLY DEPOT, BAYONNE, NEW JERSEY

NAVY REPORT SERIAL NO. NT-003-010

DEVELOPMENT OF SHORE PARTY EQUIPMENT
(STEEL WIRE PALLETS)

Authorization - Chief of the Bureau of Supplies and Accounts letter to Chief of Naval Operations, N41(PC-4)AGG, 16 Jan 47.

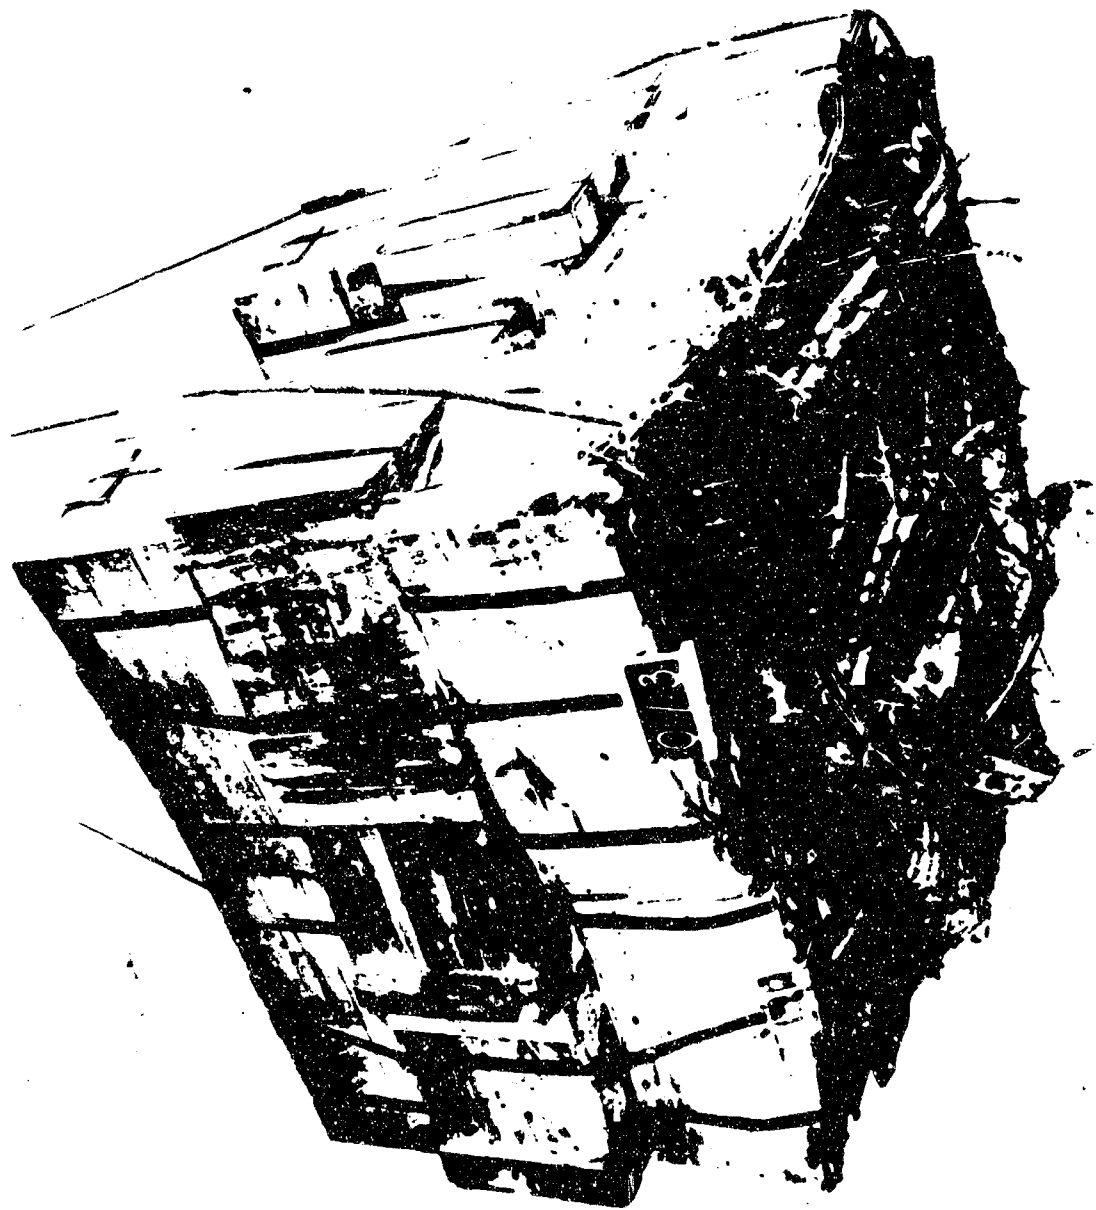
PROJECT SERIAL NO. NT-003-010
PHOTO NEG. NO. 51-12 PAGE 27

ILLUSTRATION OF STEEL WIRE PALLET DISTORTION
AFTER EXTENDED PUNISHMENT IN TOWING OPERATIONS
UNSUPPORTED.

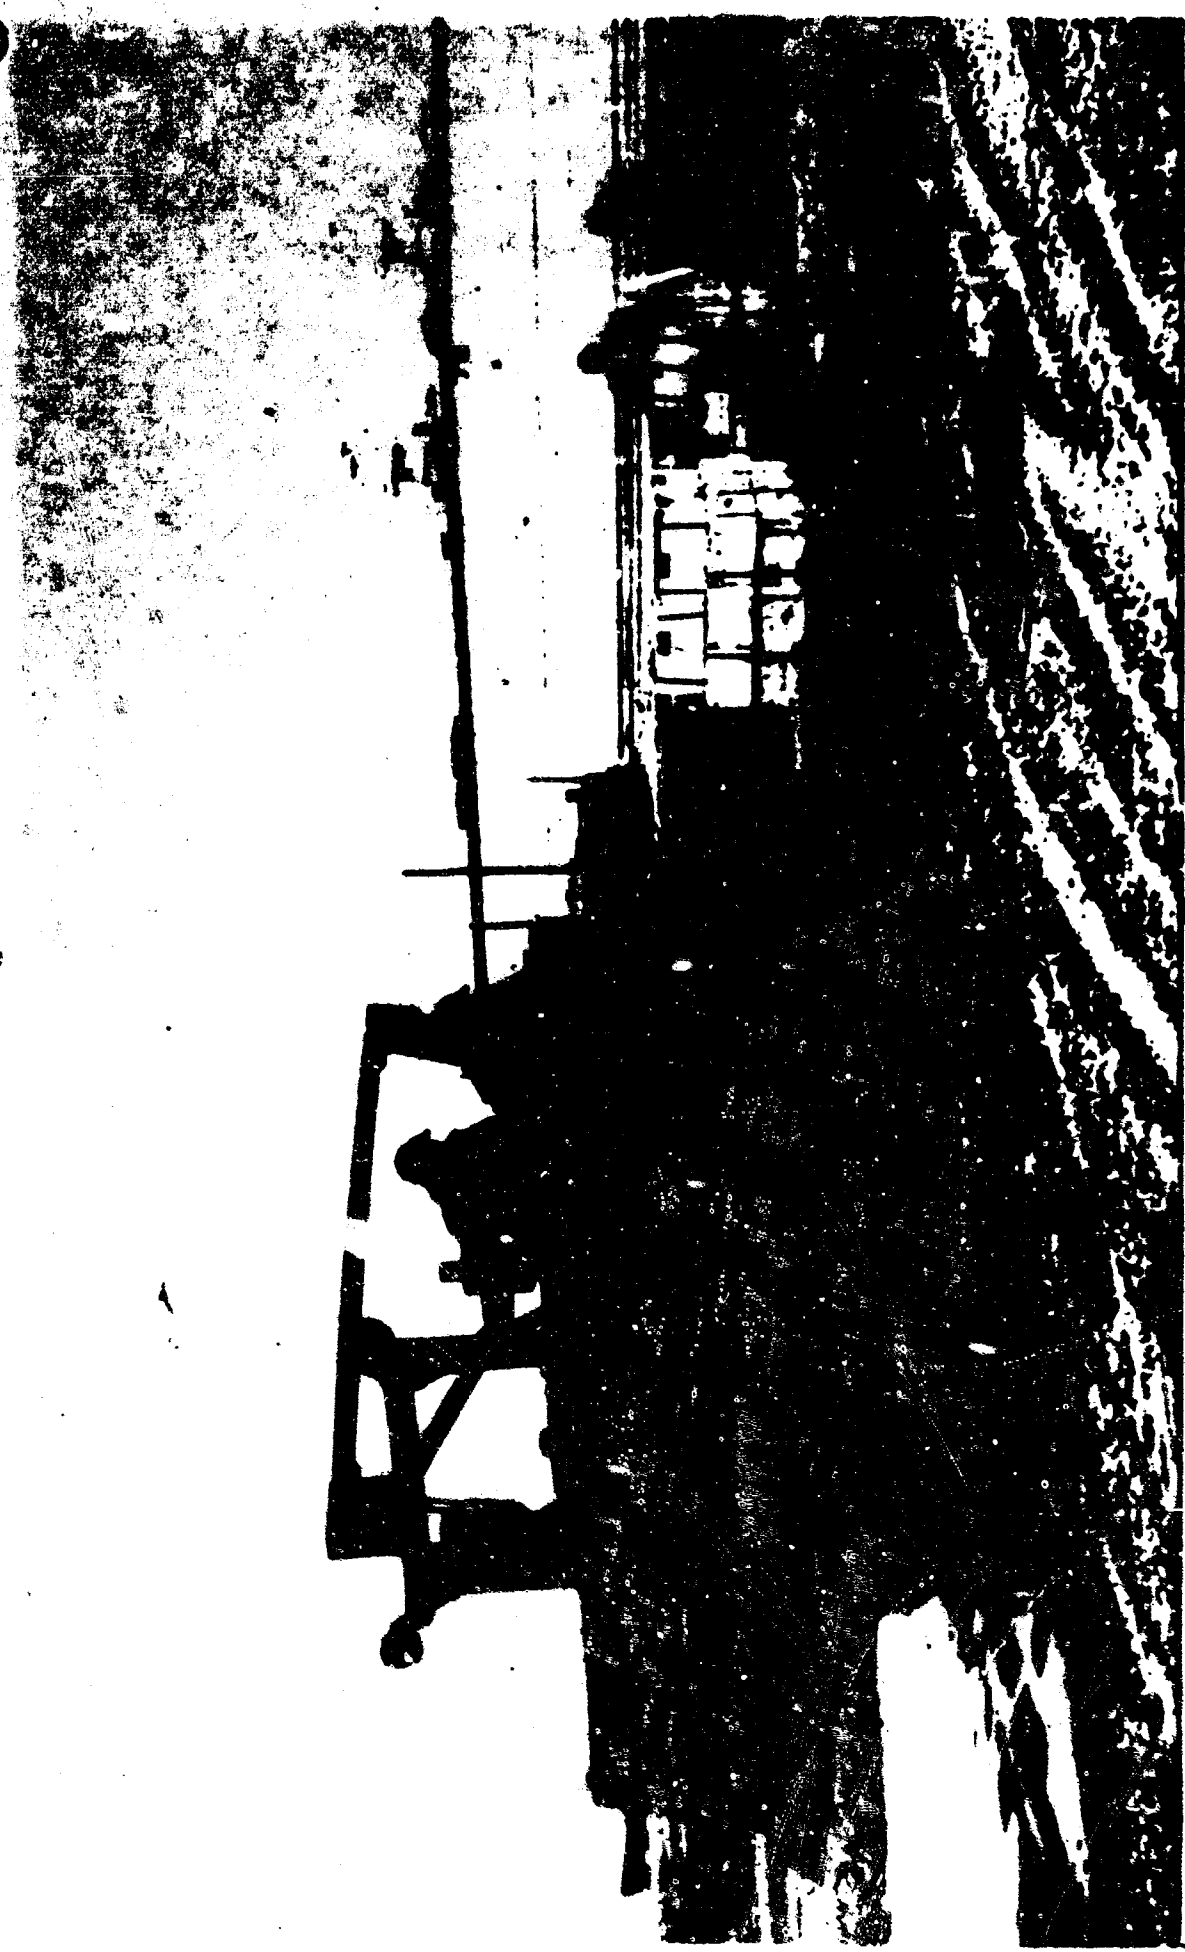
PROJECT SERIAL NO. NT-003-010
PHOTO NEG. NO. 42-2

Utilizing the same loads and the same toboggans the next test was conducted over 1500 ft of sand, loose dirt, and sandy beach. The start of this test is shown in Photo #42-2, Page 72. Photo #42-5, Page 73 was taken midway through this test with the toboggans as near to the water's edge as possible without bogging down the towing caterpillar tractor. It will be noted in Photo #42-5, Page 73 that a considerable quantity of sand had piled up in front of the second toboggan which was of the fork type. Preliminary ideas were that this would be a disadvantage due to the increased drag but practical experience proved this to be a decided advantage when moving over rough terrain. Under such conditions when a large rock or block of concrete or other obstruction was encountered directly in the path of the toboggan it was found that a portion of the sand or earth in front of the toboggan would fill in around the obstruction and such fill would enable the pallet to pass over the obstruction with very little difficulty. Photo #42-1, Page 74 shows water edge conditions and turn radius with pallets on toboggans. Photo #42-7, Page 75 indicates toboggans on grade landing from beach. During the 1500 ft run over the sand beach the prow of the solid toboggan flattened out and the loading bar bent the rear of the toboggan up due to the

STEEL WIRE PALLETS BEING DRAGGED IN TANGIER.
ON TOROSGANS OVER TEST COURSE OF SAND AND
LOOSE DIRT.

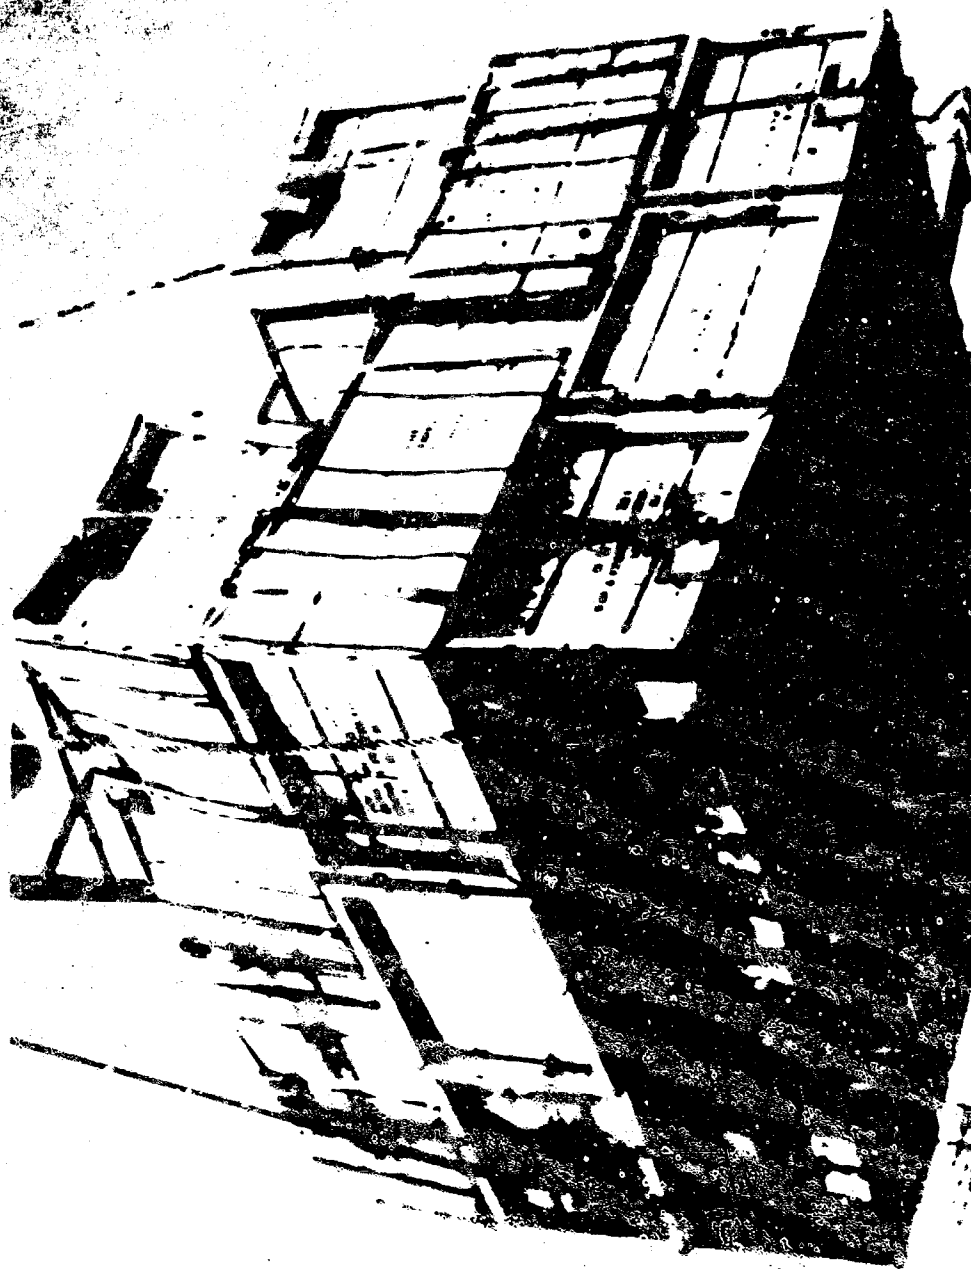
COMBINATION OF EXPANDED METAL DECK PALLET LOADED
WITH 3,500 LBS. PRIOR TO DROP TEST WITH SLINGS
PLACED UNDER THE WINGS OF THE PALLET.

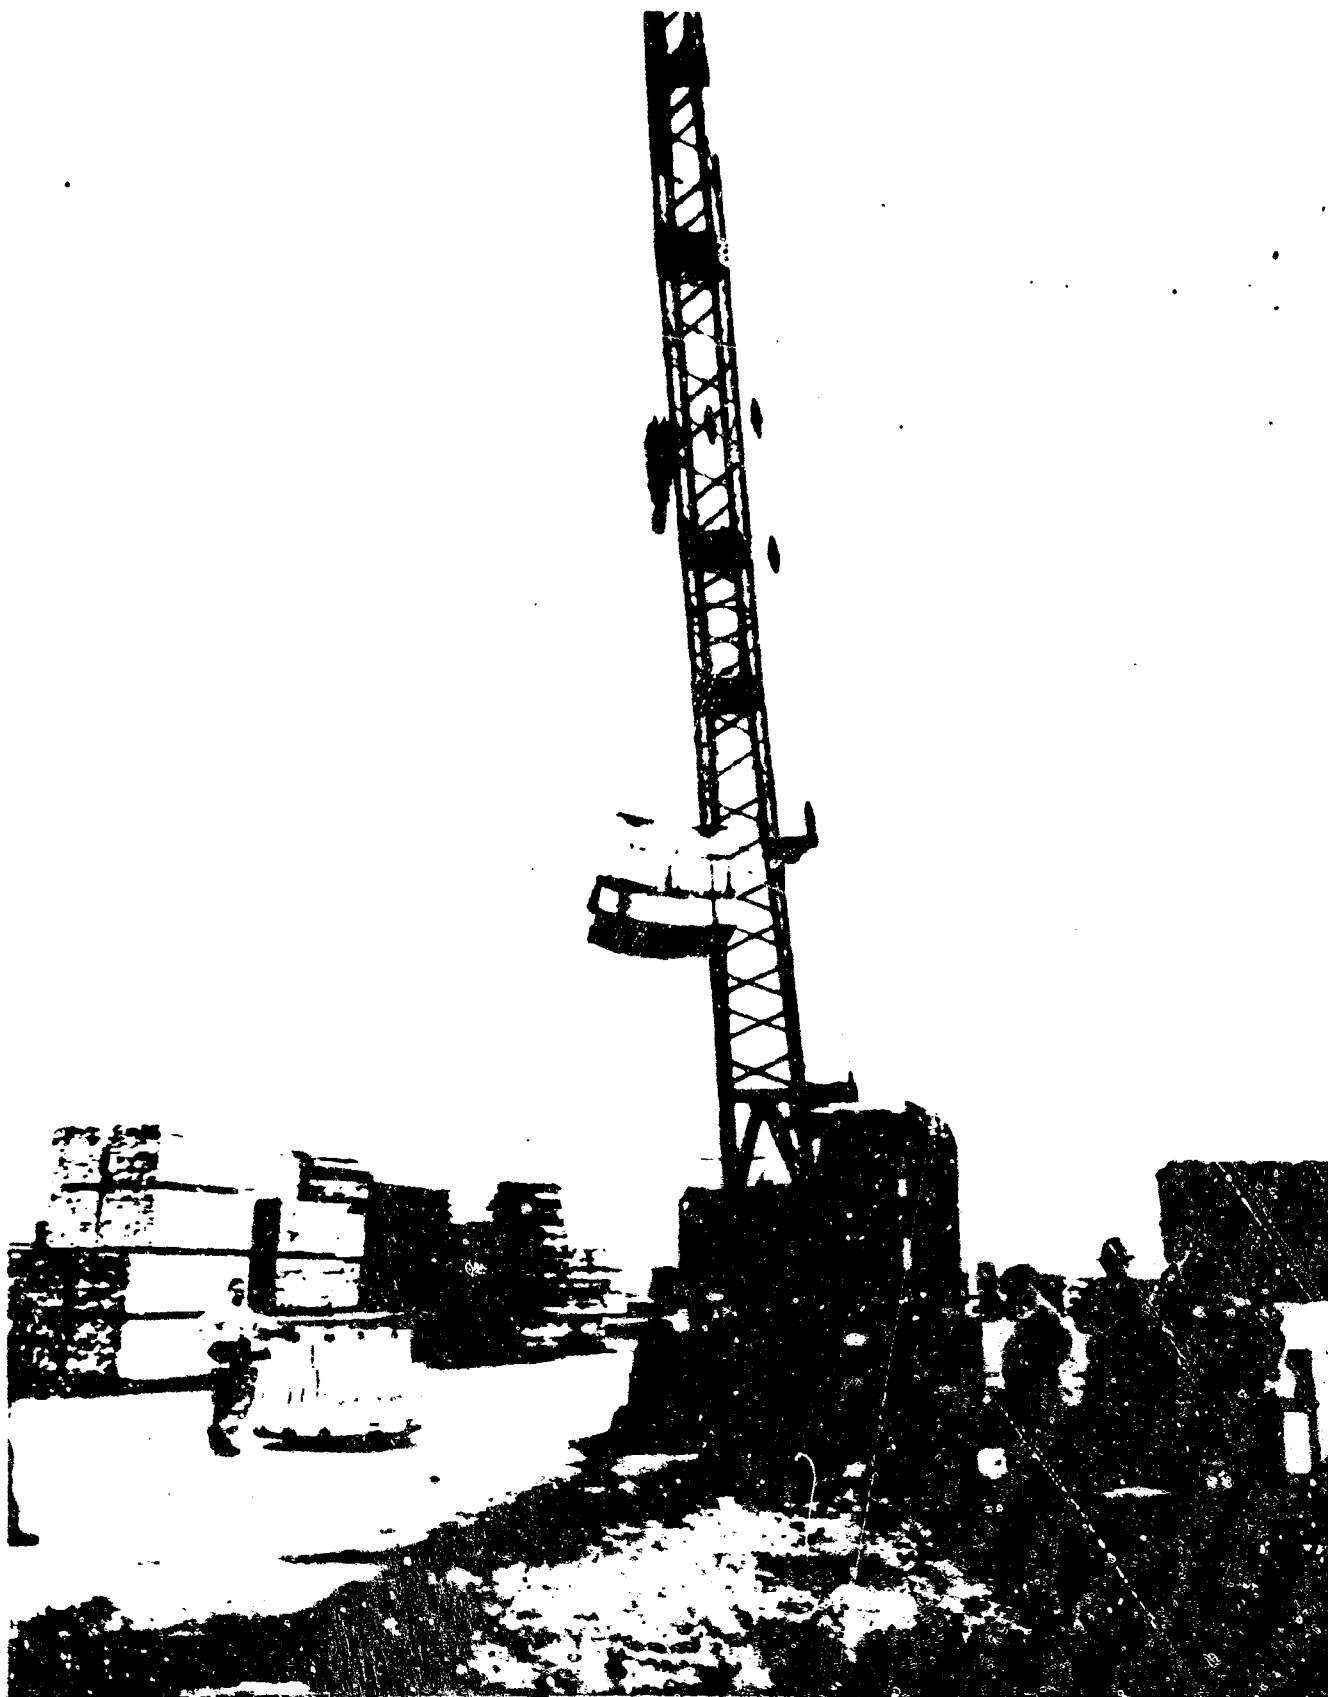
PROJECT SERIAL NO. NT-003-010
PHOTO NEG NO 42-4 PAGE 11

ILLUSTRATION OF CONDITIONS
IN DROP TEST FOR STEVE-
DORING SUITABILITY.

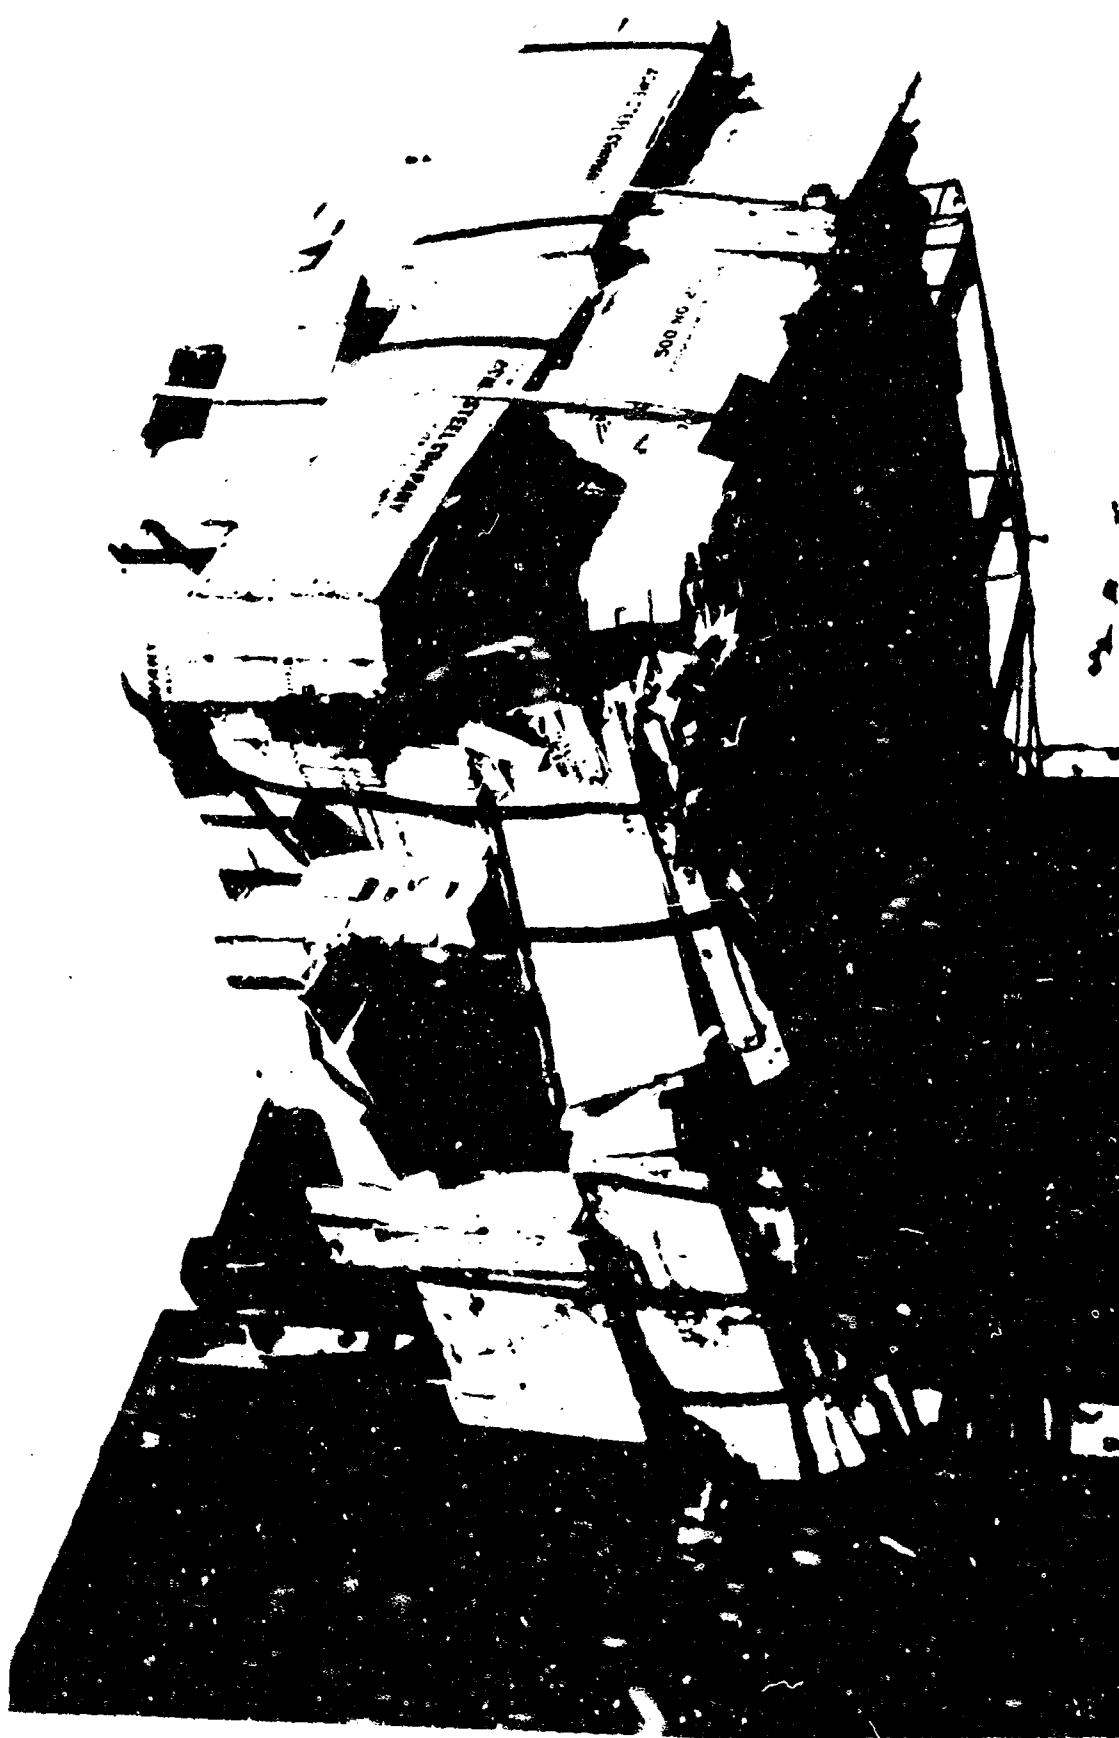
The Steel Wire Pallet (Fibreboard Deck) is not suitable and is not satisfactory for stevedoring operations. The deck of this pallet is brittle and weak and offers no reinforcement to the understructure

ILLUSTRATION OF P. 1. 1. 1. TRUCK PICK-UP OF FIBRE-
BOARD DECK PALLET FOLLOWING IMPACT TESTS FOR
STRENGTHENING SUITABILITY.

of the pallet. Upon impact the deck cracks, the pallet distorts, and no protection is offered to the pallet load. If punishment of the pallet is continued, the pallet soon deforms so as to become practically useless and the load disintegrates.
