FULL-SCALE DYNAMIC CRASH TEST
OF A
LOCKHEED CONSTELLATION MODEL 1649 AIRCRAFT

TECHNICAL REPORT

OCTOBER 1965

TECHNICAL REPORT
ADS - 38

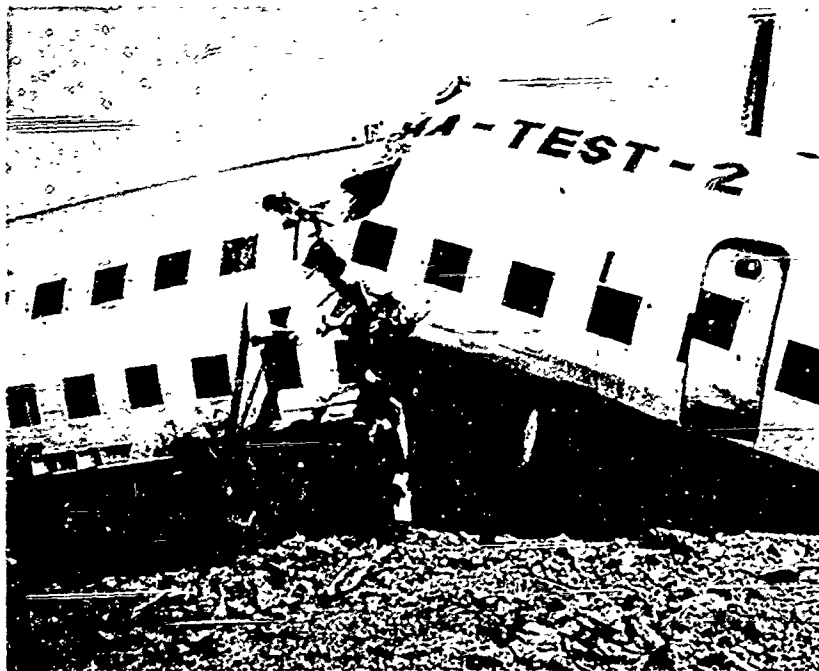
FIG. 31 FUSELAGE STATION 380 BREAK, RIGHT SIDE
