RDTR NO. 160  
3 DECEMBER 1969

# **SAFETY TEST OF FLARE EXTRUSION FACILITY**

**RESEARCH AND DEVELOPMENT DEPARTMENT  
NAVAL AMMUNITION DEPOT, CRANE, INDIANA**

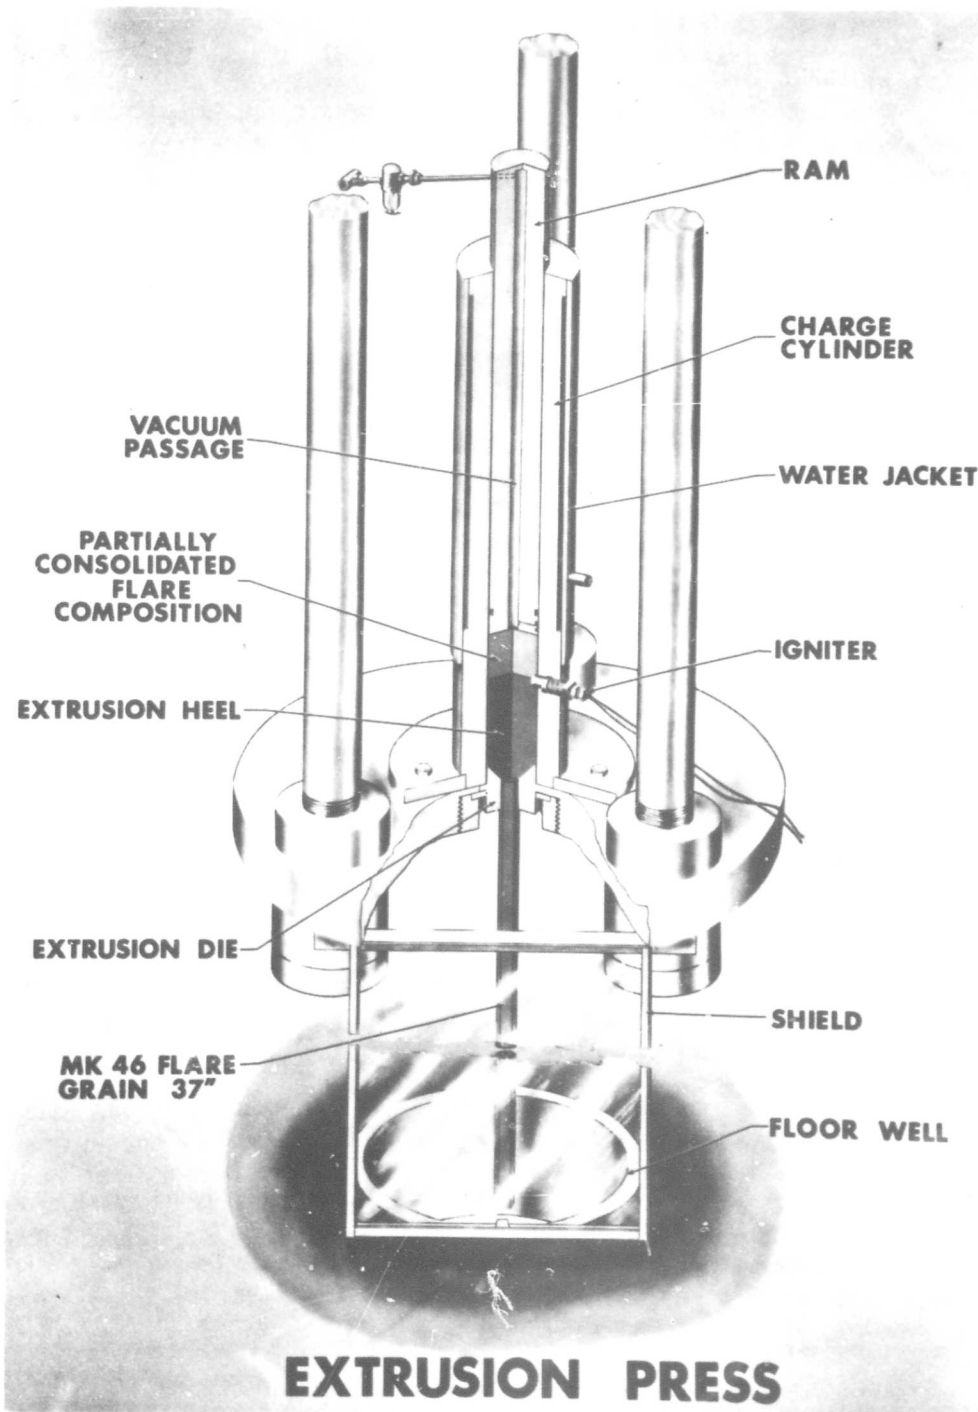
Figure 2  
13

grain. The press was loaded with seven pounds of MK 46 flare composition, so as to simulate a point in the extrusion cycle at which an accidental ignition might occur. Figure 2 is an illustration of the press as loaded for the test.

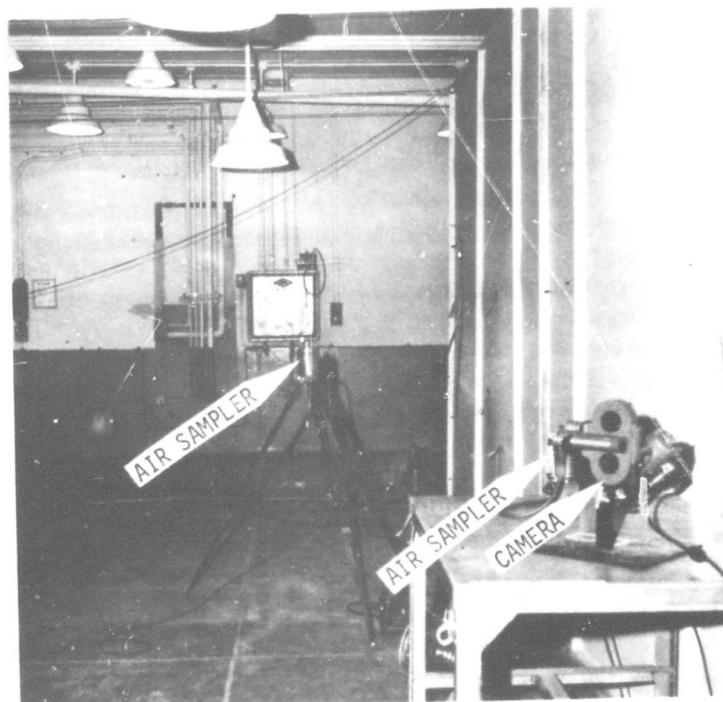
FIGURE 4a LEFT CAMERA

Instrumentation was set up in and around the press cell to collect temperature, pressure, toxicity, audio, and photographic information. Four 16mm movie cameras, running at 24 frames per second, were used. Figure 4a shows a camera aimed at the press cell from the left side. Figure 4b shows one camera aimed at the cell from the right side and another aimed

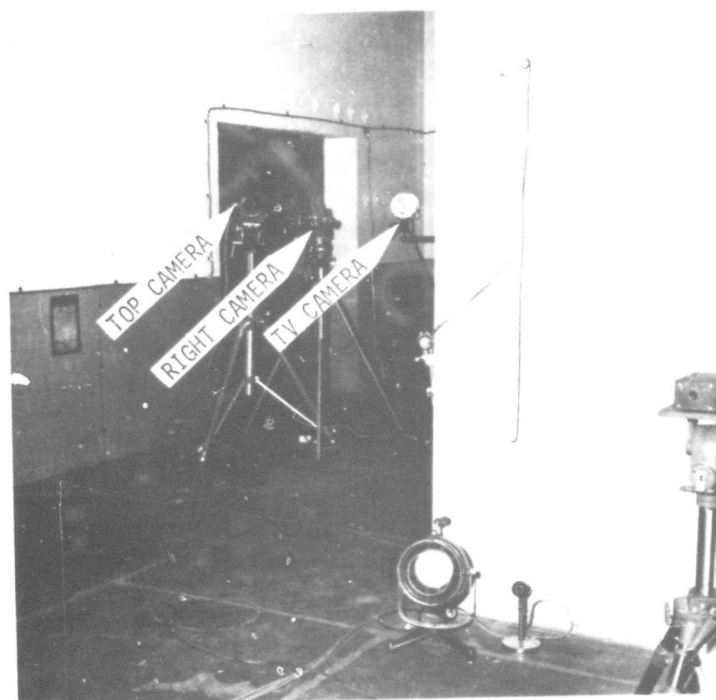
FIGURE 4b RIGHT AND TOP CAMERA

at the top of the cell. It also shows the TV camera used to monitor the test. Figure 5a shows the blowout windows before the test and the location of the outside camera which was aimed toward the bottom of the press. Two of the polyethylene panes were replaced with clear polystyrene panes. Figure 5b shows the location of two photocells mounted on tripods and thermocouples, T1, T2, and T3. The photocell on the left detected visible energy and the photocell on the right detected infrared energy. Figure 6a shows the location of T4 and a pressure transducer. T5 was located on the press as shown by Figure 6b. Figure 3 also shows small pieces of newspaper taped to the doorway. Paper was also taped to the walls inside the cell at various locations. A book<sup>1</sup> by the AEC provides information with which a relationship can be made between the radiation energy level required to ignite newspaper and the radiation energy level that causes skin burns. From tables 7.45 and 7.65, it can be seen that the energy required to ignite newspaper would at least cause first degree burns and probably second degree burns. Flash time was also considered when making the relationship.

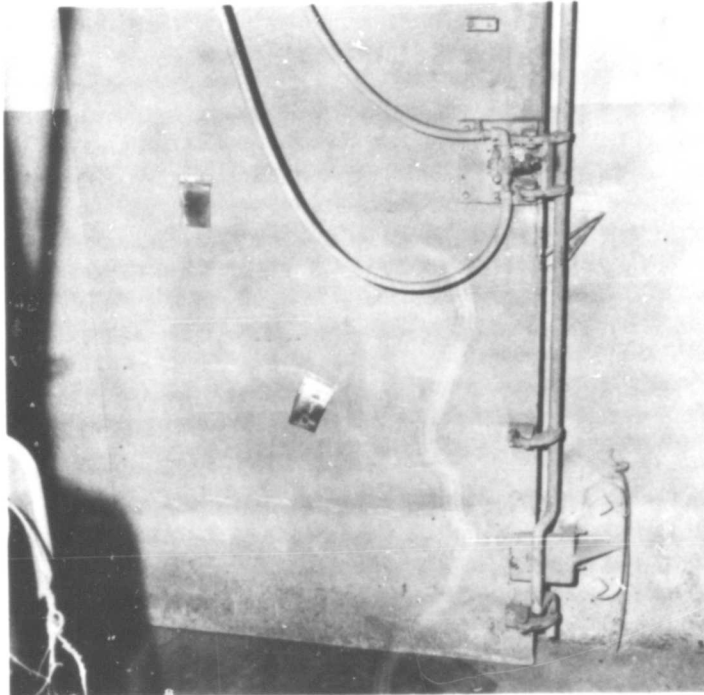
FIGURE 10a DOOR FROM INSIDE (BOTTOM)

2. Figure 8a shows the cell after the test. The shield deflected much of the heat away from the front of the cell. None of the newspaper in the doorway burned. Figure 8b shows the blowout window from the outside. The lower two rows of window sections were badly distorted. One section fell to the inside of the cell after the composition had burned out. The temperature under the press rose high enough to melt aluminum, as can be seen by figures 9a and 9b, but was insufficient at the front of the cell to burn all the newspaper on the inside of the cell door, figure 10a. Figure 10b shows the top part of the door where two pieces of newspaper scorched and the third piece mostly burned.
