MISCELLANEOUS PAPER S-69-13

EVALUATION OF HARVEY ELECTRON BEAM WELDED AM2 LANDING MAT (AM2 MOD 2)

April 1969

U. S. Army Engineer Waterways Experiment Station CORPS OF ENGINEERS

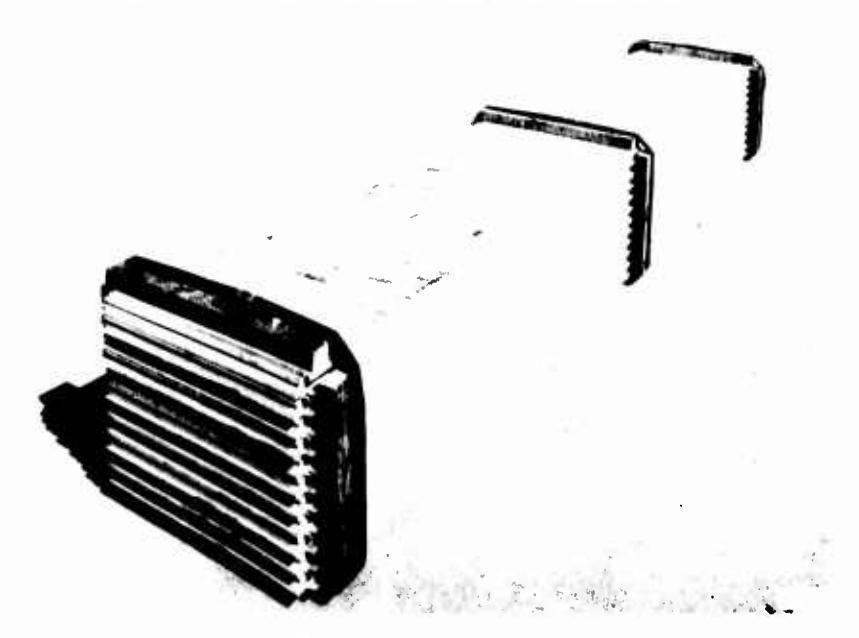
Fig. 1. Bundle of mat as received for testing

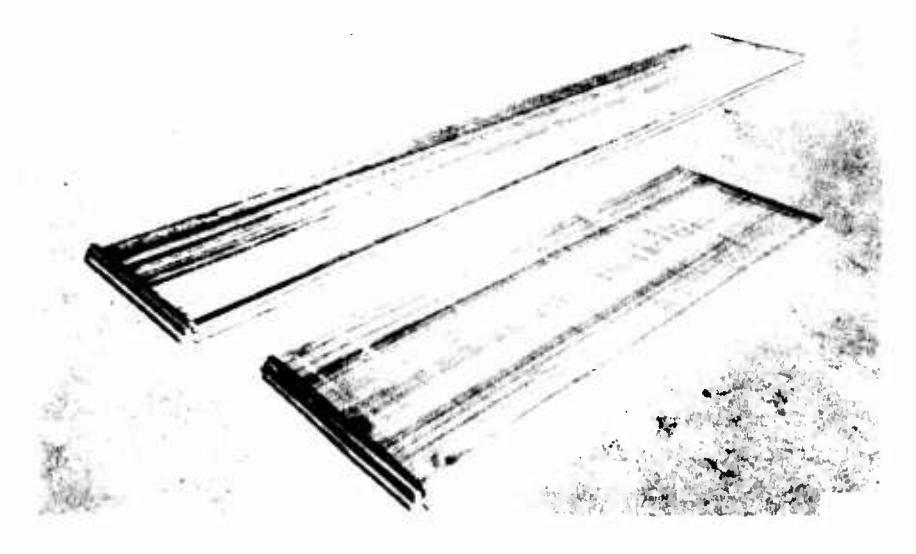
Fig. 2. View of mat showing half plank in foreground

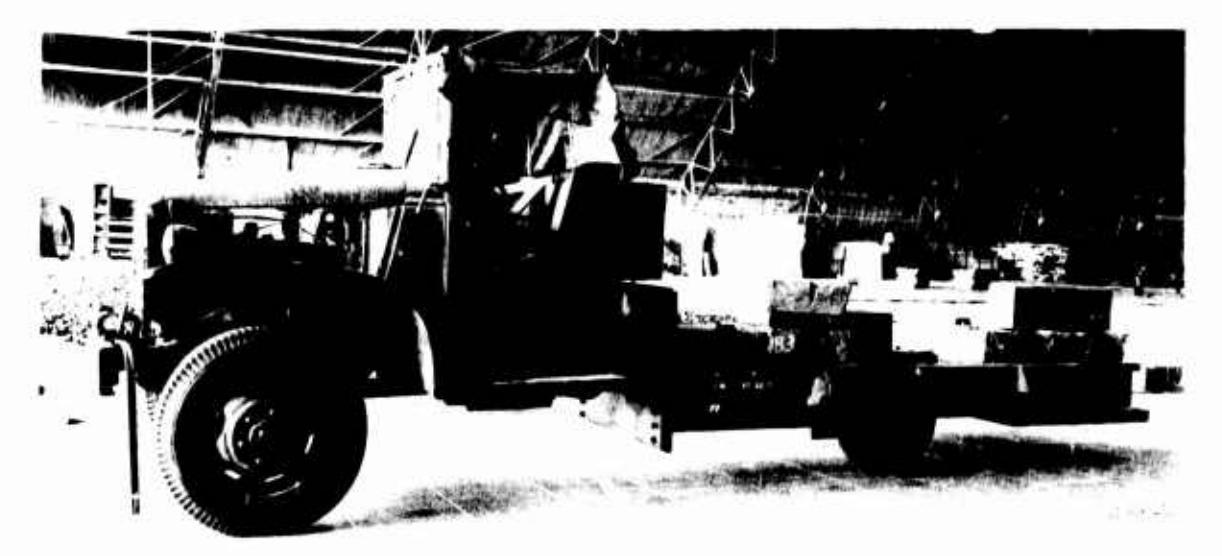
Fig. 3. Load cart used in traffic tests: 27,000-lb single-wheel load, 400-psi tire pressure, and 82-sq-in. tire contact area

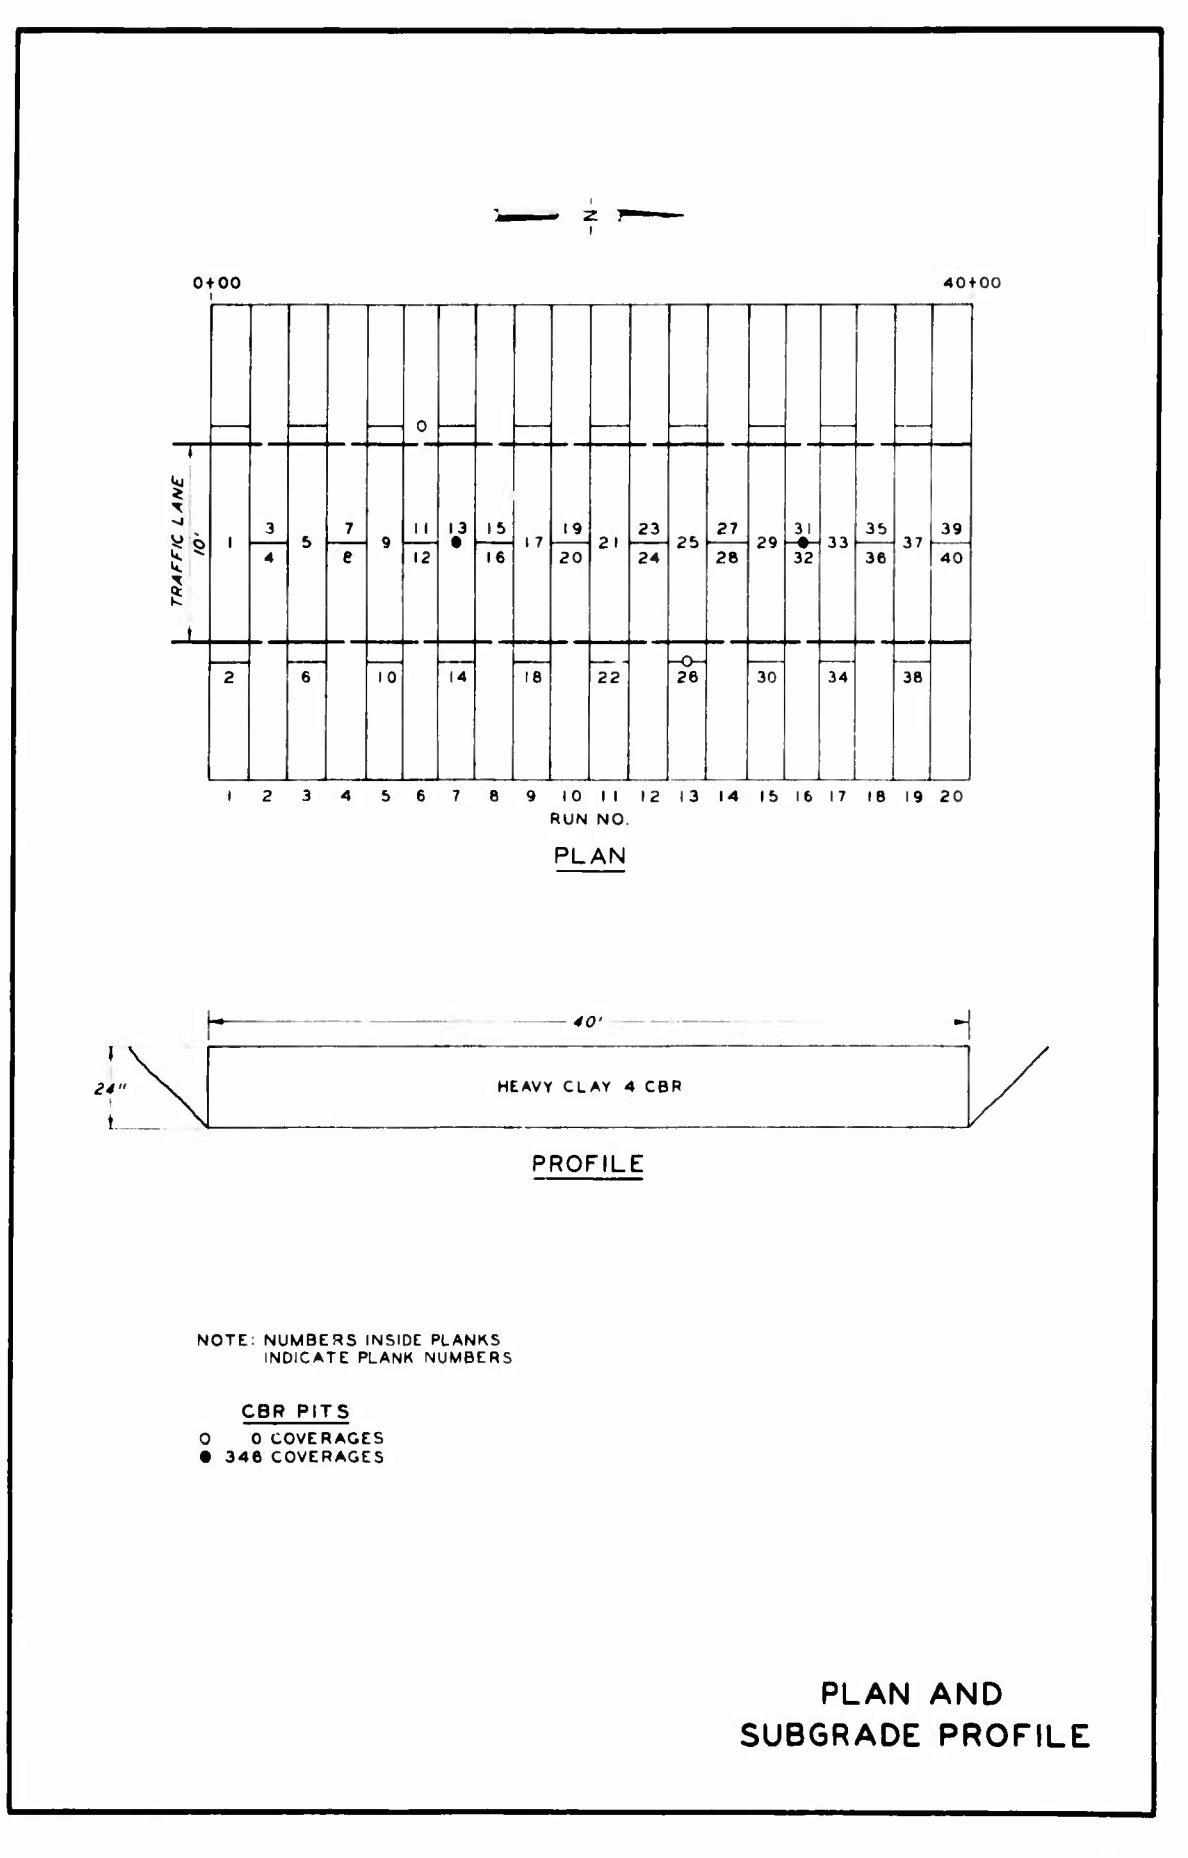
PLATE I

8. A layout of the test section is shown in plate 1. The test section was approximately 40 ft long and 24 ft wide. The subgrade was constructed of a heavy clay soil. Classification data for the subgrade soil are shown in plate 2.

12. The entire test section was surfaced with AM2 mod 2 mat placed with the long axis perpendicular to the direction of traffic (plate 1). The surfaced test section was approximately 24 ft wide. The first run of mat consisted of one full plank in the center with half planks on both ends, and the second run consisted of two full planks placed end to end. This alternating pattern was continued throughout the test section for 20 runs, or approximately 40 ft, and provided the staggered joint configuration shown in plate 1.

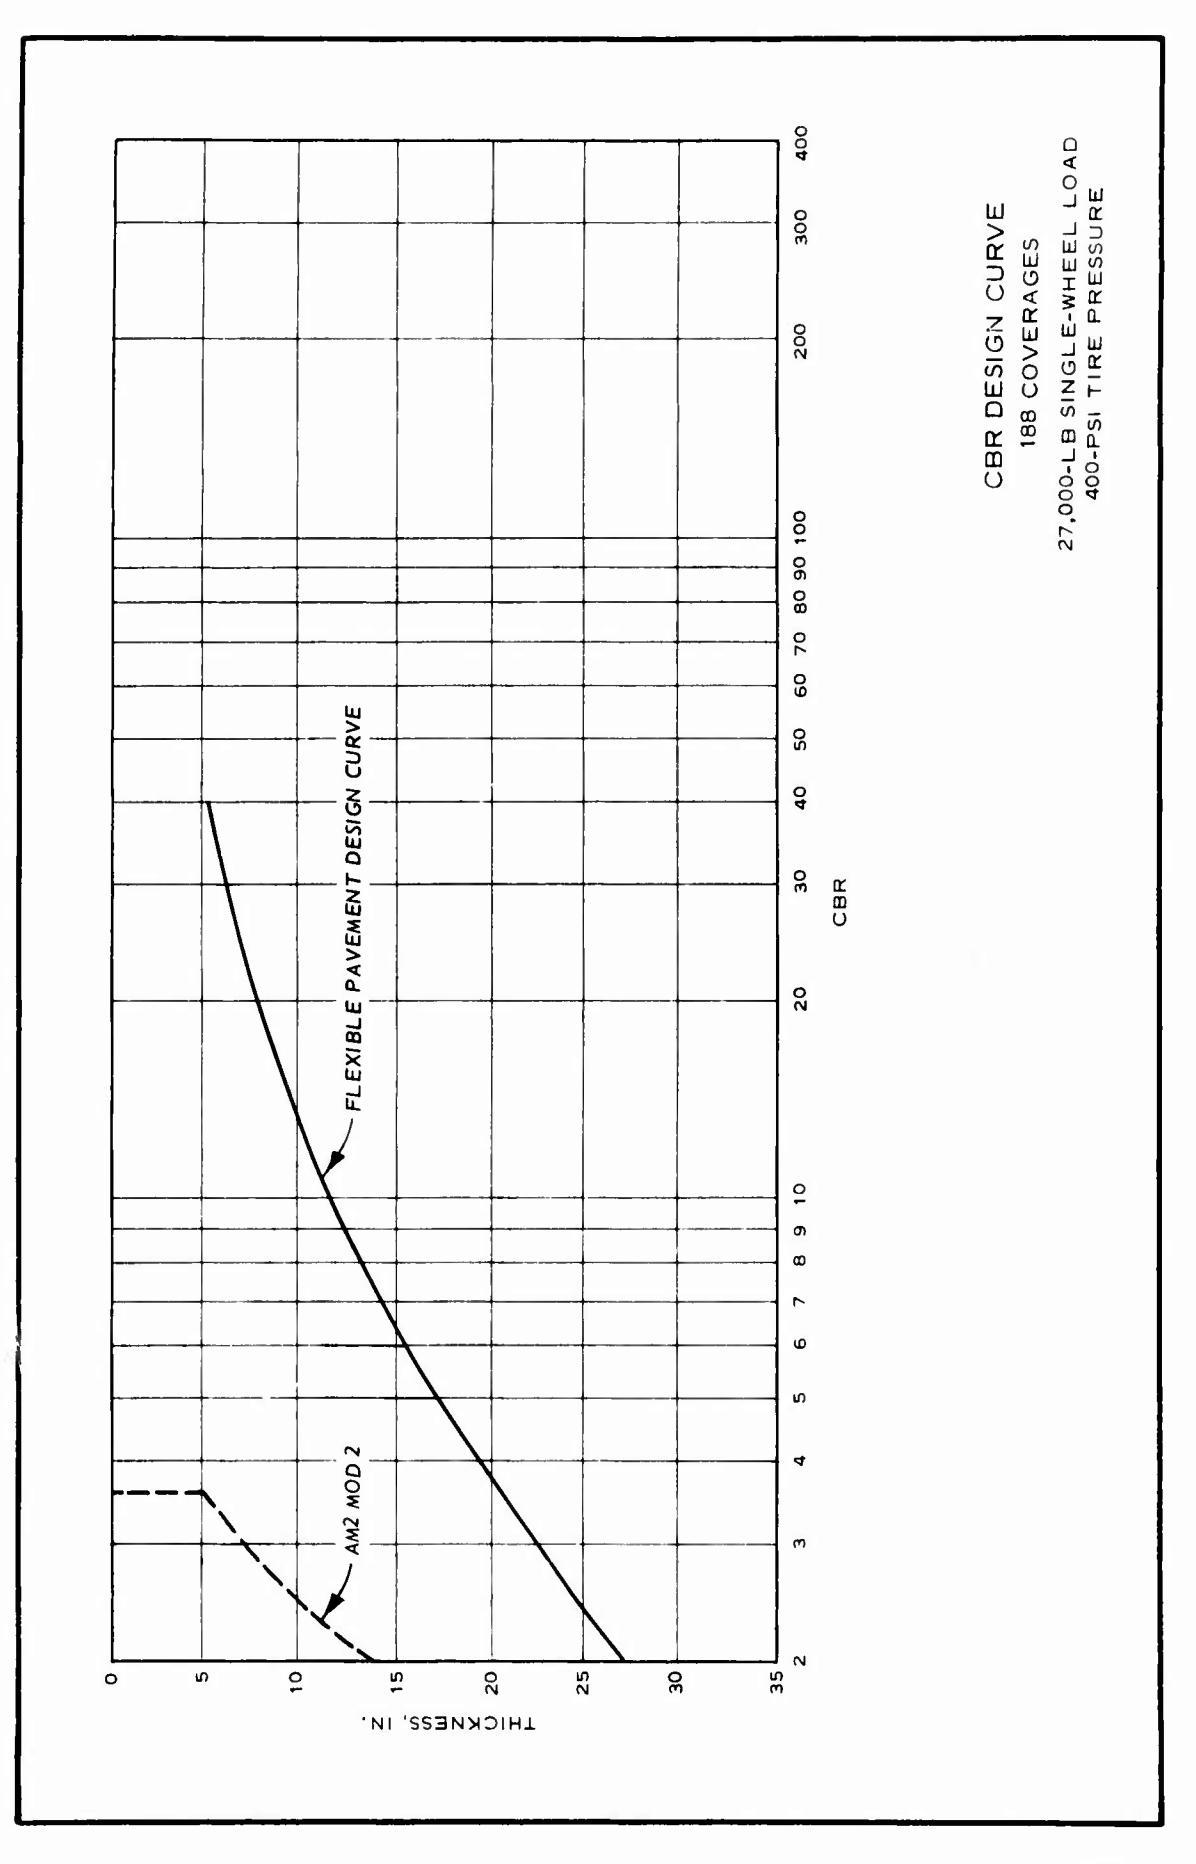
PLATE 7

27. Plate 7 shows a CBR design curve for 188 coverages of a 27,000-lb single-wheel load with a tire pressure of 400 psi. The lower curve is a standard flexible pavement CBR design curve. The curve for the Harvey mat was developed as follows. In plate 6 it is shown that a subgrade with a CBR of 3.6 will support the 27,000-lb wheel load for 188 coverages when surfaced with AM2 mod 2. It can be seen from plate 7 that a flexible pavement design based on a subgrade CBR of 3.6 will require 20.2 in. of base course. In prior similar studies, CBR design curves have been developed by merely reducing standard curve thicknesses by the thickness pertaining to the 188-coverage service life (20.2 in. in this case). This is assuming that the effective thickness of a mat plus a strengthening layer beneath it will be equal to the total thickness of an equivalent pavement structure. However, studies of soil thickness requirements beneath landing mat being conducted by WES indicate the effective thicknesses. Therefore, the CBR design curve for the AM2 mod 2 mat, also shown in plate 7, was obtained by establishing the layer thickness required so that when the total thickness. The curve is presented tentatively pending the outcome of further study of strengthening layers under landing mat.
