MISCELLANEOUS PAPER S-72-22

# CONDITION SURVEY, FORNEY ARMY AIRFIELD FORT LEONARD WOOD, MISSOURI

June 1972

Conducted by U. S. Army Engineer Waterways Experiment Station  
Soils and Pavements Laboratory  
Vicksburg, Mississippi

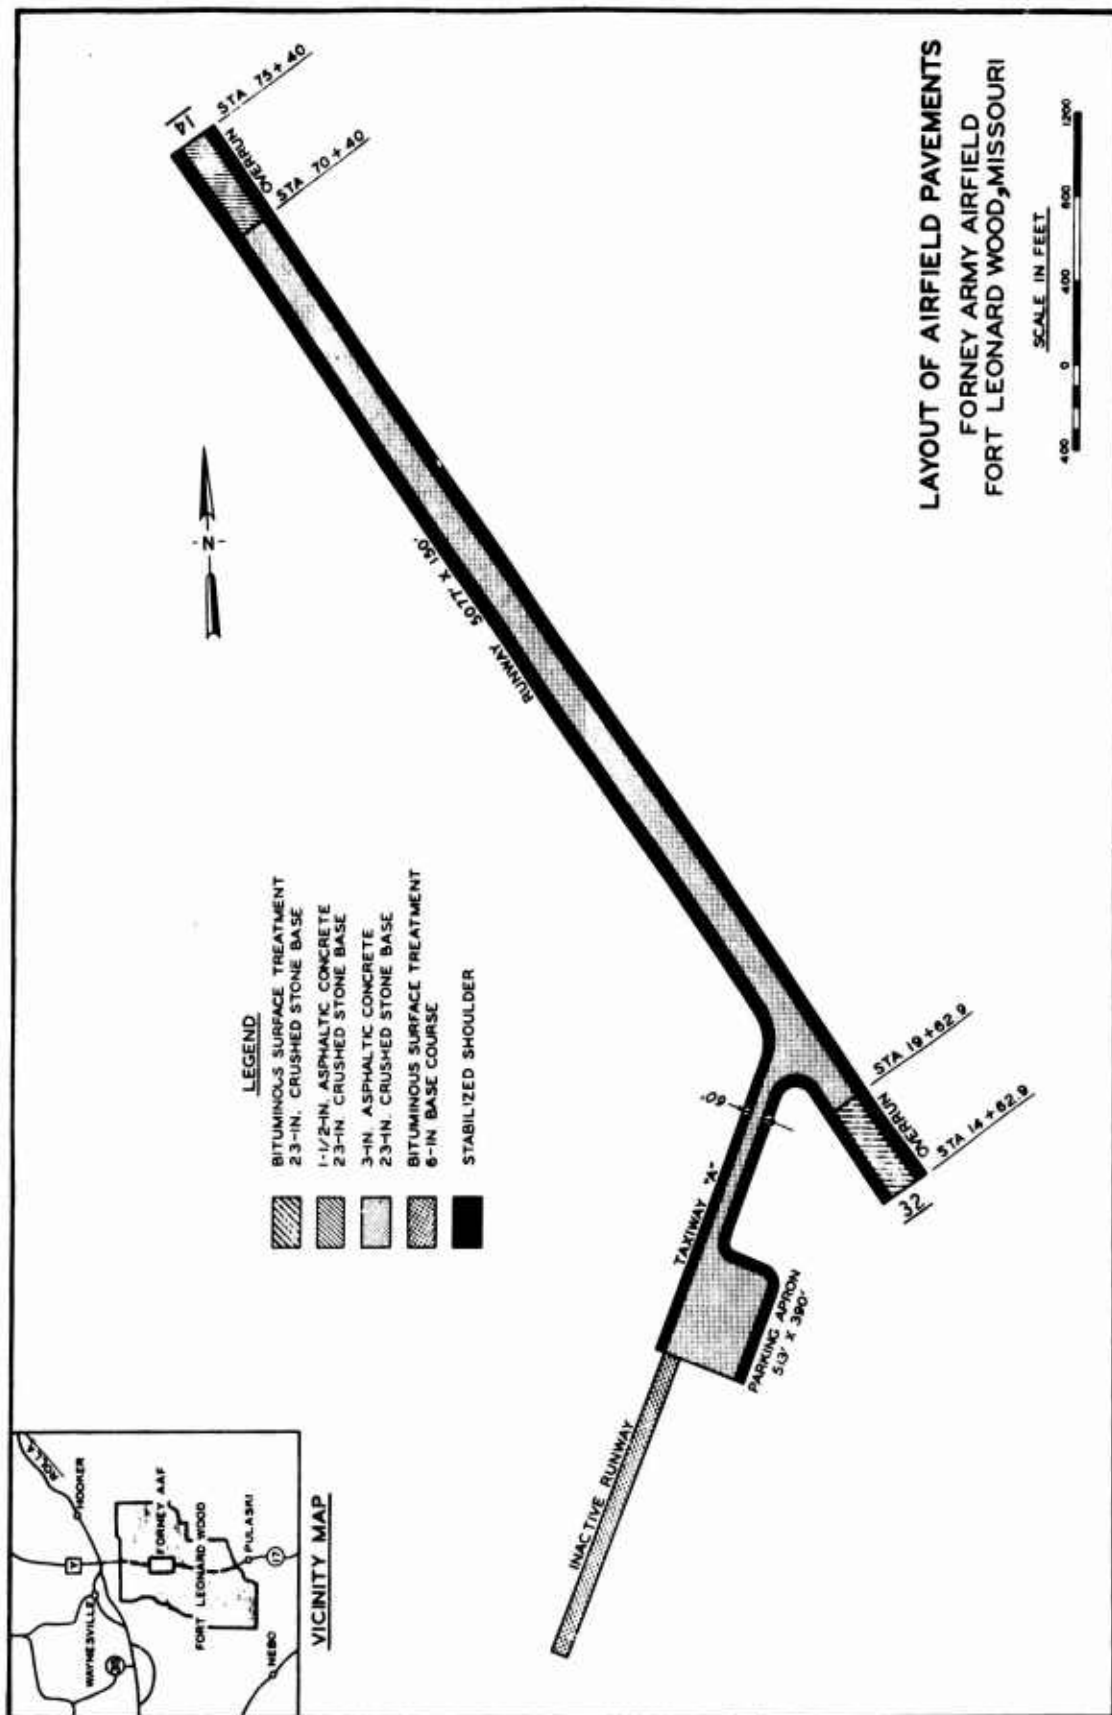
Photograph 5. Typical condition of apron area

9. The taxiway and apron contained numerous cracks. Views of typical pavements of the taxiway and apron are shown in photographs 4 and 5, respectively. The cracks in the taxiway were approximately 25 ft apart in each direction and appeared to be contraction cracks. Neither the taxiway nor the apron showed any structural distress.
