AEDC-TR-72-161

**RESEARCH AND DEVELOPMENT TESTING  
OF YTTRIA/RARE EARTH  
STABILIZED ZIRCONIA MATRIX BRICKS  
IN THE PILOT TEST UNIT (PTU) AT AEDC**

**C. R. Tinsley**

**November 1972**

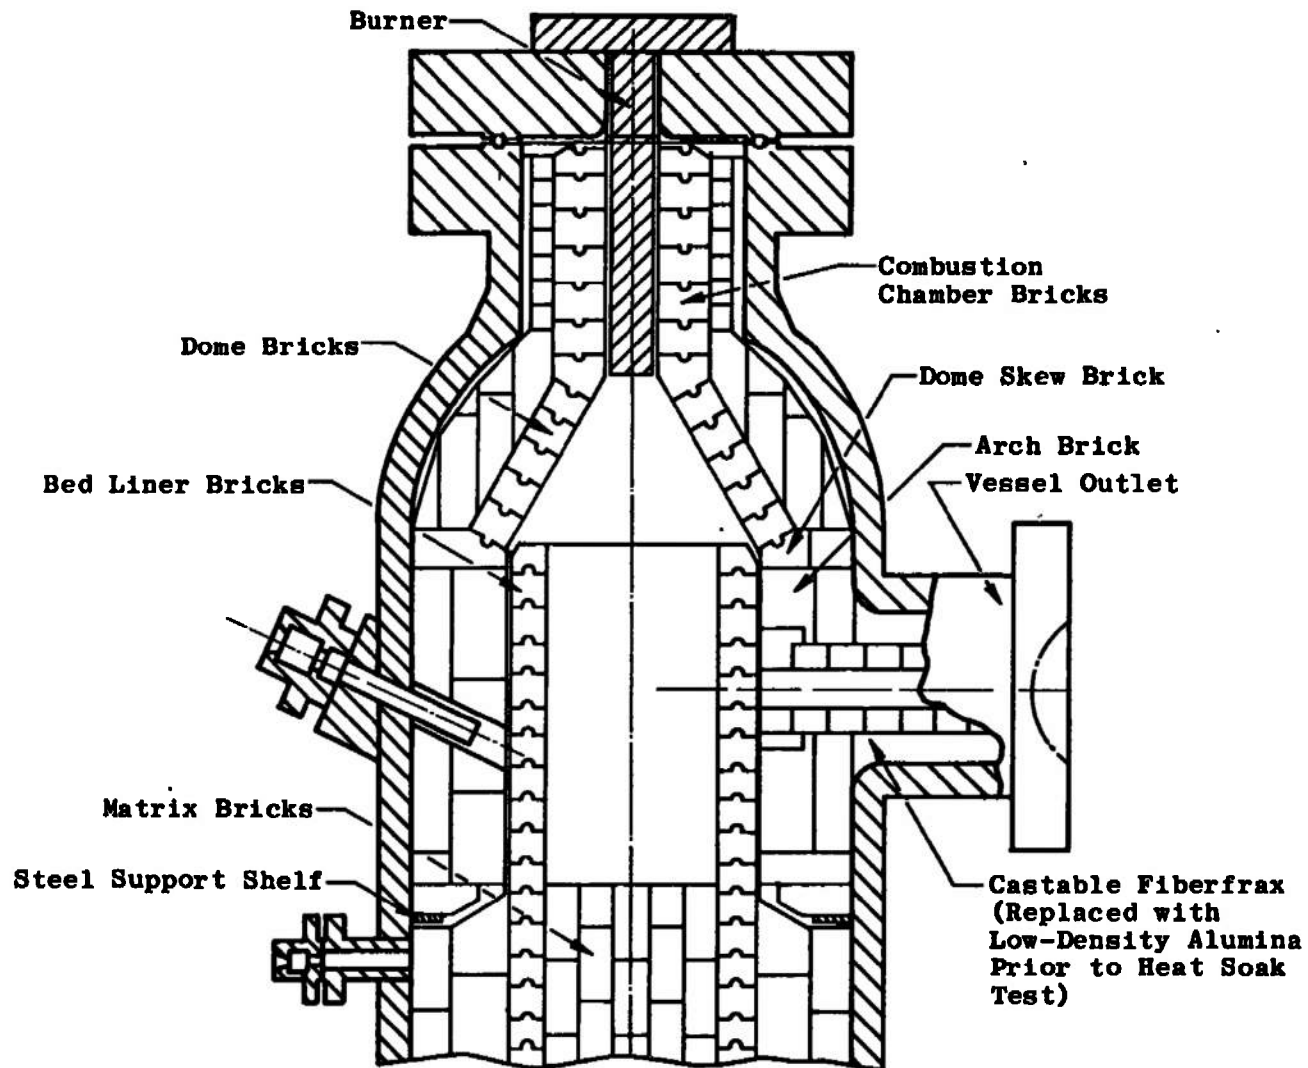
Fig. 8 Schematic of Heater Dome and Combustion Chamber Area

Visual inspection of the heater combustion chamber bricks and arch bricks adjacent to the dome skew bricks (see Fig. 8) revealed fracturing, spalling, and crumbling in these areas. However, replacement of the refractories was not deemed necessary.

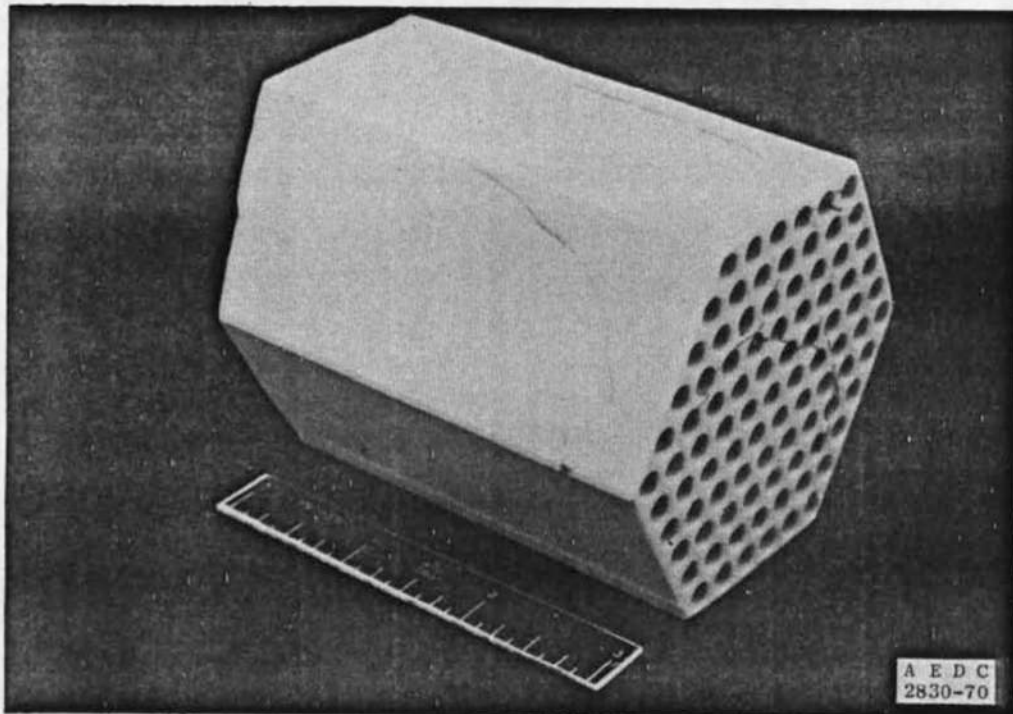
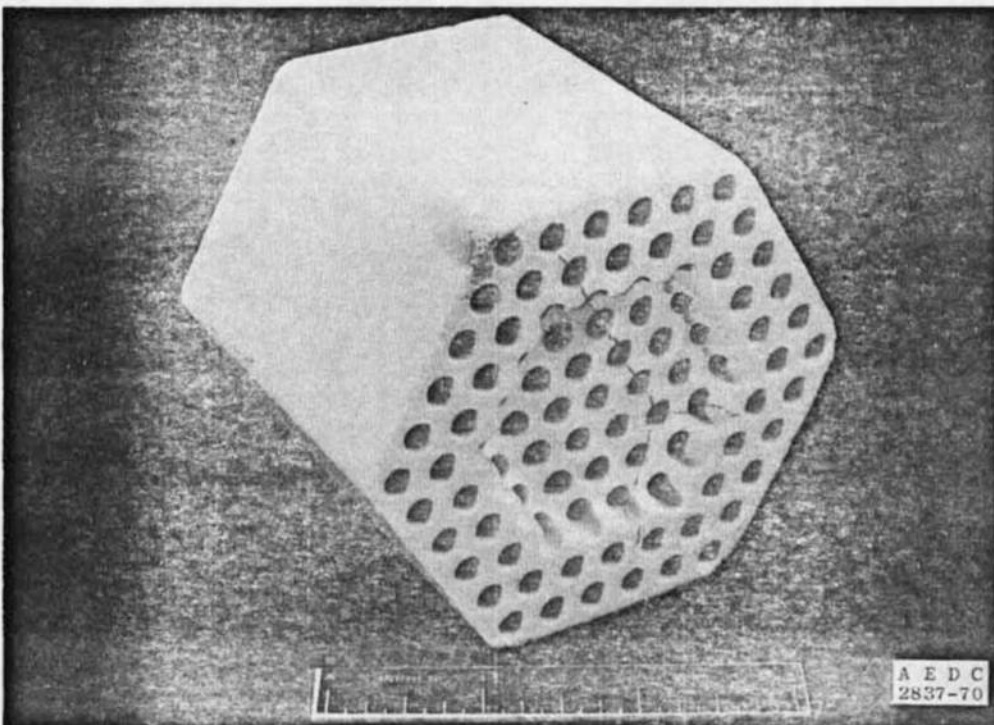
Fig. 15 Matrix Sample Bricks, Posttest 38

Posttest 38 inspections revealed (1) that nitric acid erosion was the prime factor causing burner deterioration and (2) that selected matrix bricks inspected were in good condition with only a few additional hairline cracks. Pertinent photographs taken during the inspections are presented in Fig. 15. The bricks depicted in Figs. 15a and b were also photographed after run. 37 (see Fig. 12) so that the effects of testing could be documented in typical matrix bricks.

a. Column 13, 10.9 w/o, Coors

c. Column 7, 13.8 w/o, Coors

d. Zircoa, Low Density, 12.5 w/o, Posttest 38 (Upper Block)  
Fig. 15 Continued

e. Lower Block  
Fig. 15 Concluded

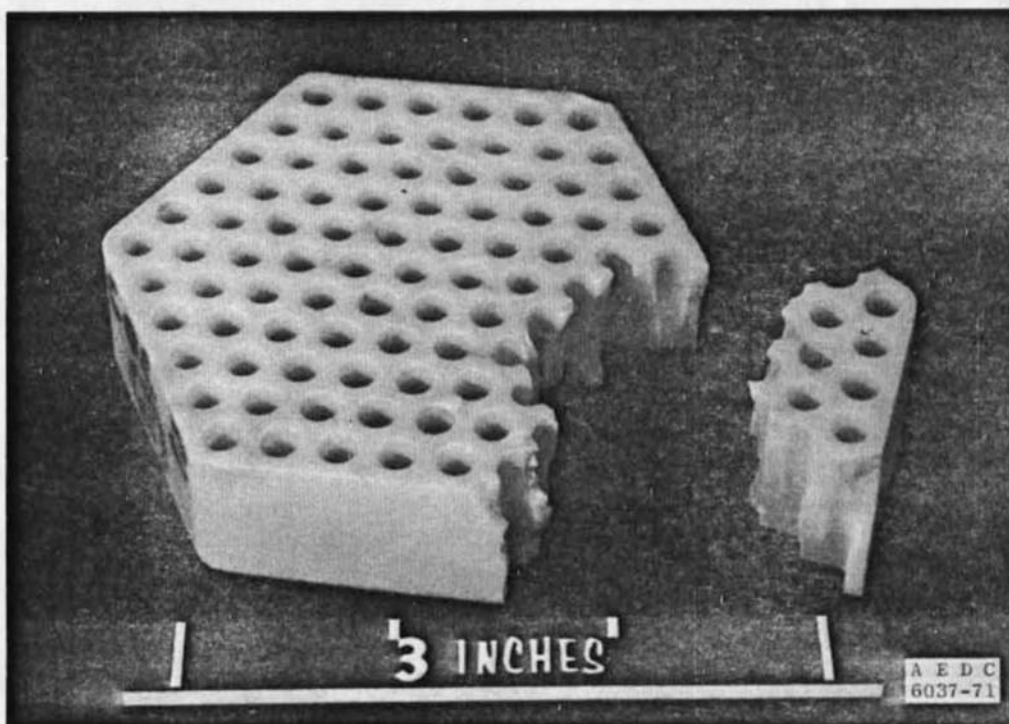
g. Zircoa, 16.5 w/o, Location 18-7

Throughout the pilot heater test program, fusion of the zirconia bricks has been noted. Occasionally, a small brick particle or chip was found fused inside a brick air passage, or a piece of one brick was sometimes found fused to the side of another brick, as illustrated in Fig. 23g. Also two or more bricks were sometimes found fused together. A sudden shock will usually separate the two. A typical example of this type of fusion is shown in Fig. 24d.

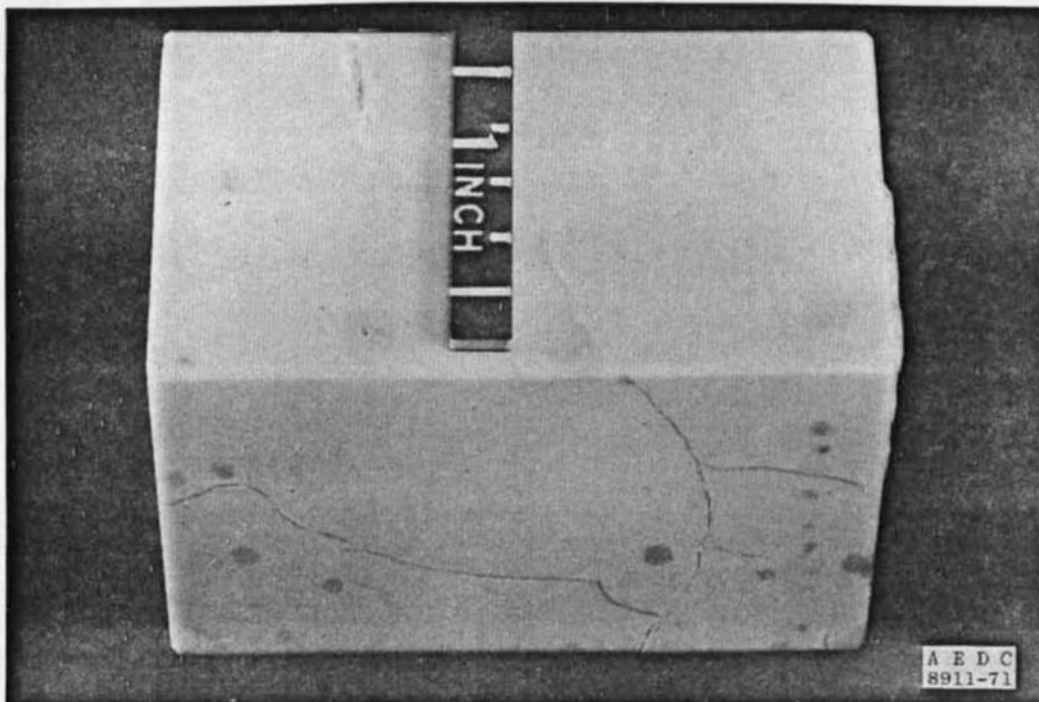
b. Side Opposite "A"

Occasionally stress marks will be discovered on the matrix bricks which are typical of those shown in Fig. 29. These horizontal indentations are caused by bricks becoming slightly misaligned as the matrix shifts with changing temperature. In cases of pronounced indentations such as these, the air passages in the brick adjacent to the surface and at the point of indentation remain slightly distorted, indicating that, because of elevated temperature, the brick was relatively soft at the time the indentation was made.

Fig. 29 Matrix Brick Exhibiting Stress Marks, Post-Run 44
