IMPROVED MATERIALS AND MANUFACTURING  
METHODS FOR GUN BARRELS. PART I

SWERR-TR-72-54

**IMPROVED MATERIALS AND MANUFACTURING  
METHODS FOR GUN BARRELS  
(PART I)**

**Dr. R. P. O'Shea, IIT Research Institute  
G. S. Allison, Battelle Northwest  
and  
J. D. DiBenedetto,  
Dr. K. R. Iyer  
USAWECOM**

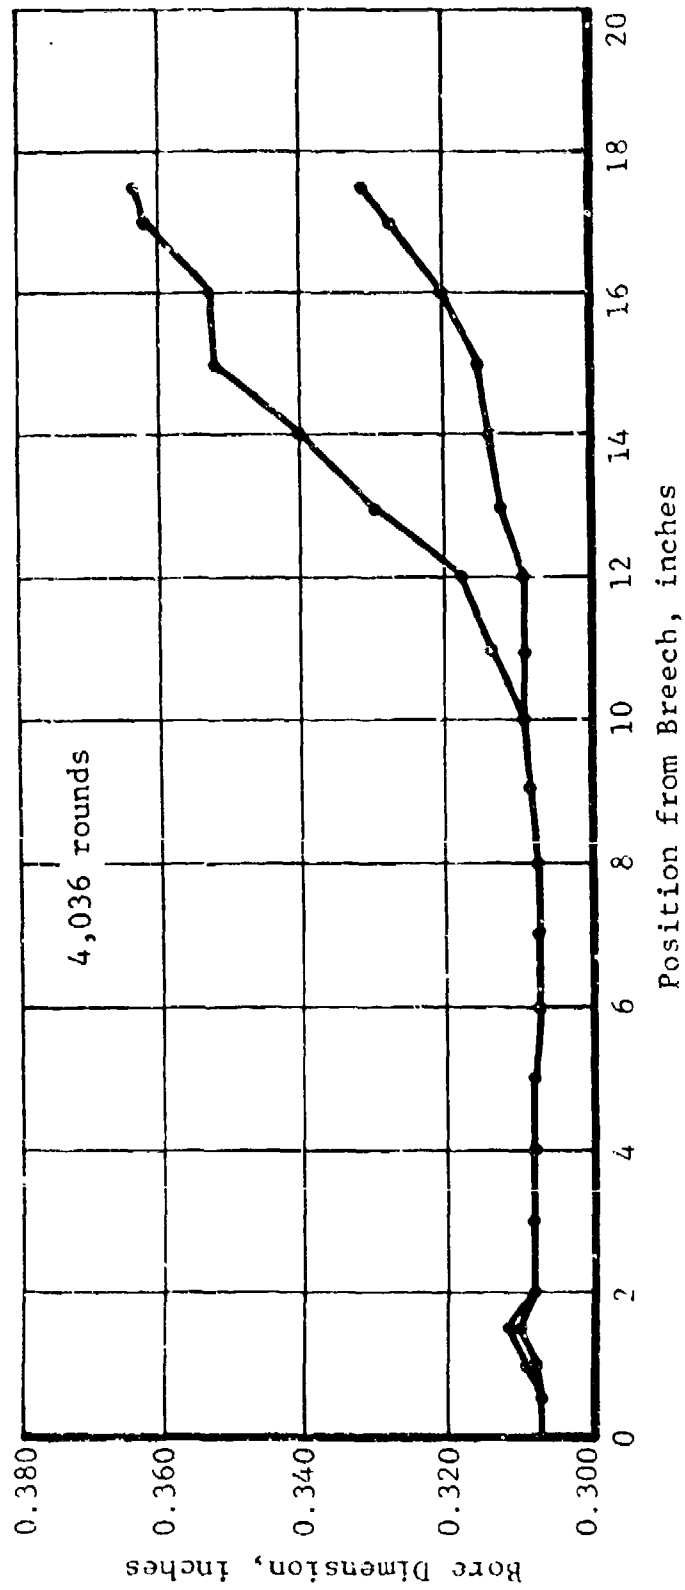
FIGURE 44 BORE PROFILE FOR CG-27 MATERIAL FOR 4036 TOTAL ROUNDS FIRED.

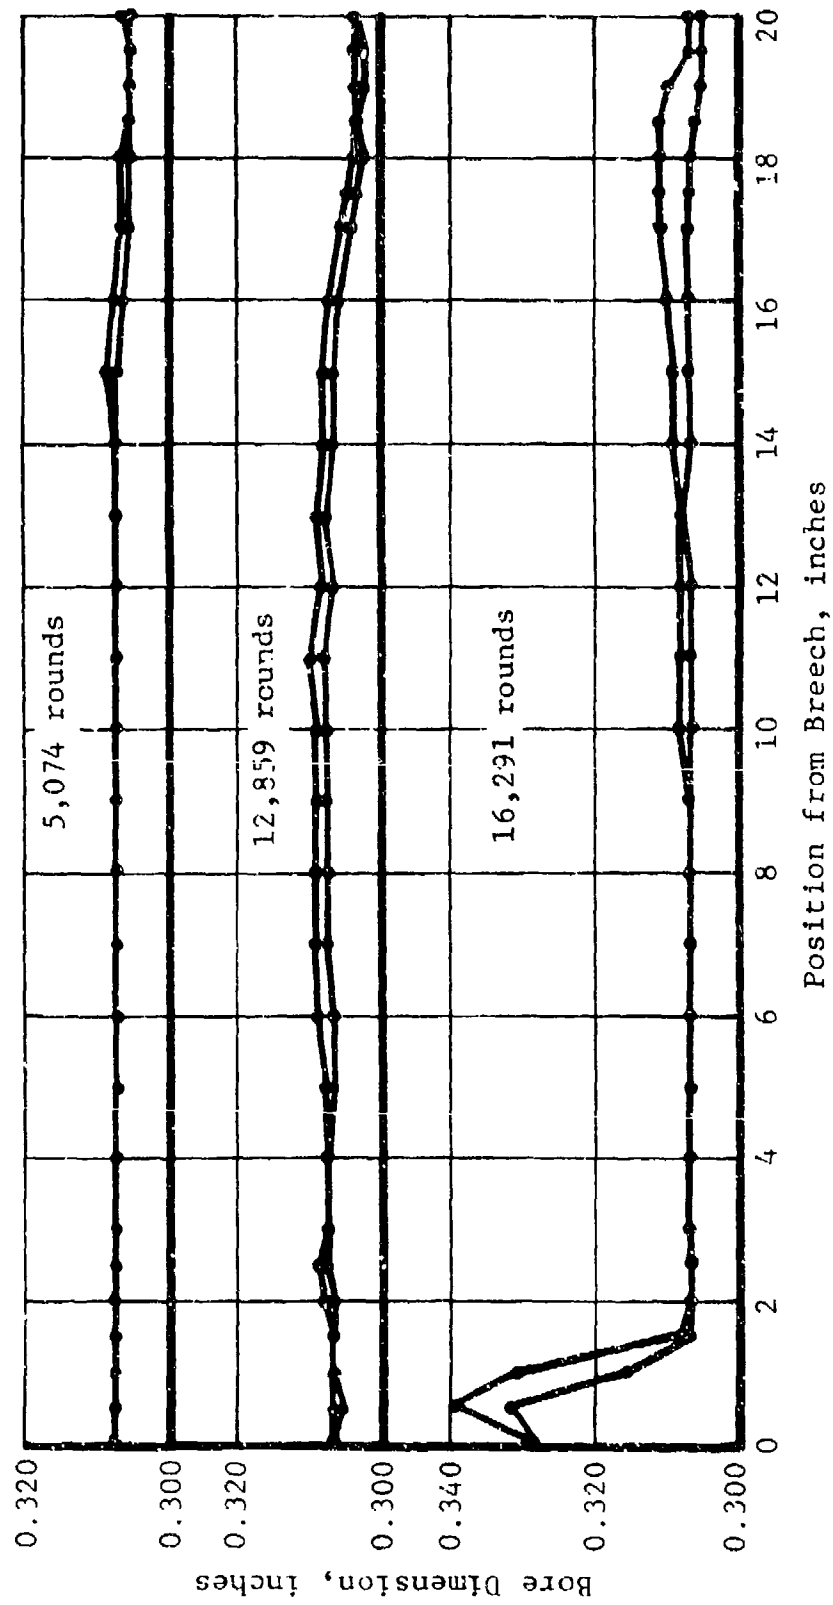
FIGURE 45 BORE PROFILE FOR H11 MATERIAL FOR VARIOUS NUMBERS OF TOTAL ROUNDS FIRED.

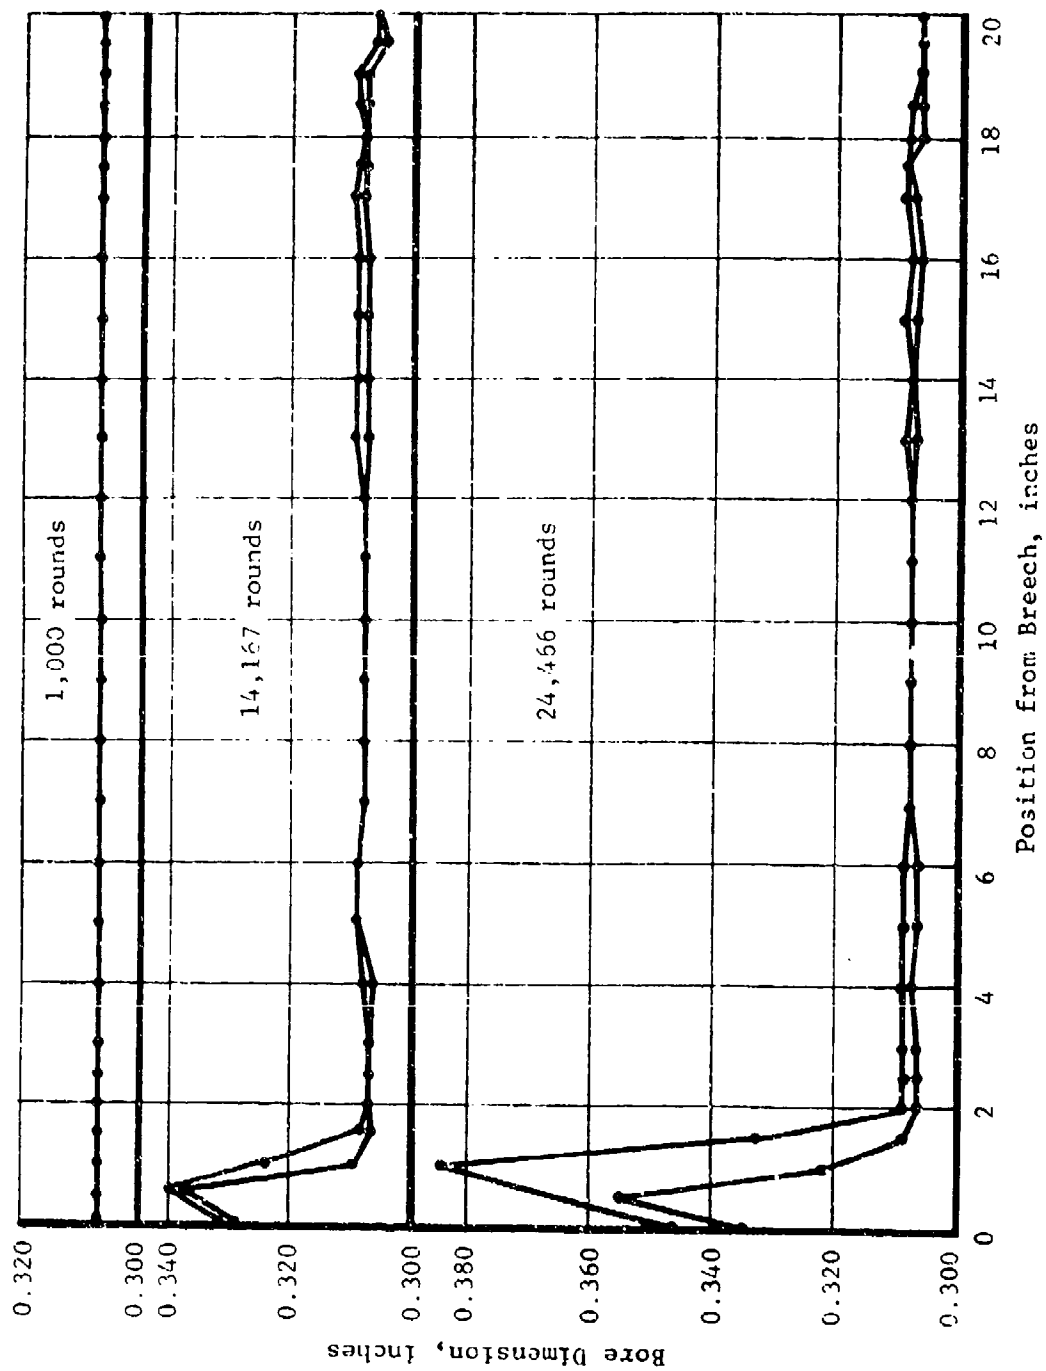
FIGURE 46 BORE PROFILE FOR H11 MATERIAL FOR VARIOUS NUMBERS OF TOTAL ROUNDS FIRED.

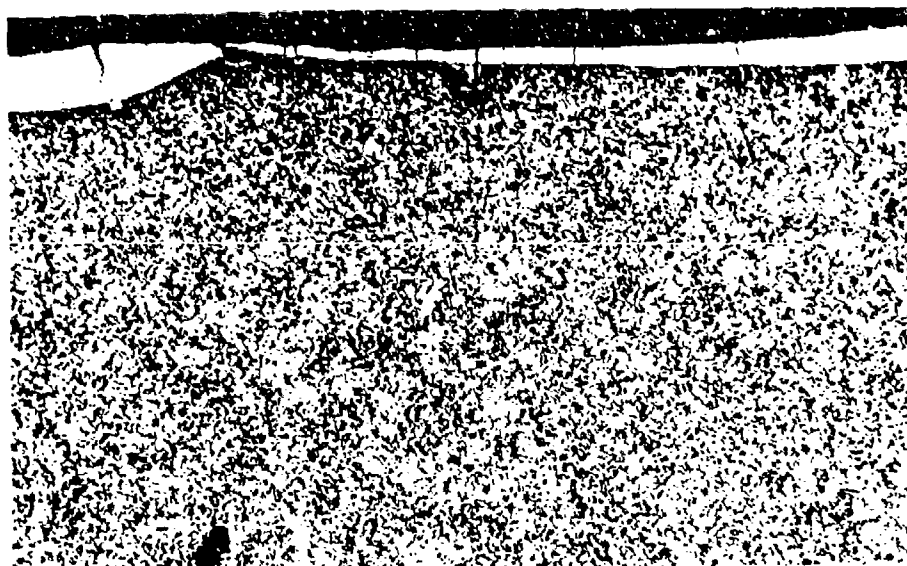
FIGURE 52 TRANSVERSE SECTION AT 10 INCHES FROM THE CHAMBER OF A STANDARD CHROME-PLATED GUN BARREL AFTER FIRING 11,283 ROUNDS AND BEING DECLARED UNSERVICEABLE.

The metallographic structure of the transverse section at the 10 inch location is shown in Figure 52. This particular site is at the intersection of a land and groove. The thickness of the chrome plate on the land has been greatly reduced, whereas very little reduction in thickness has occurred in the groove portion. The metallurgical structure appears to be rather uniform and is quenched and tempered martensite. No appreciable cracking in the steel was observed.

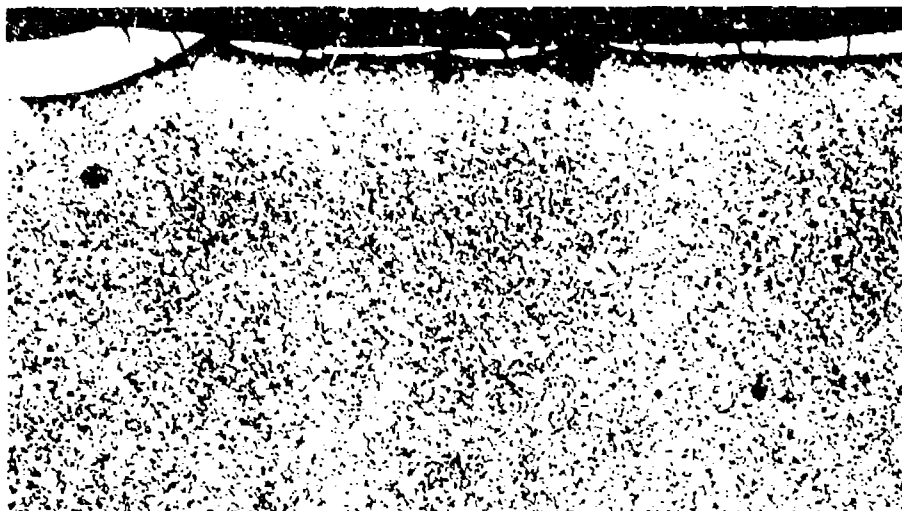
FIGURE 53 TRANSVERSE SECTION AT 17 1/2 INCHES FROM THE CHAMBER OF A STANDARD CHROME-PLATED GUN BARREL AFTER FIRING 11,283 ROUNDS AND BEING DECLARED UNSERVICEABLE.

Figure 53 shows the structure of the barrel at 17 1/2 inches from the chamber. The general physical appearance of the structure is similar to Figure 52. However, it does appear that the region directly below the land is ferrite and carbide. The bore surface at 1/2 inch from the muzzle is depicted in Figure 54. Again, it is apparent that the land is completely removed. The material above the steel is copper alloy.

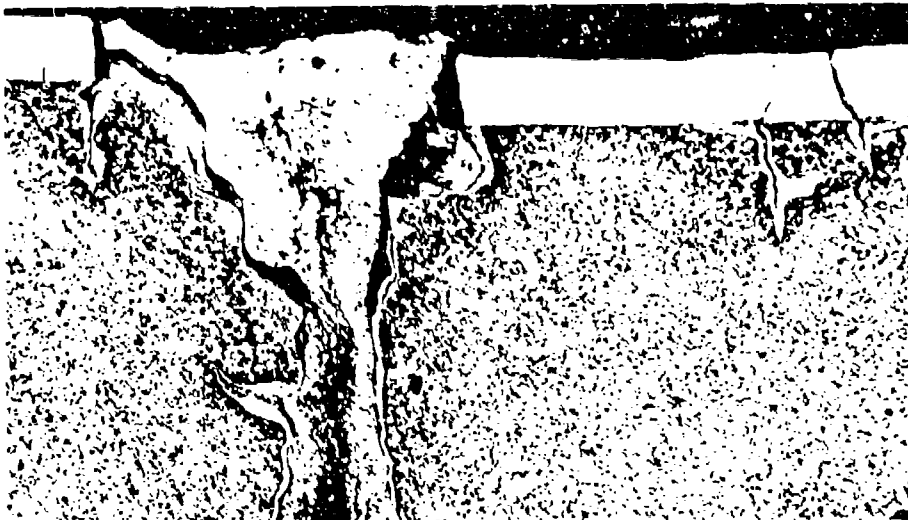
FIGURE 57 TRANSVERSE SECTION AT 2 INCHES FROM THE CHAMBER OF A STANDARD CHROME-PLATED GUN BARREL AFTER FIRING 12,068 ROUNDS AND BEING DECLARED UNSERVICEABLE.

At the 2 inch position, there are relatively large cracks in the chrome plate and the steel. Figure 57 shows a portion of the transverse section. The characteristic features are the presence of the copper alloy in the cracks, the discontinuous white layer, the change in structure to ferrite and carbide near the crack and bore surface, and the presence of most of the chrome plate.

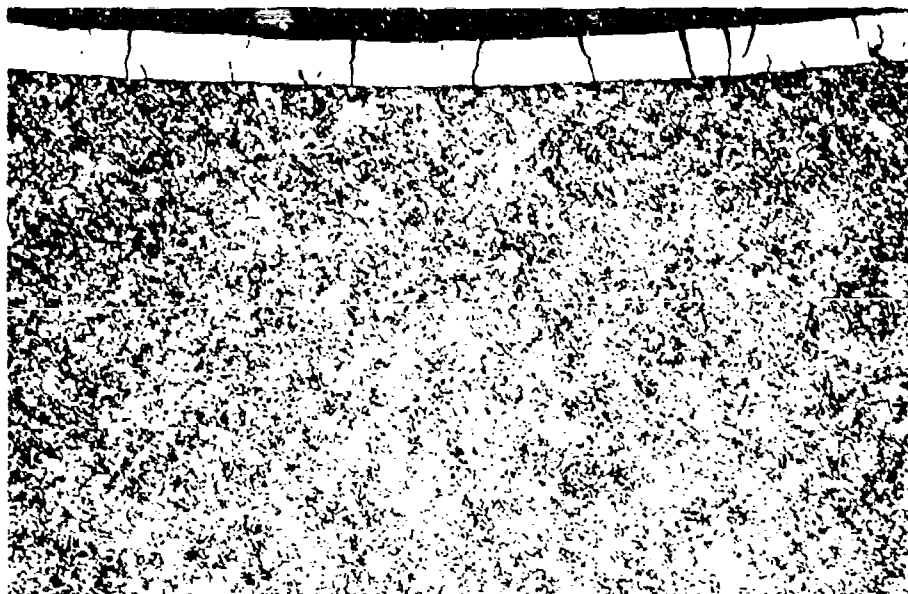
FIGURE 58 TRANSVERSE SECTION AT 10 INCHES FROM THE CHAMBER OF A STANDARD CHROME-PLATED GUN BARREL AFTER FIRING 12,068 ROUNDS AND BEING DECLARED UNSERVICEABLE.

Figure 58 shows the typical appearance of the transverse section at 10 inches. The cracks in the chrome-plate can readily be seen; however, the general integrity of the region is good. Further examination of the sample revealed a thinning of the chrome plate on the barrel similar to that of Figure 52.

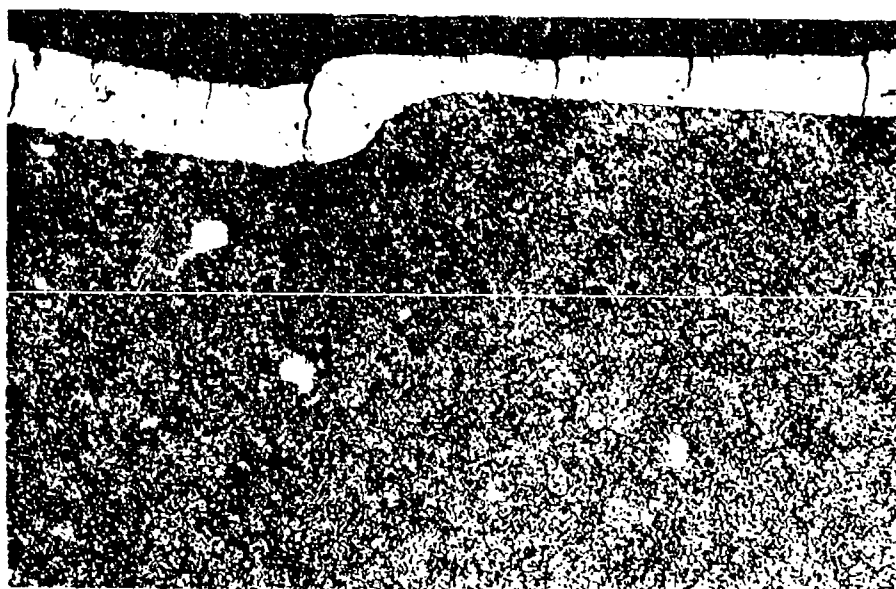
FIGURE 64 TRANSVERSE SECTION AT 10 INCHES FROM THE CHAMBER OF A CHROME-PLATED H11 STEEL GUN BARREL AFTER FIRING 16,291 ROUNDS AND BEING DECLARED UNSERVICEABLE.

Figure 63 is the bore region on a transverse section at 2 inches and is very similar to Figure 62. A transverse section at the 10-inch position from the chamber is shown in Figure 64. The reduction of the chrome plate on the land is obvious; however, review of Figure 52 shows that the chrome plate retained on the land of the H11 barrel is thicker than that retained on the standard barrel.

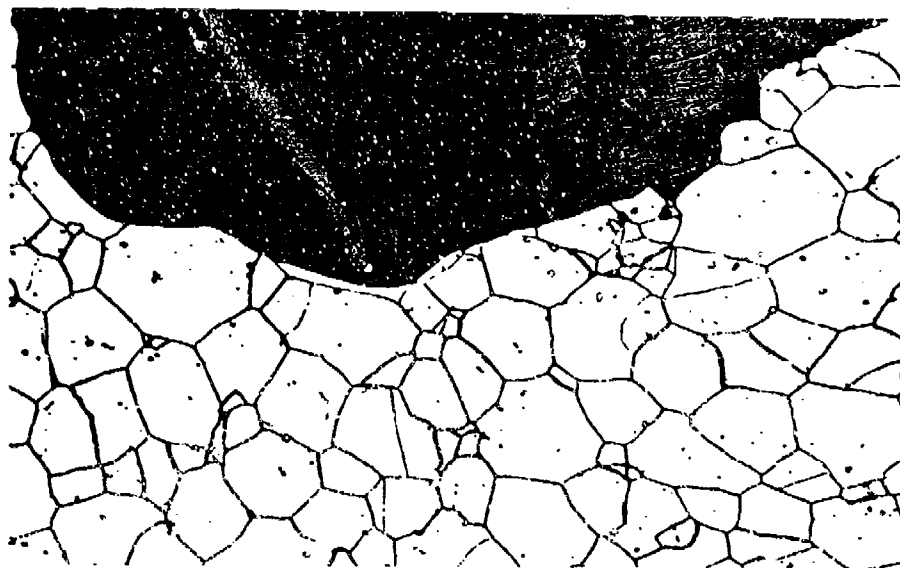
The structure of the bore surface at the 17 1/2 inch position from the chamber is revealed in Figure 83. Massive erosion has occurred at this site.

FIGURE 83 TRANSVERSE SECTION AT 17 1/2 INCHES FROM THE CHAMBER OF A CHROME-PLATED CG-27 ALLOY BARREL AFTER FIRING 7,324 ROUNDS AND BEING DECLARED UNSERVICEABLE.
