SUBJECT: Operational Report - Lessons Learned, Headquarters, 93d
Engineer Battalion (Const), Period Ending 31 January 1968 (U)

3
DEPARTMENT OF THE ARMY
Headquarters, 93d Engineer Battalion (Const)
APO San Francisco 96370

SUBJECT: Operational Report - Lessons Learned
for Quarterly Period Ending 31 January 1968

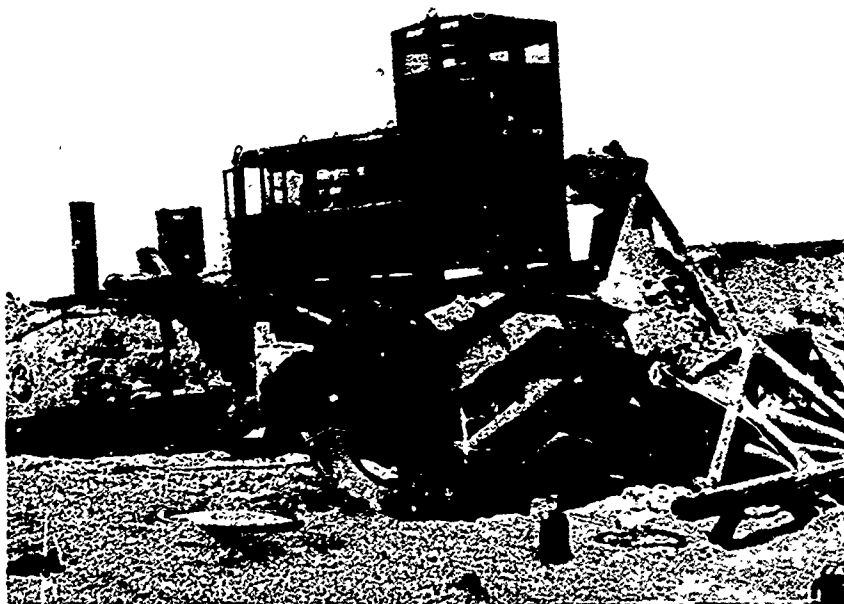
Photograph #15 - (Camp Castle) Tree crusher undergoing change from amphibian drums to land drums. Change-over takes from 18-24 hours.

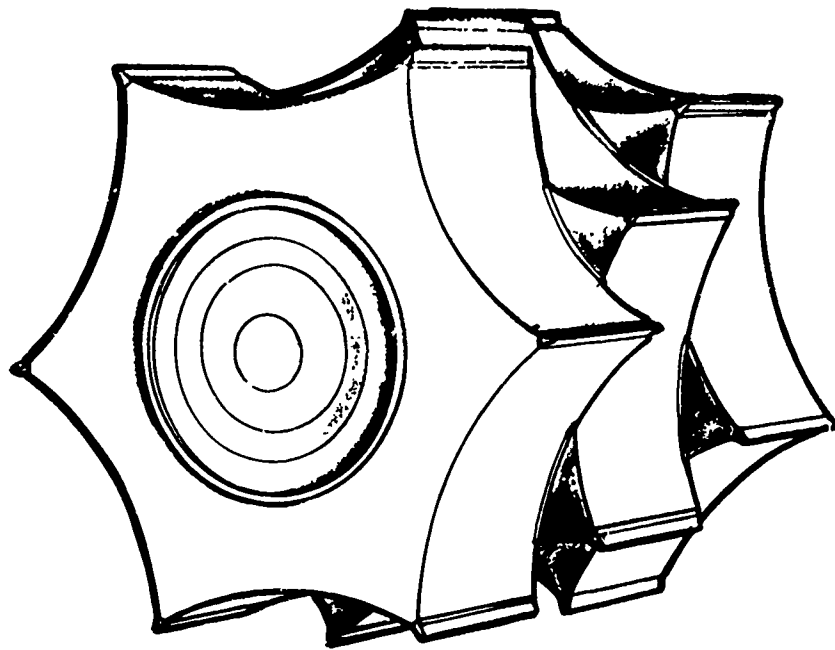
FIG. 6 POSSIBLE DRUM DESIGN - 18 POINT
(ARTIST CONCEPT)

4. Design a universal drum to replace the water and land drums, which would incorporate the best features of both drums. One manner in which this could be accomplished is shown in Figures 5 and 6. Modifying each drum to twelve points instead of six contact points would result in one point contacting the ground every 3 feet rather than every 6 feet as occurs on the present amphibian drum seen in photograph 18. This would provide a smoother ride, less shock to the machine, and reduce the possibility of breaking through an upper crust of earth. This universal drum would still give maximum flotation for water conditions. It should also reduce maintenance problems of the driver unit since less effort would be required to turn the wheel. An extreme example of the track left by the present amphibian drums is shown in photograph 19.

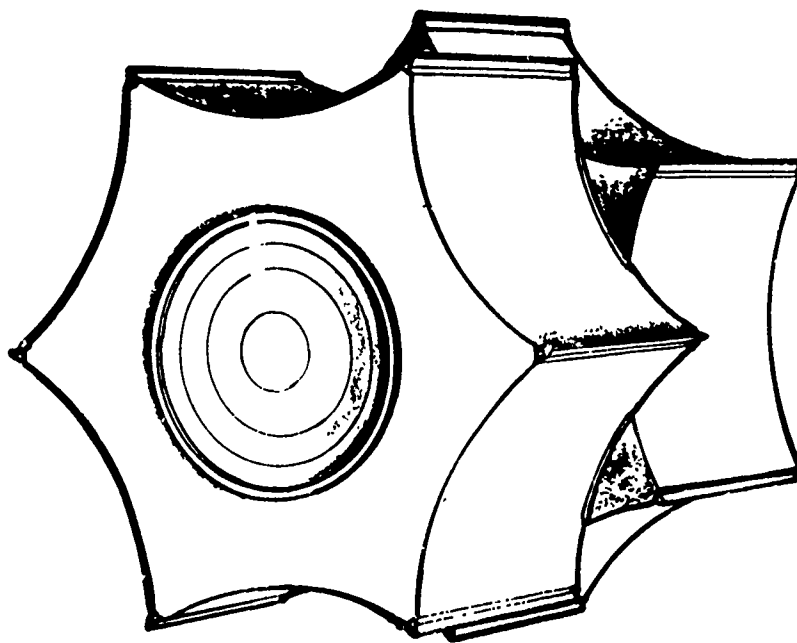
FIG. 5 POSSIBLE DRUM DESIGN 12 POINT
(ARTIST CONCEPT)

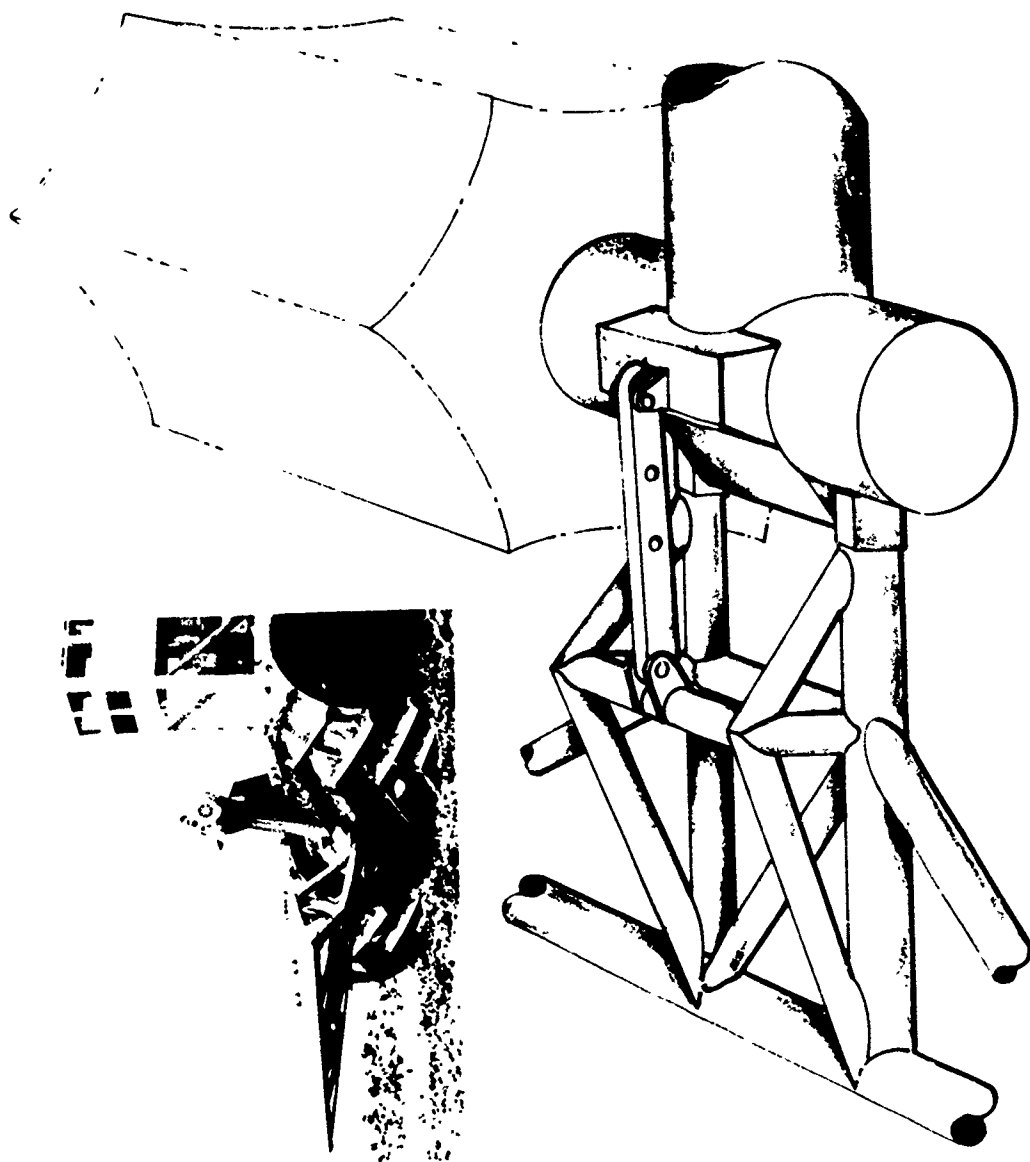
FIG. 4 PROPOSED PUSH BEAM MODIFICATION
(ARTIST CONCEPT)

Observation: The wearing of the push beams was greatly reduced by welding selvaqe cutting edges from a motor grader to the sides and bottom of the push beam.

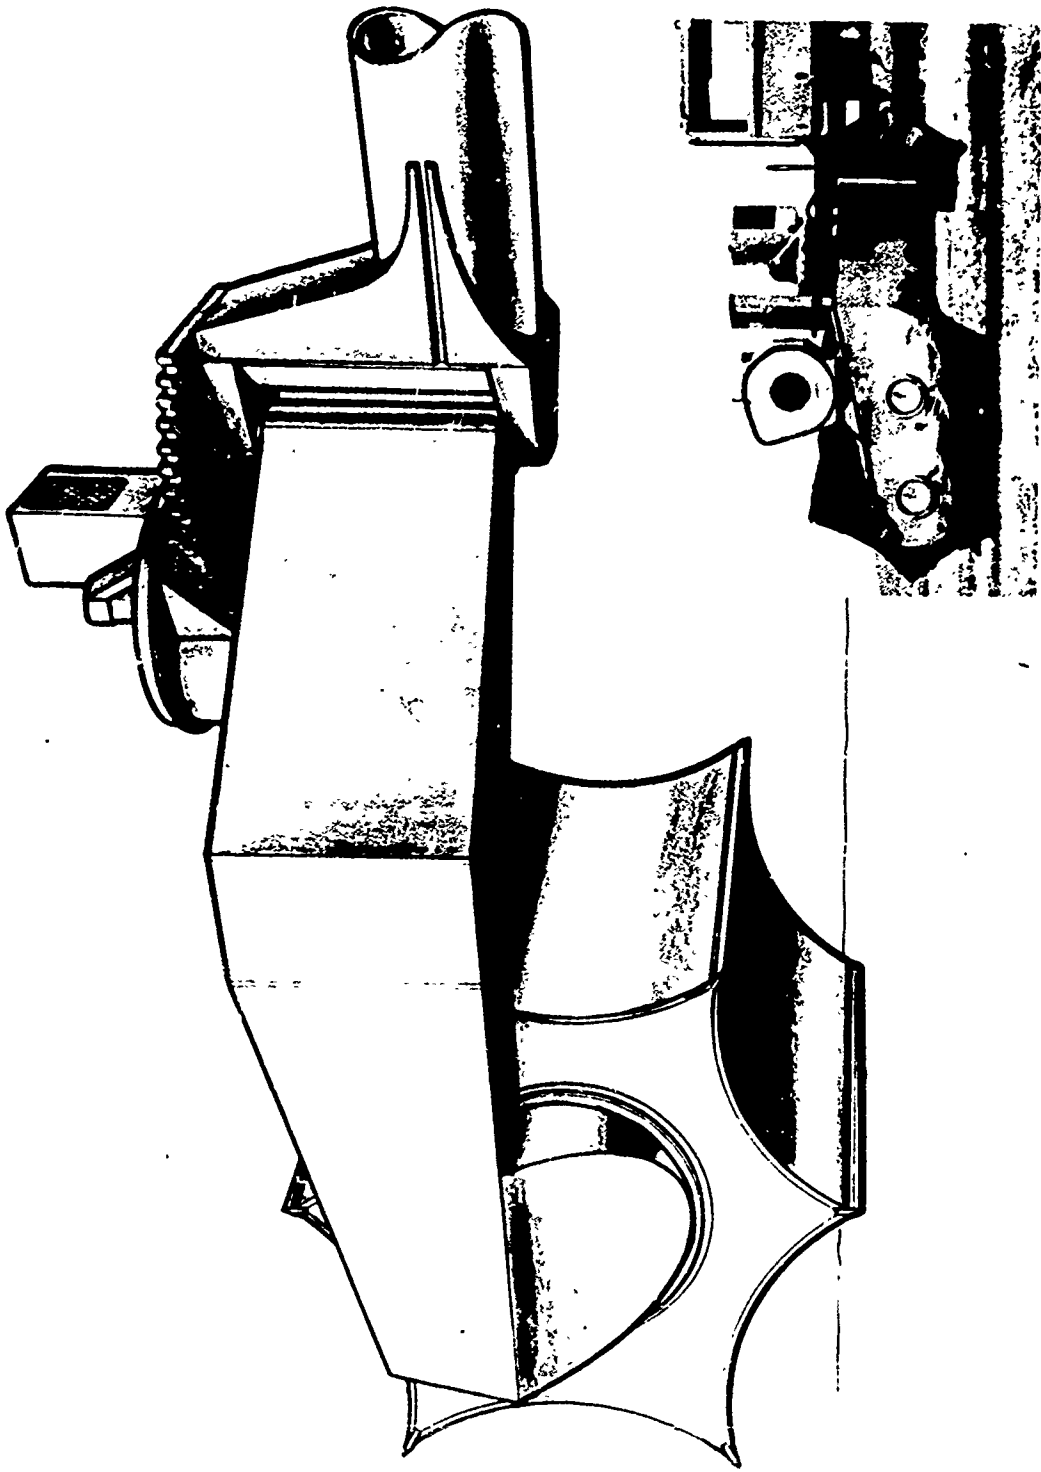
FIG. 3 PROPOSED TUG STRUCTURE MODIFICATION
(ARTIST CONCEPT)

8. Redesign the tug structure to reduce weight on rear end of machine. The present configuration seen on photograph 20 results in a ground pressure of 4 psi on the front drums and 7½ psi on the rear drum. This could be achieved by modifying the rear tug structure as shown in figures 3 and 7. The lightening of the rear assembly by 10 or more tons would greatly increase the trafficability of the machine without affecting the machine's crushing capabilities.

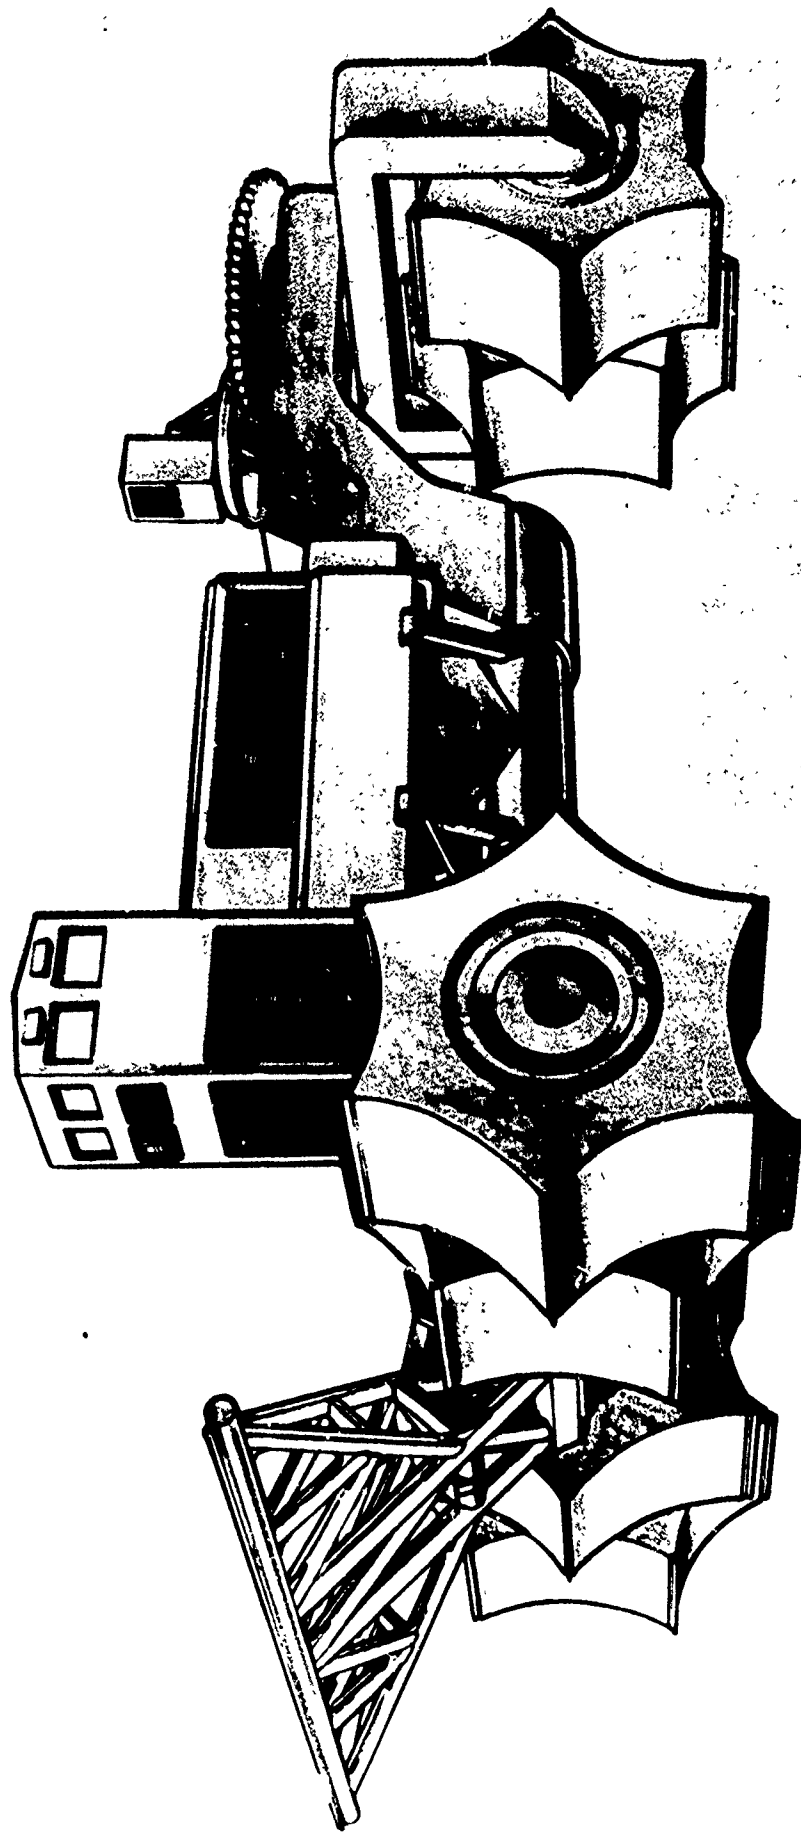
FIG. 7 POSSIBLE TUG STRUCTURE DESIGN CENTER STEERING
(ARTIST CONCEPT)

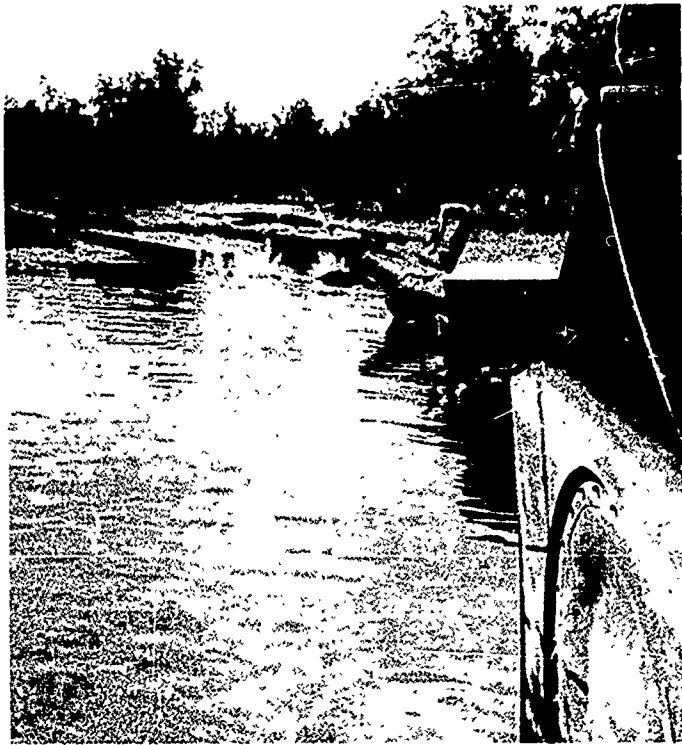
#10 -- Wedging the floats underneath the bumper assembly of crusher #2. Manuevering floats was difficult; bottomless mud at low tide and water at high tide.

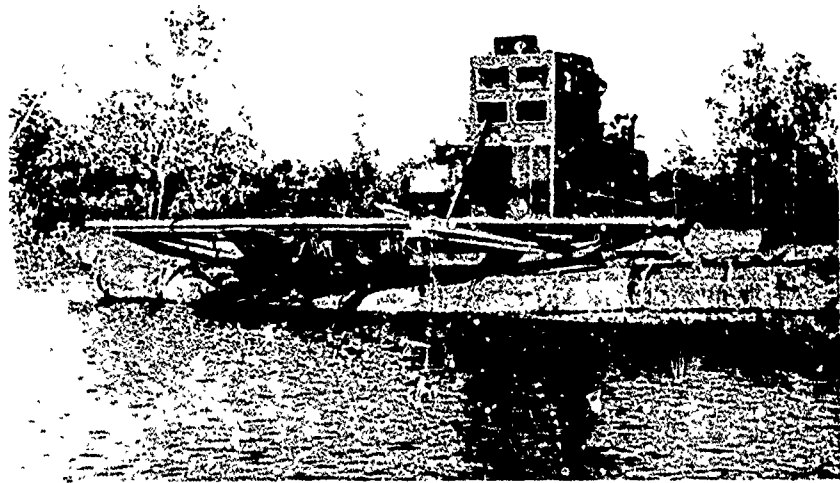
#12 -- Crusher #2 as the tide comes in. The wedged timber holds the floats under the bumper and transferred the force in a lever effect lifting the drums from the mud,

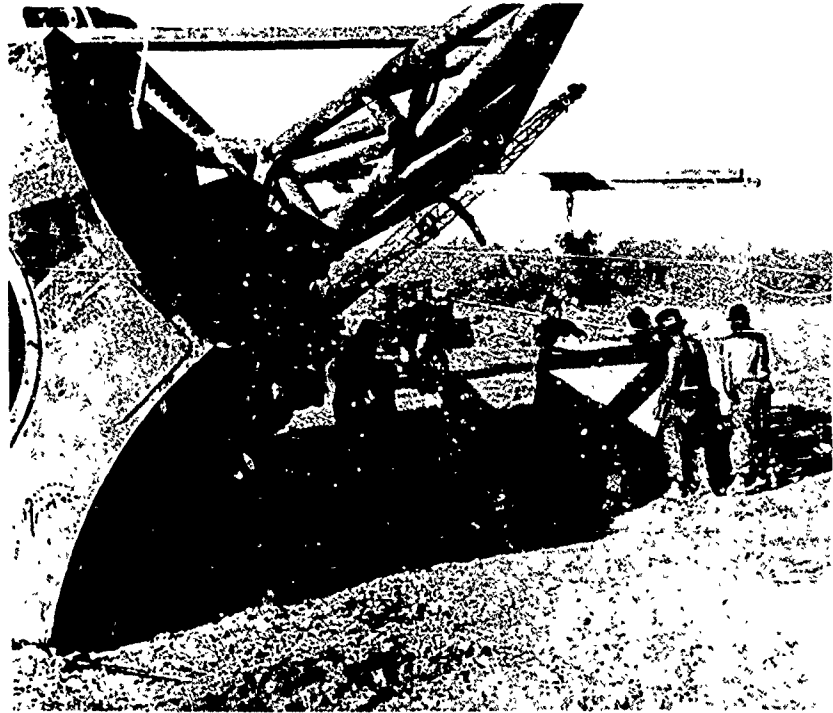
#13. Disassembly at Ap Go Dau. Large steel plates and jack stands must be positioned by hand under the bumper assembly.

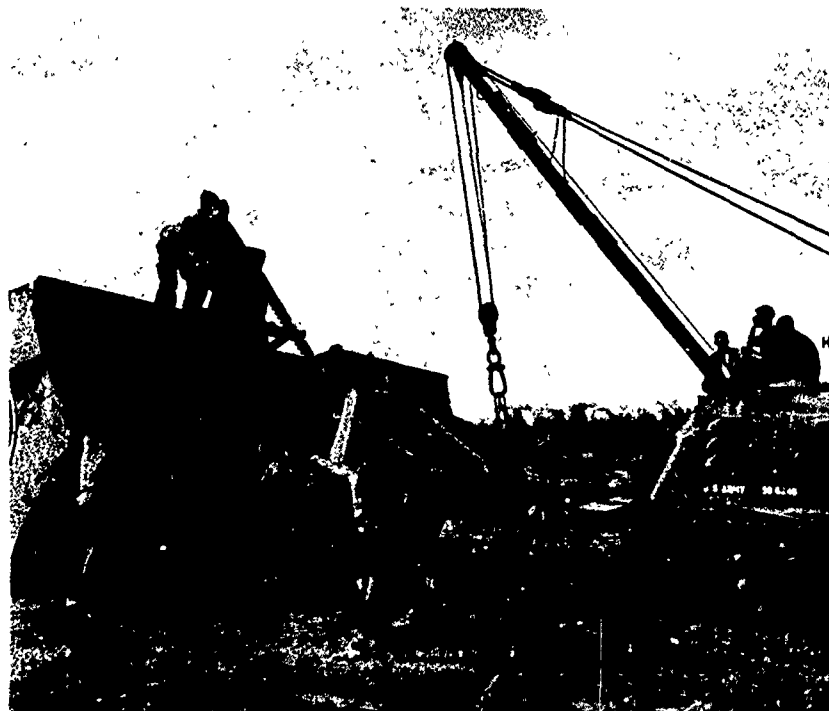
#16. Without electric power, the electric motor had to be turned with a wrench to lower the bumper.

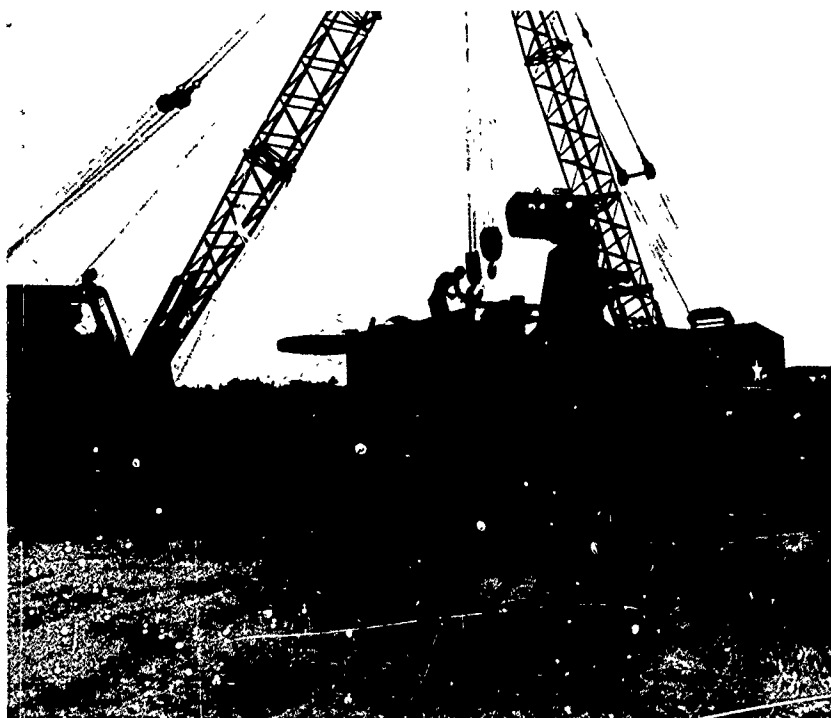
#20. The main frame being unloaded. Two 20-ton cranes must team up when a VTR is not available.

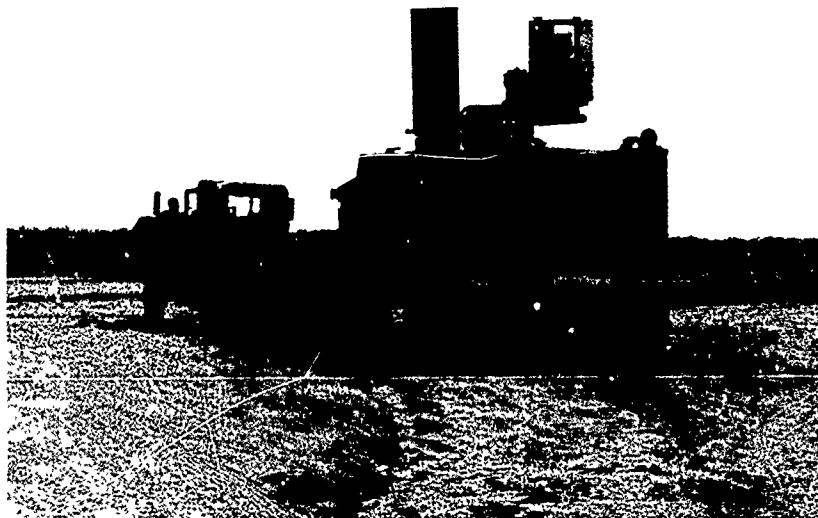
#21. The tug structure loaded for transport back to Camp Castle. The load is 14 feet wide.

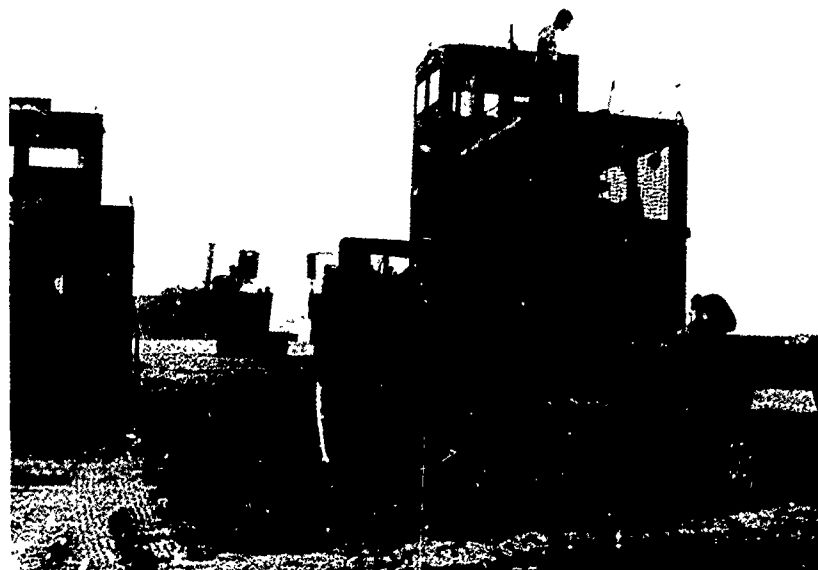
#22. The cab/engine load prior to securing on lowbed.

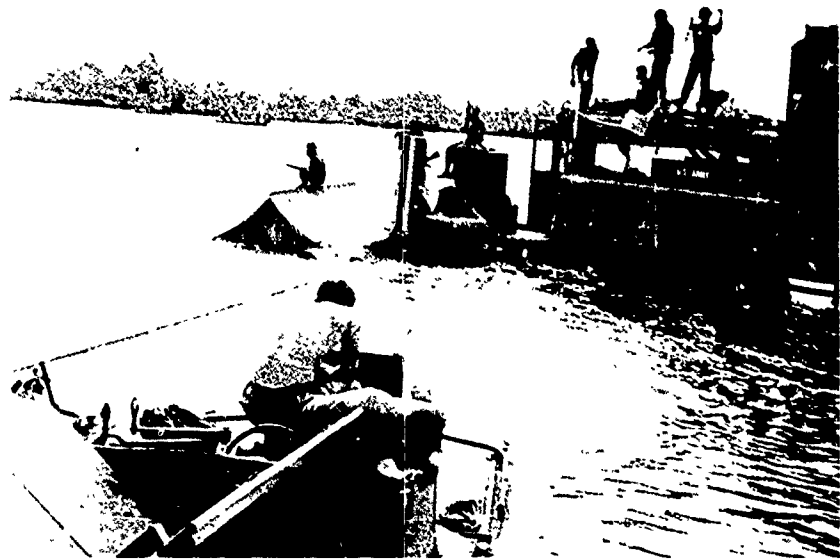
#23. The security deployed on top of the crushers. Note double lines from tug structure.

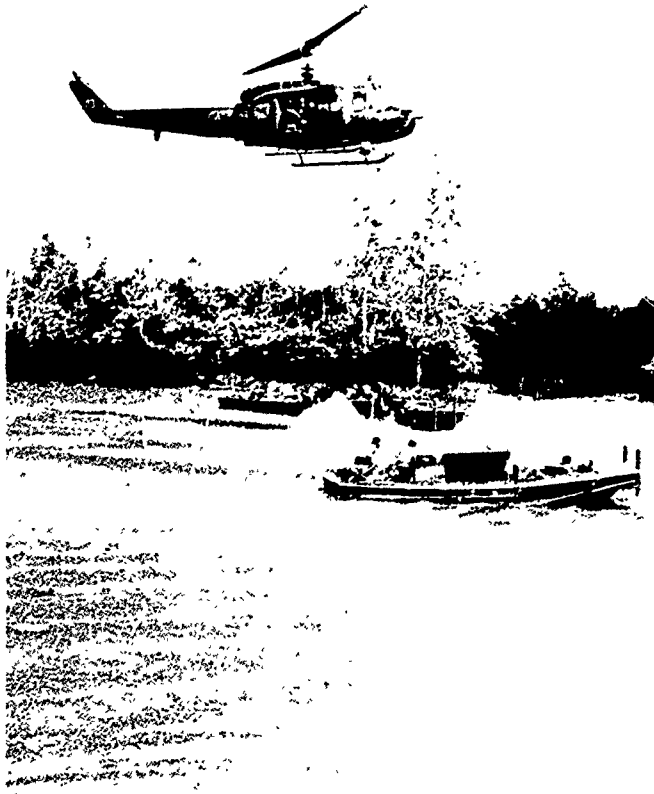
#25. Resupply of C-rations by air to security forces. Those that didn't sink were recovered. There was no bank or open space to land or drop supplies. Water cans were handed from helicopter but almost sank the boats.
