NWC TP 4738

SAFETY TESTS OF EXPLOSIVES TRANSPORT TRUCKS

This report summarizes the results of five tests conducted at the Naval Weapons Center to study the effectiveness of flash shields placed between the cab and the bed of pickup trucks of the type used for hauling explosives at NWC.

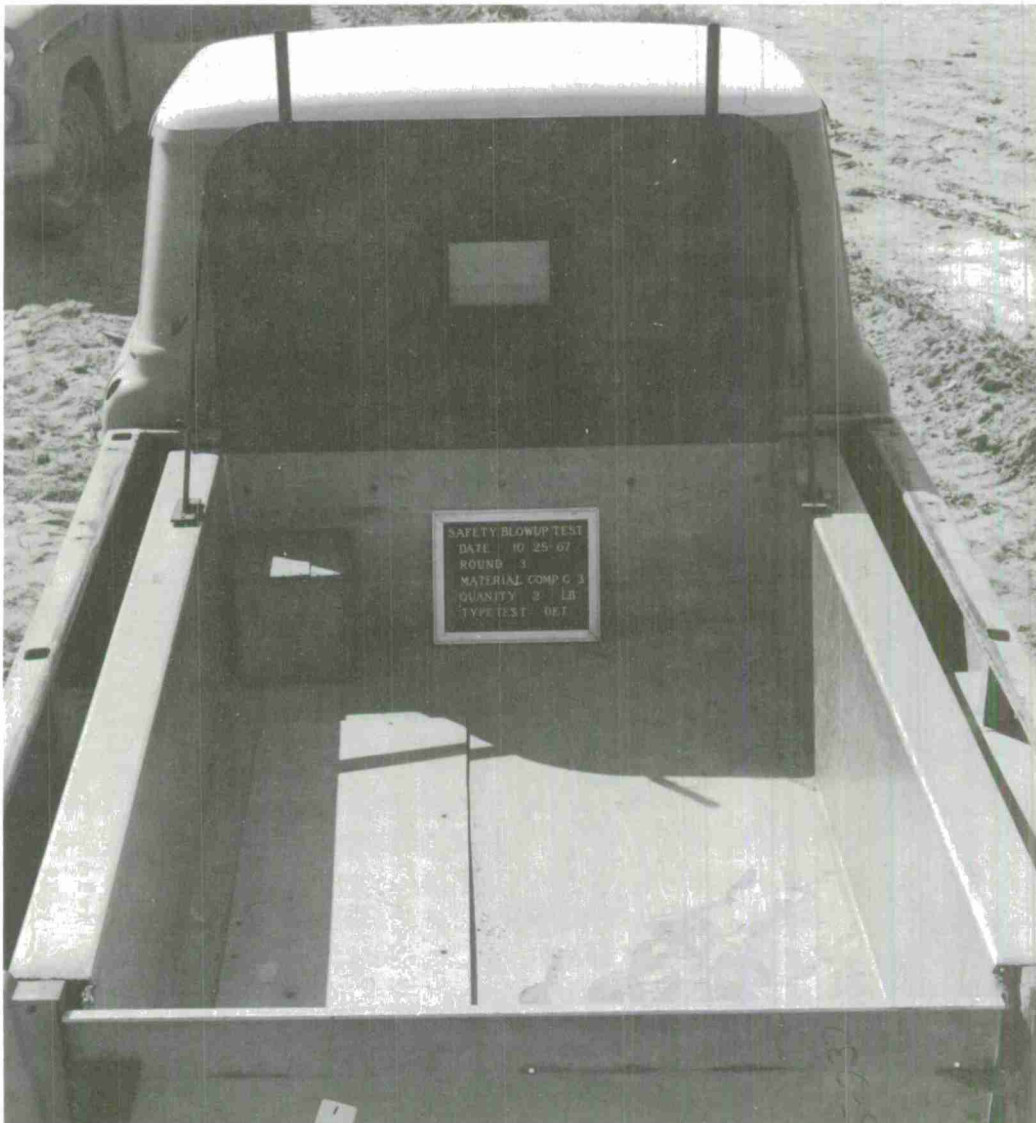
Test 3 was a detonation test in which a 2-pound demolition block of Composition C-3 in a wooden box was placed on the bed of the truck just behind the driver (Fig. 9).

FIG. 9. Truck Bed With 2-Pound Block of Composition C-3 in Place for Test 3.
