## **Demonstration of an In Situ Pipe-Lining Technology for a Fire Suppression Deluge System at Fort Drum, NY**

Final Report on Project F07-AR17

May 2018

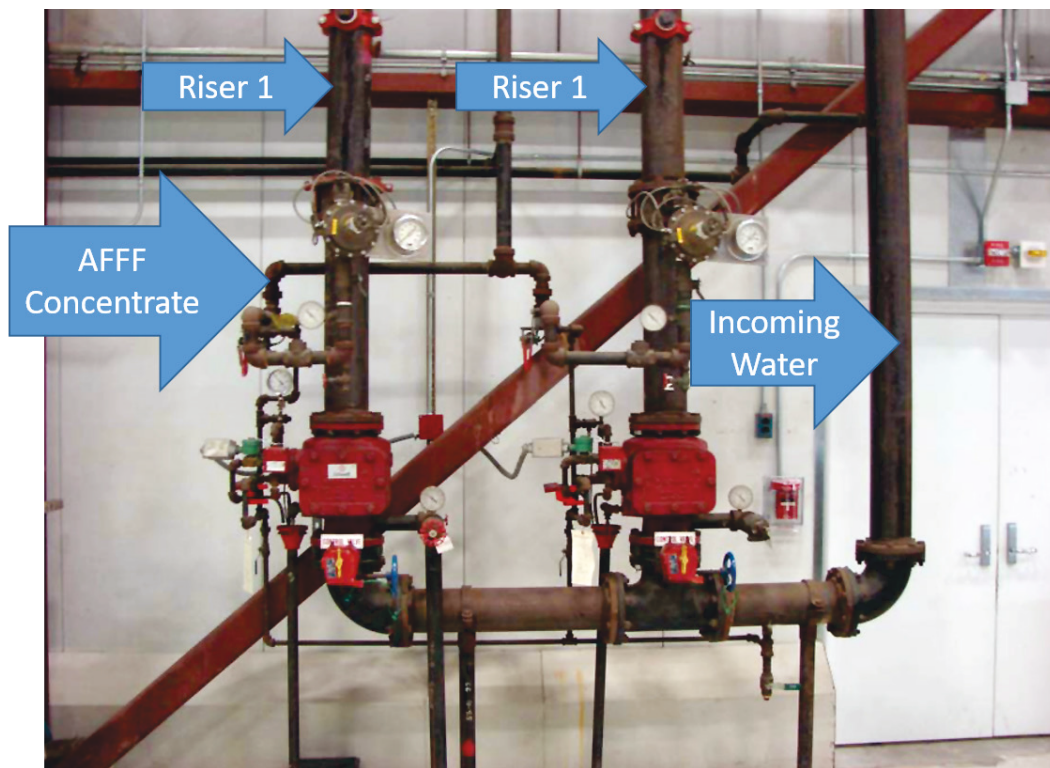
The AFFF distribution plumbing begins in the mechanical room where there are two 1,200 gal AFFF storage tanks. From near the bottom of the storage tanks, the AFFF travels to pumps through 2 in. and 3 in. diameter pipes. The pumps, when activated by an alarm system, quickly pass the AFFF through a 2 in. diameter pipe into the hangar and along the hangar wall. At each mixing station (Figure 1) and along the sides of the hangar, the AFFF distribution system also feeds fire hoses capable of dispensing water or an AFFF solution.

Figure 1. Dual mixing station.

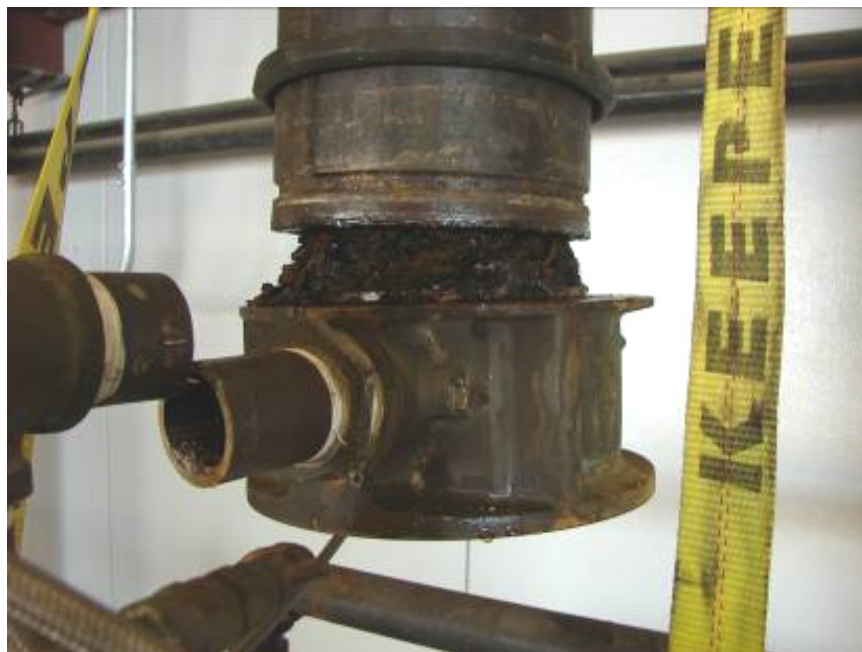
At the mouth of the fire-suppression riser coming up from the mixing station, a brass nozzle is inserted into the pipe, which allows air to mix into the water and AFFF solution to form the foam (Figure 3).

Figure 3. Mixing nozzle.

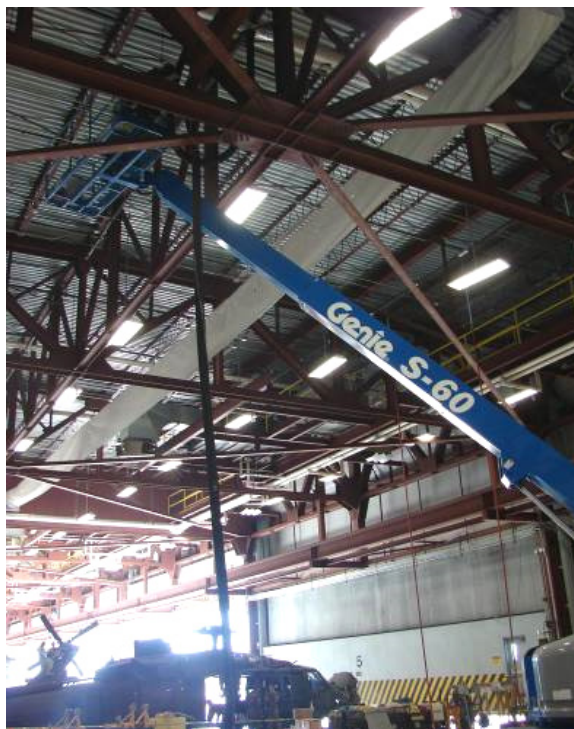
The deluge system is the portion of the fire-protection system that manifolds along the ceiling and contains the sprinkler heads. In this case, the deluge system was approximately 45 feet above the hangar floor. To reach that height, 60-foot manlifts were used, as shown in Figure 4.

Figure 4. Manlifts were used to reach the connections near the ceiling.
