SITE SPECIFIC REPORT SSR-2525-SHR

PIPELINE COATING CONDITION ASSESSMENT AND INSTALLATION ASSESSMENT, SAN NICOLAS ISLAND

November 1999

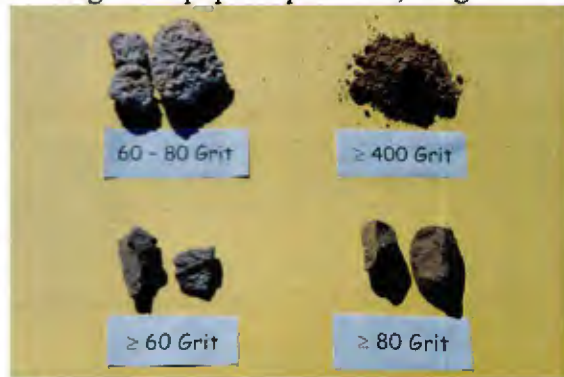
In an attempt to quantify soil and rock abrasion on the coating, representative rock and soil samples, taken from the island, were lightly rubbed against the coating. The resulting scratches were visually matched to equivalent sandpaper scratches made from known grit sizes. San Nicolas Island rock and soil produced coating scratches equivalent to 60 – 400 grit sandpaper. In the laboratory investigation, the sandpaper equivalent of island soils and rocks were used (see section titled "Abrasion Resistance").

Top to Bottom (L to R): Shell embedded soil, soil, pumice type rock, and sand stone.

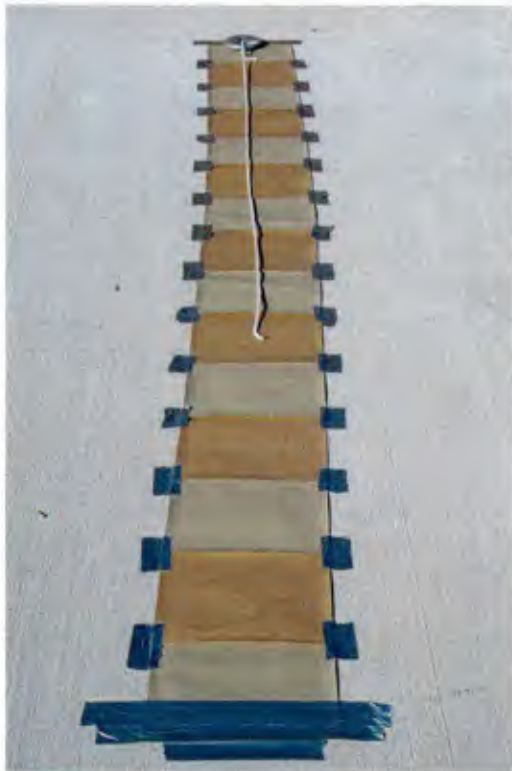
Test Parameters: A) Coated sample size, 7.854 in², B) Initial sample weight, 149.62735 g, C) Coating thickness on sample, 75 – 85 mils, D) Shore A Hardness of coating, 95 (full cure), E) Weight attached to sample, 2.5 lbs (0.361 psi), F) Sandpaper type, 100 grit (7 sheets) & 120 grit (8 sheets), G) Total length of sandpaper, 10 feet, and H) Weighted sample pulled 9 times through the complete length of sandpaper.

Ten feet total of alternating 100 and 120 grit sandpaper.
