## Guided Wave Testing of Trunnion Rods at West Point Dam, Georgia

*by Jason D. Ray, Richard W. Haskins, and James A. Evans*

**PURPOSE:** This Coastal and Hydraulics Engineering Technical Note (CHETN) describes trunnion rod crack detection testing using the portable guided wave test system on a sample of the trunnion rods located at West Point Dam, Georgia, in January 2016. It is also intended to be used as a guide for test efforts at other sites.

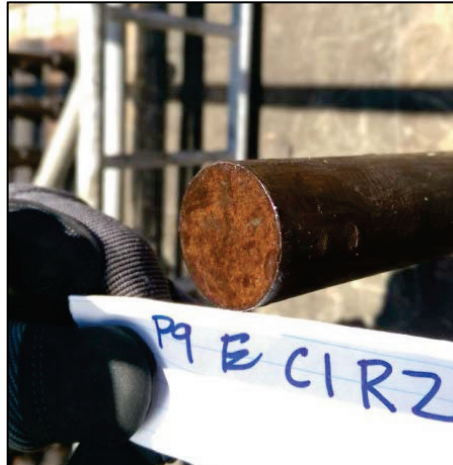
**TEST PLAN:** Safety concerns at this dam dictated that no grinding or unnecessary contact with the rods would be allowed. It was known before testing that the rod ends were, for the most part, in good shape and would not require any work to prepare the surfaces. A few rods exhibited surface anomalies (Figure 4). Other rods were very flat and were quite responsive to the test (Figure 5).

Figure 5. Typical rod without corrosion.

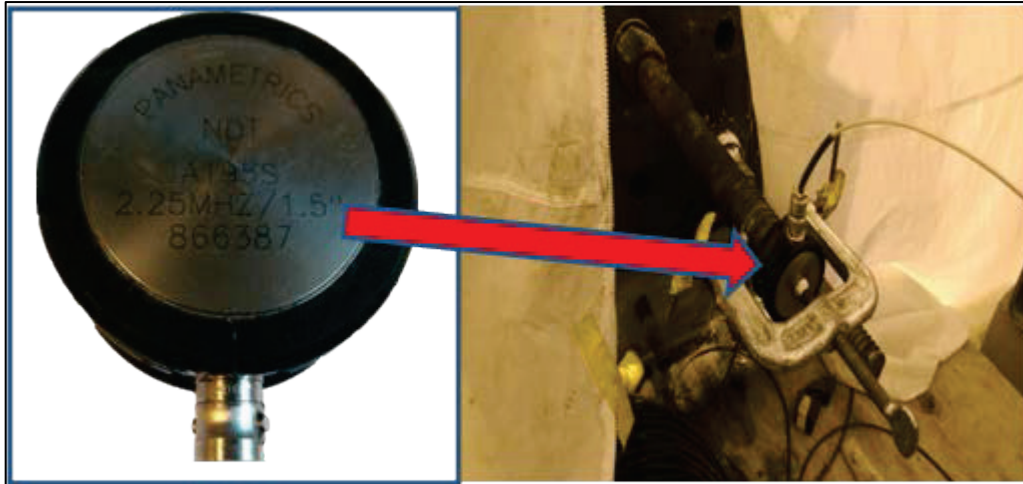
**TEST METHOD:** All rods for each pier were tested before moving to the next pier. First, each rod was visually inspected for proper placement of the transducer on the rod end (Figure 7). At West Point Dam, preparation for proper transducer placement involved cleaning the rod ends of caked-on grease using a putty knife. Safety procedures were observed, being careful to stay out of harm's way by standing clear of any possible projection of the rod.

Figure 7. Panametrics transducer (left) and transducer clamped on rod (right).

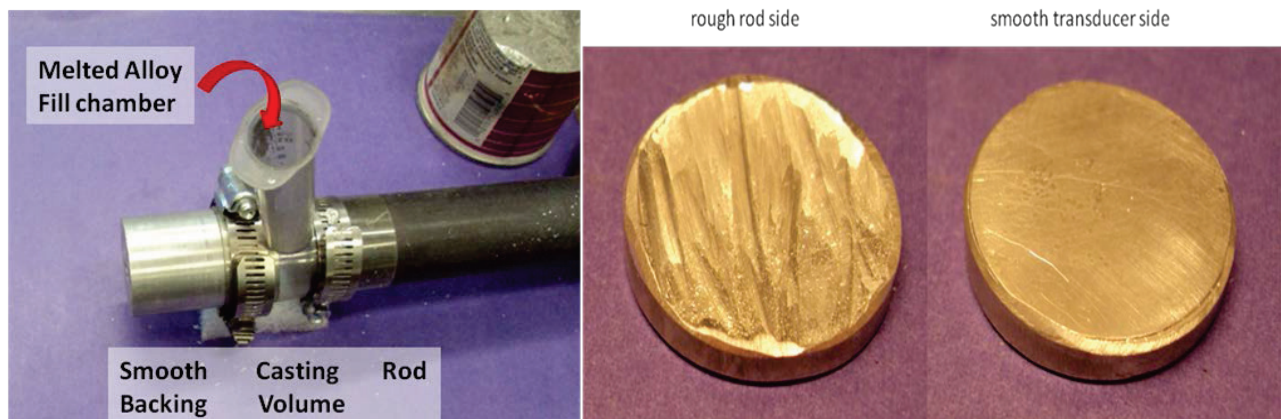
Figure 8. Trunnion rod end casting assembly and sample casting.

If cases where the rod ends are too rough to make adequate contact with the transducer, a Fields metal casting may be made of the rod end to interface to the transducer (Figure 8). This procedure will eliminate the need for grinding or cutting off the rod ends. This will decrease the risk of having a rod break and project out of the tube.

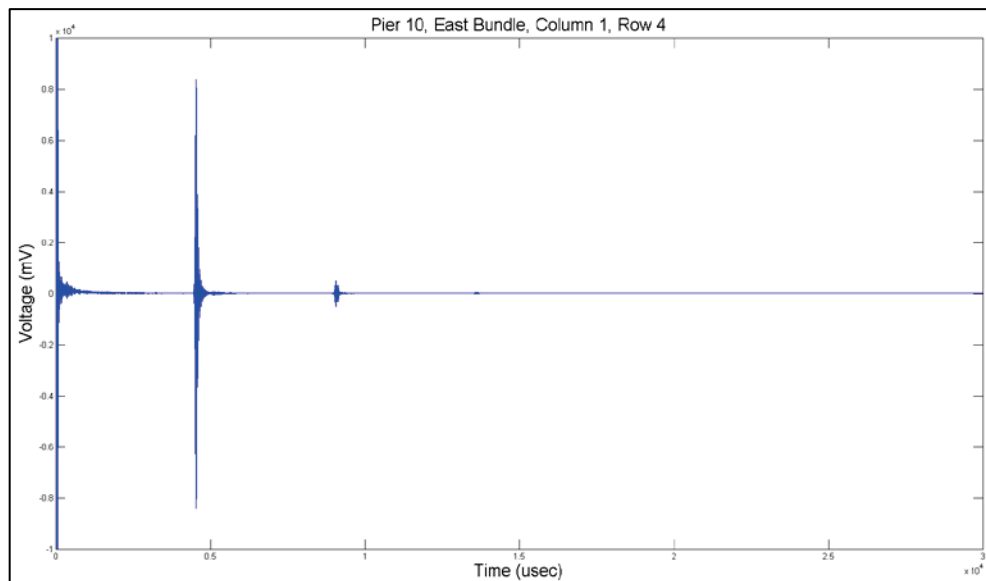
Figure 10. Typical acoustical guided waves response from rods.

Though the rods were of similar length, diameter, and visible condition, the level of the output varied from rod to rod. These results can be contributed to several factors, including the angle and the condition of the fixed end of the trunnion. All of the rods tested, with the exception of one (Figure 11), displayed a variation of the typical response shown in Figure 10.
