Evaluation of Reentry Effects of Delta II Second Stage Propellant Tanks

March 21, 2018

Gary L. Steckel¹ and Paul M. Adams²

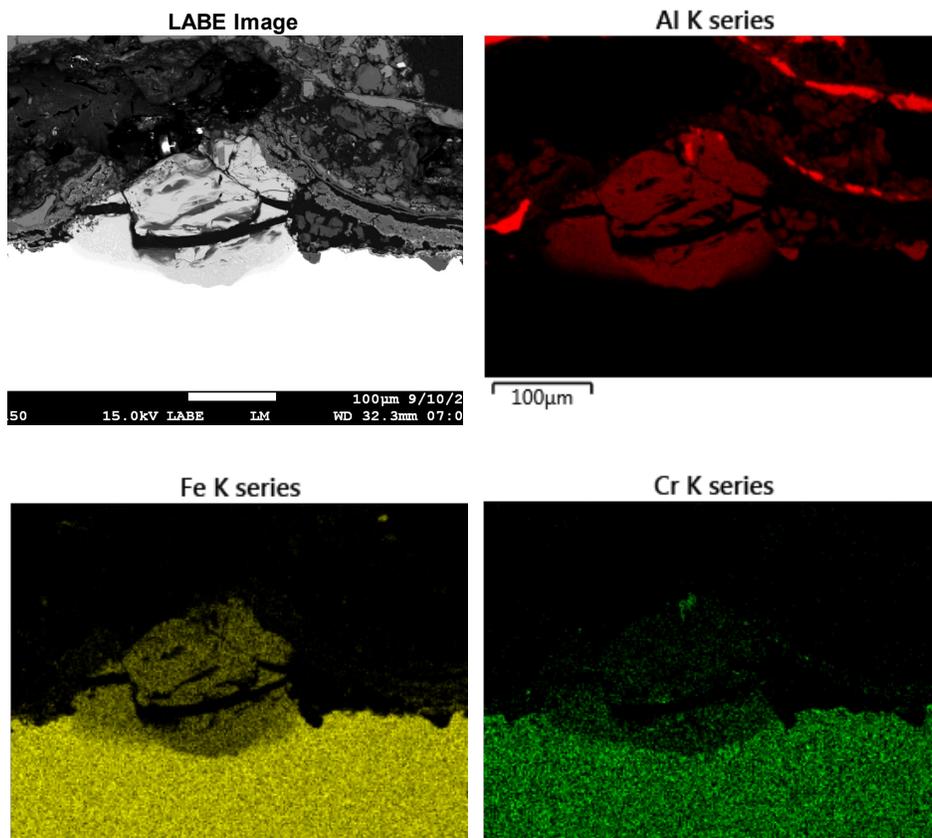
Polished cross-sections of the four samples were examined by optical microscopy to identify areas with possible alloying between the aluminum splatters and stainless steel tank surface. An example of an area selected for analysis is shown in the optical micrograph in Figure 13. This area appeared to have resolidified aluminum splatters on the tank surface and a resolidified area that appeared to be bonded to the tank surface—an indication of alloying between the aluminum and stainless steel. Figure 14 presents a SEM image of the same area, along with EDS elemental maps showing the locations of Al, Fe, and Cr (red, yellow, and green, respectively). The Al map verified the presence of Al splatters on the tank surface. The Fe and Cr maps clearly highlight the stainless steel tank wall. Most importantly, the maps verified the presence of Al, Fe, and Cr within the resolidified material that appeared to have a continuous bond with the tank wall. Thus, the mapping verified alloying between the Al splatters and stainless steel wall, making this a suitable area for more detailed SEM/EDS analyses to determine the peak reentry temperature at this location on the propellant tank.

Figure 14. Electron image and elemental maps of area in Figure 13.

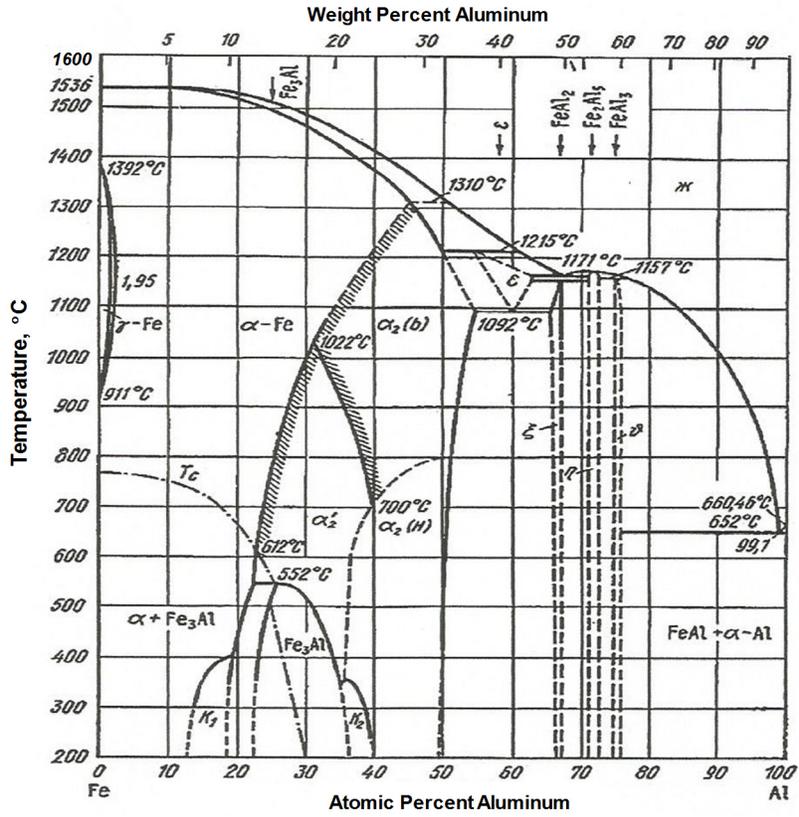
Following the procedure used by Wan [3], peak reentry heating was estimated by measuring the compositions of the phases that did and did not melt during reentry and determining their melting temperatures from the Fe–Al phase diagram. The Fe–Al phase diagram was recently updated by Matysik, et al. [10] and is shown in Figure 16. It will be shown below that the area of interest for our analysis is between 50 and 75 at. % Al. This region on the phase diagram is quite complicated near the melting point and is magnified in Figure 17. Depending on the Al concentration, several different intermediate phases (α_2 , ϵ , ξ , η , and ν) can form during cooling between 1200° and 1150°C. All these phases remain stable at room temperature, except for the ϵ phase that decomposes into the α_2 and ξ by the eutectoid reaction at 1092°C.

Figure 16. Iron–aluminum phase diagram.

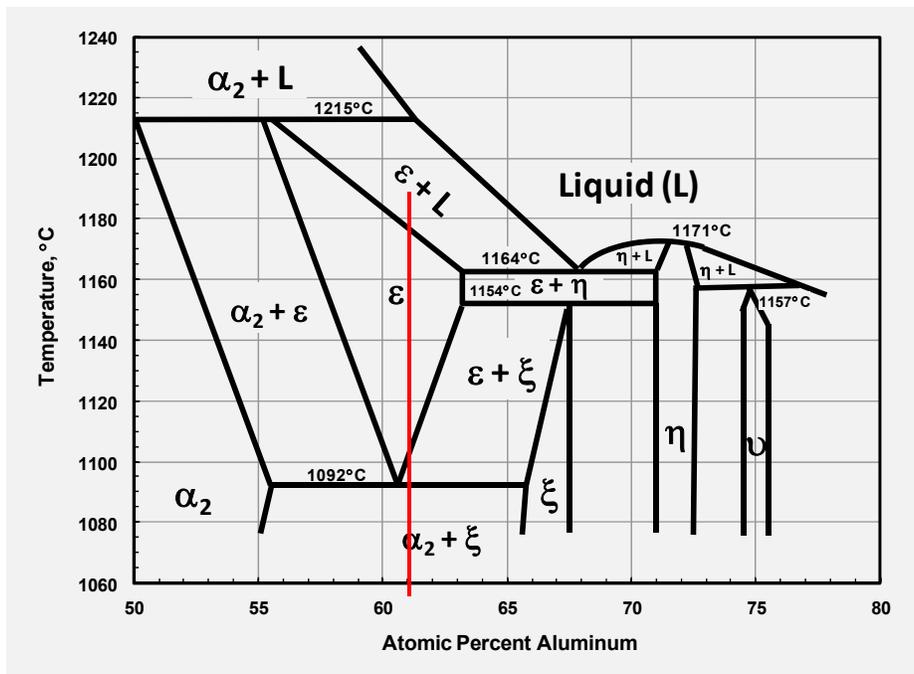
Figure 17. Magnified view of iron–aluminum phase diagram between 50 and 80 at. % Al.

large area EDS scan of the two-phase resolidified region gave an Al content of 61 at. %, the weighted average for the two phases. From the phase diagram, at temperatures below 1092°C, an alloy with 61 at. % Al (as indicated by the red line) has a microstructure consisting of α_2 with an Al content of approximately 55 at. % (light phase in Figure 18) and ξ with an Al content around 66 at. % (dark phase). For 61 at. % Al, melting initiates at 1075°C. Thus, the peak reentry temperature at this location on the tank was at least 1075°C, but did not exceed 1215°C.

Sample B and C came from the forward and aft ends of the cylindrical section, respectively, on the 90° side of the tank. Sample A3 was from the forward dome on the 270° side of the tank. Similar peak temperatures at these locations suggest that the Mongolia tank had uniform reentry heating around the tank, except for locations such as the cylinder edges or melt-through area with special heating conditions. It is concluded that the tank was spinning and/or rotating during reentry, with no apparent preferential orientation. Similar conclusions were reached for the Texas tank [3], which had an estimated reentry temperature of 1200 to 1280°C. It should be noted that Wan used a different version of the iron–aluminum phase diagram for his analysis. When his analysis is repeated using the updated phase diagram (Figures 16 and 17), the reentry temperature range drops to 1164°C to 1250°C.

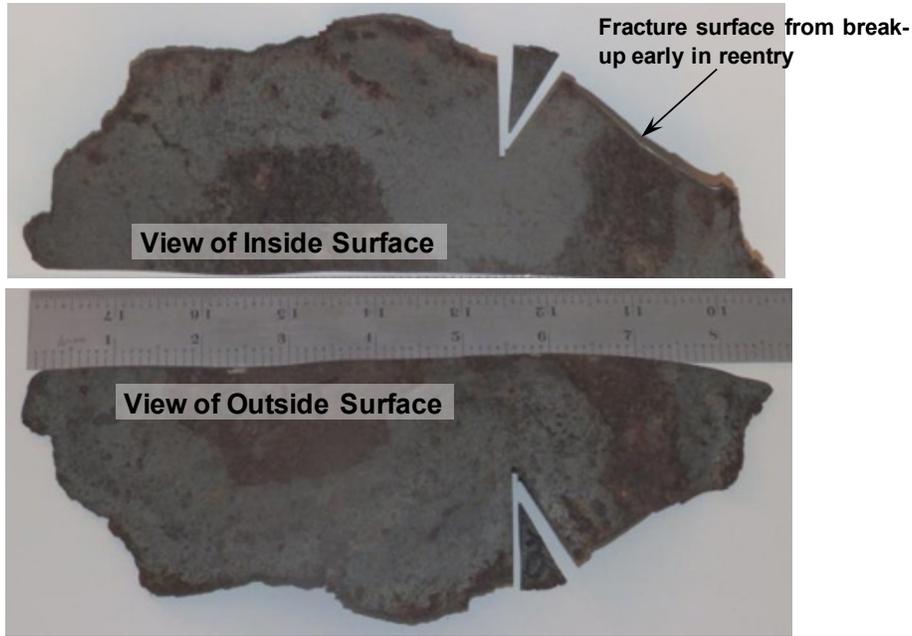
Sample A1, shown in Figure 19, was cut from the aft dome of the propellant tank along the path where the dome fractured during breakup. It was originally cut from the tank for evaluation because the light gray pattern on the outside surface suggested that a thick layer of molten aluminum had splattered along the fracture path during reentry. However, once the sample was removed, it was discovered that a matching gray pattern was also present on the inside surface (Figure 20). SEM/EDS spectra were taken on the surfaces of the gray area as well as the reddish area. No aluminum was detected on the gray area, and

Figure 20. Photographs of outside and inside surfaces of Sample A1.

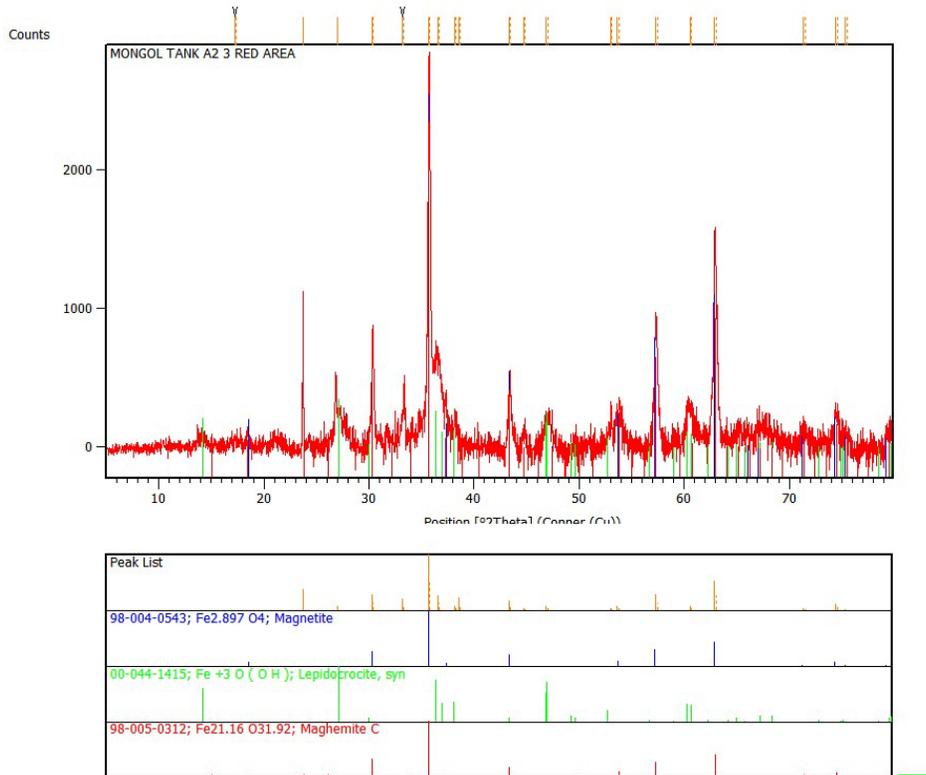
X-ray diffraction spectra were taken for the gray and reddish areas to further characterize the oxide layers. Magnetite (Fe_3O_4) or maghemite ($\gamma\text{-Fe}_2\text{O}_3$) and lepidocrocite ($\text{FeO}(\text{OH})$) matched the spectra for the reddish area (Figure 21). Magnetite and maghemite have the same diffraction peaks, so either or both oxides may have been present. However, maghemite is normally not stable at room temperature, so the reddish oxide is likely magnetite [11].

Figure 21. X-ray diffraction spectrum obtained from reddish oxide on Sample A1.

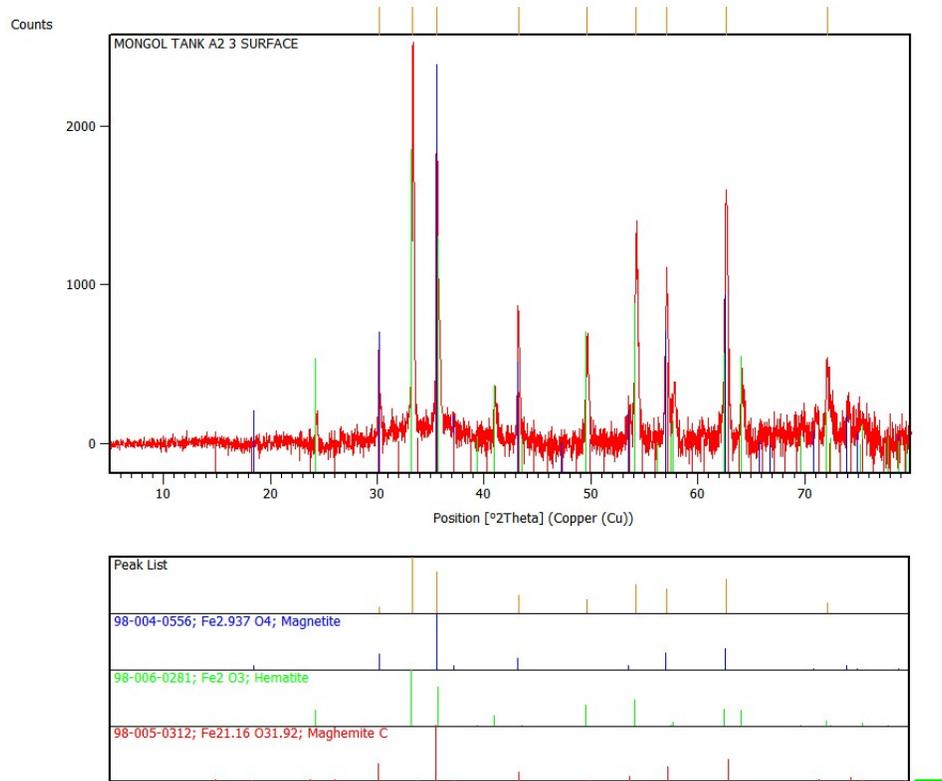
Figure 22 shows the diffraction pattern for the gray area. Magnetite and/or maghemite plus hematite (α -Fe₂O₃) matched the diffraction peaks. Hematite and magnetite are both stable at room temperature, and the gray area is likely a combination of these two oxides. At temperatures below 570°C, iron oxidizes

with an inner layer of magnetite and outer layer of hematite [11]. Therefore, hematite probably caused the gray color. Similar color patterns were observed at a few locations along the forward and aft edges of the cylindrical section. Thus, it was only observed near tank edges. It was assumed that the hematite formed during reentry, but only at locations having favorable temperature and air flow characteristics.

Figure 22. X-ray diffraction spectrum obtained from gray oxide on Sample A1.
