| 403093S | DEPARTMENT OF THE ARMY UNITED STATES ARMY AVIATION TEST BOARD' Fort Rucker, Alabama 36360 STEBG-TD SUBJECT: Letter Propert, "Product Improvement Test, T53-L-11 Metal Spray Repaired Engine," RDT&F Project No. , USATECOM Project No. 4- | 17. |

SUBJECT: Letter Report, "Product Improvement Test, T53-L-11 Metal Spray Repaired Engine," RDT&E Project No. , USATECOM Project No. 4-5-0151-13

ENGINEERING ANALYSIS

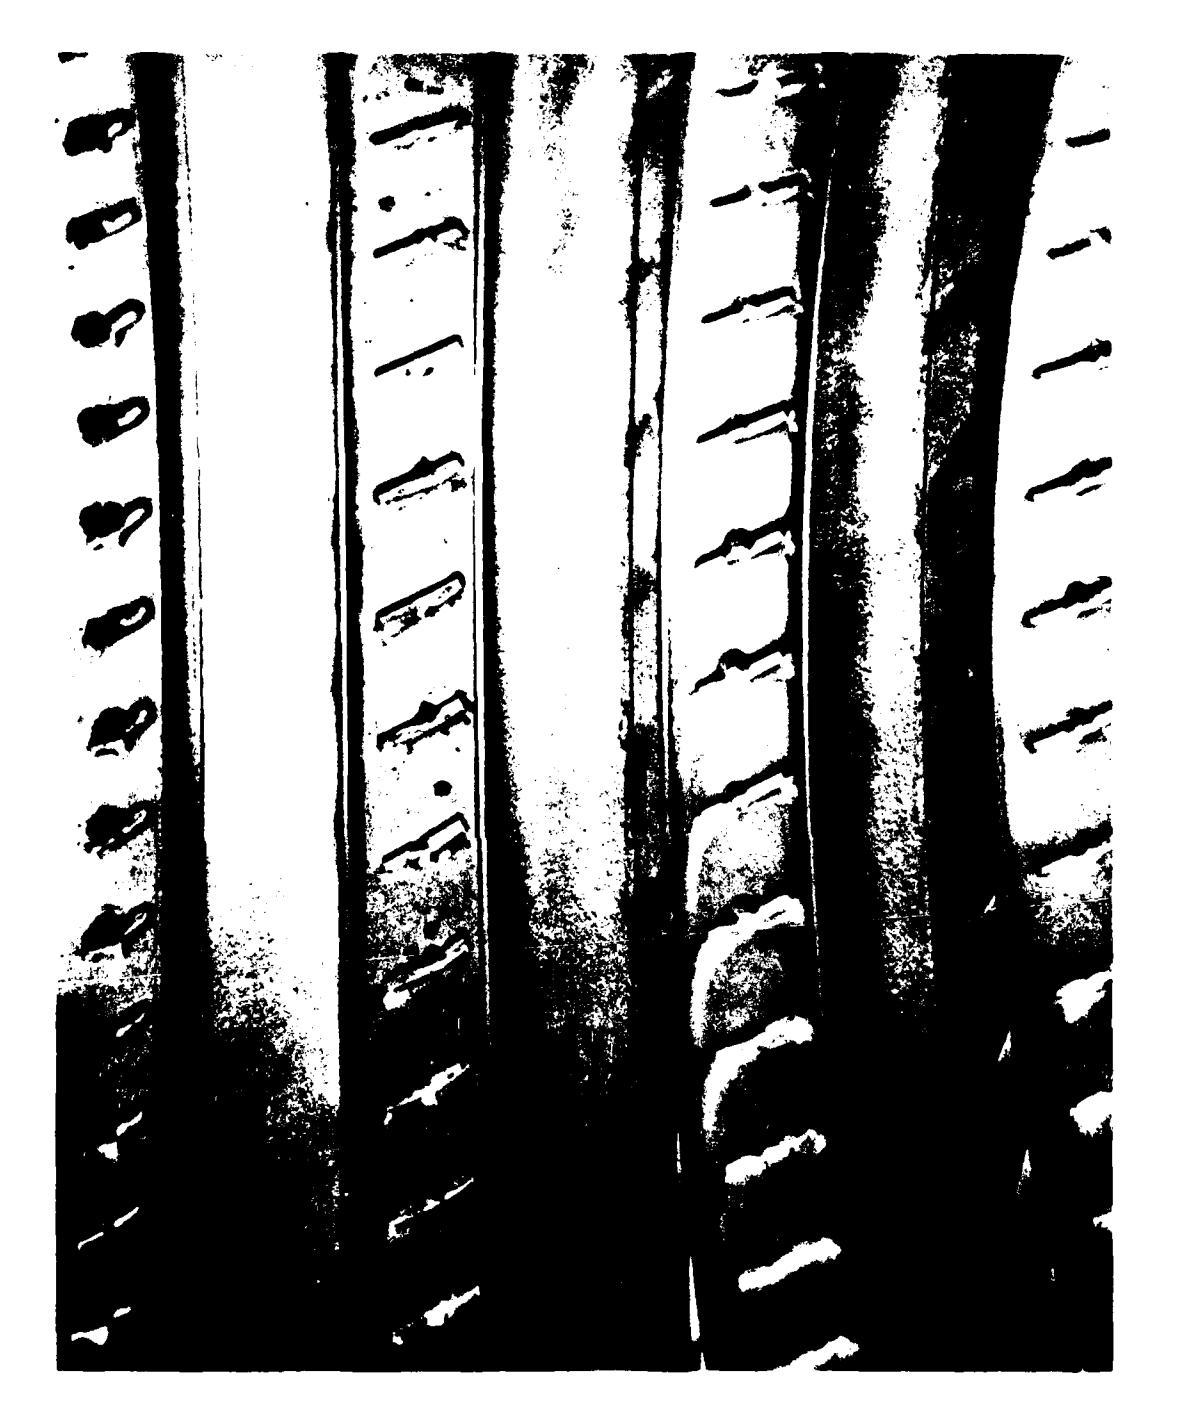
Figure 24.

3. The top compressor case was again removed and inspected at 161.2 engine hours (3.3 sand hours). The general condition of the tophalf compressor lands is shown in figure 20 (left side, forward section), figure 21 (right side, forward section), figure 22 (left side, rear section), and figure 23 (right side, rear section). Figure 24 shows a center section of the third-, fourth-, and fifth-stage lands. Figure 25 shows the same area shown in figure 16. The pitting at the leading edge of the fifth-stage land had developed further. Figure 26 shows the general condition of the blades and vanes. Also observed at this inspection and pictured in figure 26 were erosion depressions (indicated by the arrow) in the lower compressor case aft of the second-stage stator vanes. The same area after 113.0 engine hours (2.2 sand hours) is indicated by the arrow in figure 19.

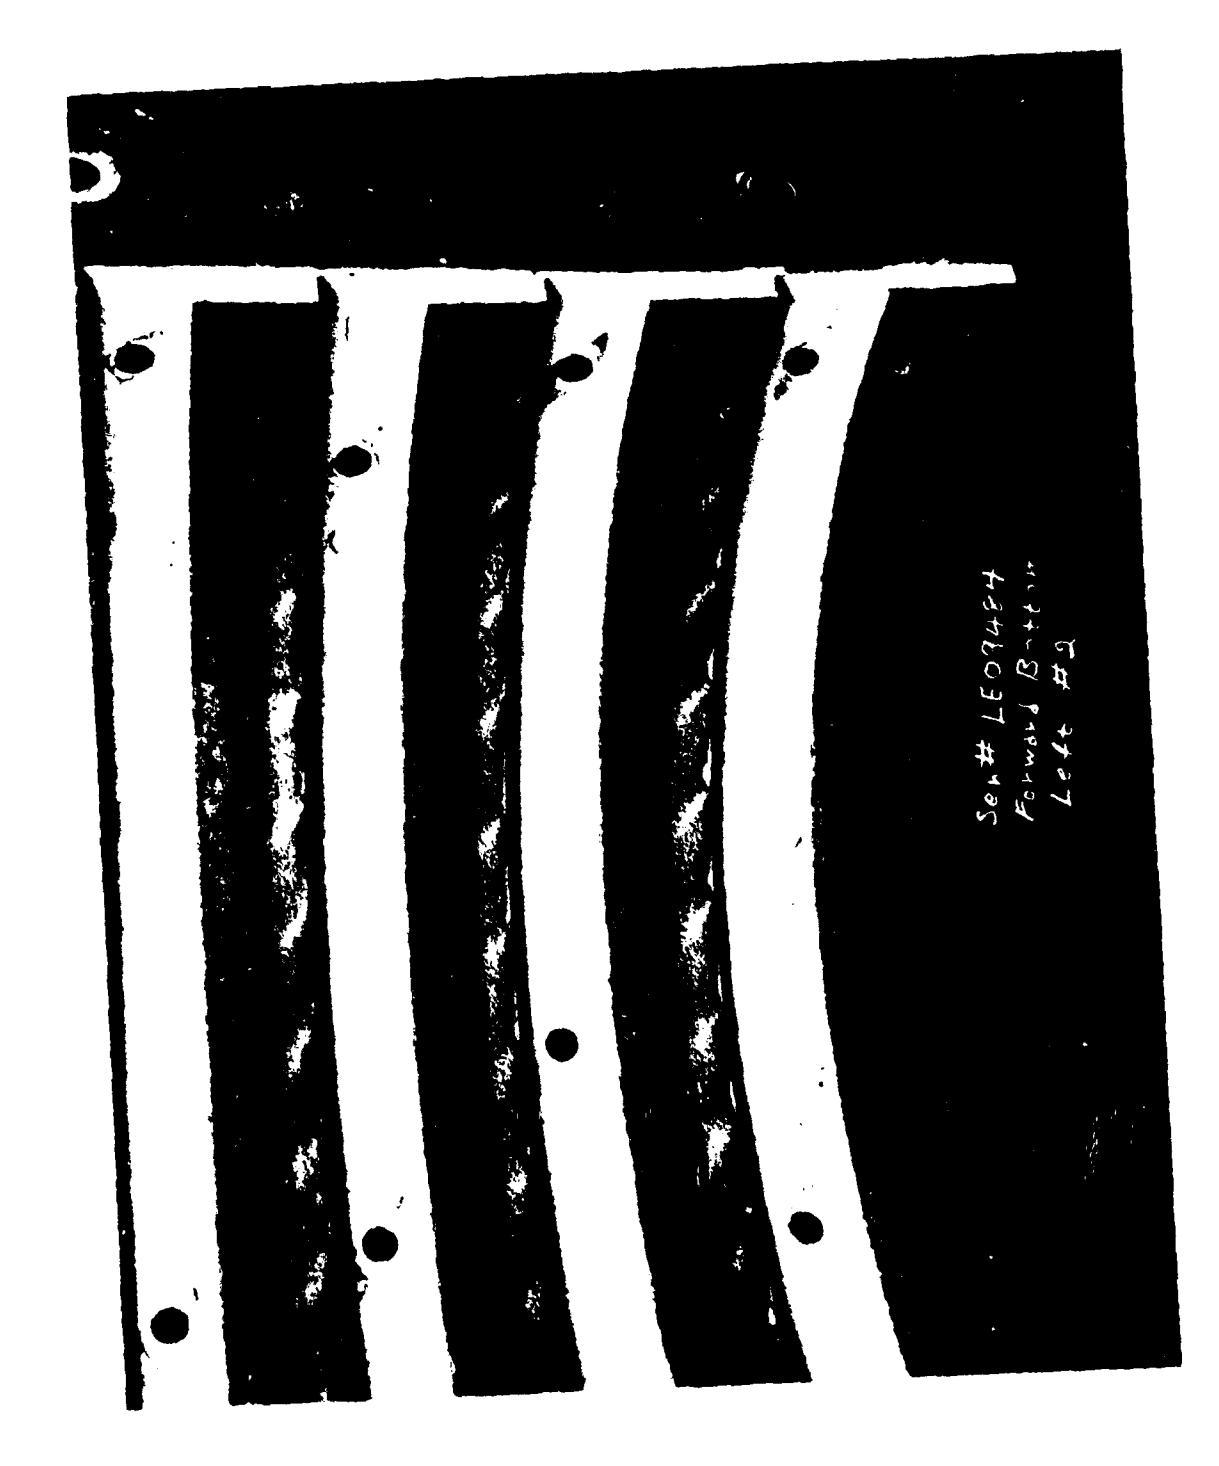
Figure 29.

4. The engine was disassembled for inspection at USAADMAC after the test was terminated at 174.5 engine hours (3.6 sand hours). Figure 27 shows the general condition of the top case of the compressor. Inspection of the lower half of the compressor case revealed that it sustained far greater erosion damage than did the top half of the case. The condition of the lower half of the compressor case is shown in figure 28 (left side, forward section), figure 29 (right side, forward section), figure 30 (left side, rear section), and figure 31 (right side, rear section). The condition of the centrifugal impeller housing is shown in figures 32 and 33. The general condition of the rotor assembly is shown in figure
