Technical Note N-1450

EXPERIMENTAL POLYURETHANE FOAM ROOFING SYSTEMS

August 1976

CIVIL ENGINEERING LABORATORY  
Naval Construction Battalion Center  
Port Hueneme, California 93043

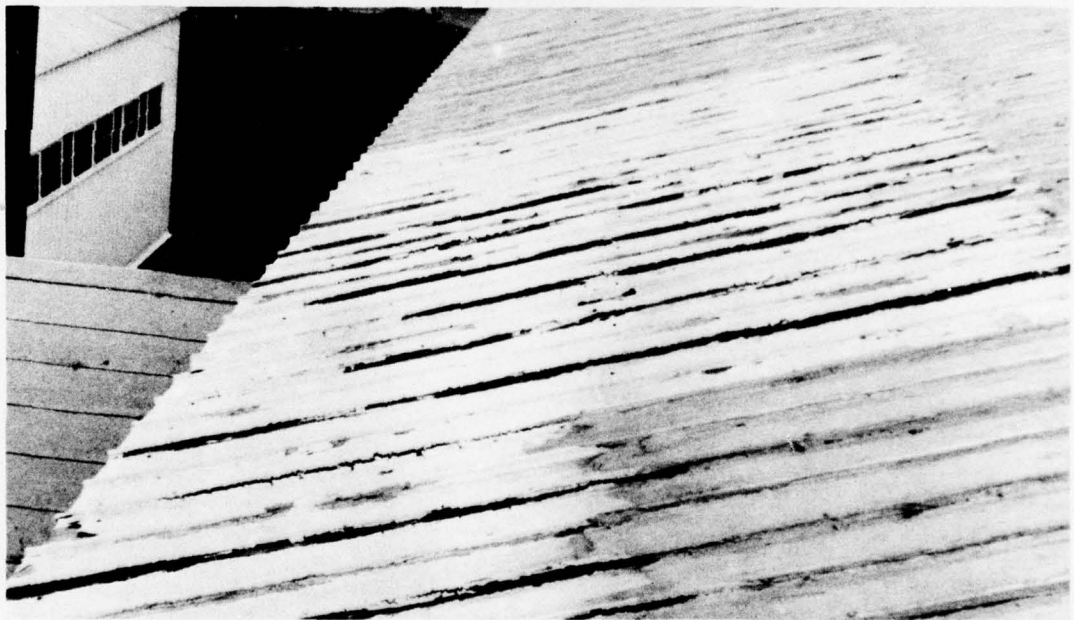
Figure 2. North Building Showing Paint and Bitumen Accumulations, Before Reroofing

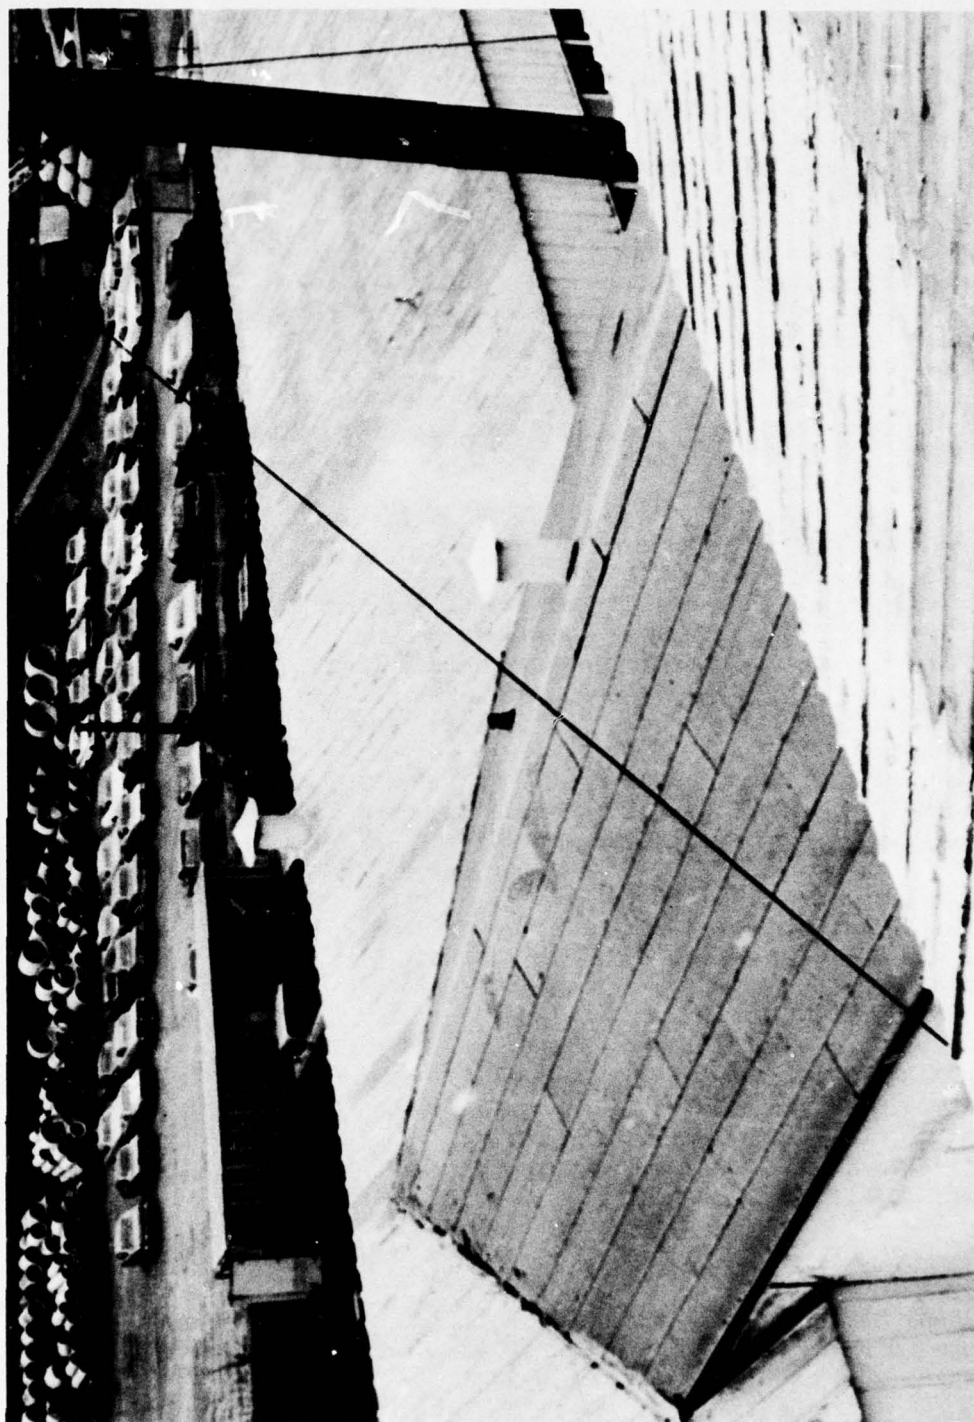
Figure 3. Portions of North Building (Foreground) and South Building and Interconnecting Boiler House, Before Reroofing

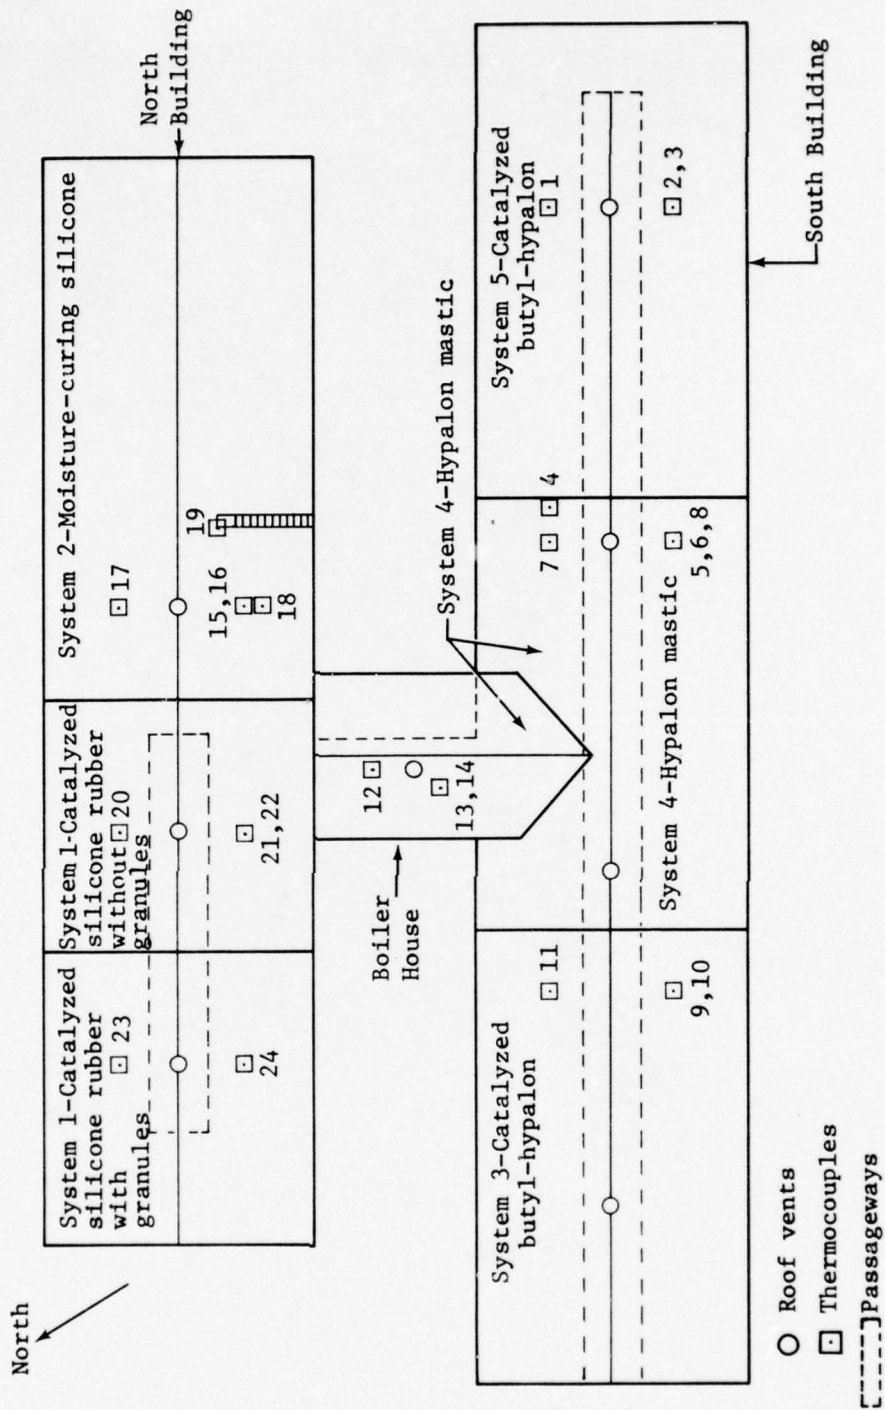
Figure 5. Layout of Thermocouples and Coating Systems on Reserve Center Buildings

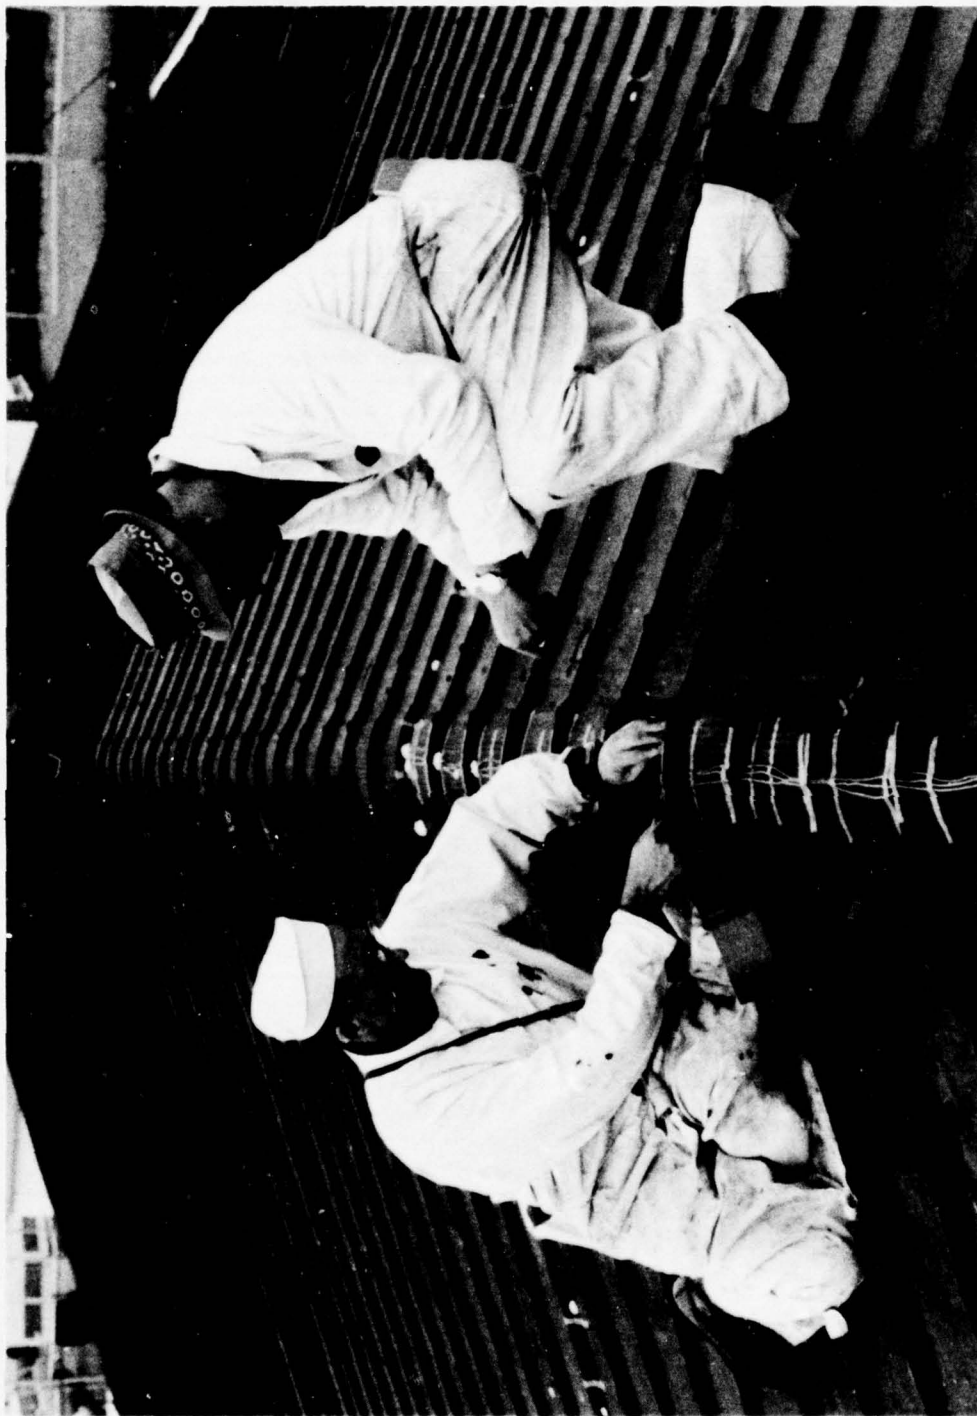
Figure 6. Installation of Thermocouple Wires

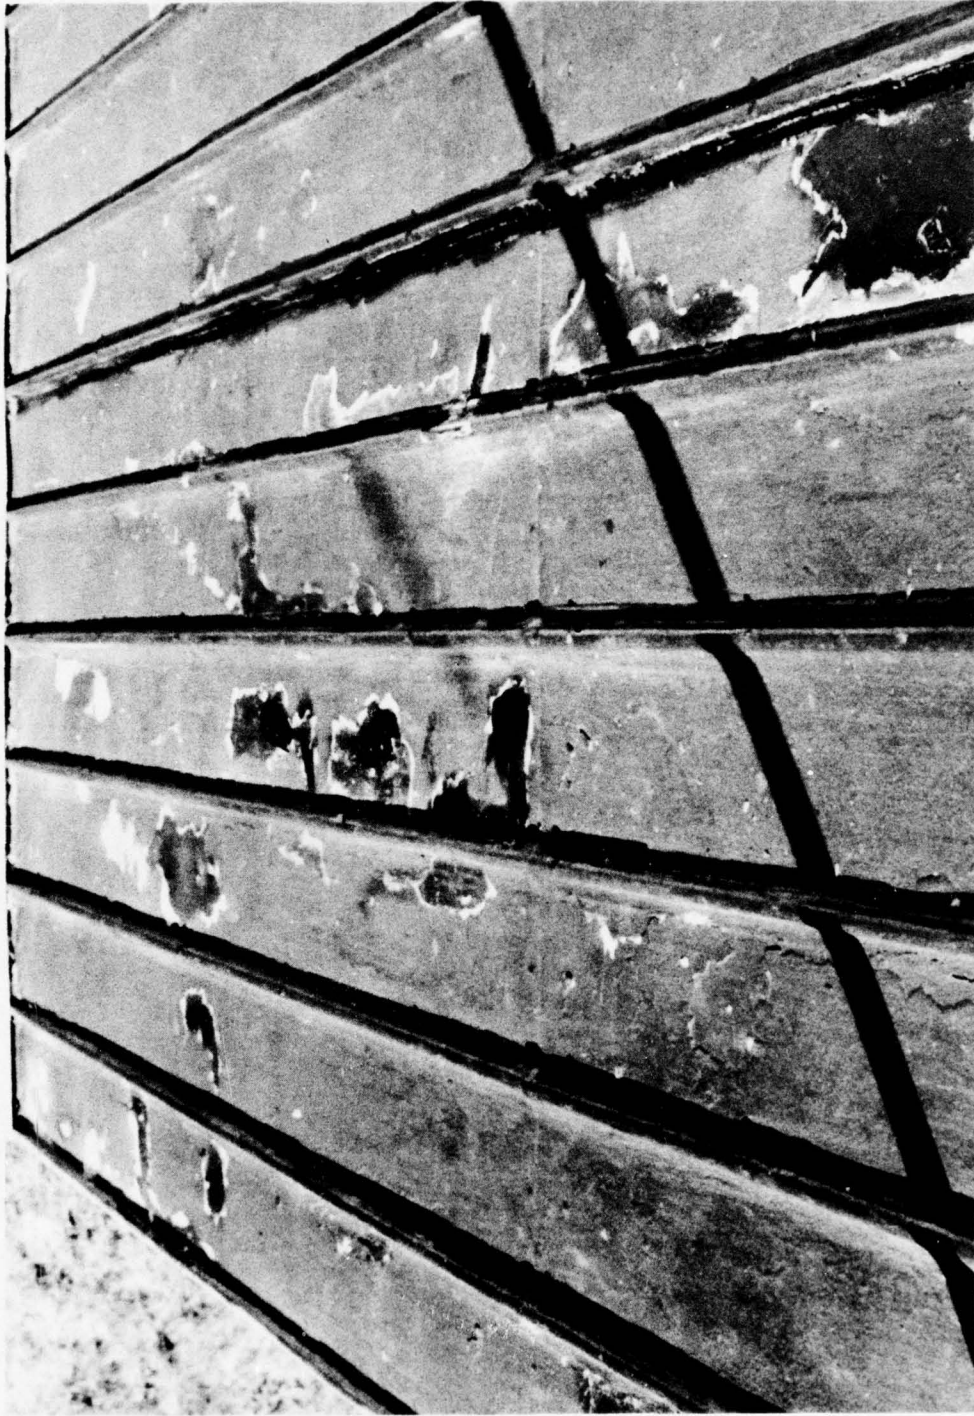
Figure 8. Spot-Primed Areas Ready For Foam Application

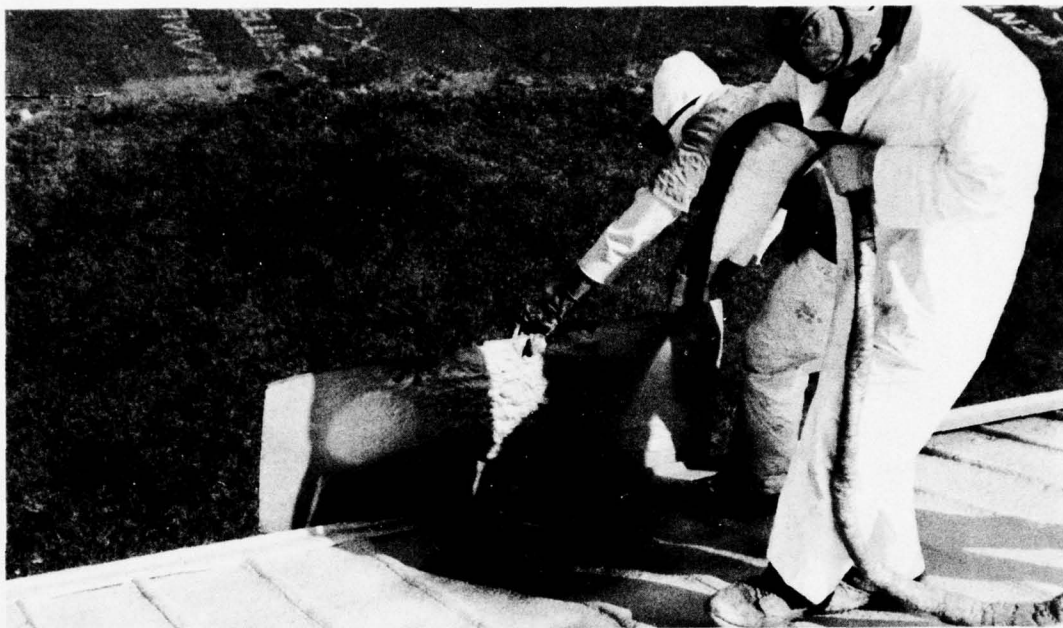
Figure 9. Spray-Application of Polyurethane Foam

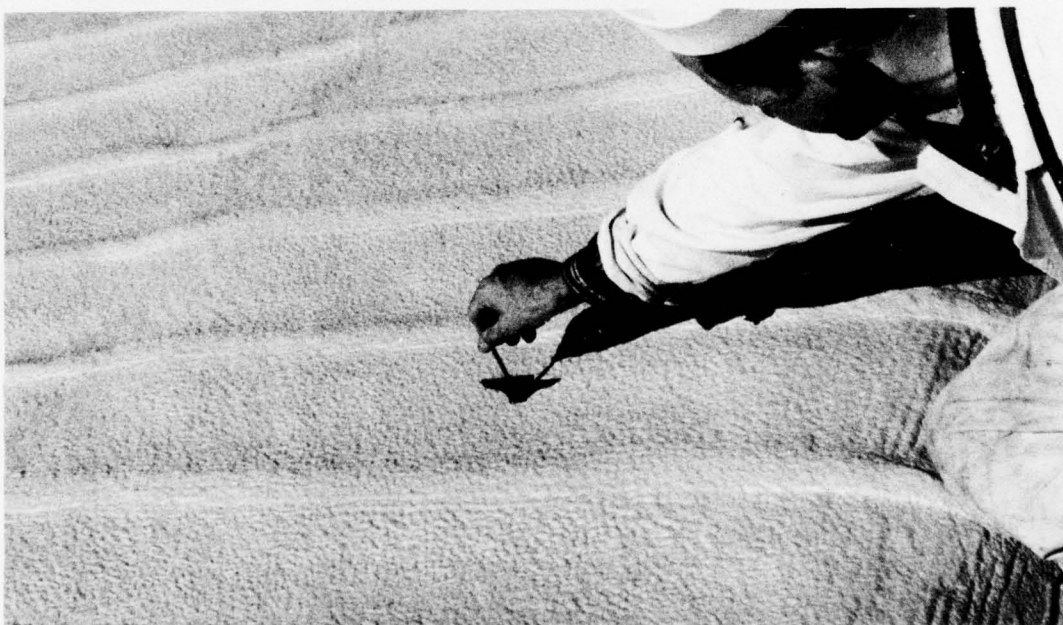
Figure 10. Measurement of Foam Thickness

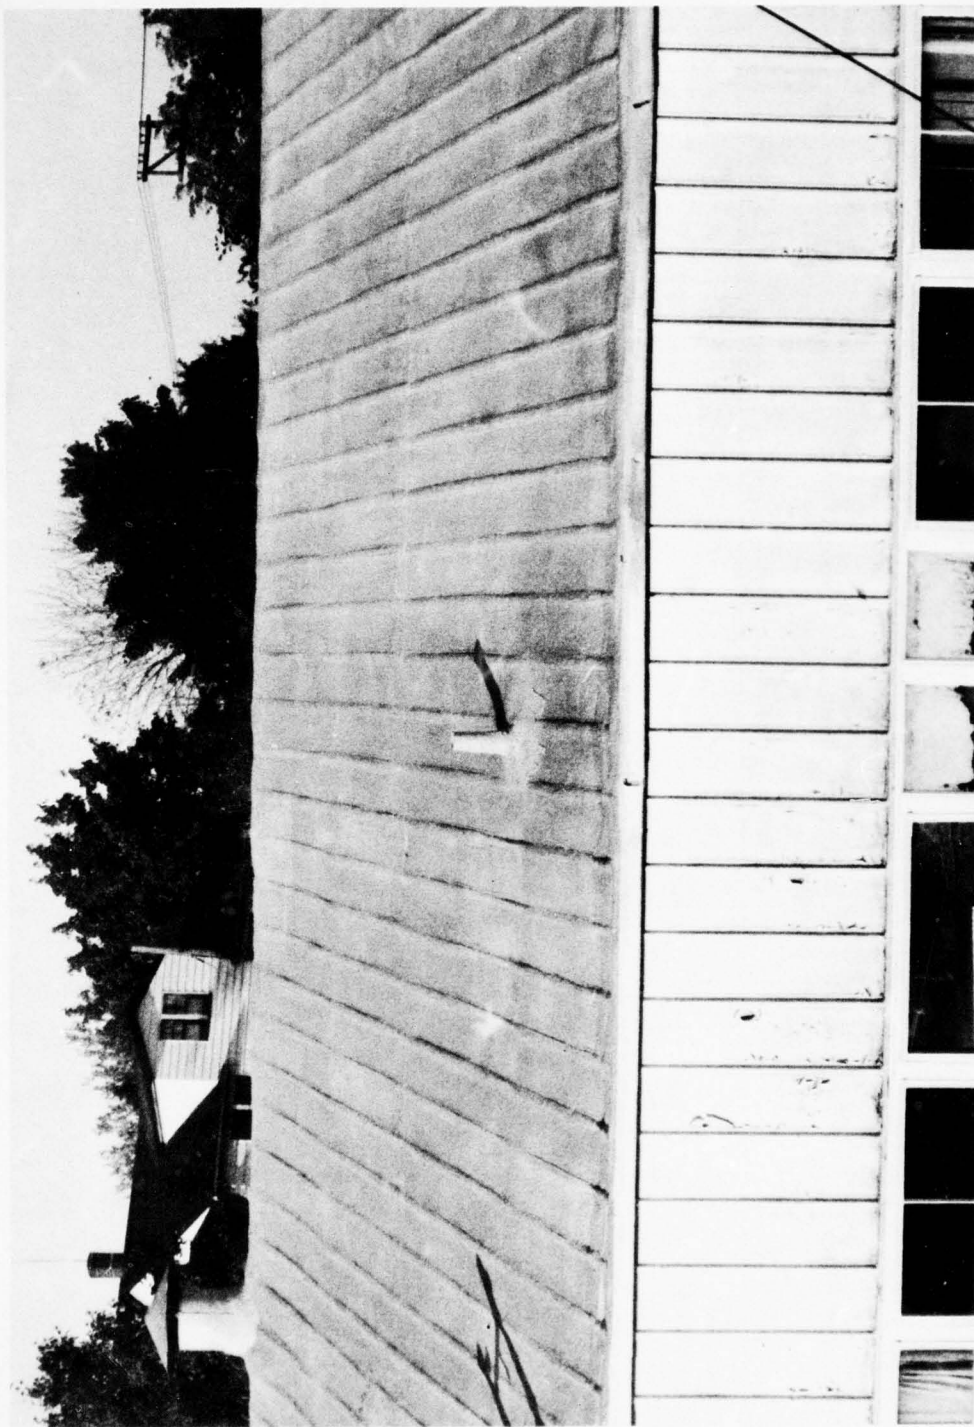
No problems were encountered either with the silicone coating or with the granules, although the applied coating was about 50% thicker (total of 30 mils) than recommended by the manufacturer (20 mils). Within 5 minutes after applying the top coat, granules were wafted into the still-wet top coat on the western half of the System 1 area to assure proper bonding of the granules to the top coat. A representative of the manufacturer of the catalyzed silicone rubber coating was present during both the foaming and coating applications. The completed south side of this section is presented in Figure 12, in which the darker colored area on the left has the granules.

Figure 12. Completed South Side of Catalyzed Silicone Rubber Coating Section (System 1)

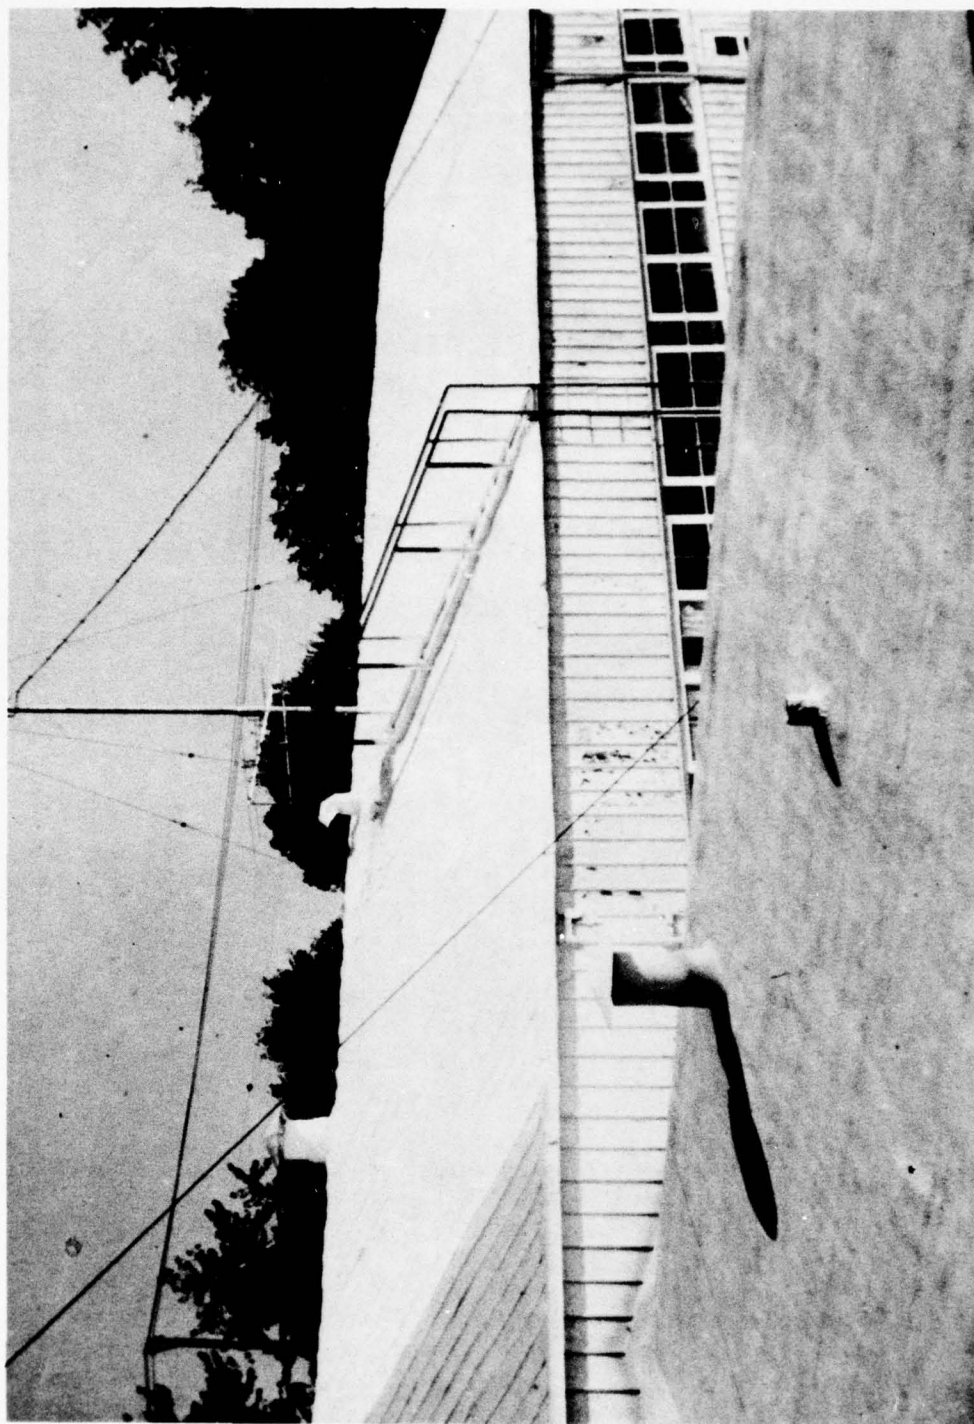
This one-part, moisture-curing silicone rubber coating was easily applied with conventional airless spray equipment. The light-gray base coat was permitted to dry overnight, and the white top coat was applied the following day. The completed south side of System 2 is pictured in the background of Figure 13.

Figure 13. Completed South Side of Moisture-Curing Silicone Rubber Coating Section (System 2)

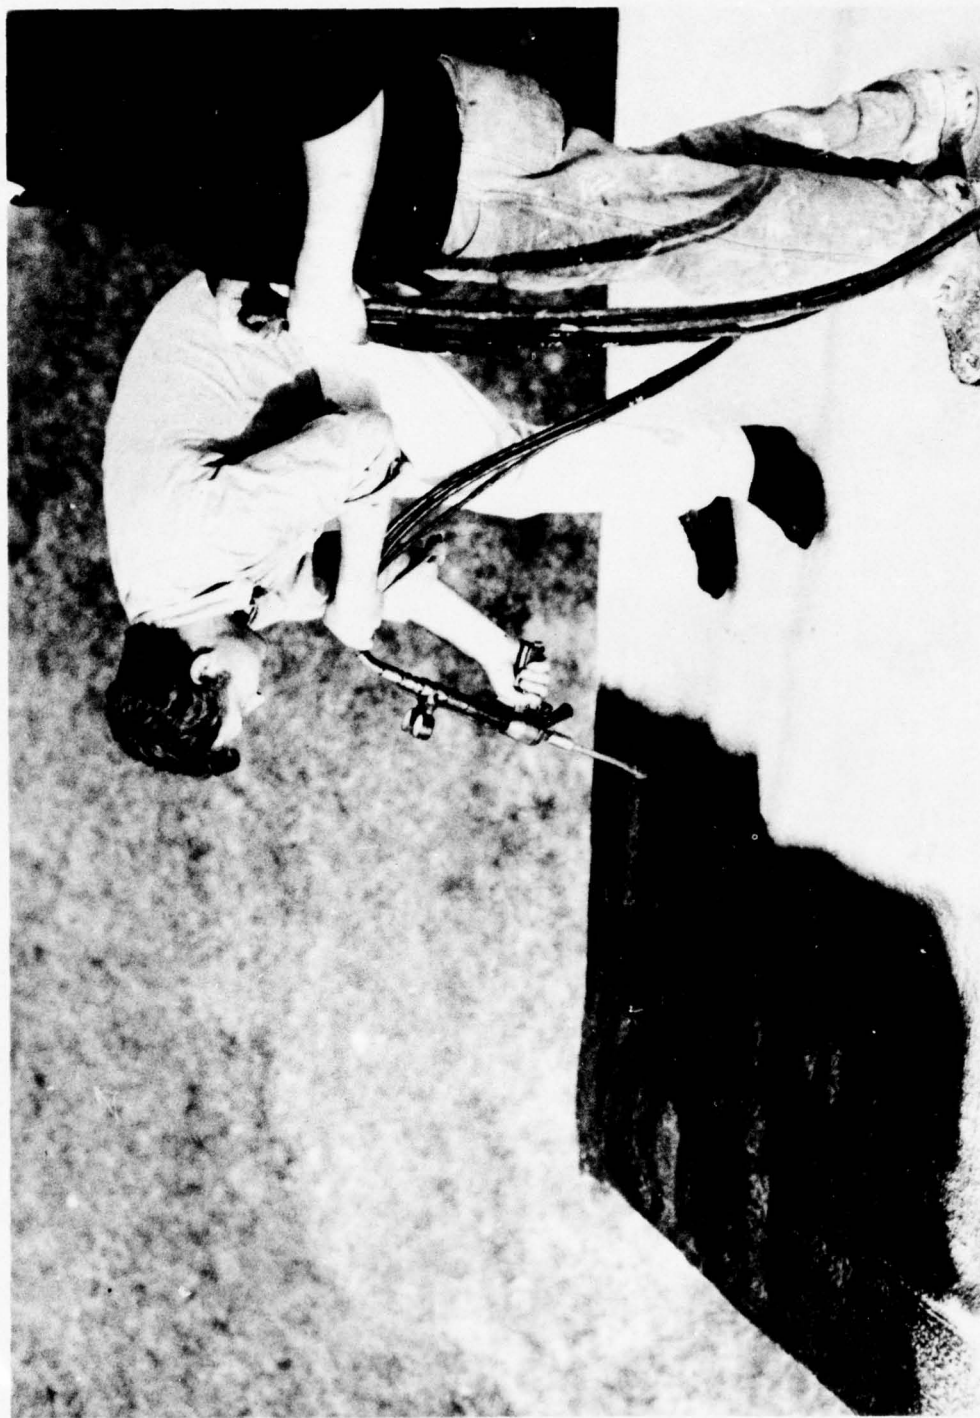
The coating materials of System 3 consist of one coat of a black, catalyzed butyl rubber base coat and one coat of a white, catalyzed hypalon top coat. The catalyzed butyl base coat has a relatively short pot-life and requires a special spray gun and apparatus for application. The two components of the butyl are thoroughly mixed as they pass through the mixing tube of the spray gun. Figure 14 shows the special spray gun being used to apply the black butyl base coat.

A great deal of trouble was encountered during application of the base coat. The spray gun became plugged a number of times, and each time it was necessary to disassemble and clean it thoroughly. In addition, the black butyl base coat was so thin that it tended to run when applied at the recommended rate. This was a greater problem on the north side than on the south side of this section. Accordingly, the north side was given a second coat of butyl the following day.

Figure 14. Spraying Black Butyl Base Coat of Catalyzed Butyl-Hypalon Coating (System 3)  
With Special Spray Gun

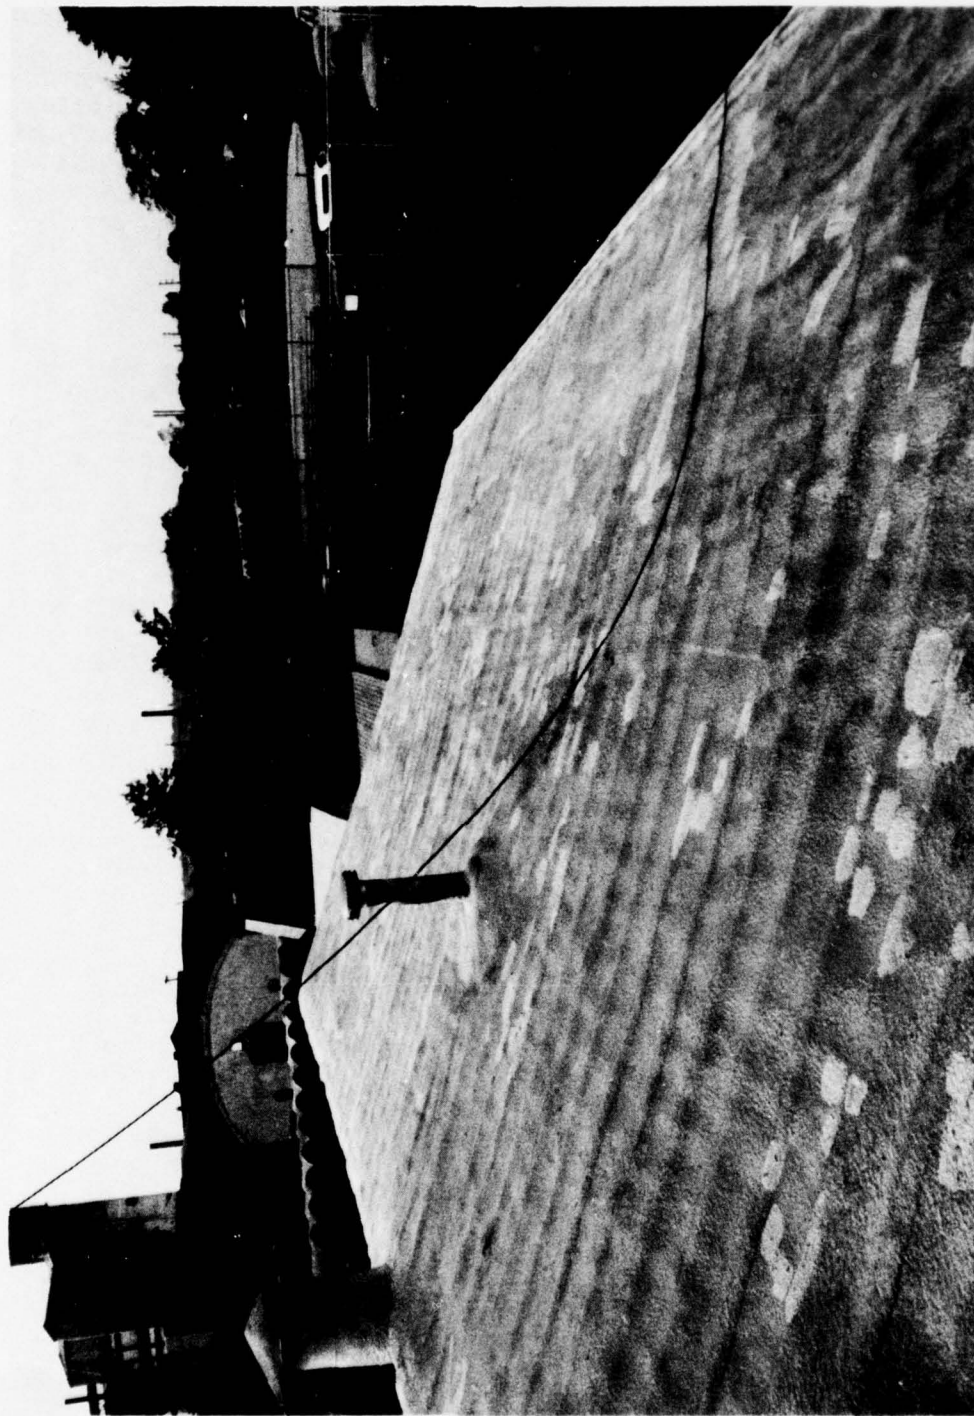
The white hypalon top coat was applied between 4 hours and 20 hours after application of the base coat. The hypalon was also very thin and had very poor hiding characteristics when applied at the recommended rate. Therefore, this system had a very blotchy appearance when completed. Both the base and top coats of System 3 were applied under the direction of the manufacturer's representative. The north side of the completed System 3 section is pictured in Figure 15. The light-colored spots are places where the manufacturer's representative attempted to overcome the splotchiness by spot-touching with the hypalon top coat the day following completion of the system.

Figure 15. Completed North Side of Catalyzed Butyl-Hypalon Coating Section (System 3)

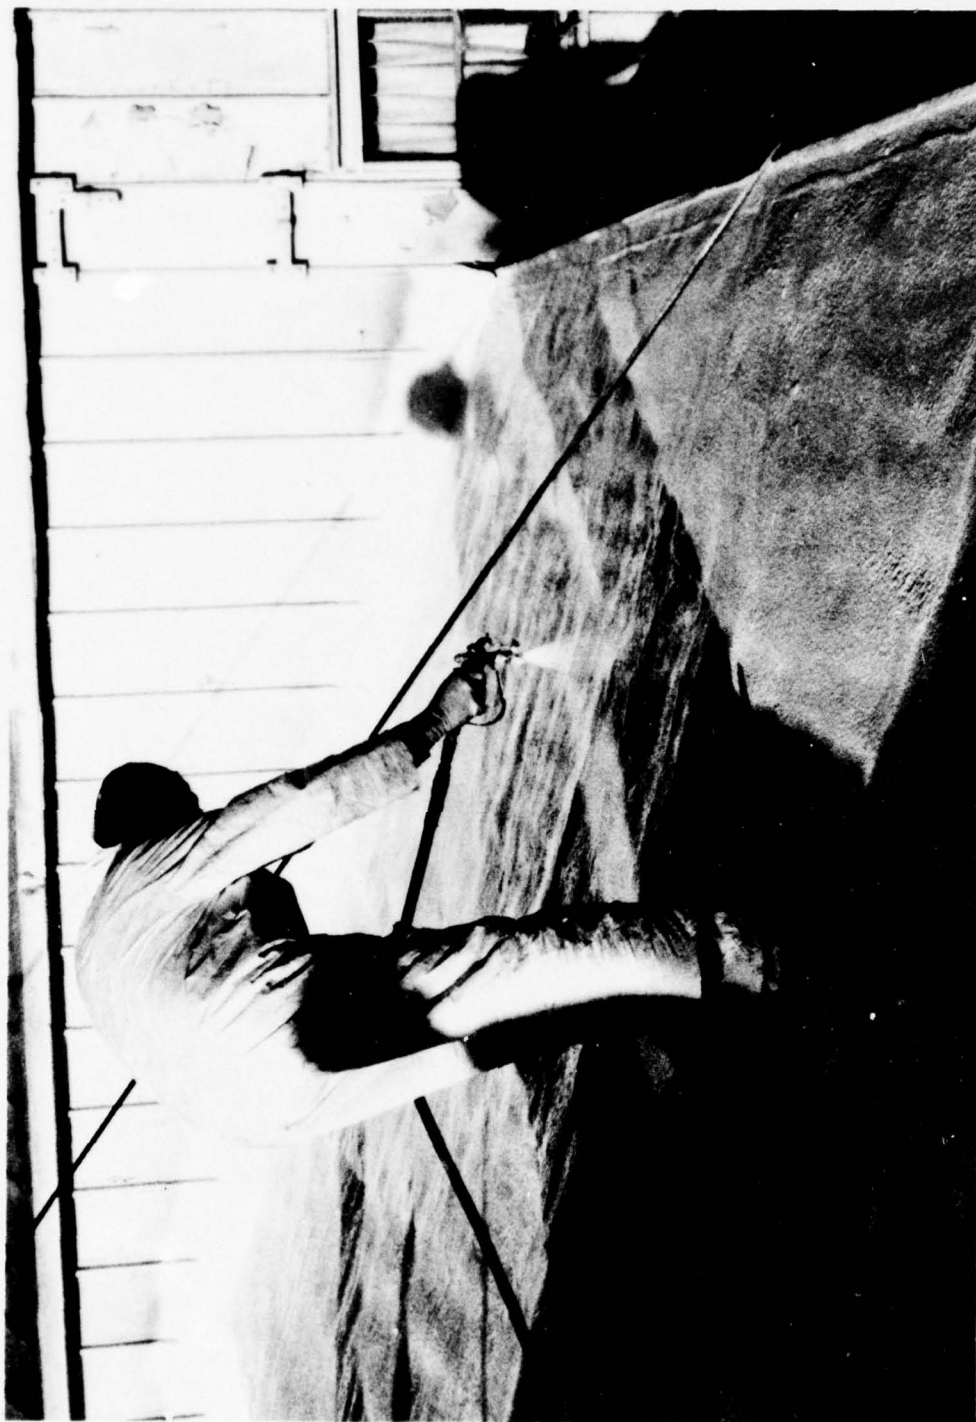
System 4. Hypalon Mastic. This coating system consists of one coat of a white, single-component hypalon mastic applied with conventional 40:1 ratio airless spray equipment. Although only about 30% solids, the mastic was very thixotropic, making spraying somewhat difficult. Heating the mastic with an in-line heater at about 125°F reduced the viscosity of the material sufficiently to enable it to be sprayed, but it was still necessary to purge the spray gun frequently to remove blockage and maintain a proper spray pattern. Figure 16 shows the hypalon mastic being applied to the foamed roof on the Boiler House.

Figure 16. Spraying Hypalon Mastic Coating (System 4)

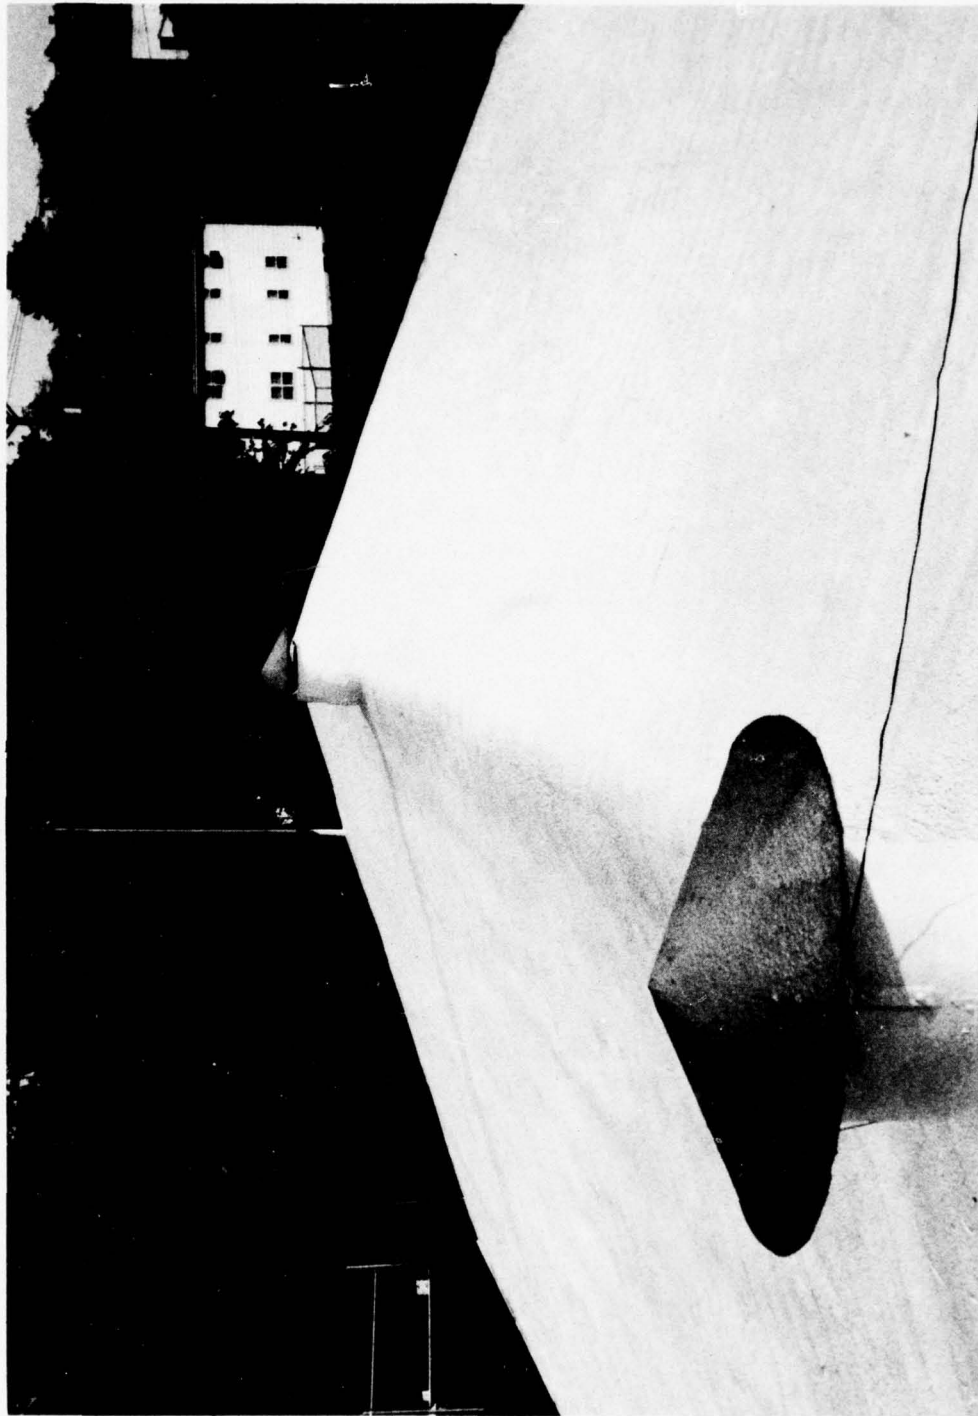
As recommended by the manufacturer, the top coat was not applied until the base coat had cured for 2 days. This was to allow for proper solvent evaporation from the base coat to minimize pinholing in the top coat. The completed system is shown in Figure 17.

Figure 17. Completed Section of Catalyzed Butyl-Hypalon Coating (System 5)

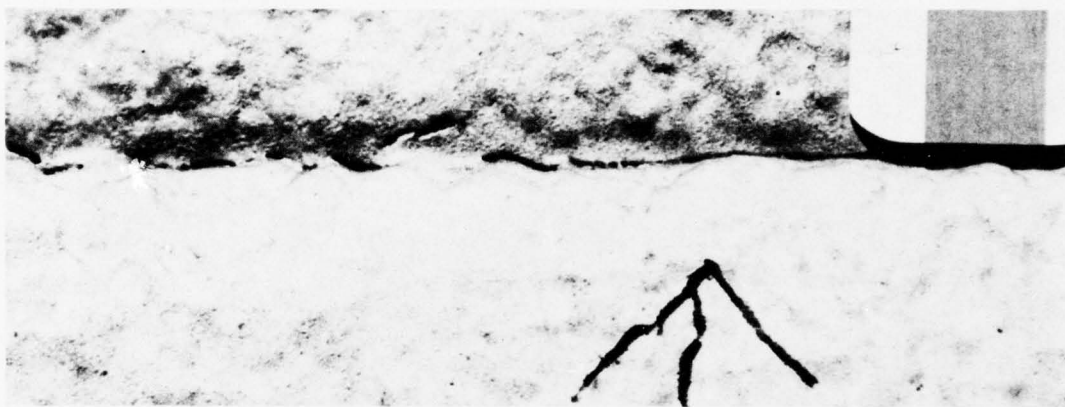
(b) After 18 Months of Exposure.

Figure 28. Cracking of Moisture-Curing Silicone Rubber Coating in a Depression Along a Rib; Note Cracking Has Not Progressed.

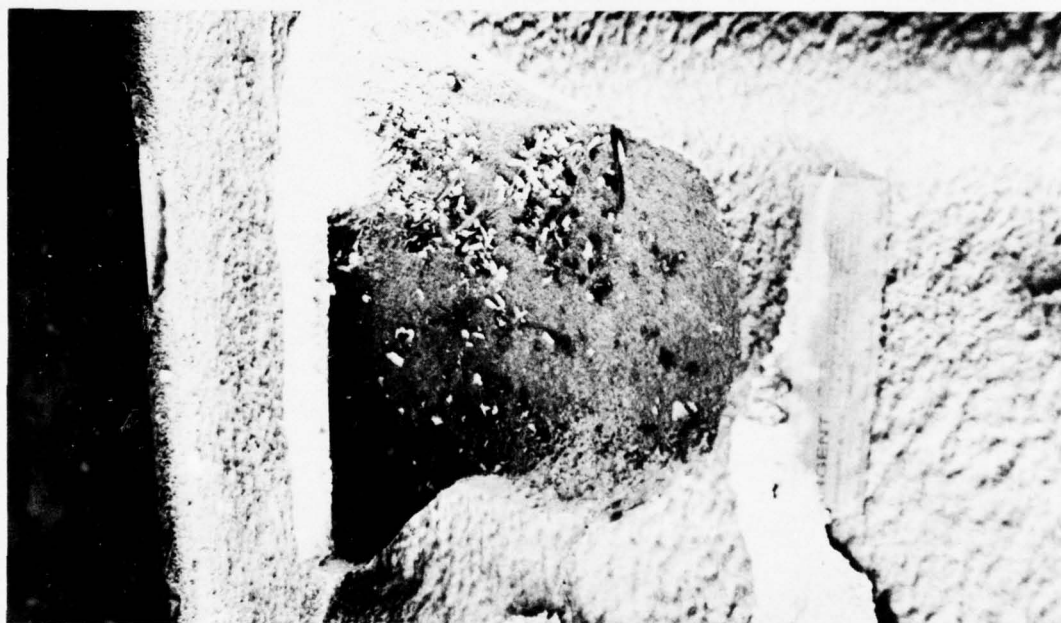
The largest instance of bird-pecking occurred in the System 2 section in a most unusual manner. Rather than pecking through the coating to reach the foam, the birds attacked the foam from underneath the gravel stop. The larger of two of these pecked areas is shown in Figure 30. Their repair is described in the following section.

(b) Void Exposed When Coating Was Removed.

Figure 30. Area in System 2 Section Where Birds Pecked Foam From Beneath Gravel Stop

Finally, during August 1975, two bird-pecked areas were discovered in the System 2 section, one of which was shown previously in Figure 30. In order to prevent the exposed foam from deteriorating, on-the-spot repairs were made by CEL personnel. The pecked areas were cut out with a sharp knife to expose good foam. The foam was then protected

with a cold asphalt roof patching material (Figure 49). These repairs should provide sufficient protection to the foam. Since the hollowed-out areas are adjacent to the gravel stop, standing water will run underneath the gravel stop and off of the roof.

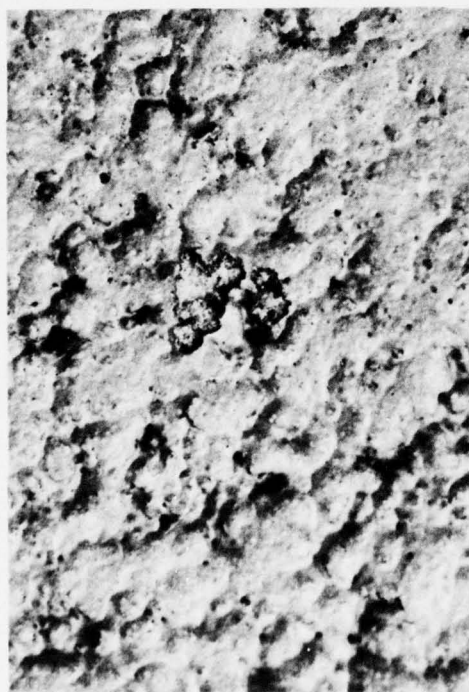
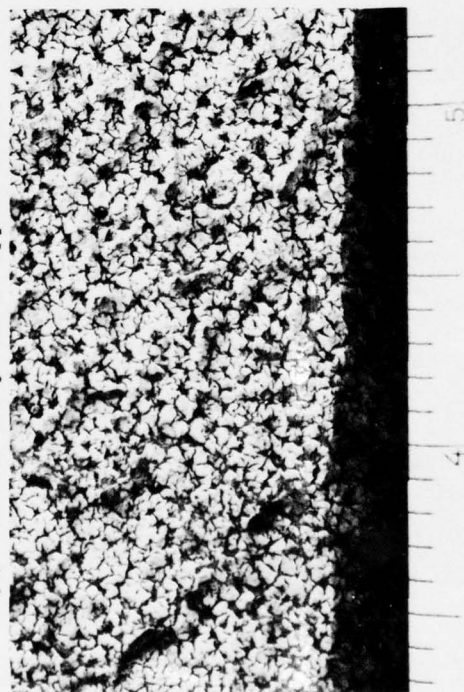
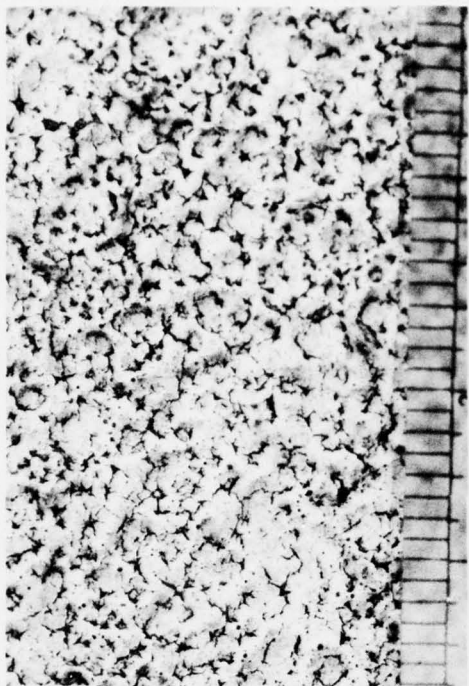
Figure 31. Progressive Degradation of Catalyzed Butyl-Hypalon (System 3)

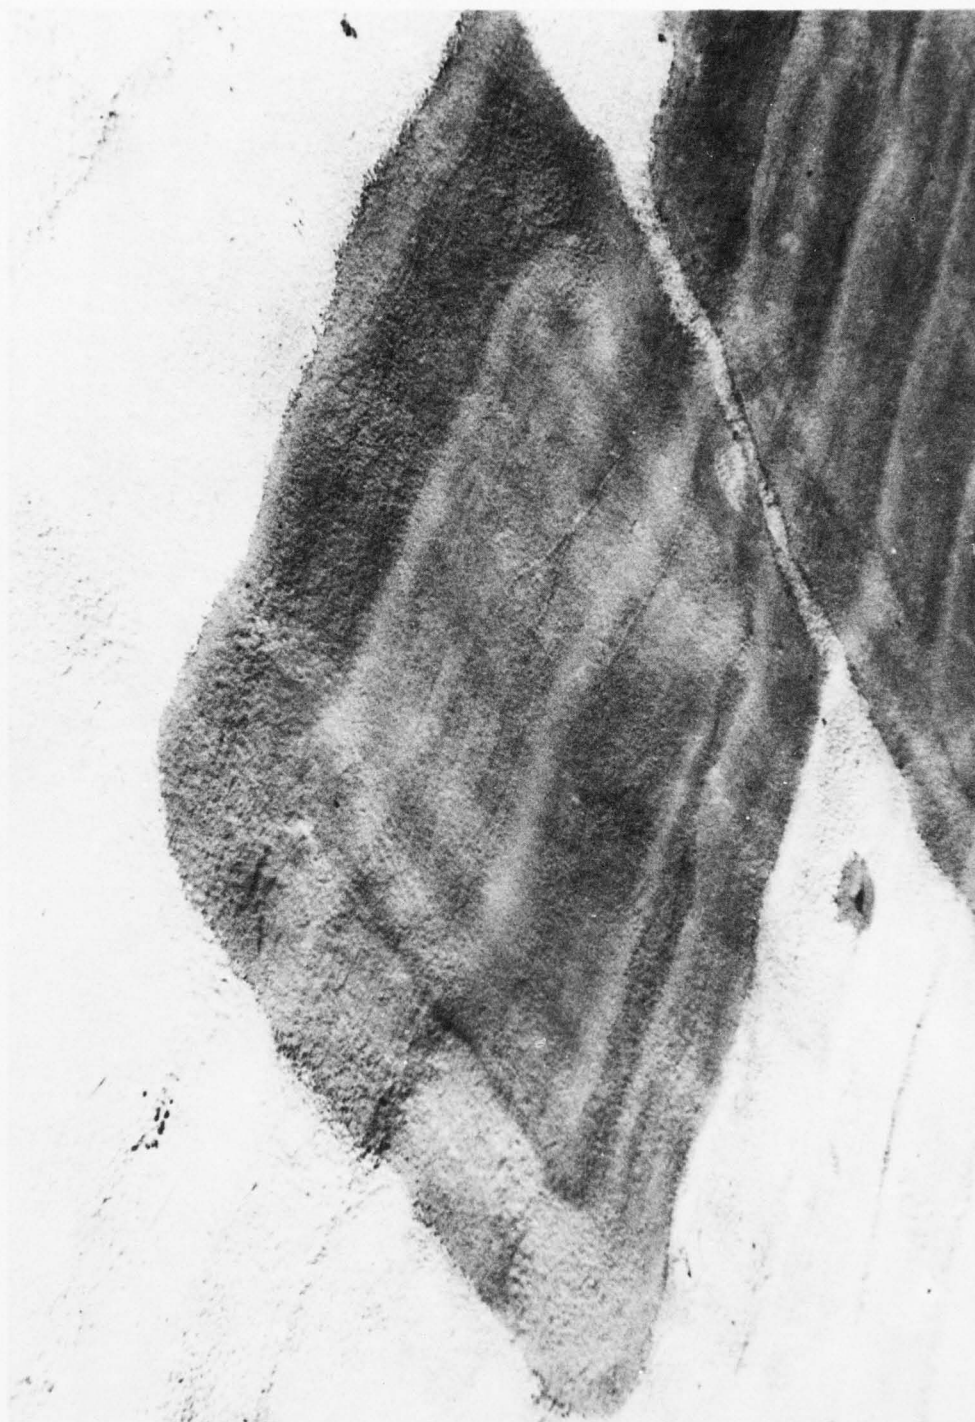
Figure 47. Repaired Areas Complete With Catalyzed Silicone Rubber Top Coat of System 1

In August 1974 the foam and coating contractor returned to NRC to repair the areas of poor foam. Progressive removal of the poor foam down to the underlying asphalt primer on the steel deck is pictured in Figure 43. Peripheral edges of the cut foam were then bevelled to provide a better surface for bonding the new foam, as shown in Figure 44. Application of the first lift of new foam is seen in Figure 45. The completed foam portion of the two patched areas in the System 3 section are shown in Figure 46. Repaired areas complete with the catalyzed silicone rubber top coat of System 1 are pictured in Figure 47.

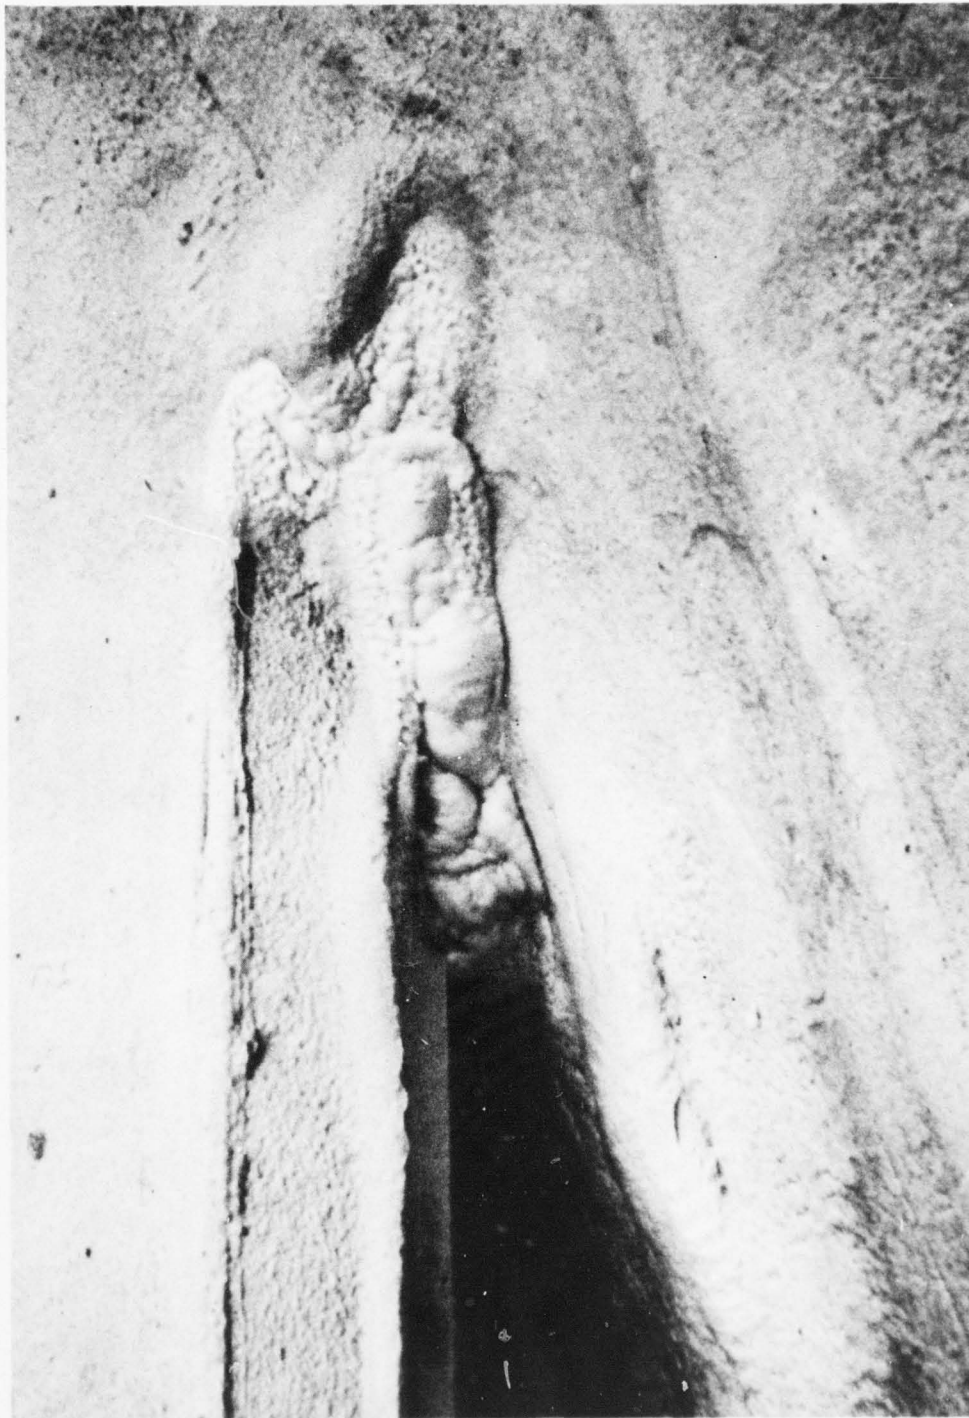
Figure 48. Junction of Boiler House Eave and South Building Filled With Foam

Leaking of water was reported in the vicinity of the junction between the Boiler House and the South Building (see Figure 22). To prevent further leaking, the eave-to-roof connecting areas were filled with foam by the contractor, as shown in Figure 48. These areas were then coated with the top coat of the catalyzed silicone rubber (System 1). No leaking has been reported in the ensuing year since the contractor made these repairs.
