**CRITICAL DESIGN REVIEW  
UH-1N HELICOPTER RESCUE HOIST**

TECHNICAL REPORT ASD-TR-73-25

JULY 1973

AERONAUTICAL SYSTEMS DIVISION  
AIR FORCE SYSTEMS COMMAND  
WRIGHT-PATTERSON AIR FORCE BASE, OHIO

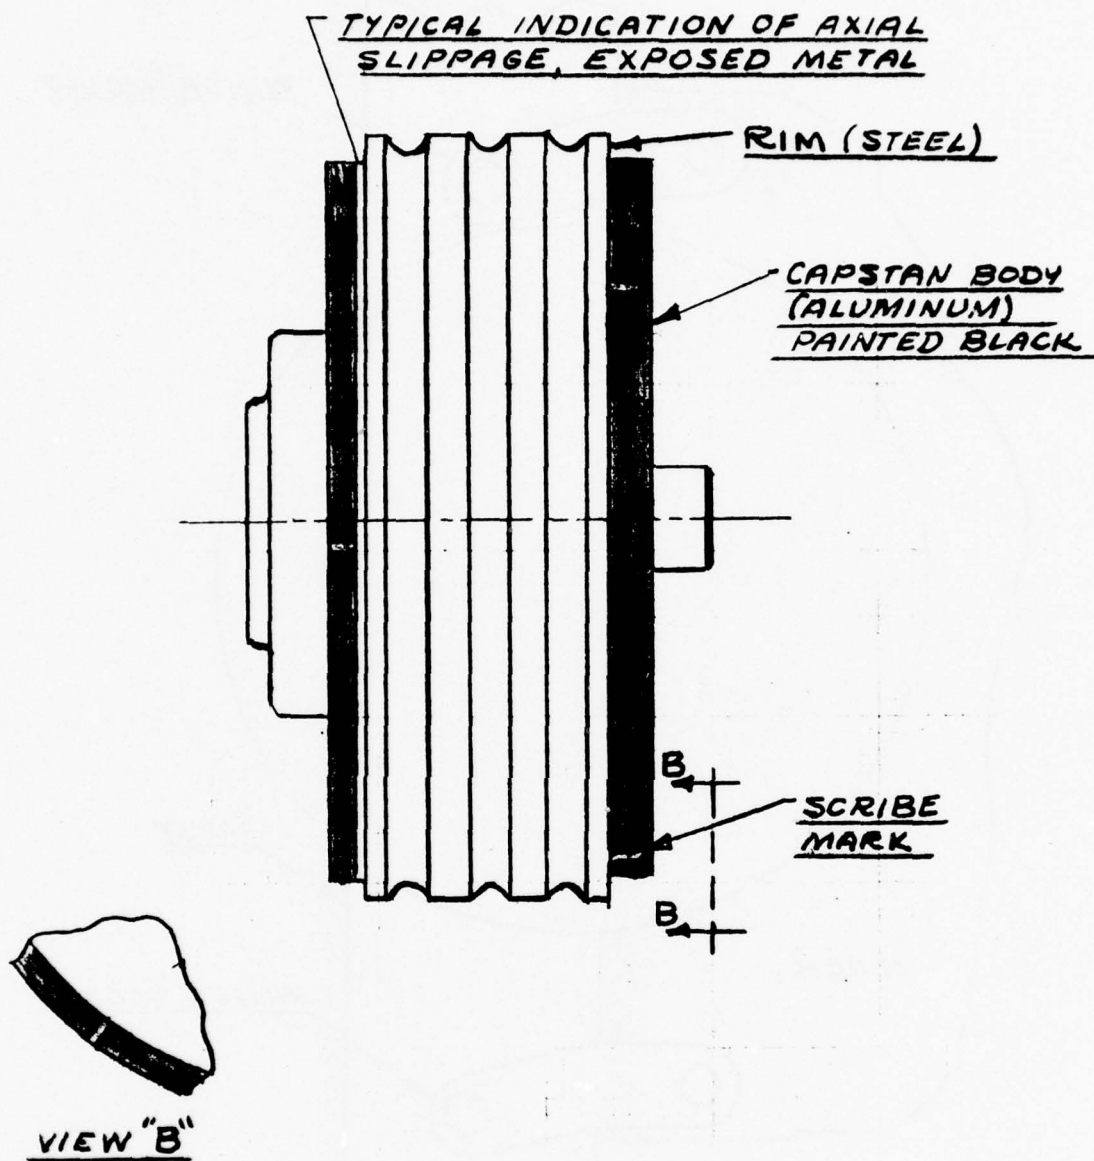
FIGURE 10

SECONDARY CAPSTAN

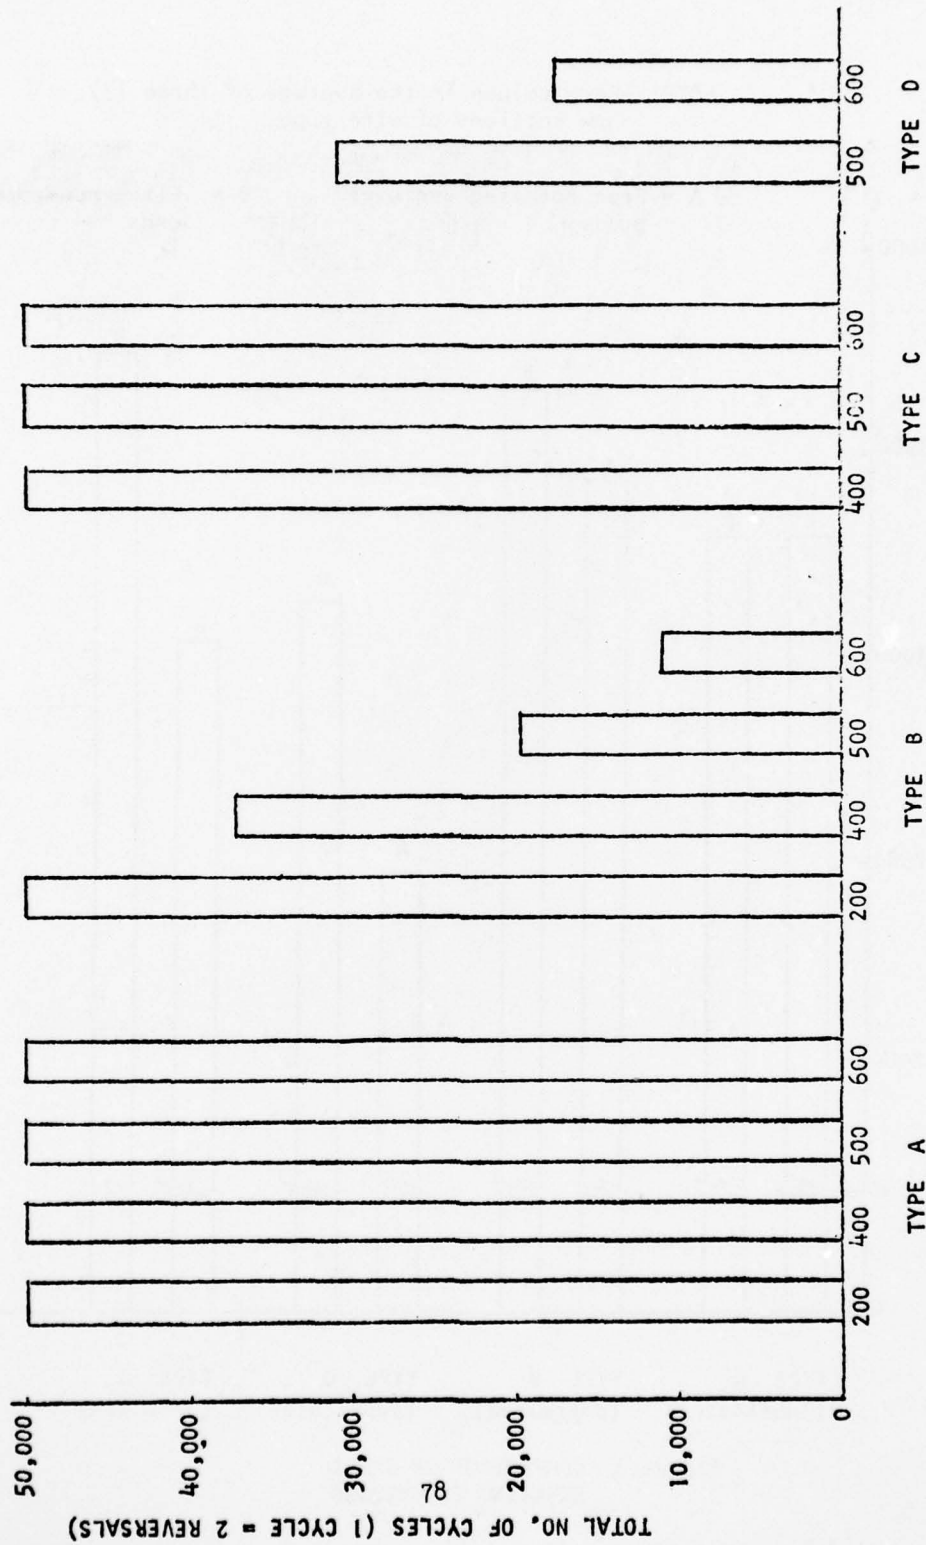
Figure 5 TOTAL NUMBER OF CYCLES VS LOAD IN TENSION AND TYPE

Figure 5 shows the average total number of cycles achieved by each type of cable at specific tension load levels. Types A and C completed 50,000 cycles under all loads without a failure, whereas B and D failed prematurely at the indicated number of cycles.

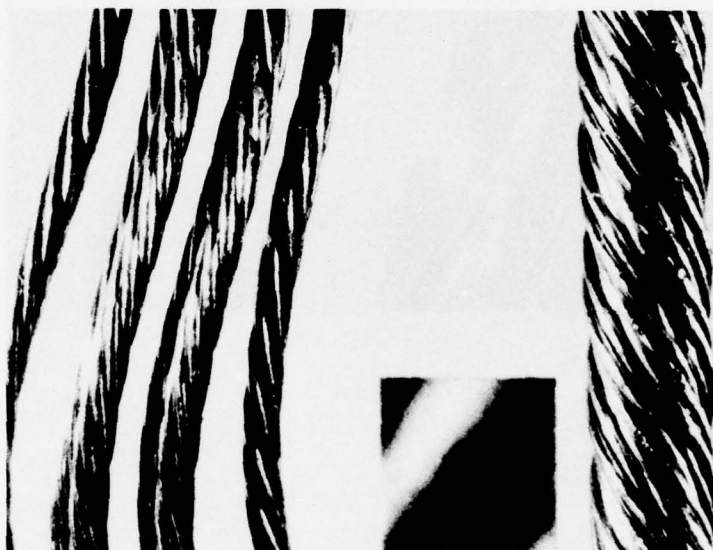
Figure 8 TYPE A CABLE  
(0 Cycles)

Figure 8 (photograph C) shows new, unused Type A cable.
