# PULSED PLASMA PROPULSION TECHNOLOGY

FINAL REPORT FOR PERIOD 10 MARCH 1972 - 30 MAY 1977

AUTHORS: DOMINIC J. PALUMBO  
WILLIAM J. GUMAN

FAIRCHILD INDUSTRIES, INC.  
FAIRCHILD REPUBLIC COMPANY  
FARMINGDALE, N.Y. 11735

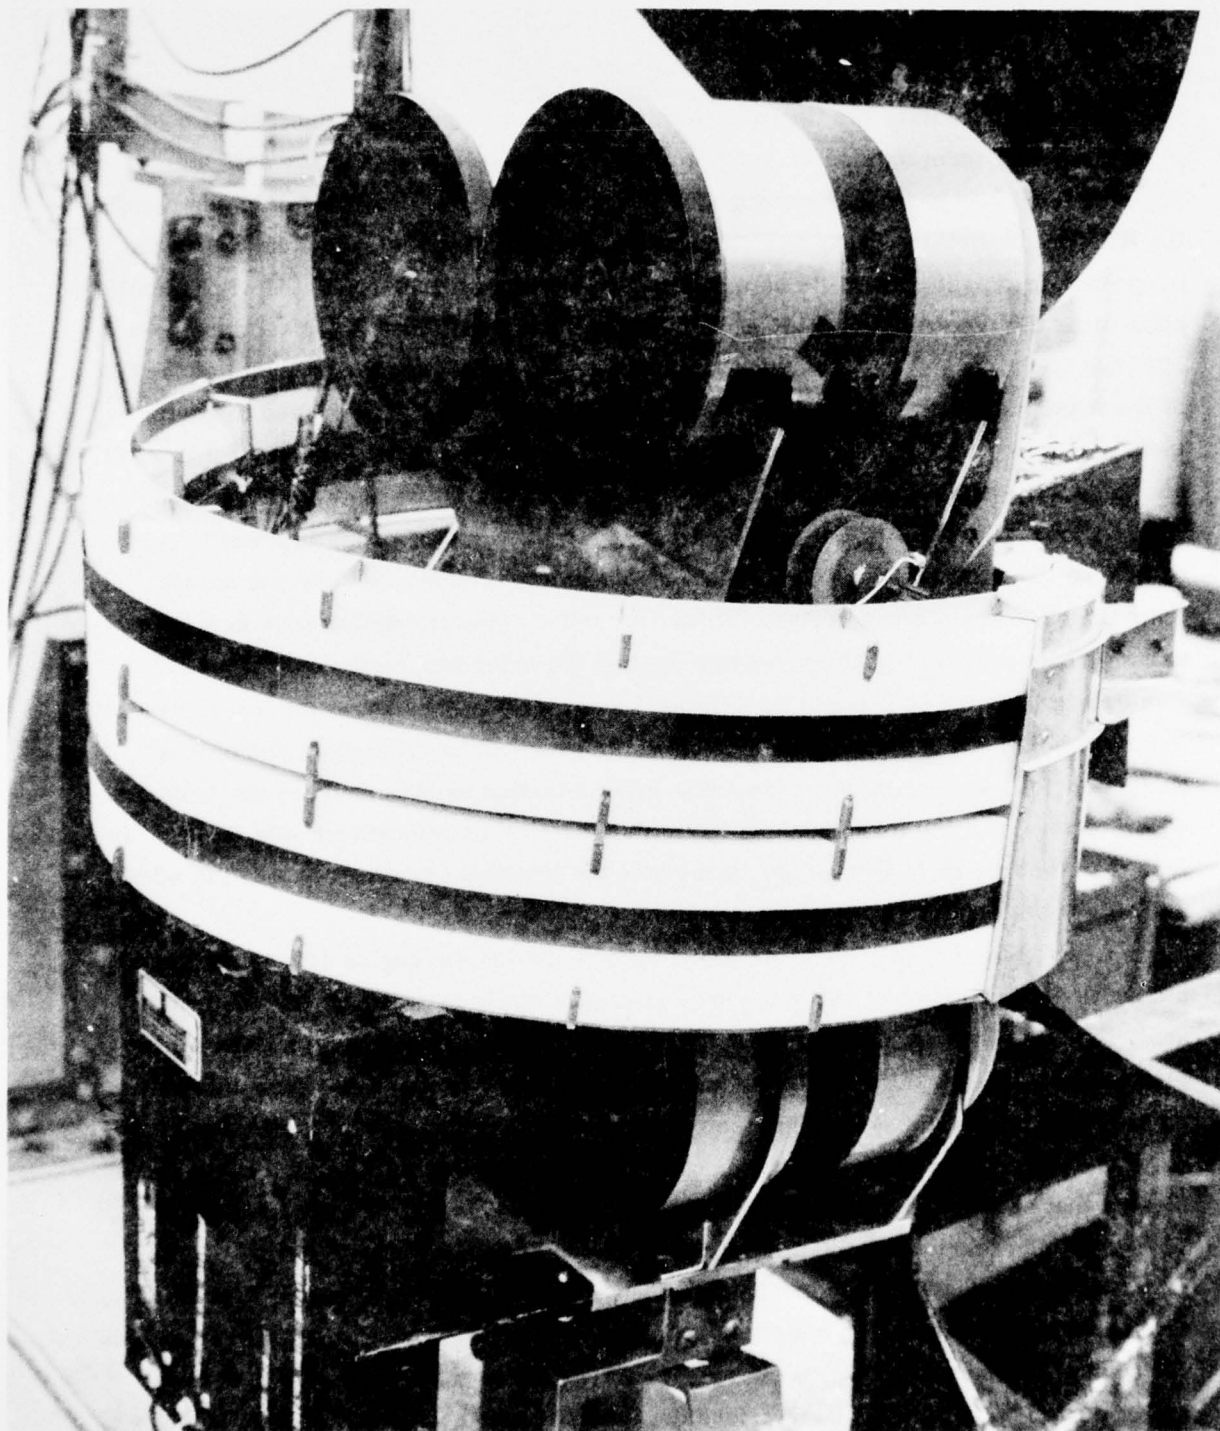
Figure 2. Photograph of Intermediate Thruster System With Mylar Capacitors

During the period of time that the KF-film capacitors were being manufactured (see Reference 5), the thruster was modified to accept Maxwell Lab's off-the-shelf Mylar capacitors having a capacitance of 60 microfarads. These units were, of course, much larger both dimensionally and weight-wise than the KF-film capacitors were expected to be. The 60 microfarad off-the-shelf Maxwell units weigh 12 pounds (5.44 kg), are rated at 8KV, and measure 6.5 inches (16.50cm) long by 6 inches (15.24cm) in diameter. These capacitors were adapted to the existing strip line assembly using four elbow-shaped strip line assemblies specially designed and fabricated for that purpose. A photograph of the thruster system with the four Mylar capacitors is presented in Figure 2.

The purpose for running the thruster in this intermediate configuration was to begin generating long term data on the system as soon as possible so that any deficiencies could be identified prior to beginning the actual endurance test which would run using the KF-film capacitors being manufactured. In particular, new modifications to the propellant feed system were to be evaluated. These innovations consisted of physically separating the innermost propellant section from the middle and outer sections by a .04 inch (1.0mm) strip of aluminum mounted rigidly to the support brackets at the OD of the inner rod section, and using an independent separate spring to feed the outermost section. The .04 inch aluminum strip (referred to henceforth as the splitter rail) and the spring are evident in Figure 2. The purpose for the splitter rail, which penetrates about .06 inches (1.5mm) between the inner and middle propellant sections, is to take up the outward radial load induced by pushing the inner rod into the nozzle from the back end. It had been found during earlier experimentation (see Reference 4) that this outward force pushing directly against the outer two sections of propellant was causing binding because of the friction incurred. By separating the inner from the outer sections, the frictional force on all sections would be minimized and binding would hopefully be eliminated. Much the same situation existed between the middle and outer sections but the force pushing the middle section into the nozzle was considerably less than that on the inner section, and hence the frictional loading between the middle and outermost sections was considered to be a lesser factor.

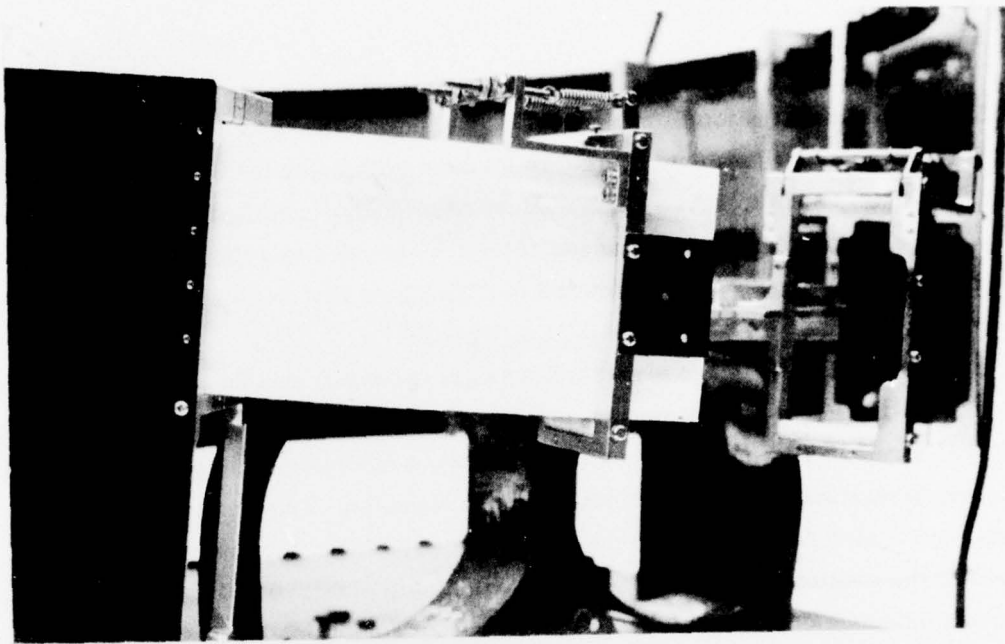
Figure 8. Spring Loaded Roller Assembly

Structural rigidity of the propellant support assembly was enhanced by redesigning the configuration of the center support and alignment ring. In addition, this main structural member was machined out of a continuous aluminum plate whereas it had previously been manufactured from NEMA G-10 phenolic. The propellant support brackets were also redesigned and machined from .25 inch (6.35 mm) aluminum as opposed to the original .125 inch (3.68 mm) aluminum plate. The brackets closest to the nozzle entrance on either side were fitted with a spring loaded Teflon roller to insure that the propellant rods would be pushed down onto the anode surface just prior to coming in contact with the fuel retaining shoulder while maintaining free motion of each propellant section under thermally expanded conditions. A photograph of this arrangement is presented in Figure 8.

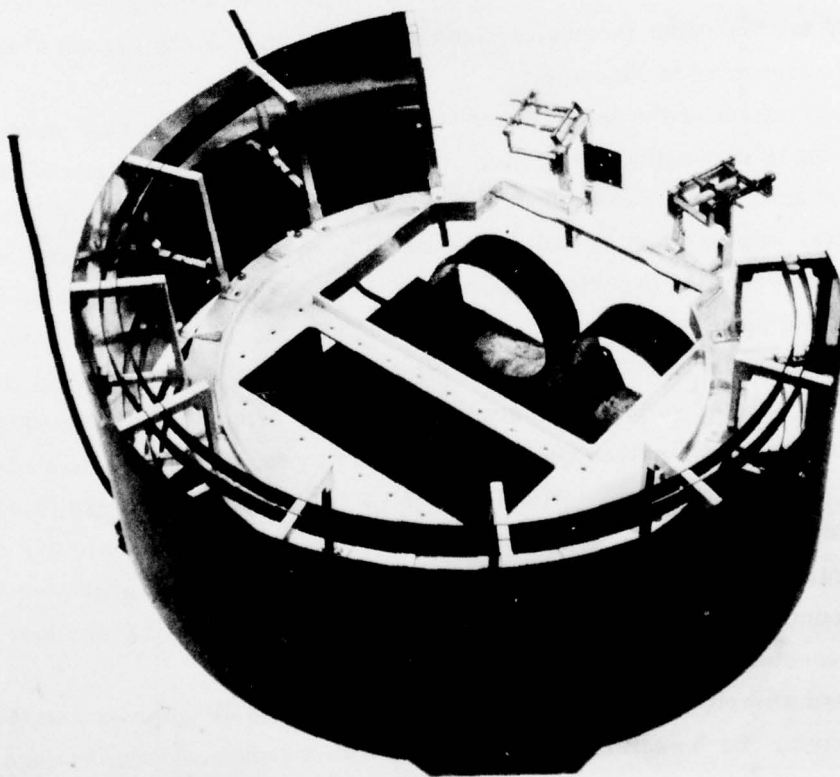
Figure 9. Refurbished Propellant Support Structure

In order to minimize the spring force required to feed the individual propellant sections, the idea of separating the sections using a thin aluminum rail around the periphery of the helix was expanded upon. It was decided to separate the middle from the outer sections of propellant as well as the inner from the middle sections. It was also seen (as a result of the experience generated from working with the system) that the sections should be separated on both the top and the bottom because of the tendency for them to tilt under spring loading and possibly bind together if separated on only one side. Thus, "splitter rails" which separate the three propellant sections from one another on both the top and bottom were incorporated into the refurbished system. The splitter rails were specially coated with TUFRA-4 Teflon coating process to minimize friction between the rails and the propellant sections. In addition, a continuous aluminum skin was fabricated which ties together all of the propellant support brackets around the outside circumference. A photograph of the complete refurbished propellant support structure is presented in Figure 9.

The force required to move the propellant rods has been reduced by a factor of ten in the case of the innermost section and to a comparable degree on the other two sections as a result of these modifications. Special order negator springs having appropriate dimensions and force were manufactured for the refurbished system by Ametek Hunter Spring Division, thereby eliminating welding of individual springs to obtain one having the required length.

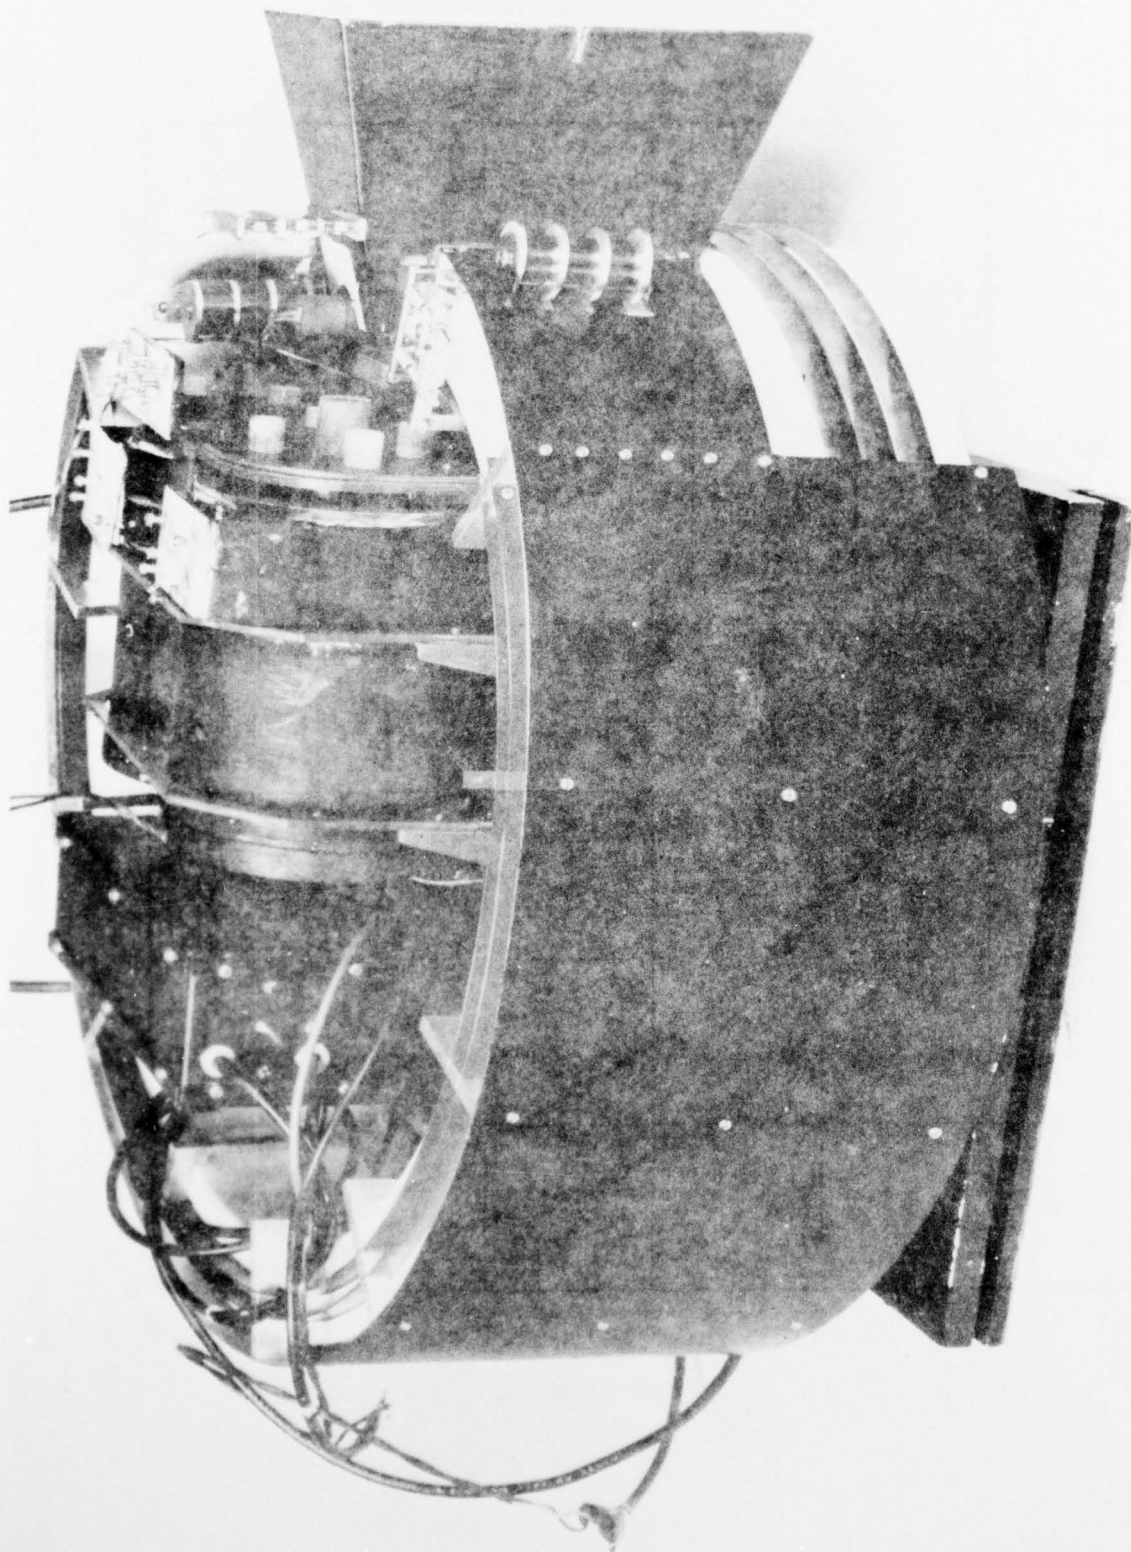
Figure 13. Refurbished Thruster System

Photographs of the completed refurbished thruster system are presented in Figure 13. Thermal vacuum testing of the complete system (including the refurbished power converter) was performed at Fairchild Republic and the results, presented in Figure 14, indicate completely compatible operation in vacuum.
