# INFRARED THERMOGRAPHY OF BUILDINGS

## Qualitative Analysis of Window Infiltration Loss

Federal Office Building, Burlington, Vt.

September 1977

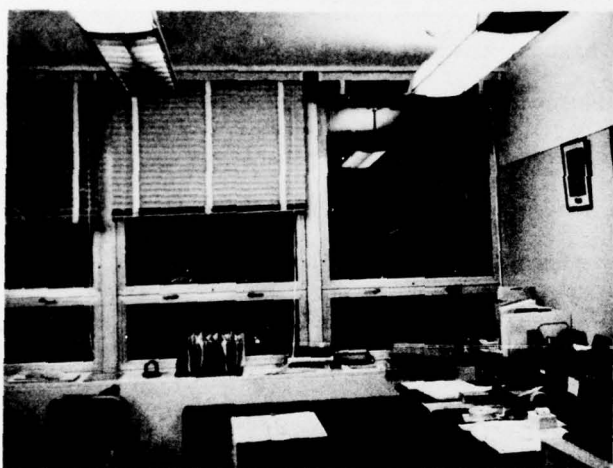
Figure 3.

air leaking through the seal at the top of the opening window. Generally speaking, the air leakage at this location was not as severe as it was around the framing space of these windows. Figure 3 is a photograph of three windows in Room 621.

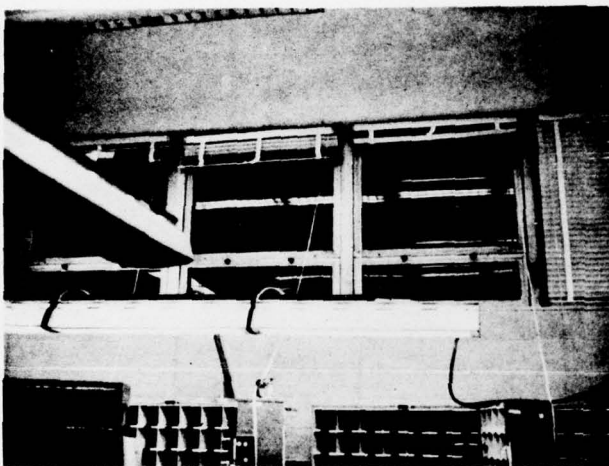
Figure 21.

Figure 20 is a thermogram of two south-facing basement windows in the Post Office workroom. Figure 21 is a photograph of these windows.

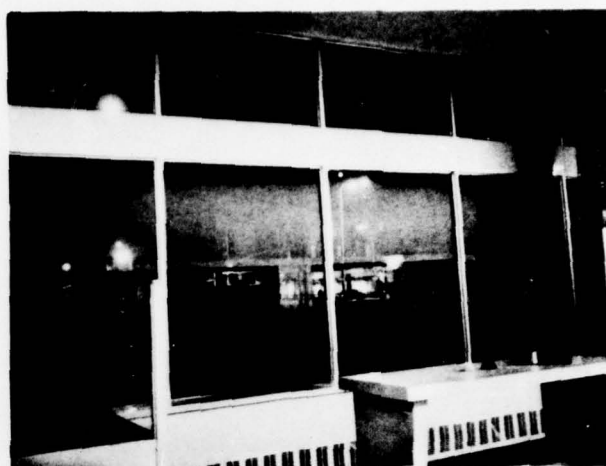
Figure 26.

Figures 23 and 24 are thermograms of the lower sections of the east-facing stationary single-pane windows in the Post Office lobby. Arrows identify a plume of heat rising from the convectors directly under these windows. Figure 25 is a thermogram of the top section of one of these windows. The arrows locate the warm spots on the glass due to the heat rising from the convectors. Figure 26 is a photograph of these windows.
