DEGRADATION OF COATING ALLOYS IN SIMULATED MARINE ENVIRONMENTS

R.H. Barkalow and F.S. Pettit Pratt & Whitney Aircraft Division United Technologies Corporation 400 Main Street East Hartford, Connecticut 06108

15 June 1978

Final Report: 1 March 1976 to 1 March 1978

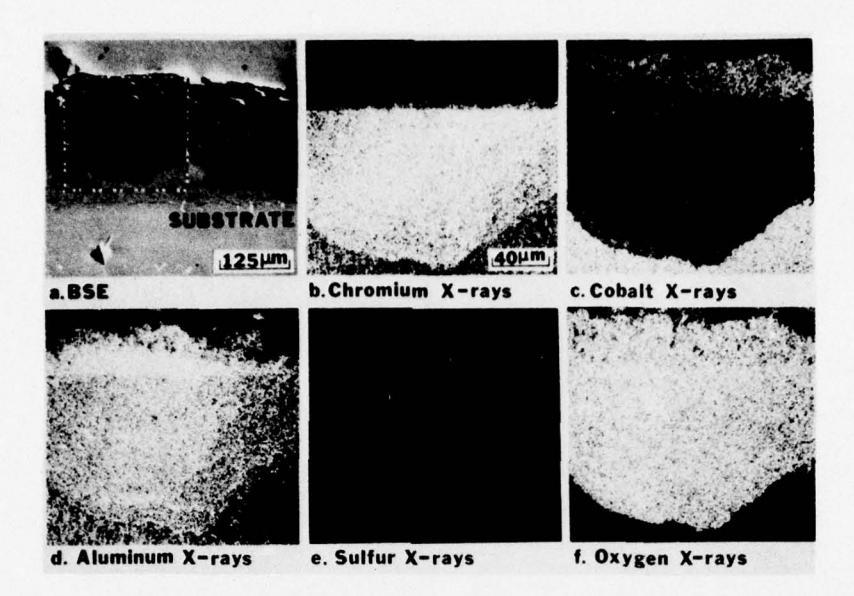
Figure 2 presents low magnification x-ray area scans showing the entire depth of a protrusion and oxide mound. It is evident that the volume of the protrusion is primarily Cr_2O_3 with relatively little CoO; conversely the oxide mound contains CoO but very little Cr_2O_3 (Figs. 2b, 2c). Aluminum oxide is present in both the protrusion and the mound; aluminum enrichment delineates the attack front in some areas and several lines of Al concentration in the protrusion presumably mark prior locations of the scale/metal interface (Fig. 2d). Sulfur appears to be concentrated at the attack front, although the entire boundary of the protrusion is not uniformly well defined in X-ray images (Figure 2e).

Figure 2. Low magnification X-ray images showing composition of oxides in coating protrusion and overlying mound. Box in (a) is area of X-ray scans.

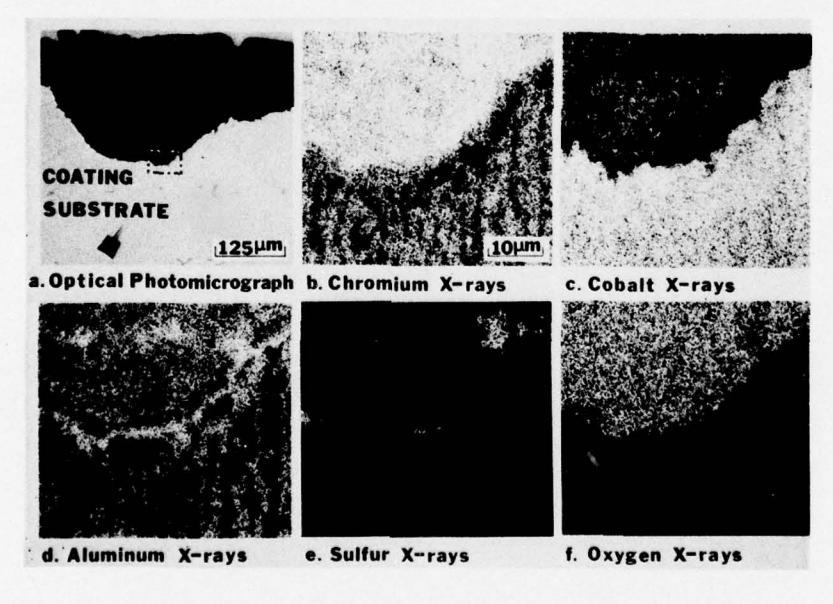
The distribution of Cr, Co, Al, S, and O at the scale/metal interface is shown by the high magnification X-ray images in Figure 3 (the area ill-

ustrated is approximately that of Fig. 1d). The scan for chromium (Fig. 3b) suggests that the α -Co phase immediately in contact with the scale may be depleted in Cr, but there is otherwise no indication of a Cr gradient in the coating. The scale/metal interface is sharply defined by Co depletion in the protrusion (Fig. 3c) as well as by Al enrichment (Fig. 3d); however, the entire periphery of the protrusion is not marked by Al enrichment as prominent as that in the area of Fig. 3d. Sulphur is likewise non-uniformly concentrated in the scale at the attack front (Fig. 3e), apparently in areas also rich in aluminum. Oxygen is present up to the scale/metal interface (Figure 3f).

Figure 3. High magnification X-ray images showing element distribution in attack front at bottom of coating protrusion. Area of X-ray scans (box in 3a) is approximately that of Fig. 1d.

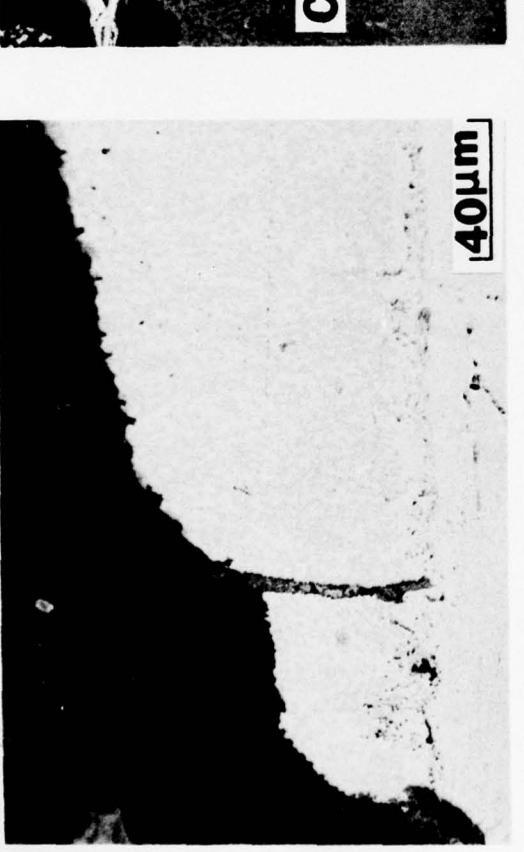
7a. Penetrated coating at leading edge

Figure 7. Microstructure near failed leading edge of PWA 68-coated Mar-M509 first stage vane operated 2770 hours in Asiafreighter engine. Area of 7c is shown in X-ray images of Figure 8.

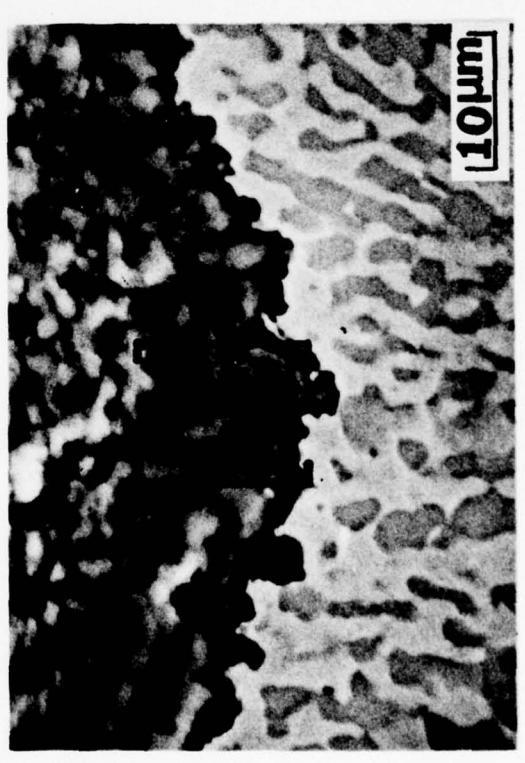
7c. Scale/metal interface; boxed area in 7b

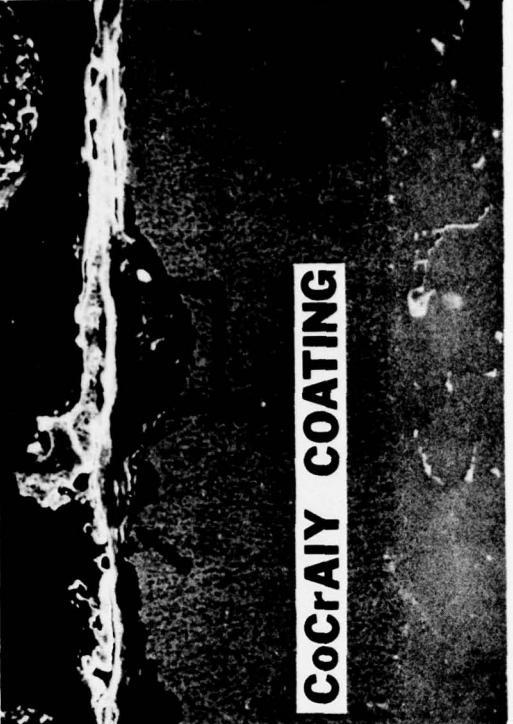
7b. Typical nodular attack and surface corrosion products near leading edge

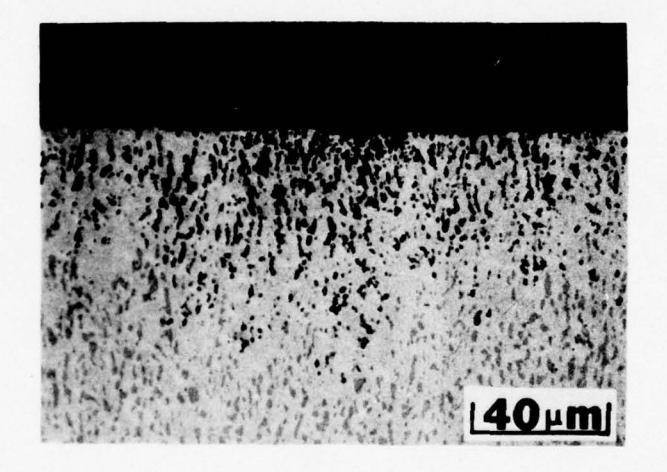
Figure 9. Surface microstructure of Co-25Cr-6Al-0.5Y after cyclic hot corrosion testing for 500 hours at 649° C (1200°F). Salt deposits were (a) 100% Na₂SO₄, (b) Na₂SO₄ - 1% NaCl, and (c) Na₂SO₄ - 10% NaCl.

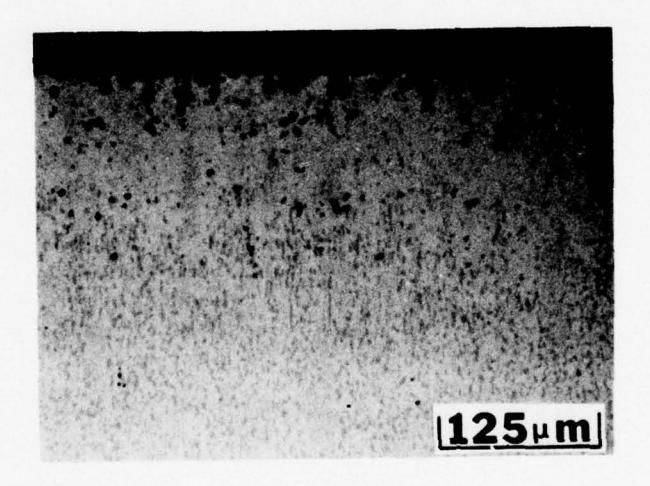
Figure 10. Surface microstructure of Co-25Cr-6Al-0.5Y after cyclic hot corrosion testing for 500 hours at 899° C (1650°F). Material, test conditions, and salt deposits are the same as those of Fig. 9 except for the higher temperature.

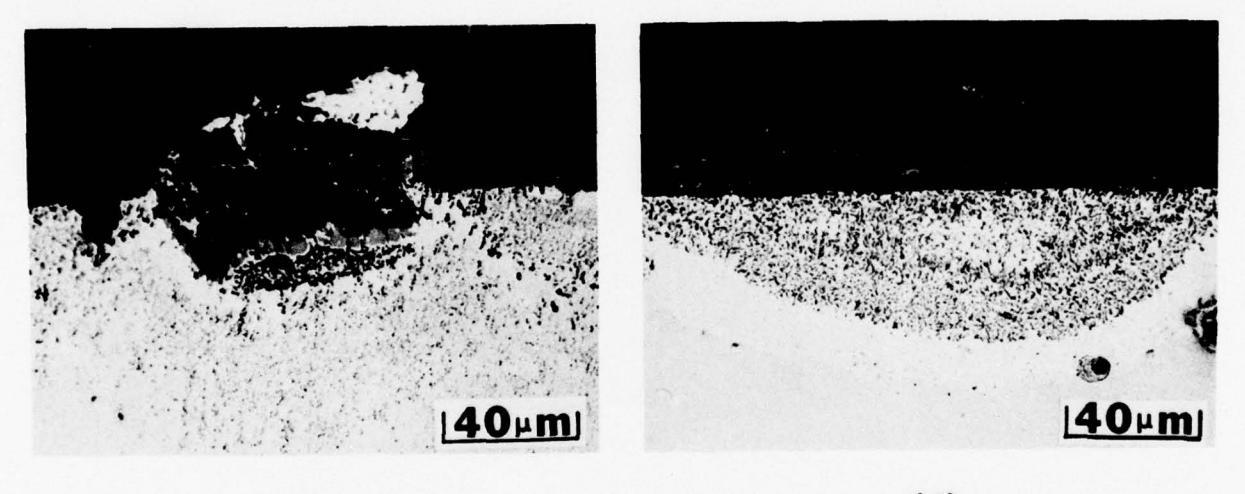
Figure 12. Surface condition and corresponding microstructures of uncoated IN 738 (Ni-16Cr-8.5Co-3.4Ti-3.4Al-1.75Mo-2.6W-1.75Ta-0.12Zr-0.85Nb-0.012B after 300 hour hot corrosion test at 899° C (1650° F). Specimens were washed and recoated with 1 mg/cm² of Na₂SO₁ every 20 hours. The specimen heated in air containing about 300 ppm NaCl vapor was less attacked than that exposed in chloride-free air.

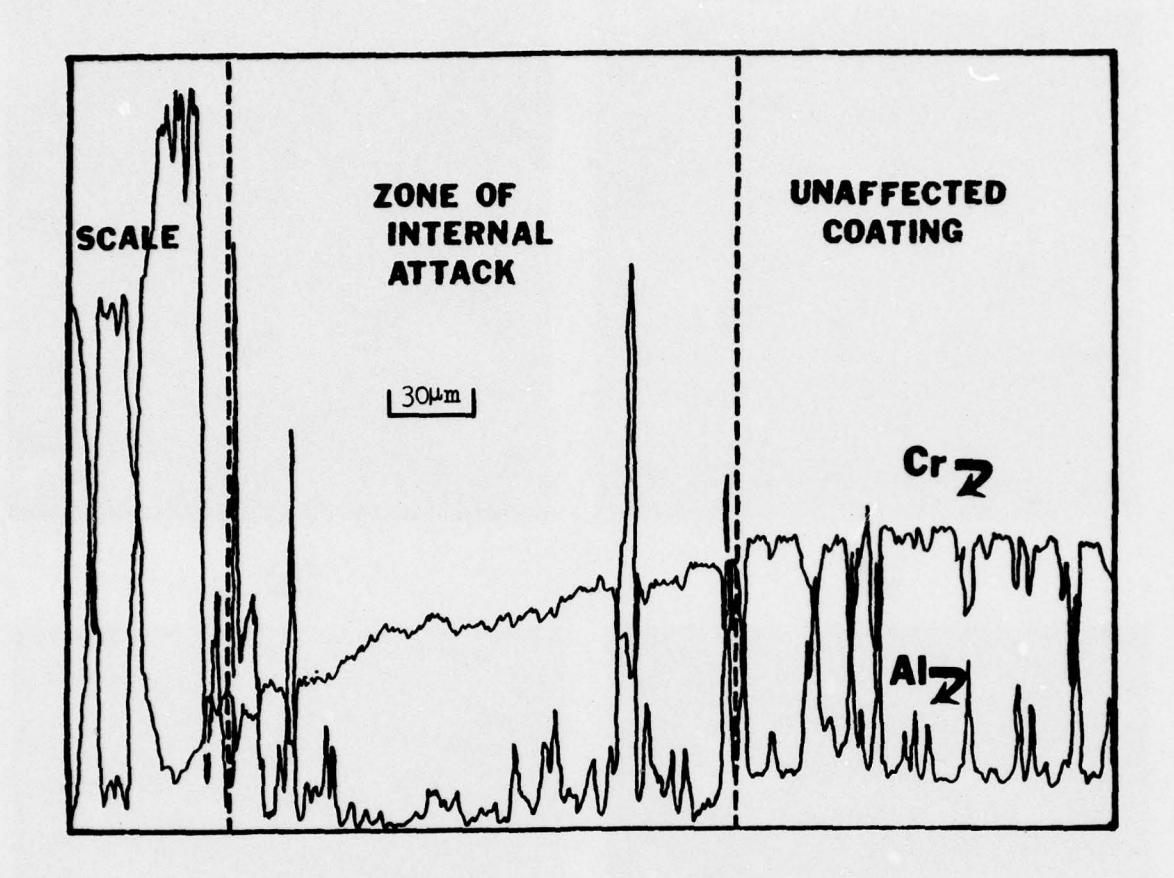
Figure 17. Semiquantitative line scans for Cr and Al in the specimen of Figs. 15 and 16. Peaks and valleys in unaffected material reflect different Cr and Al content of the α -Co and β -CoAl phases but a uniform average composition. Zone of internal attack includes Al-rich phases, but Cr content decreases smoothly across the zone.

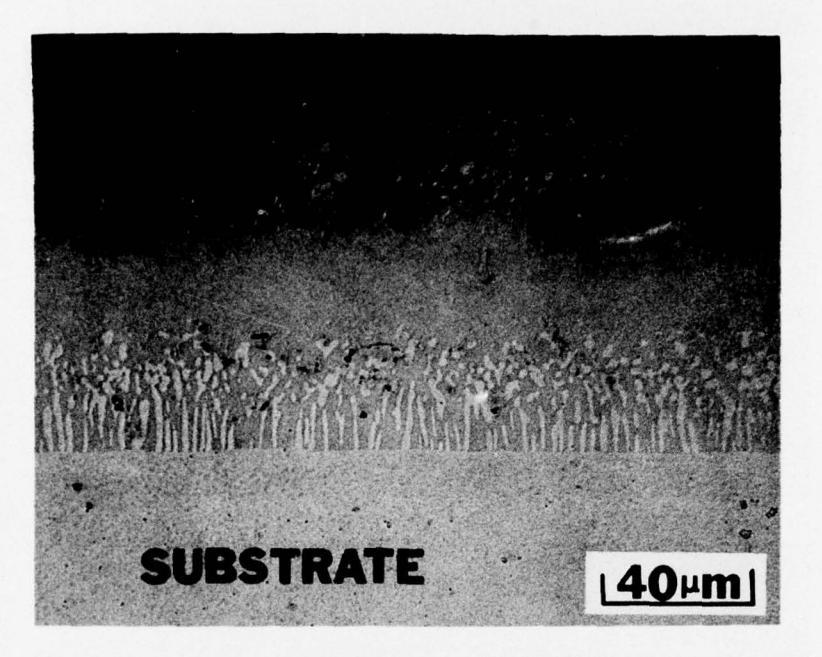
Figure 24. Pre-test microstructure of PWA 273 diffusion aluminide coating on IN 738 substrate.

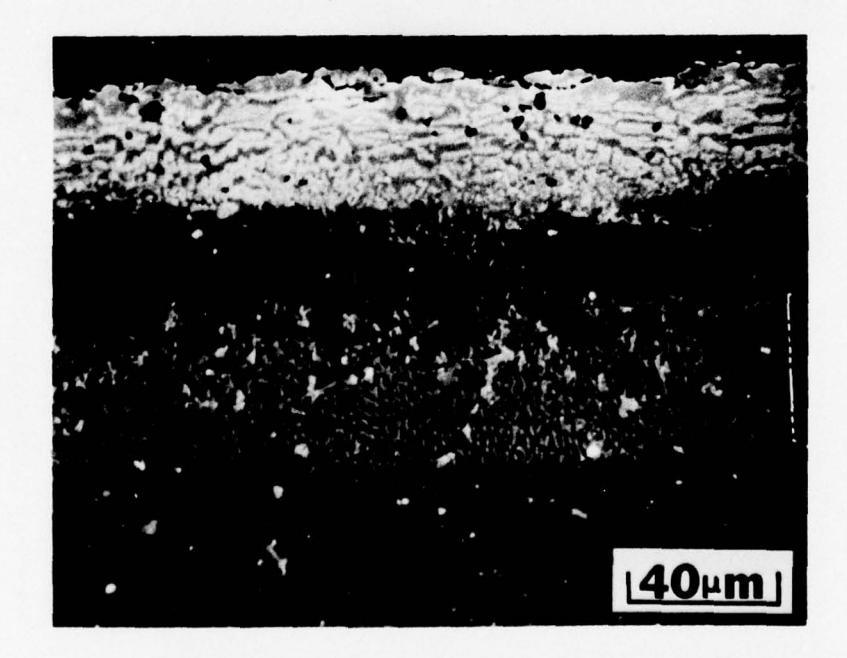
Figure 25. Scanning electron micrograph (secondary electrons) of LDC-2A coating. Note layered structure similar to FWA 273 but with Pt-rich phases in the outer layer.

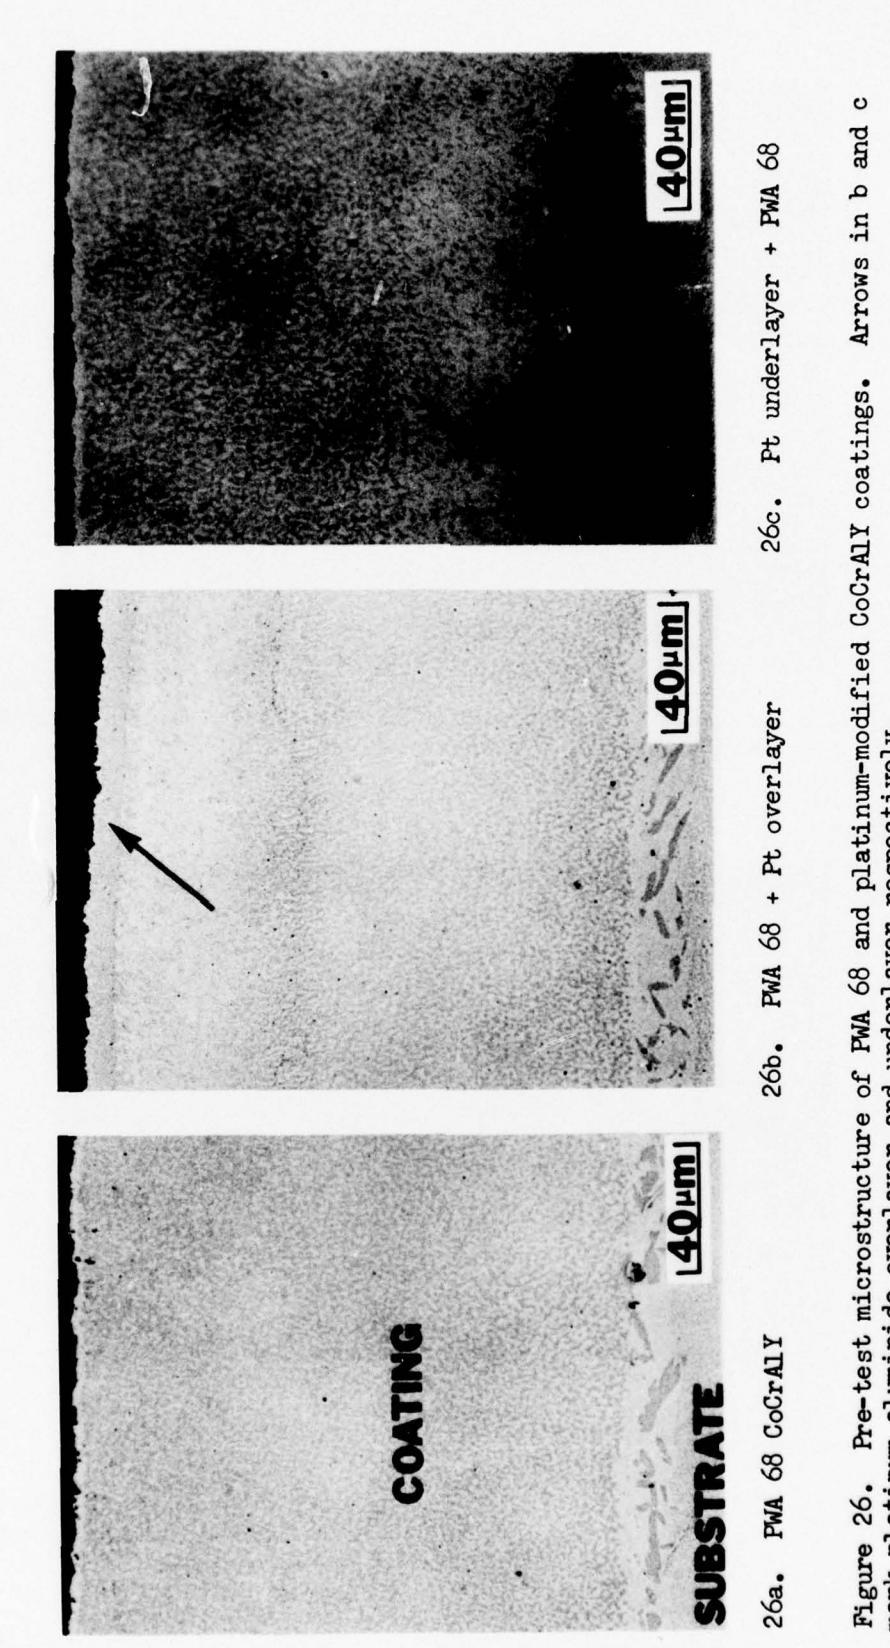
Figure 26. Pre-test microstructure of PWA 68 and platinum-modified CoCrAlY coatings. Arrows in b and c mark platinum aluminide overlayer and underlayer respectively.

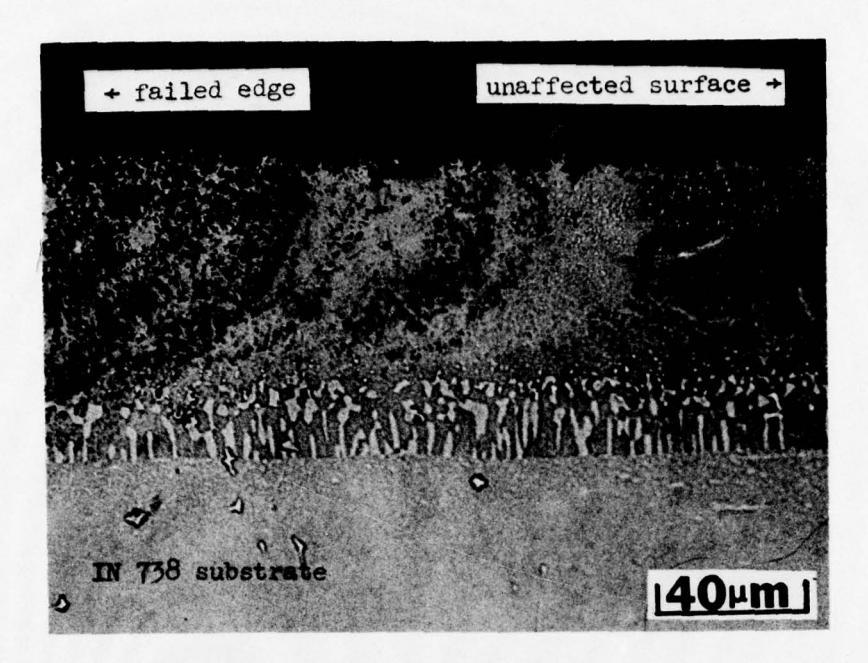
36a. Oxidation at edge of coupon

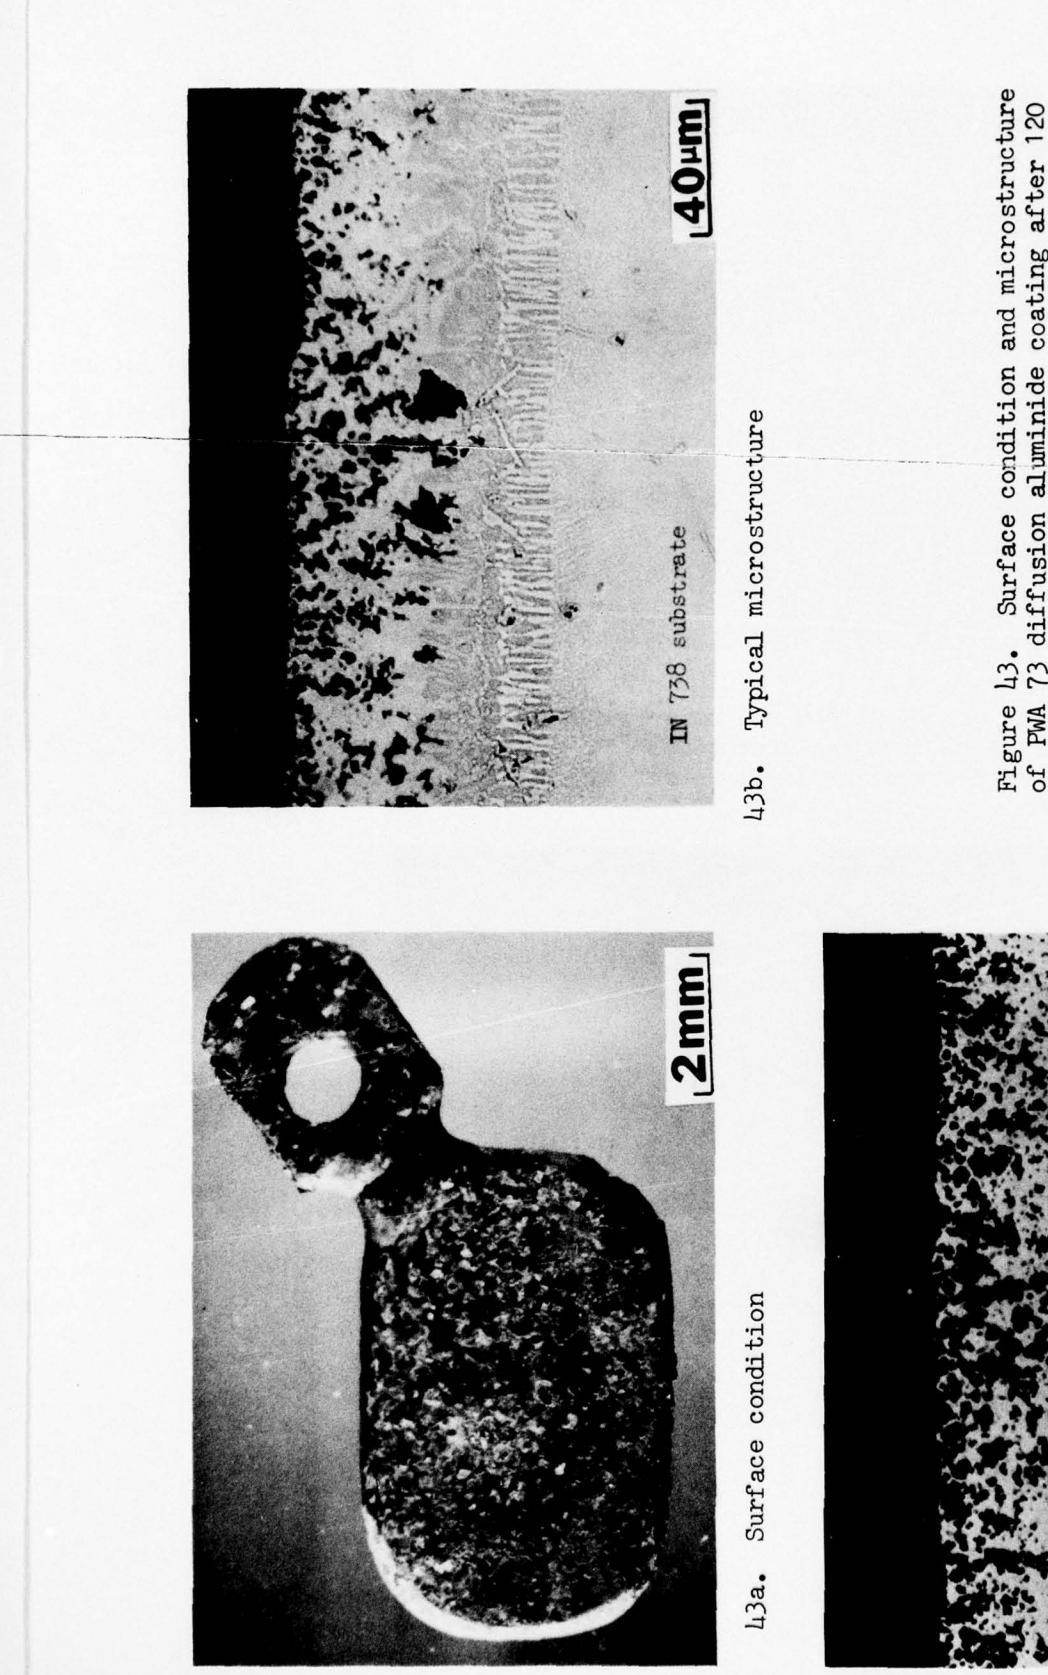
Figure 43. Surface condition and microstructure of PWA 73 diffusion aluminide coating after 120 hours in 899°C cyclic hot corrosion test with Na_SO₄ - 50% NaCl. Test was terminated due to general surface degradation and corner failure.

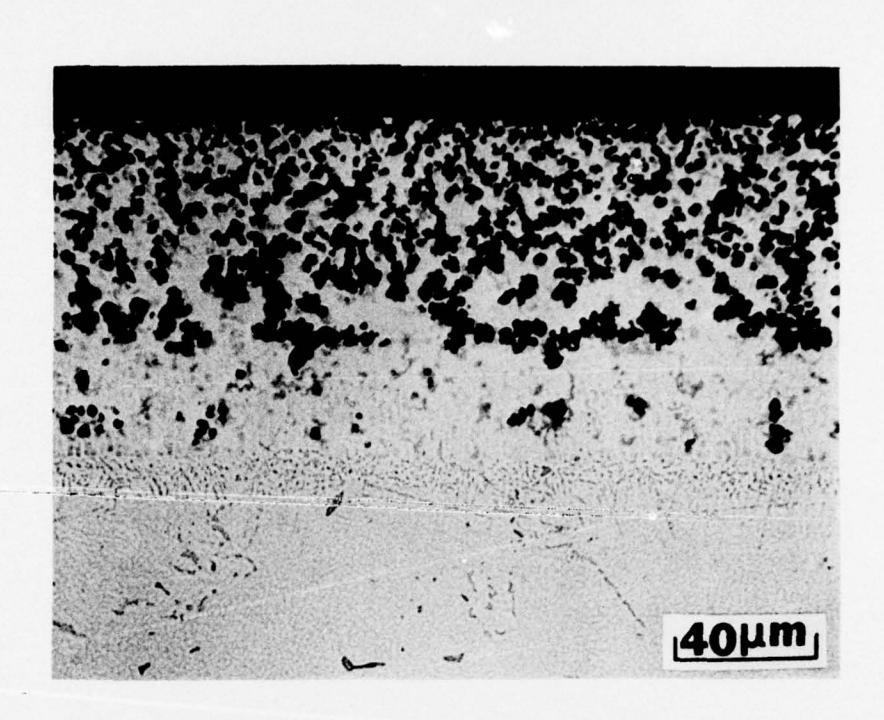
44a. 1000 hours

Figure 44. Microstructural degradation of PWA 273 diffusion aluminide coating in $899^{\circ}C$ (1650°F) cyclic hot corrosion test with Na₂SO₄ - 50% NaCl.

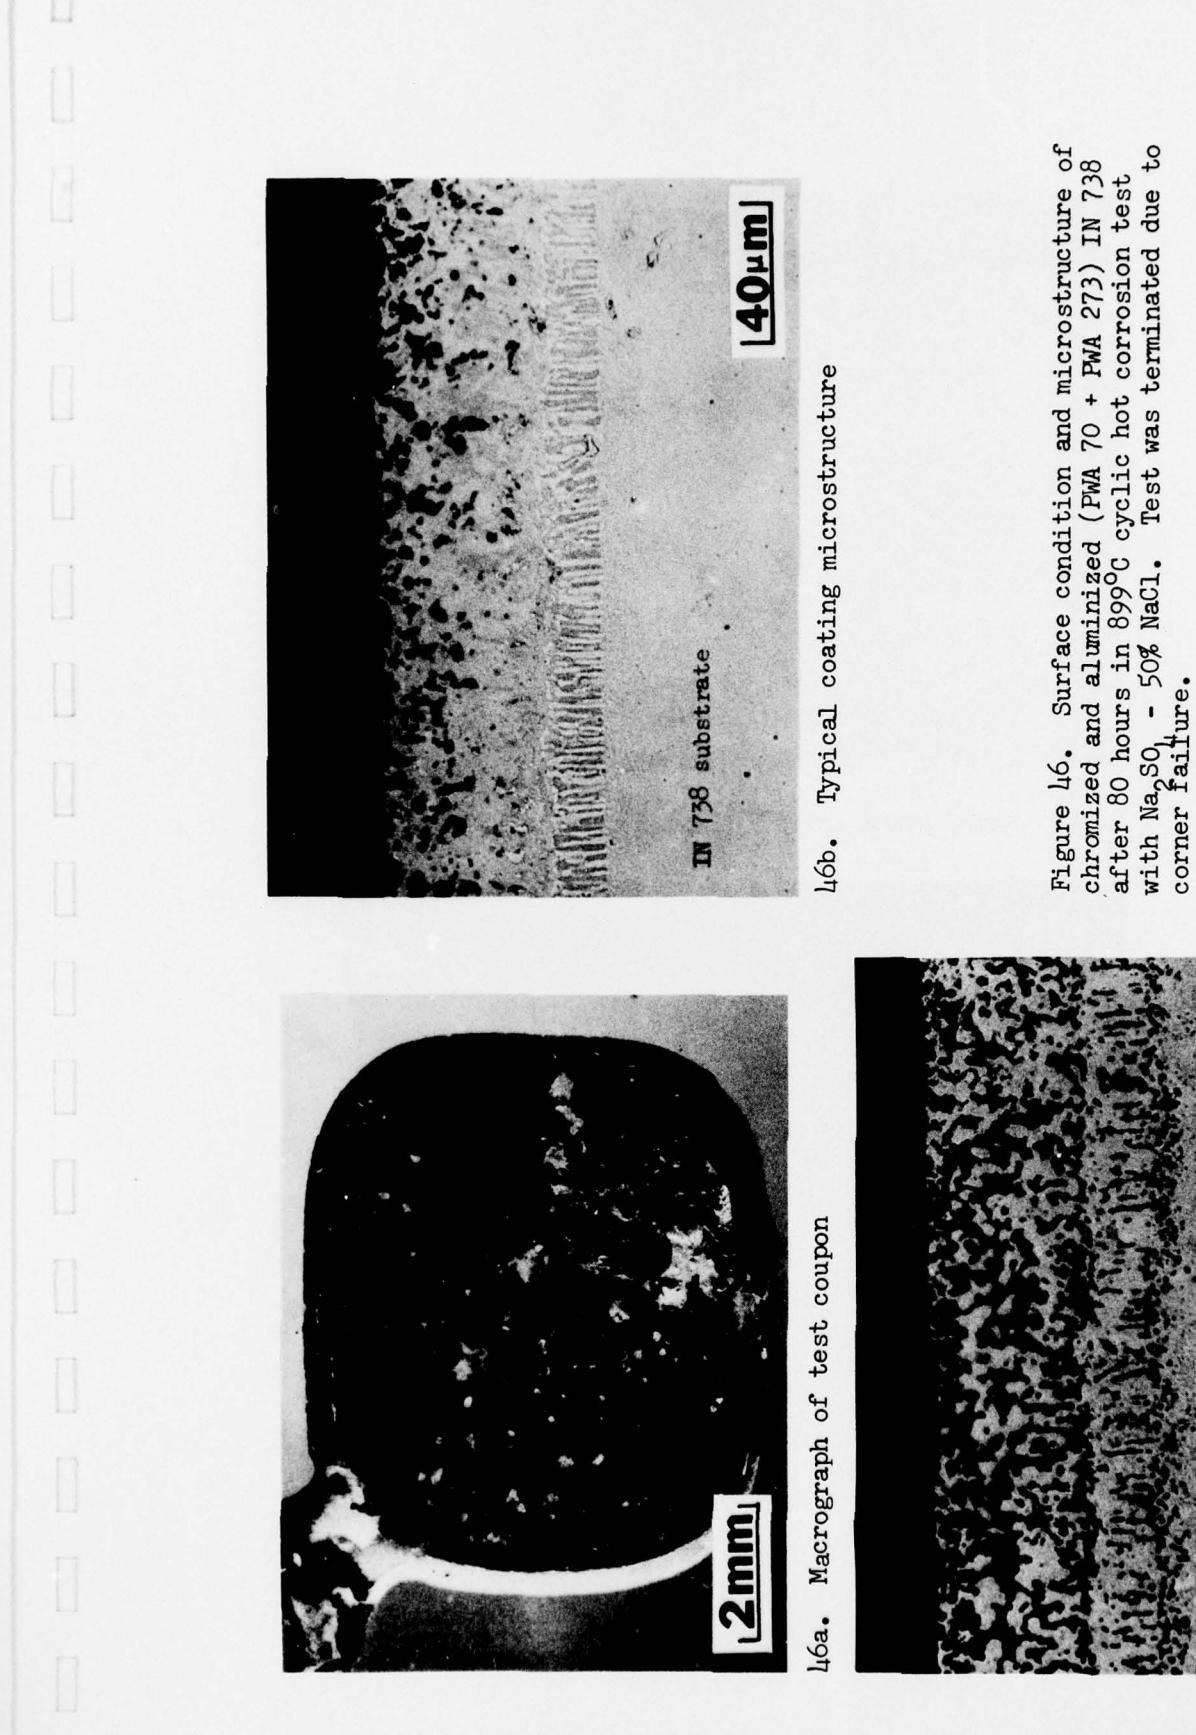
Microstructure at failed corner 46c.

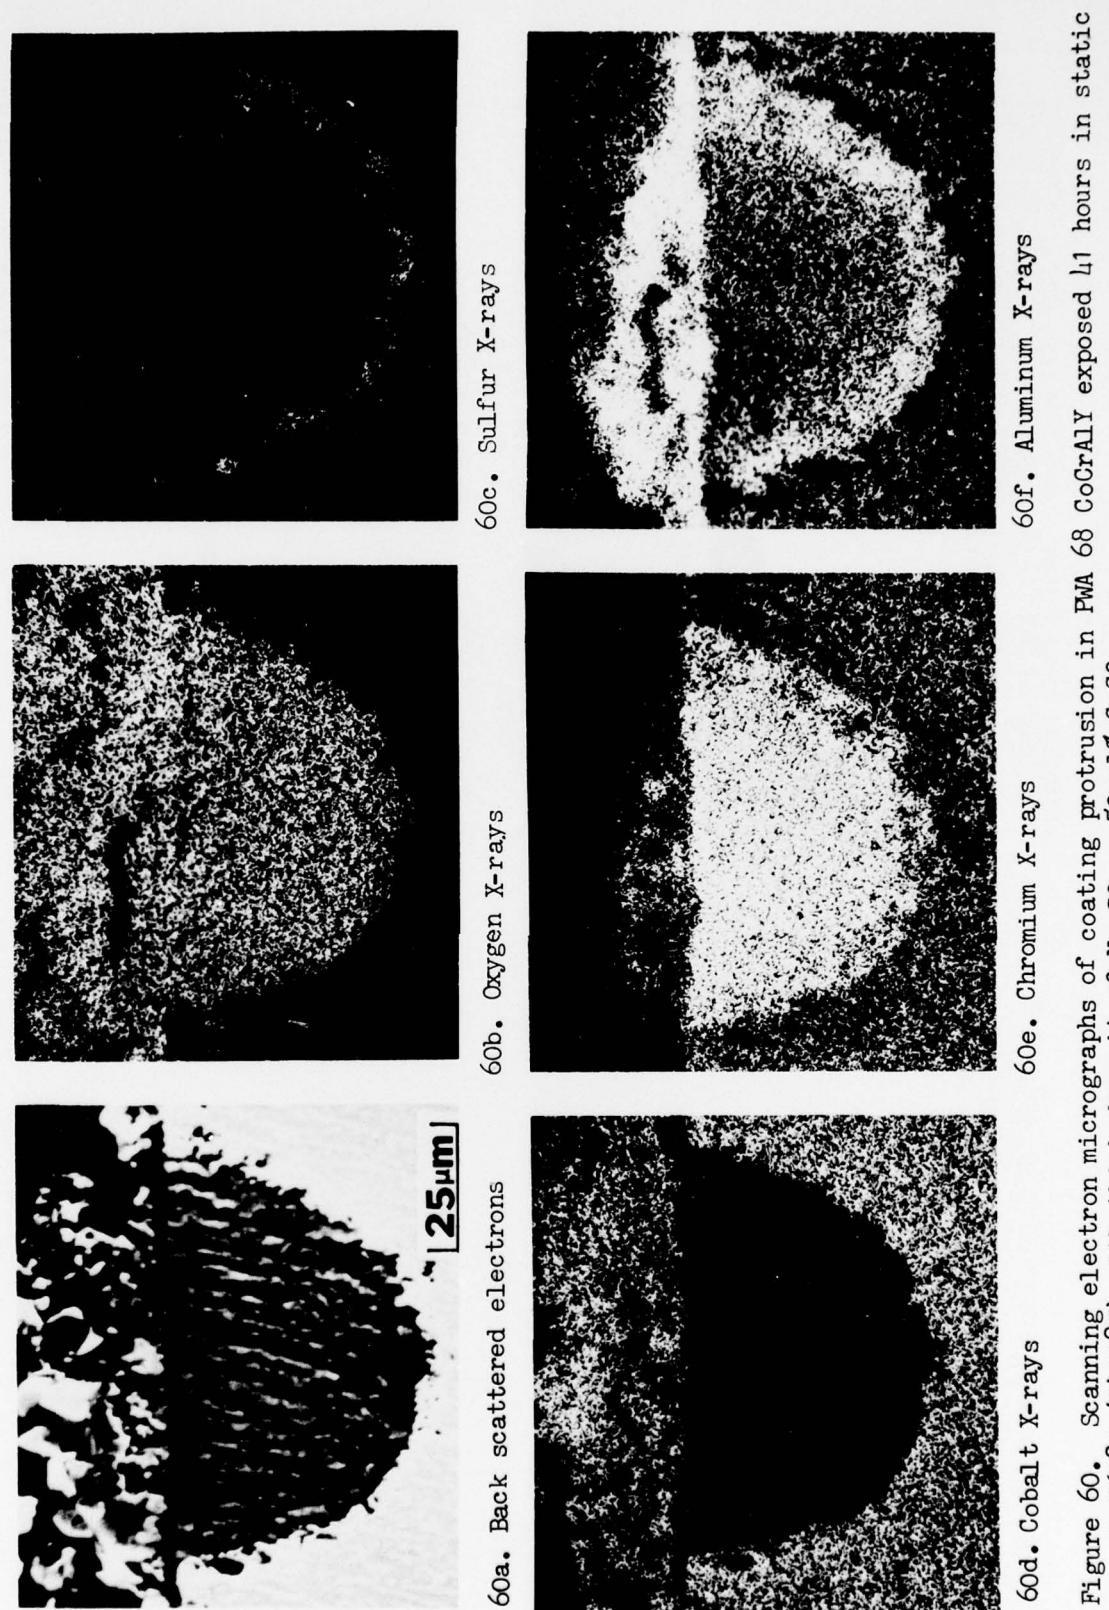
Figure 60. Scanning electron micrographs of coating protrusion in PWA 68 CoCrAlY exposed 41 hours in static air at 760° C (1400^oF) with thick deposit of Na₂SO₄ - 50mol% CoSO₄.

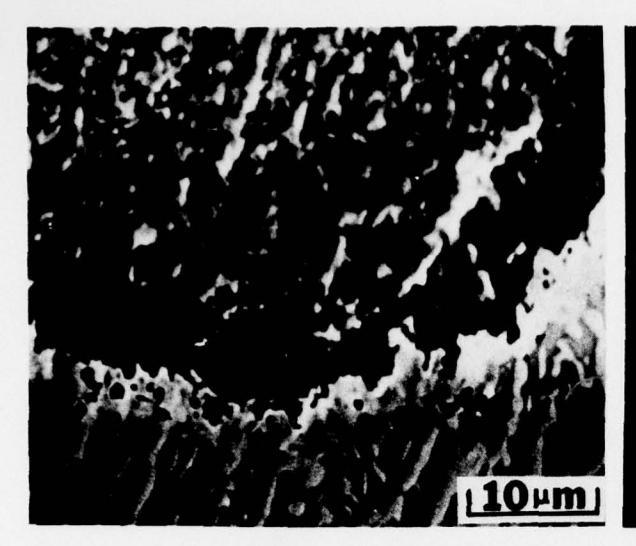
61a. Secondary electrons

Figure 61. Microstructure and element distribution of attack front in coating protrusion developed by 760° C exposure to thick deposit of Na₂SO₄ - 50 mol% CoSO₄. Entire protrusion and overlying oxide mound are shown at lower magnification in Fig. 60.

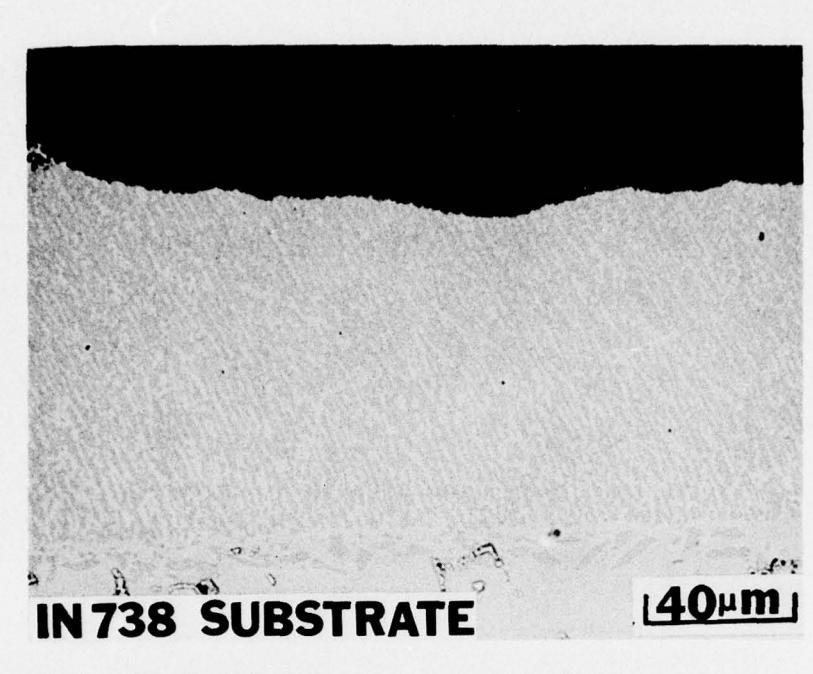
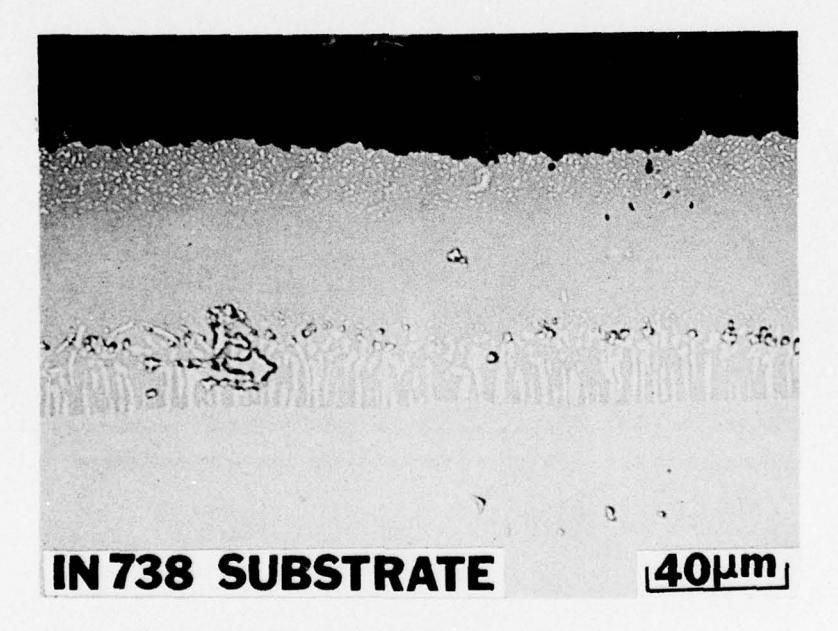
The initial experiment was run at a very high SO₃ pressure (~ 0.2 atm) to determine in a short testing time if attack would occur at a low temperature (649°C, 1200°F) where a thin Na₂SO₄ deposit heated in air is known to be innocuous. Both CoCrAlY (FWA 68) and a diffusion aluminide coating (FWA 273 on IN738) suffered significant microstructural degradation in 20 hours (Figure 62). Except for a tendency to general surface degradation rather than localized, nodular attack, the microstructure of the attack front in the CoCrAlY coating appeared very similar to those observed in the mixed sulfate experiment and in service hardware.

Figure 62. Attack of CoCrAlY and Ni-base diffusion aluminide coatings produced in 20 hour test at 649° C. Samples were coated with $\sim 1 \text{mg/cm}^2$ deposit of Na₂SO₄ and exposed to ~ 0.2 atm SO₃ pressure.

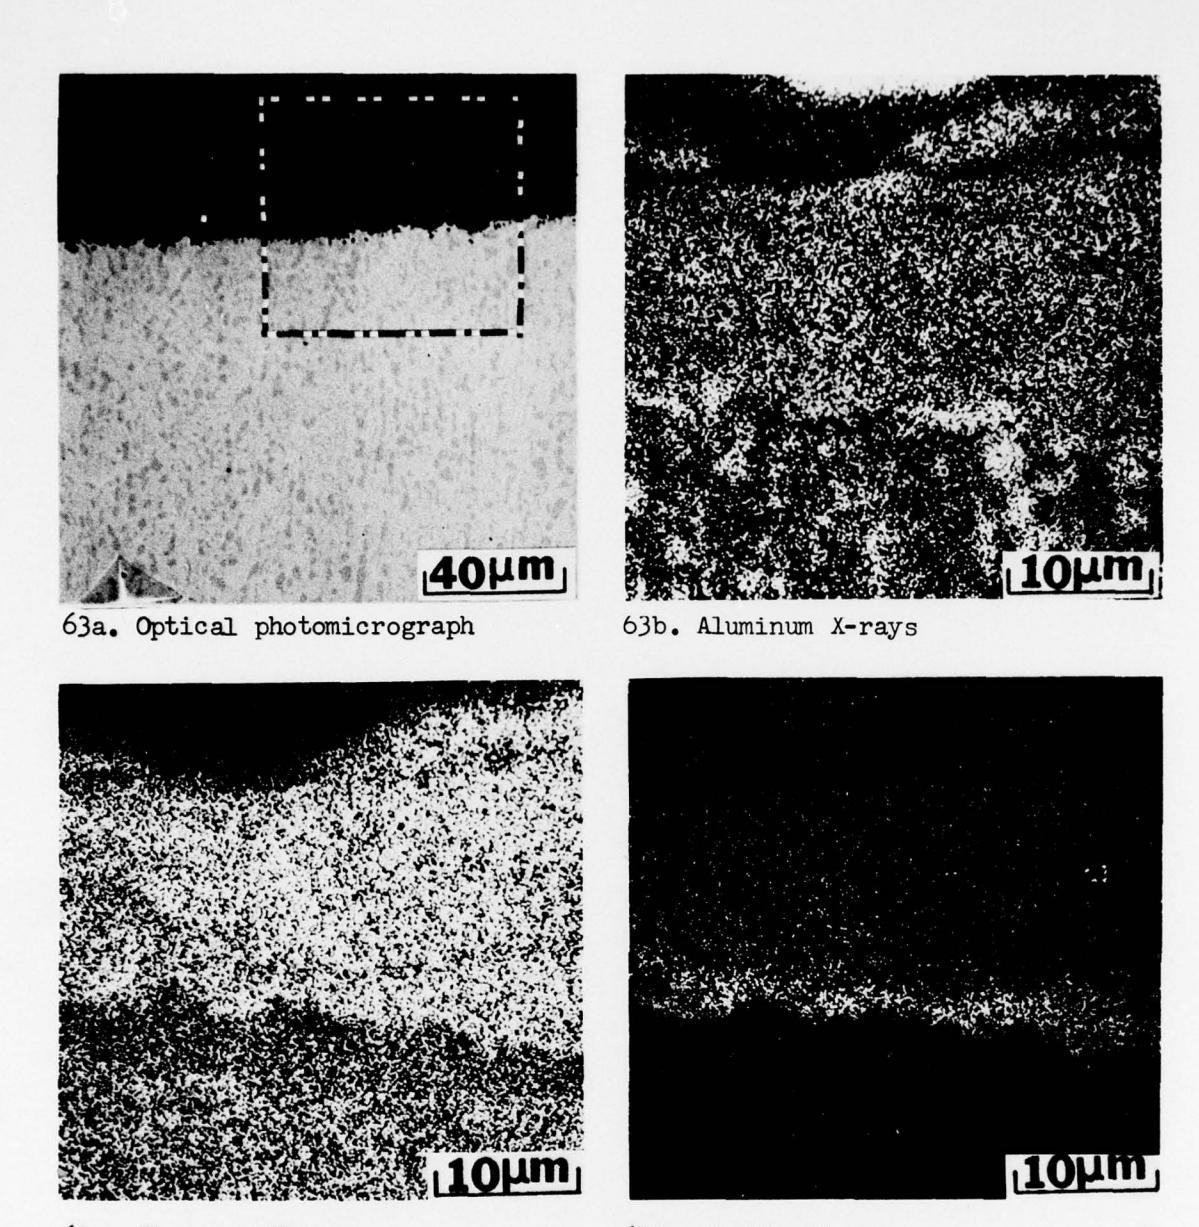
Specimens of bulk Co-25Cr-6Al were coated with ~ 1 mg/cm^2 of Na₂SO₄ and Na₂SO₄ - 50% NaCl and exposed for 100 hours (5 cycles with washing and reapplication of fresh salt every 20 hours) at 649°C. The rate of attack was less at the lower SO₃ pressure, but the nature of the scale and the attack front was apparently the same. Also significant was the virtually identical degradation of the specimens coated with sulfate and sulfate-50% chloride (Figures 63, 64), the sulfate-chloride specimen exhibiting substantial scale formation but no evidence of the porous zone of internal attack characteristic of chloride-induced dealloying.

Figure 63. Hot corrosion of Co-25Cr-6Al produced in 100 hour (5 cycles with fresh Na₂SO₁ salt applied every 20 hours) test at 649° C with $p_{SO_3} = 0.04$ atm. Box in 63a is approximate area of X-ray images showing Al- and Cr-rich scale and concentration of S at the scale/metal interface.

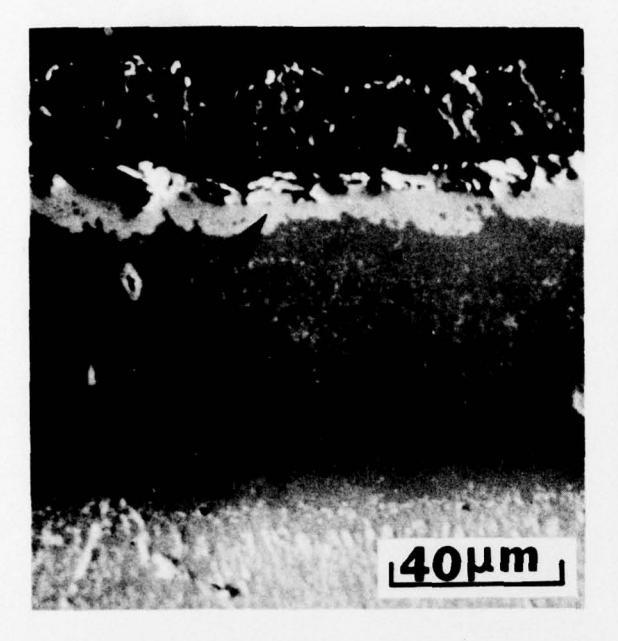
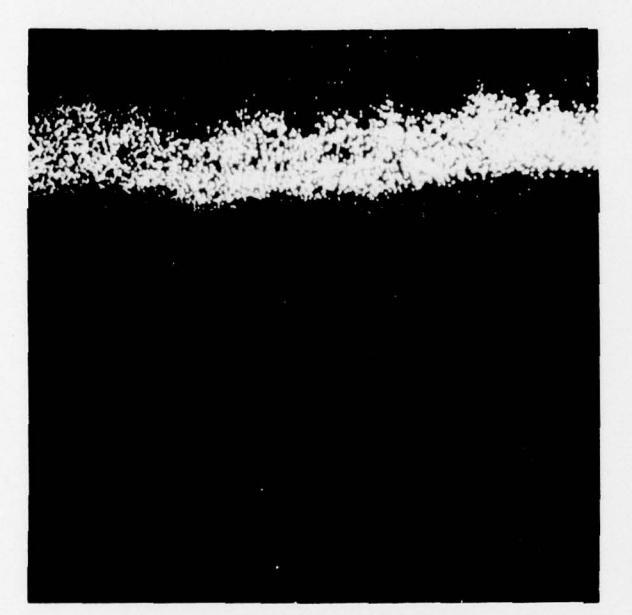
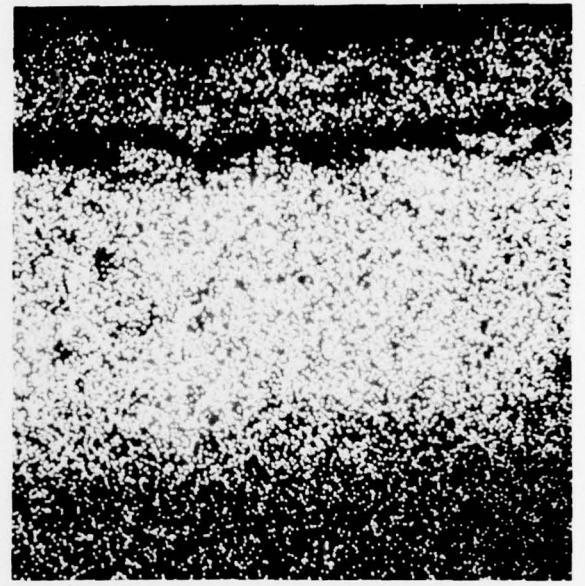
Somewhat surprisingly in view of the ineffectiveness of the Pt overlayer on CoCrAlY, the Pt-modified FWA 273 appeared distinctly better than the other aluminides. The initial visual inspection at 20 hours suggested relatively little degradation, although there was some evidence of selective attack after 100 hours. Metallographic examination showed a Pt-rich surface layer generally unaffected except for a thin scale (Figure 71).

Figure 71. SEM photomicrographs of sputtered platinum + PWA 273 diffusion aluminide coating tested concurrently with the specimens of Fig. 70. Residual salt and surface scale are evident on the dry-polished sample, but a Pt-rich surface layer (arrow) is still intact and there is minimal dealloying of the β -NiAl.

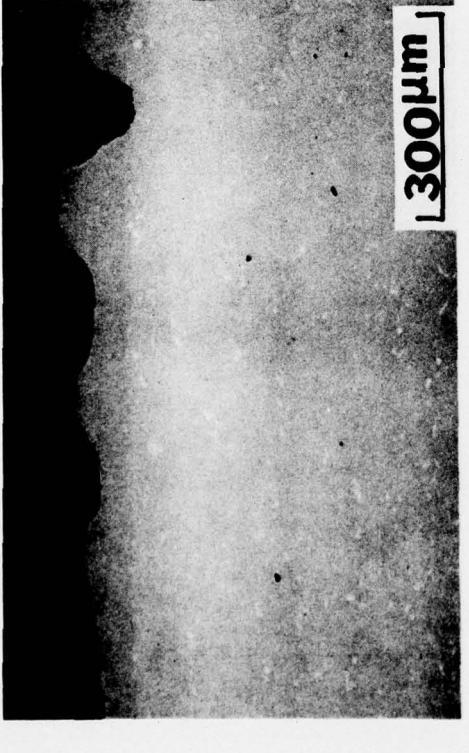
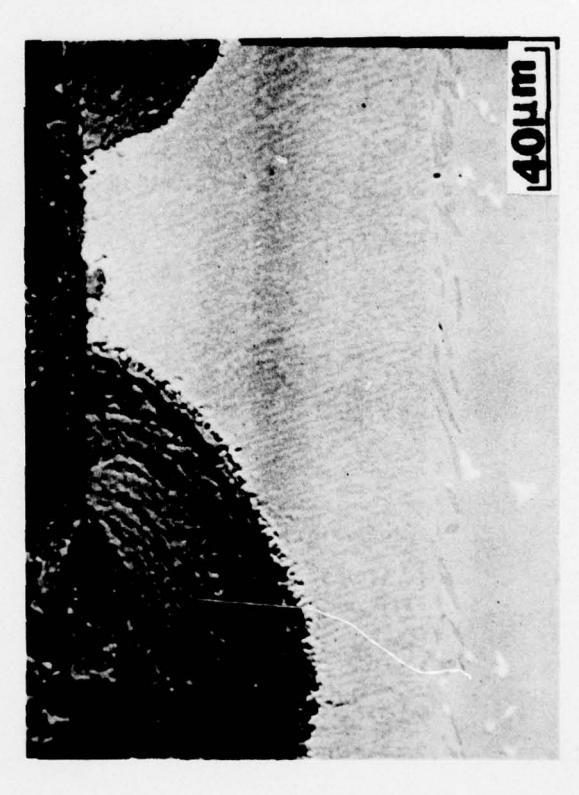
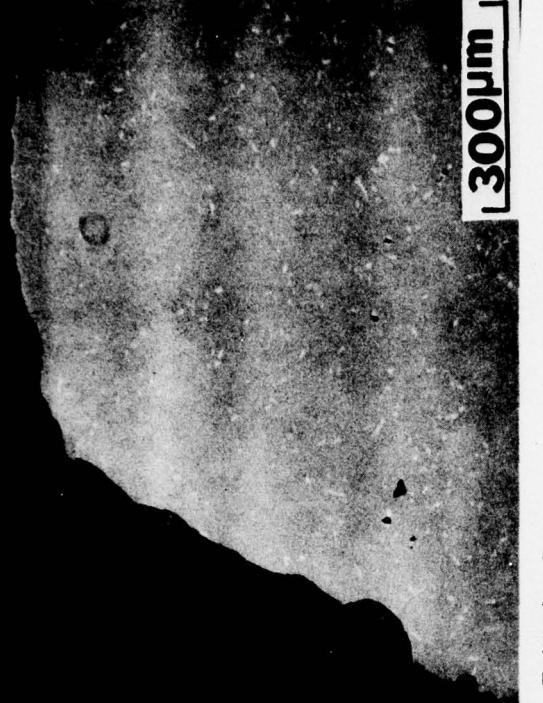
b. Failed edge

Figure 73. CoCrAlY-coated IN 738 exposed 40 hours at 760°C (1400°F) with Na₂SO₁ salt and SO₃ in the gaseous environment. Coating was penetrated in numerous areas and completely consumed on one edge of the coupon.

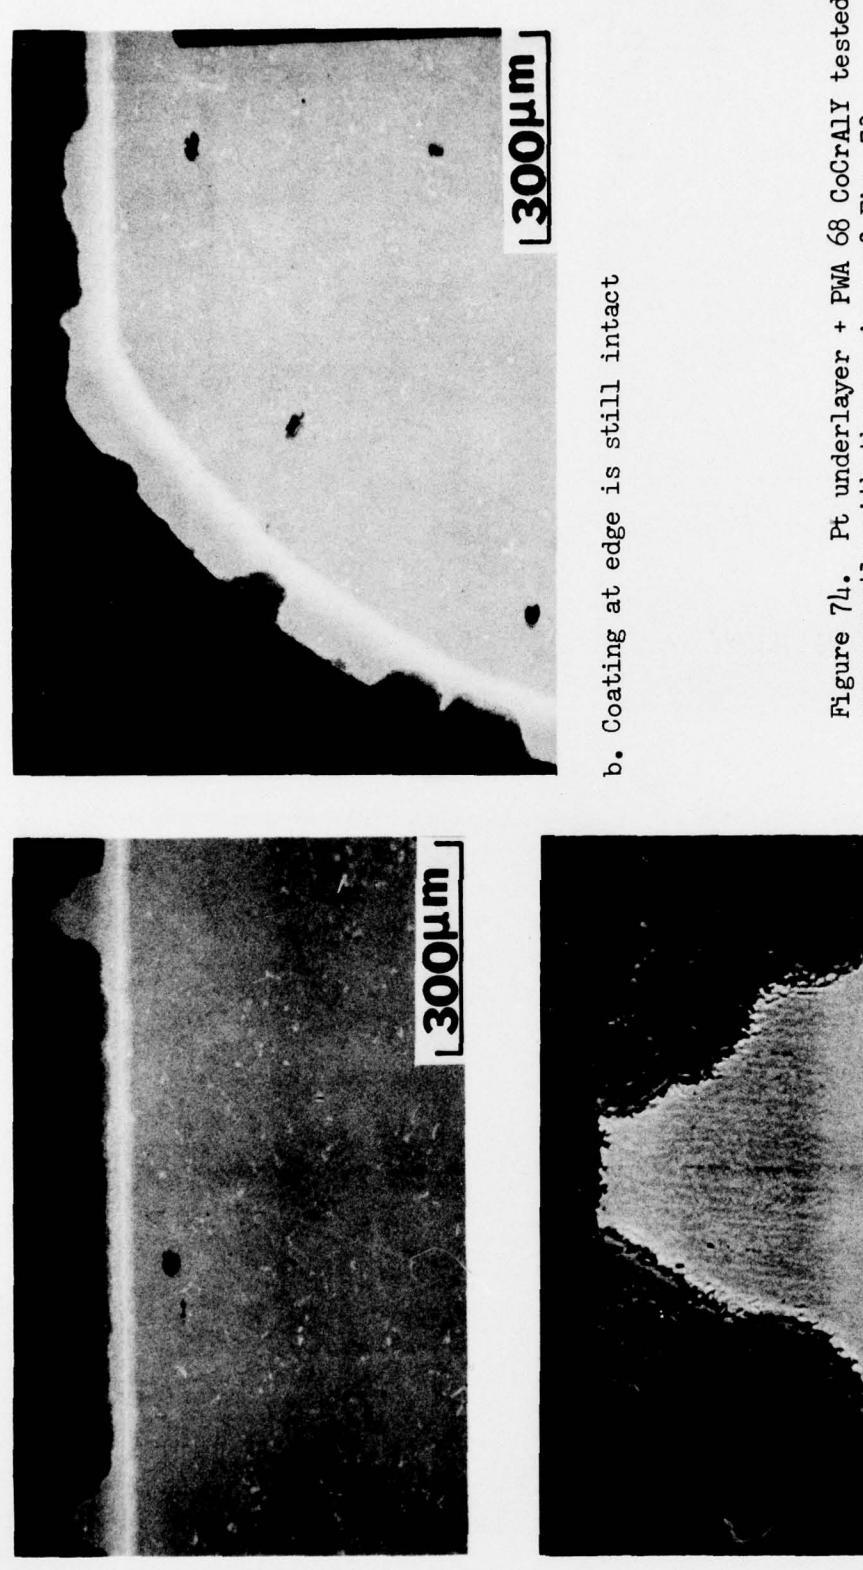
a. Typical protrusions and structure of scale/ metal interface

The Co-25Cr-6Al showed several areas of very deep, localized attack as in Figure 72b. Again there was a substantial β -depleted zone with precipitates of Cr-rich sulfides (black arrows); a layer of corrosion product immediately adjacent to the scale/metal interface was highly enriched in aluminum and sulfur (area scans not presented). Lastly, two specimens of FWA 68-coated IN738, one with a platinum underlayer, were tested at 760°C (1400°F); the equilibrated SO₂ pressure at this temperature is about 0.02 atm. Visual observations indicated the attack was more severe than at 649 or 899°C, and the test was terminated after 40 hours. Metallographic examination confirmed the extensive hot corrosion of both specimens. The FWA 68 coating was penetrated in numerous areas of highly localized attack, and the coating on one edge of the specimen was completely consumed (Figure 73). General surface degradation and material consumption was even more extensive on the specimen with the platinum underlayer, and two sites of penetration into the substrate were observed on the plane of polish being examined. However, there was a striking tendency for the attack front to stop at the platinum-containing diffusion zone, even on the curved edge which is almost always the initial site of localized coating failure (Figure 74).

Figure 74. Pt underlayer + PWA 68 CoCrAlY tested concurrently with the specimen of Fig. 73. General surface degradation was equally extensive, but attack front tends to stop at Pt-containing zone.
