PASSAIC RIVER BASIN  
RAMAPO RIVER, BERGEN COUNTY  
NEW JERSEY

# LAKE VREELAND

## PHASE I INSPECTION REPORT NATIONAL DAM SAFETY PROGRAM

JULY 1978

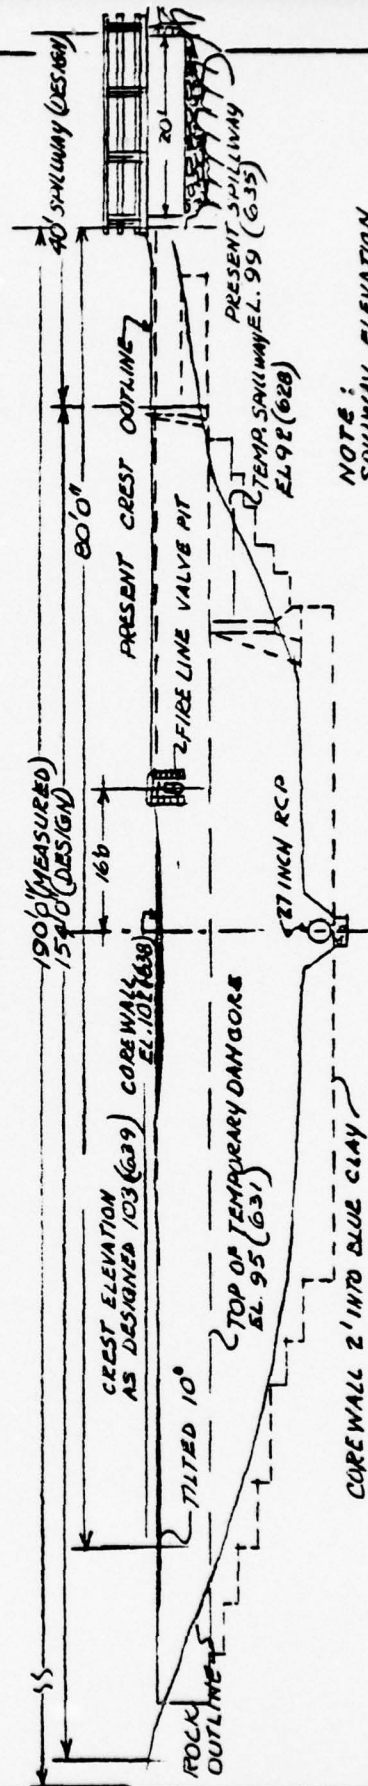
COREWALL OUTLINE  
SCALE 1 INCH = 20 FEET  
SOURCE: DNB 57704

3.1.1 Dam: Some sink holes as large as 9 inches in diameter were observed along the top of the dam. These sink holes were present chiefly along the downstream side of the concrete corewall and the upstream edge of the crest. A section of the exposed corewall on the south side was tilted about 10 degrees toward the downstream. The ground surface at the crest and the top of the corewall were not uniform, which may indicate the results of differential settlements. The downstream embankment varied considerably in slope, material composition and gradation, and method of construction. The material exposed along the downstream slopes is composed chiefly of silty sand, gravel, and boulders. The junction of the embankment and abutment did not show any seepage at the time of inspection. Seepage was not observed along the embankment slopes and toes. There is a small wet ditch located along the toe of the right valley wall at the distance of about 20 feet downstream from the toe of the embankment. A group of intermittent springs with estimated flow of 15-20 gpm at the time of inspection has developed 220 feet downstream from the toe of the embankment at the center of the access roadway. Small amounts of leakage reported (see letter Page E-4, Appendix E) coming out of downstream toe along the concrete culvert pipe at the time of initial reservoir filling, was not discovered at this time of inspection. At a subsequent site visit by the inspection team on June 27, 1978, neither springs nor wet spots were visible.

d. Engineering investigations and studies should be made of the condition of the tilted concrete corewall as well as determination of the properties of the embankment as it pertains to the structure's stability. These investigations and studies should be completed within six months from the date of approval of this report. Any remedial measures found necessary as a result of these investigations and studies should be initiated within calendar year 1979.
