# LAKE VALHALLA DAM

## PHASE I INSPECTION REPORT NATIONAL DAM SAFETY PROGRAM

NJ 00330

JULY 1978

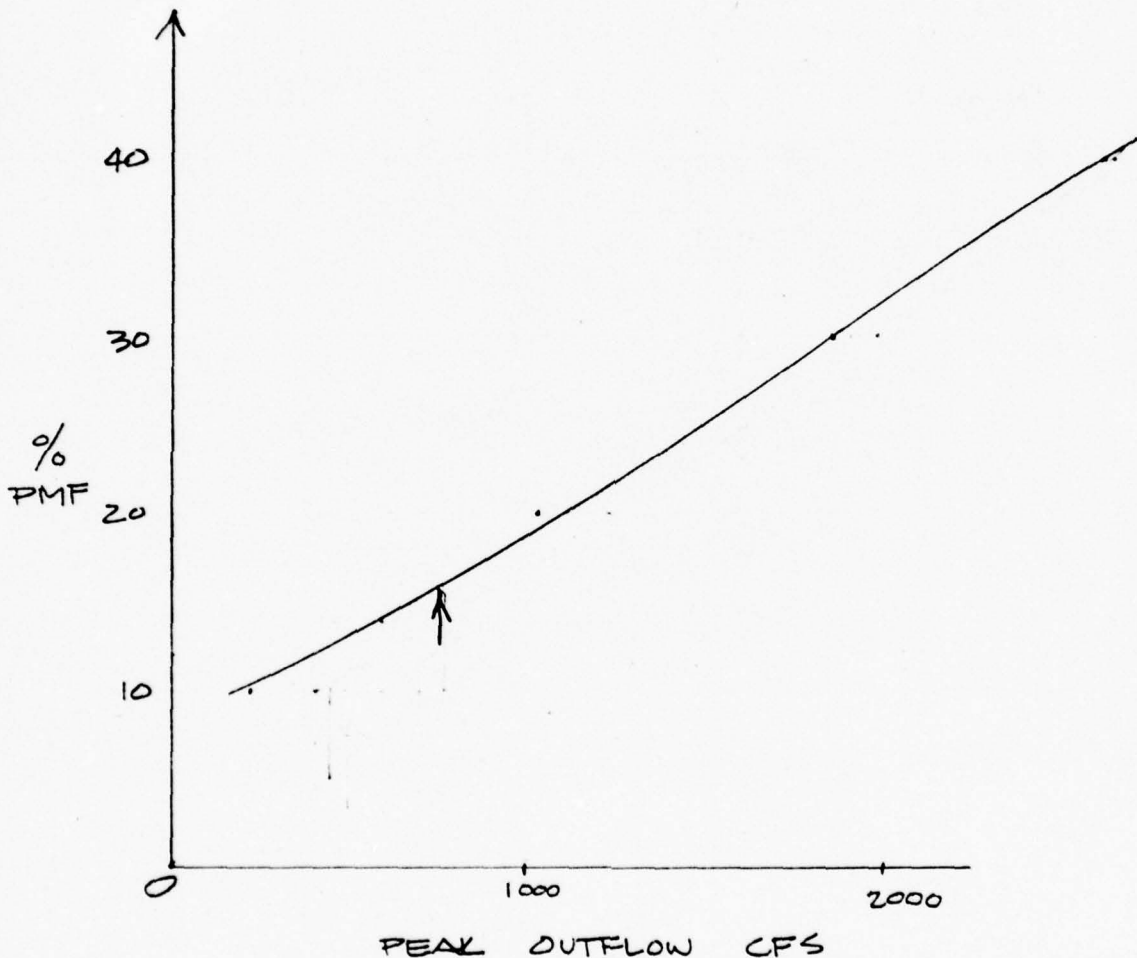
OVERTOPPING POTENTIAL

3. OVERTOPPING OCCURS AT EI 401' or 760 cfs  
 $\therefore$  DAM CAN PASS APPROX 16% OF PMF W/O OVERTOPPING
